# **MIR ENVIRONMENTAL EFFECTS PAYLOAD AND RETURNED MIR SOLAR PANEL CLEANLINESS**

Gale A. Harvey, Donald H. Humes, and William H. Kinard  
NASA Langley Research Center, Hampton, VA 23681-2199

## **ABSTRACT**

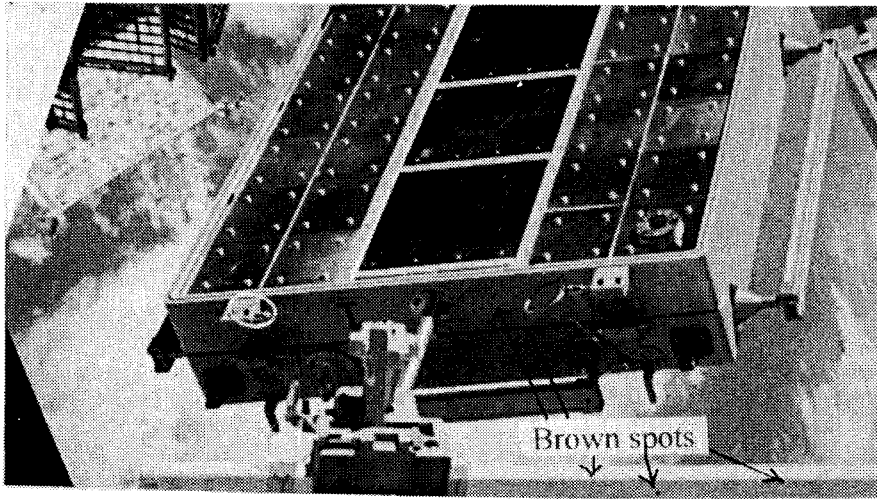
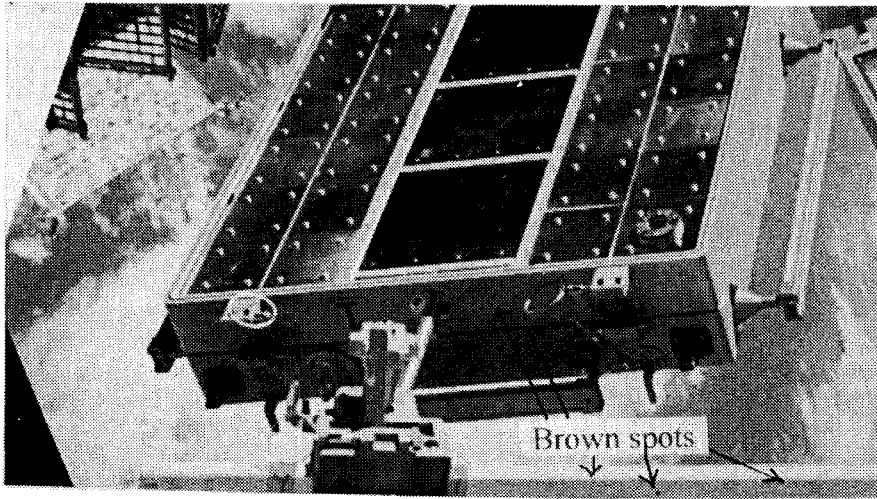
The PECs were bagged immediately after removal from the Orbiter upon return from space. The readily apparent spots and splashes on the PPMD experiment and on the PPMD PEC (Figure 2) were initially reported on at the ISS/MIR Space Environment Effects Workshop in Houston, TX in January 1998. The probable source of the water soluble residues on the PPMD was thought at that time to be Orbiter fluid waste dumps.

Figure 2.- STS 86 photograph of brown spots on PPMD and handrail.

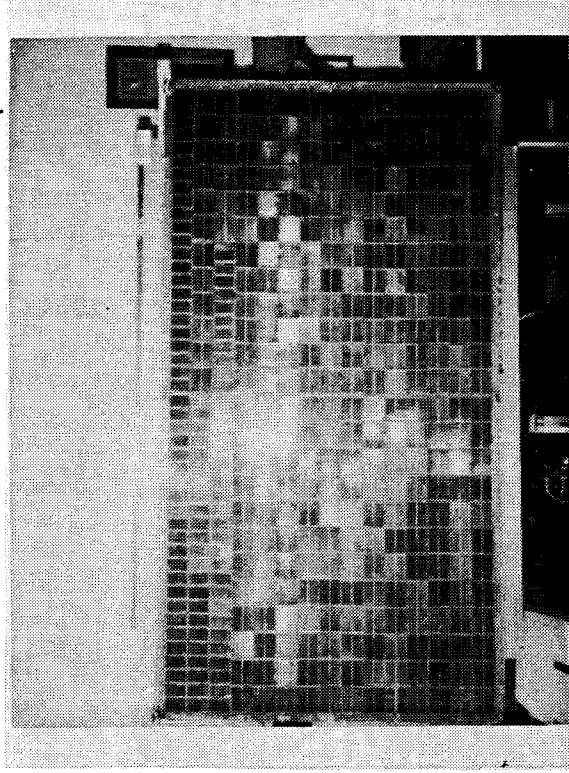
Section 8 (Figure 16) was removed from the solar panel and sent to Langley Research Center for microscopic examination and measurements of micrometeoroids and space debris impacts, and for cleanliness evaluation and contamination analyses. Section 8 was first examined visually with a six power comparitor (magnifying glass) and hand held illumination at oblique angles. About 95% of the solar cells have visible white backscatter on at least one edge of the cover glass. The white backscatter is mostly due to creep of the polymer potting between adjacent

solar cells onto the cover glasses, and from fine spray ejecta from discharges within the potting material. Amber and black particles are ejected from many of the discharge sites in addition to the fine spray (which is dark under normal [90°] illumination). However, many of the darker cells result from a darker silicon wafer within the cell rather than a coating or film on the cover glass. The brightness of the cells near the center of Figure 16 is an artifact of reflected light from the camera's flash.

Figure 16.- Photograph of section 8 of returned solar panel.
