Implementing recommendations of the Columbia Accident Investigation Board – development of on-orbit IR thermography

Brian P. Ottens^{*a}, Bradford Parker^a, Ryan Stephan^b

ABSTRACT

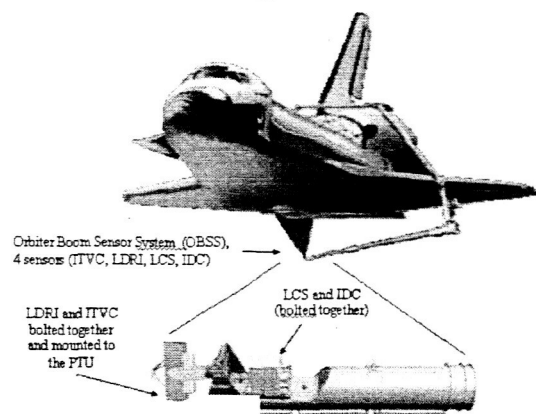
Figure 1: The OBSS

The initial response to the CAIB recommendation for on-orbit inspection was the development of a flight inspection system, the Orbiter Boom Sensor System (OBSS). The OBSS (Figure 1) consists of a boom extension to the current Shuttle Remote Manipulator System (SRMS), the Integrated Sensor Inspection System (ISIS), and various infrastructure modifications (both on the orbiter and the ground) to support each.

As one can see in Figure 1, the boom and SRMS position ISIS and move it about so that the TPS is within its field of view. Exact flight configurations and schedules will not be discussed in this paper, however, ISIS generally consists of the Laser Dynamic Range Indicator (LDRI), which is affixed to the Intensified Television Camera (ITVC). Both of those are mounted to the Pan-and-Tilt Unit (PTU) for 2-DOF motion independent of the boom, and a fixed-to-boom Laser Camera Head (LCH) + periphery device. The periphery device interface was designed so that any dimensionally, thermally, and electrically suitable instrument could be affixed to the LCH, but the only periphery device currently under development is the IDC, a 2Mpix digital camera with interchangeable lenses

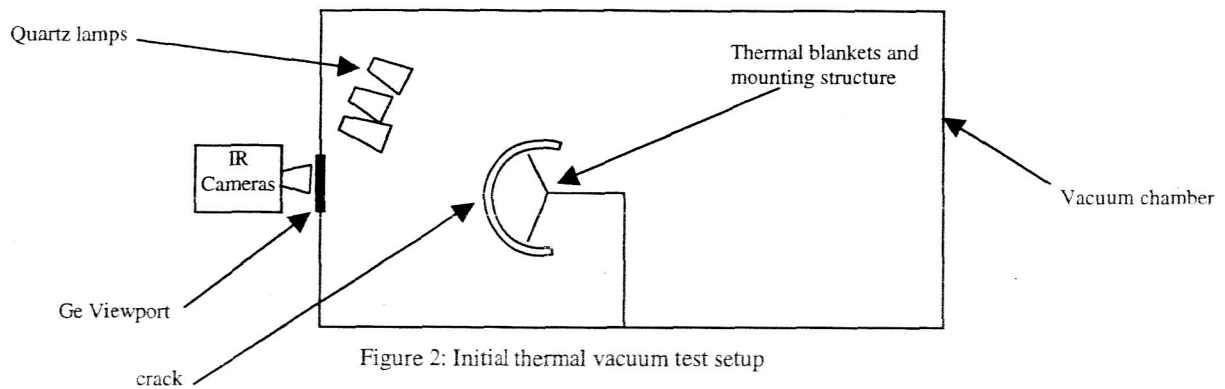
This task was accomplished by installing a damaged RCC panel 6 (from Discovery) into the setup shown in Figure 2, and acquiring IR measurements at temperature gradients of $>5^{\circ}\text{C}/\text{in}$. The thermal gradients were established by warming the top portion of the RCC panel with quartz lamps while the bottom portion of the panel viewed a cold chamber shroud. The RCC damage was the result of hypersonic foam impact testing⁵, and because high-velocity impacts have been shown to create cracks in RCC⁶, it was a good sample to gauge feasibility. Furthermore, it represented damage manifesting itself in a narrow crack, which is, as previously alluded to, is a particularly difficult challenge for direct measurement techniques. One can see a detail of this damage in Figure 3.

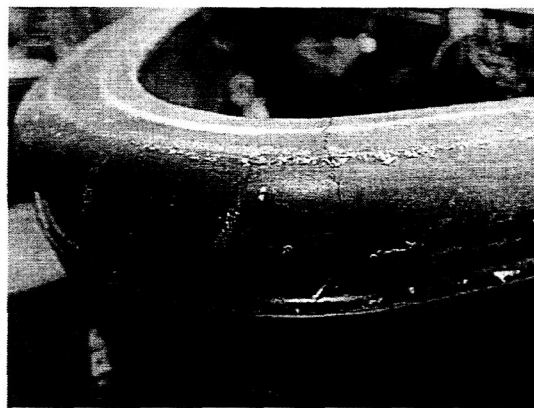
Figure 3: Close-up of damage (CAIB Photo by Rick Stiles 2003)

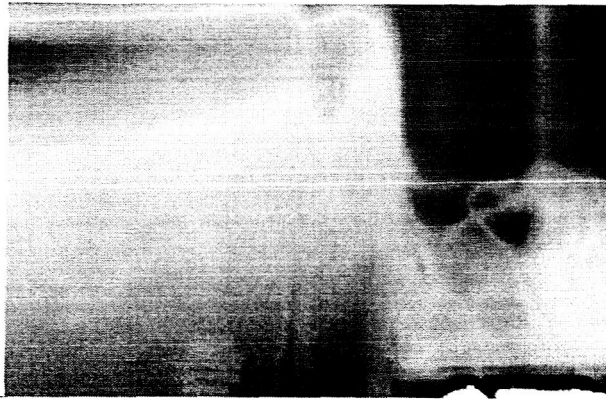
The two commercial cameras produced the best images of the crack damage in the RCC panel, and an example thermal image is shown in Figure 4. The crack created an impediment to in-plane heat flow, and as a consequence, created a perturbation in the panel top-to-bottom thermal profile that can be visually detected in the thermal image.

Figure 4: Thermal image from initial thermal vacuum testing

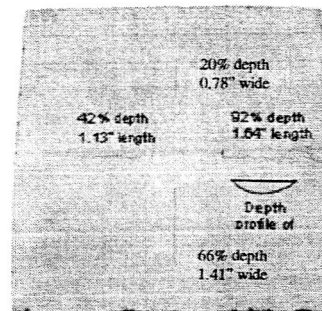
In order to study narrow cracks, we obtained a 6"x6" sample of RCC from the precious supply available. We then cut four slots into this sample using a 0.006 inch wide, diamond cutting wheel. The four slots, which were arranged in a pinwheel fashion, had depths of 92, 66, 42 and 20 percent of the sample's thickness. The profile of the slots corresponded to the profile of the portion of the 3 inch diameter cutoff wheel that plunged into the sample (Figure 5).

Figure 5: Simulated damage profiles

For this probability of error, we decided to use a value of 1 in 10,000, which we felt was quite conservative. With this value, we performed an analysis to determine the lowest thermal gradient where a crack of minimum width and length could be detected. For the minimum dimensions, we obtained preliminary RCC damage testing results which recently became available. They suggested a need to detect 15 mil wide, 3 inch long, complete thru-cracks, so our analysis focused on the 92 % depth, 1.64 inch long, 12 mil wide simulated crack in Figure 5.

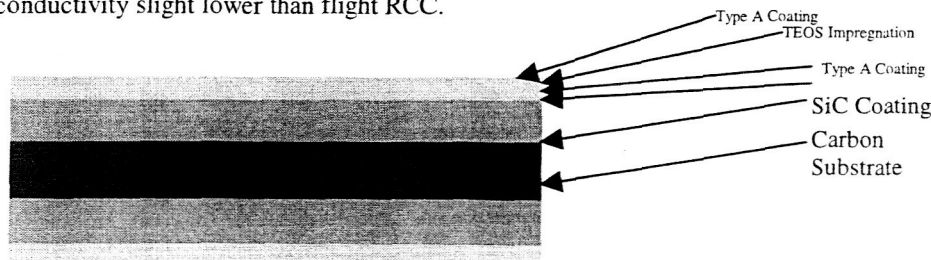
Figure 6: RCC

We believe this sample differed compositionally from the RCC used for flight only by a lack of TEOS impregnation and Type-A sealant on the outermost surface (Figure 6). Therefore, the emittance of the test coupon was slightly higher and the thermal conductivity slight lower than flight RCC.

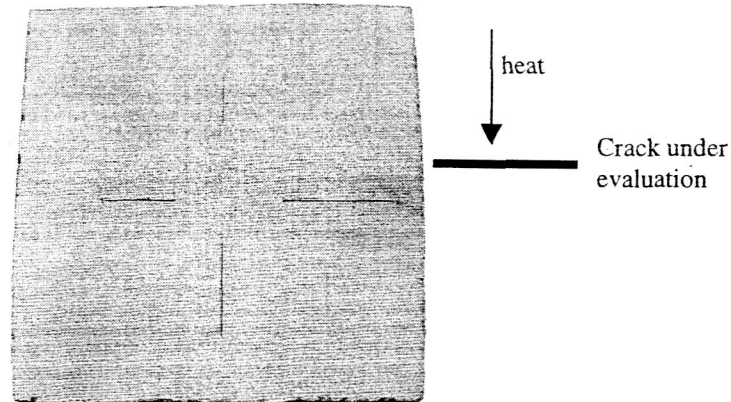
For the in-air phase of our measurements, we induced thermal gradients of various magnitudes across the face of this sample as shown in Figure 7. For all of these measurements, sufficient time was allocated to allow $\Delta\text{Temp}/\Delta\text{time}$ to be very small, and gradients were measured using the IR camera. Thermal images were then captured with the Indigo Merlin camera described in appendix A, and those images were analyzed using several methods.

Figure 7: Direction of thermal gradients

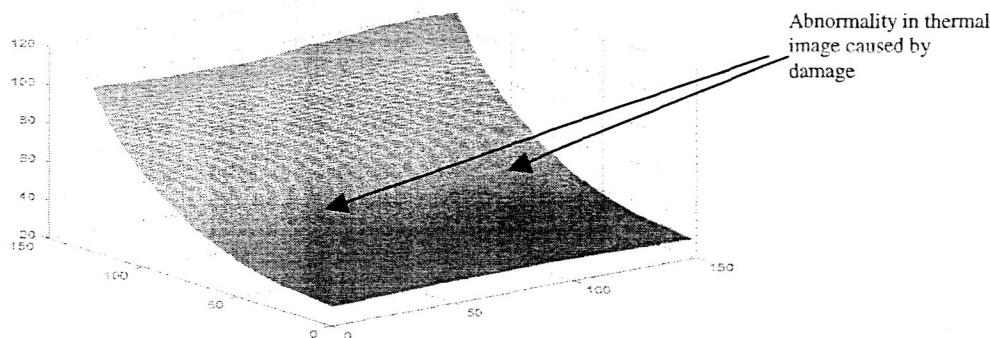
Our first tests were performed using rather high gradients (6-12 degrees C per inch), and results were analyzed. 3-D temperature plots of the sample were generated using MATLAB's surf command (Figure 8), and as expected, abnormalities in temperature profile were apparent in the general area of the slots. Then, a colleague recommended we compute a simplified derivative image by ignoring $\Delta T/\Delta x$ in the direction perpendicular to our induced gradient (it would be very small) and simplifying the $\Delta T/\Delta y$ into a differential between its neighbor in the direction of temperature increase. After comparing data for a similar thermal gradient (Figures 9 and 10), the results were extremely satisfying. It shows our technique was successful in correlating a relationship between depth of crack and magnitude of surface gradient across the crack, a significant milestone in the effort.

Figure 8: Temp profile using MATLAB surf command

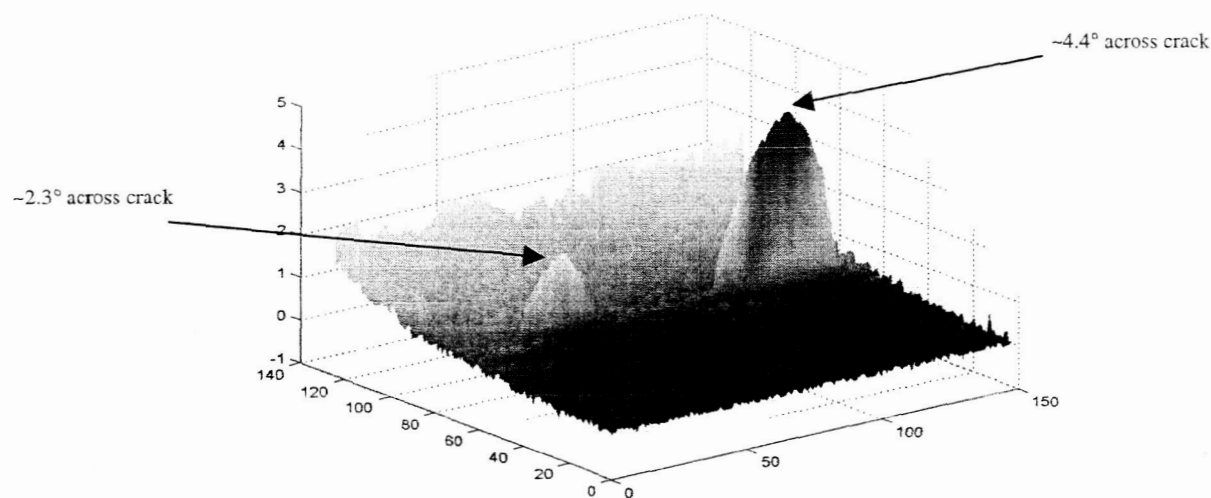
Figure 9: Plot of modified derivative filter for depth = 42% (left) and 92% (right)

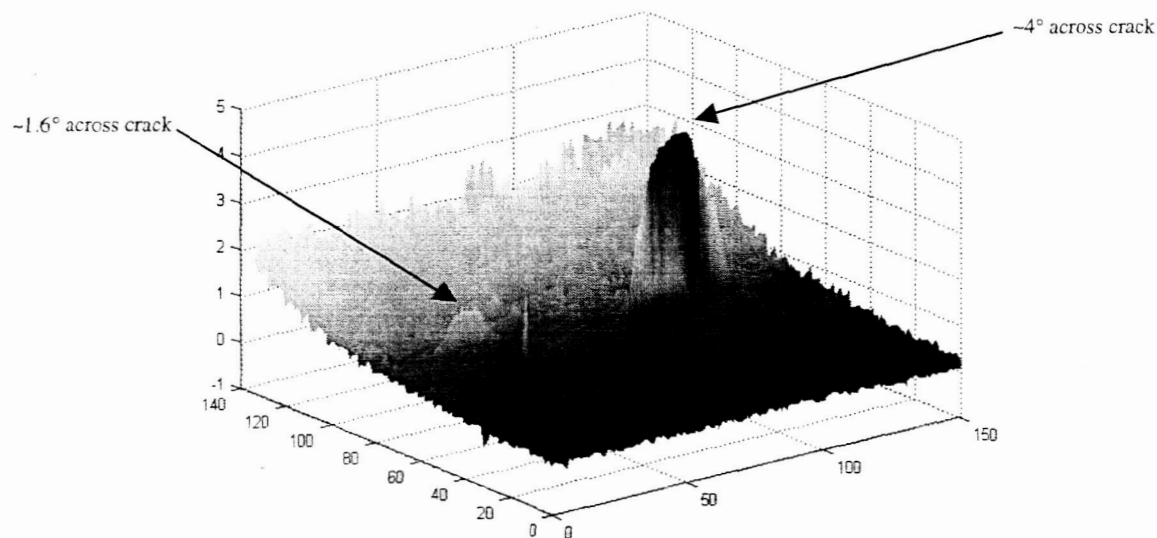
Figure 10: Plot of modified derivative filter for depth = 20% (left) and 66% (right)

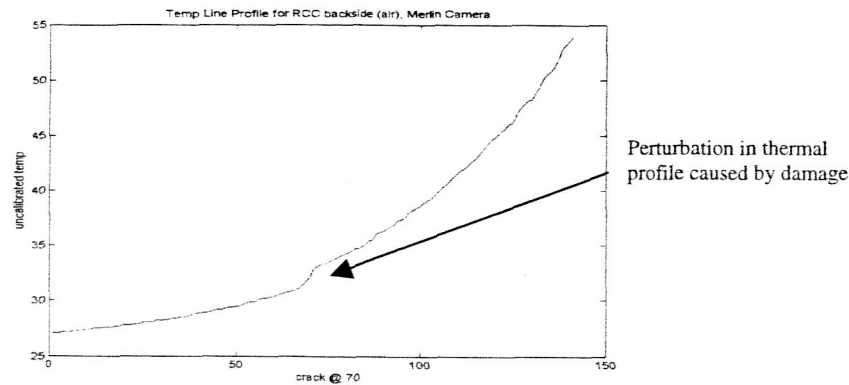
Figure 12: Temperature perturbation resulting from RCC damage

Our colleagues at LaRC suggested the coefficients in Figure 11, and this works well when detection is very difficult, however, at the time of this writing, the authors now believe the optimum filter to be a 2-D extension of the localized thermal impedance phenomena shown in Figure 12.

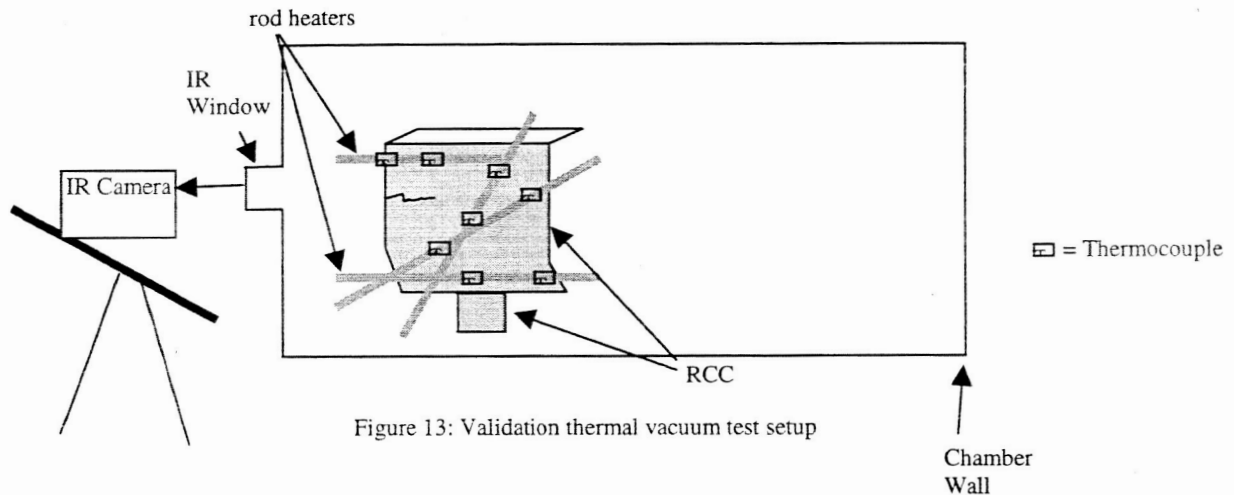
After refining our procedures to utilize gradients approaching $1^{\circ}\text{C}/\text{in}$, we began to scrutinize the effect of convection. Attempts were made to quantify it, but after many unsuccessful attempts, a vacuum test was planned. Figure 13 shows physical configuration, and thermal gradients in excess of $2^{\circ}\text{C}/\text{in}$ to less than 0.25. Data was acquired on both the RCC Sample and Columbia panel #4R, and most results showed that the elimination of convection allowed us to reduce the necessary gradient even further. It also showed led us to the conclusion that subjectivity now became the dominant factor in detection. Specifically, if we knew a crack was present, we could quickly see evidence of it, but if we did not have a prior knowledge of damage, we lost confidence that what we were seeing was actual damage and not "noise."

Figure 13: Validation thermal vacuum test setup

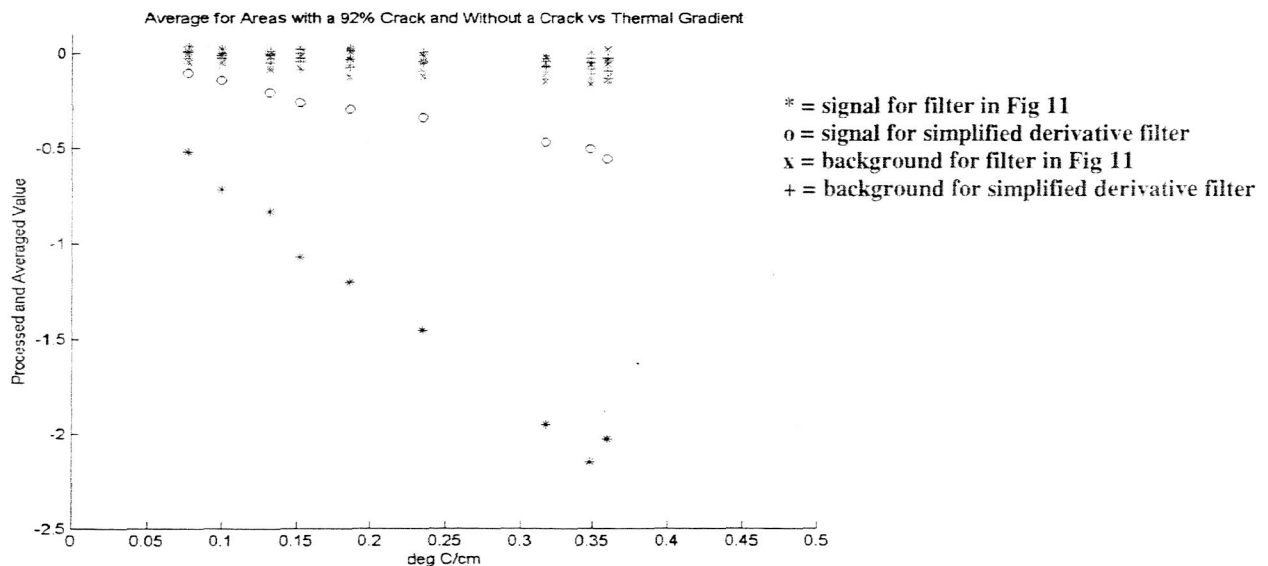
What we found (Figure 15) is that even at very low gradients ($<0.1^{\circ}\text{C}/\text{cm}$), there was still significant offset between the damaged locations and the background, approximating $>3\sigma$ from the mean. However, faith in the fidelity of our measurements was not certain past one significant figure beyond the decimal point. To verify that this gradient was within the constraints of practicality, the authors were also performing calculations to determine the suitability of $0.1^{\circ}\text{C}/\text{cm}$ for on-orbit inspection. Those results came out favorably, and specifically, detailed analysis of a 444 km altitude, beta angle of 30° , bay to earth roll, tail to velocity vector yaw/pitch, and orbit period of 5598.62 sec showed that 95% of the RCC reached this gradient at some point during its cycle (Figure 16), a high enough value to validate our results.

Figure 15: Signal and background plotted together

After filtering the test image with the coefficients in Figure 11, we averaged the area of pixels equal to the actual length of the crack (and not solely the ones in the deepest portion of the half-penny) and compared it to a "background." The background consisted of the same length of pixels, averaged together, and offset from the damage by 4,5,6, and 7 rows in both directions, so as to obtain a large sample of representations and avoid local effects.

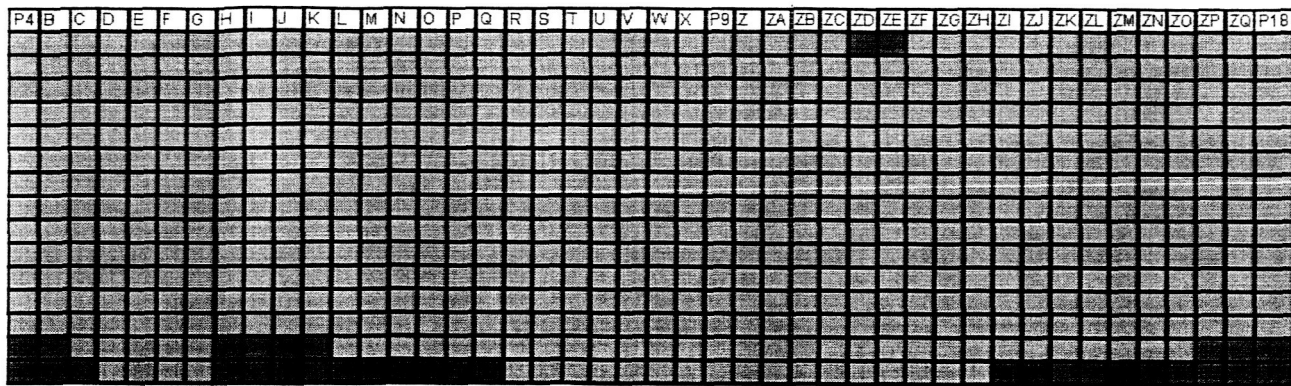
Figure 16: Map of sufficiency for 0.1°C/cm
