NASA/TP-2005-213150

Arc Jet Screening Tests Of Phase 1 Orbiter Tile Repair Materials and Uncoated RSI High Temperature Emittance Measurements

**Engineering Directorate
Structural Engineering Division**

June 2005

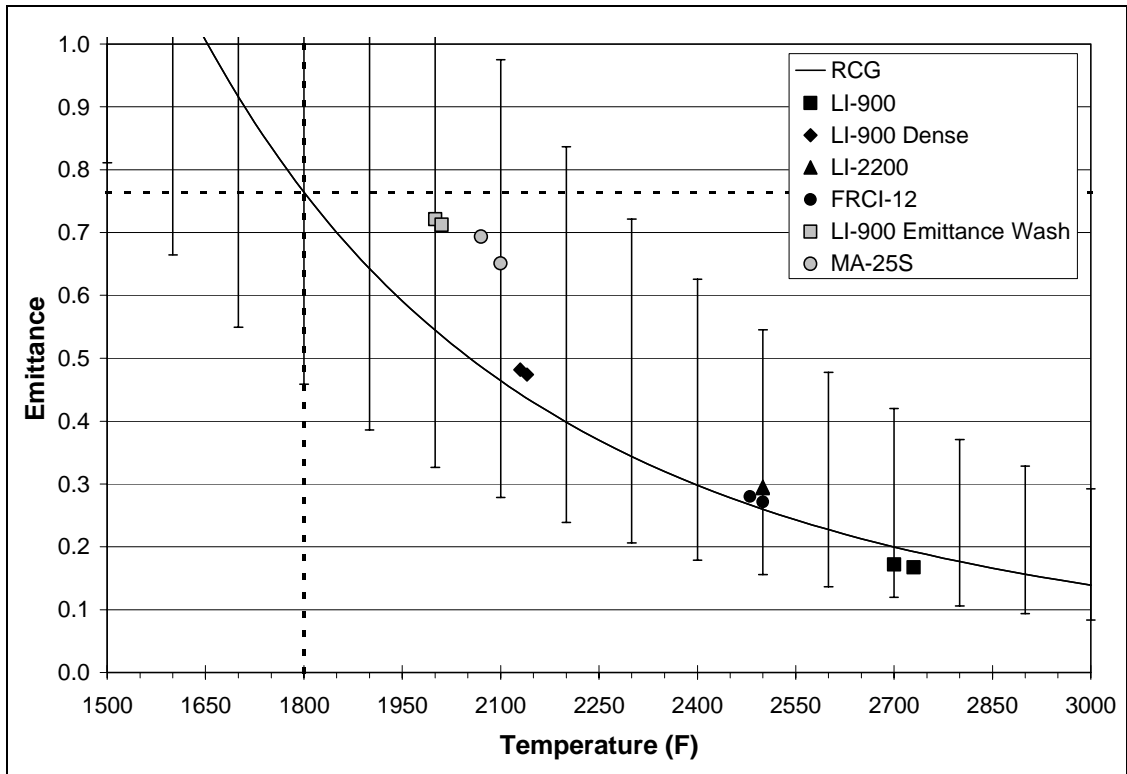
Figure 11: Constant Heat Flux Comparison for 1700°F Condition

A comparison was made of all the results from each condition to estimate any catalytic effects. Figure 10 through Figure 14 demonstrate how the emittance of RCG would have to change with temperature to maintain a constant heat flux according to EQUATION 3 with the dashed lines indicating the measured RCG data. The constant heat flux is a radiation equilibrium value. The error bars denote the potential effect of catalytic heating for the arc jet conditions as calculated by Bouslog⁵. Non-catalytic heating can be 30-40% lower than the RCG value and fully catalytic heating can be 60-110% higher. LI-900 is consistently demonstrating lower catalytic heating than RCG while LI-900 with an emittance wash and MA-25S has higher catalytic heating. All of the data points are bounded by the catalytic heating region (from non to fully catalytic) indicating reasonable results.
