Integrity of Polymethylmethacrylate (PMMA) Chemically Welded Joints Examined

NASA Glenn Research Center's Capillary Flow Experiments (CFE) program is developing experiment payloads to explore fluid interfaces in microgravity on the International Space Station. The information to be gained from the CFE is relevant to the design of fluid-bearing systems in which capillary forces predominate, for example in the passive positioning of liquids in spacecraft fuel tanks. To achieve the science goals of CFE, Glenn researchers constructed several types of experiment vessels (ref. 1). One type of vessel, known as the interior corner flow (ICF), will be used to determine important transients for low-gravity liquid management in a two-phase system. Each vessel has a cylindrical fluid reservoir connected to each end of the test chamber by internal transport tubes, each with a quarter-turn shutoff valve (see the following photograph). These multipiece vessels are made from polymethylmethacrylate (PMMA) because of its excellent optical properties (i.e., the fluids can be observed easily in the vessel). Because of the complexity of certain vessels, the test chamber had to be manufactured in piece

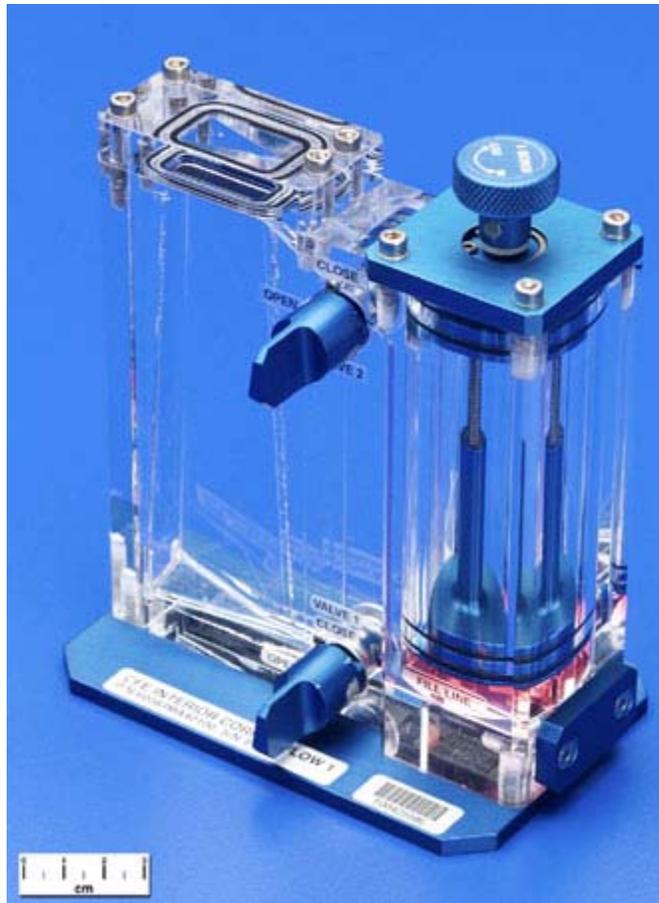
Interior corner flow vessel for CFE experiment.
