A Study of Spur Gears Lubricated With Grease- Observations From Seven Experiments

Timothy L. Krantz and Robert F. Handschuh
U.S. Army Research Laboratory, Glenn Research Center, Cleveland, Ohio

Prepared for the
58th Meeting of the Society for Machinery Failure Prevention Technology (MFPT)
cosponsored by ONR, NASA, ARL, NAWC, and NSWC
Virginia Beach, Virginia, April 26–30, 2004

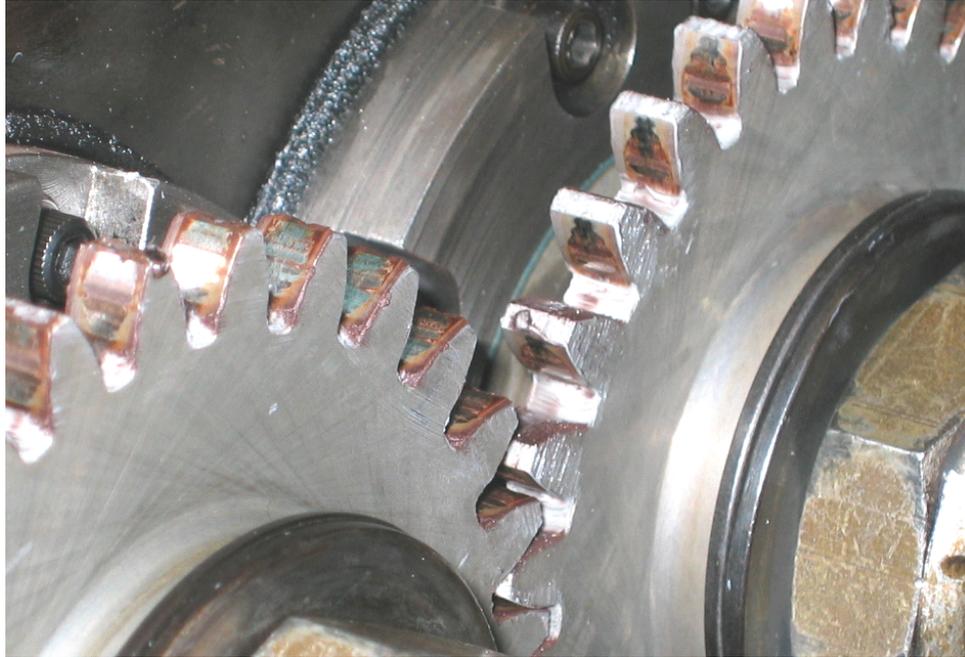
Figure 2.—Condition of the test gears after 3 hr of operation for test number 1 having test conditions of perfluoro type grease, 515 rpm shaft speed, 5 ft-lb torque, and ambient air atmosphere.

The first grease test was conducted at 5 ft-lb of torque, ambient air, and a speed of 515 rpm. Red colored debris was present after 1 hr of operation. Figure 2 documents the appearance of the test hardware after 3 hr of operation. Significant wear was observed, and the grease and contact areas of the gears have a red color. The test was then run an additional 26 hr unattended. The total test duration in terms of shaft revolutions was 927,000. At the completion of the test, a significant amount of red “dust” covered the test chamber, shafts, and gear teeth sides (Fig. 3). The grease was discolored, including some red colored grease. It is not known at this time if the red grease samples contain red colored wear debris or if the red color also indicates some chemical breakdown of the grease. Grease samples were collected and stored for post-test evaluations.

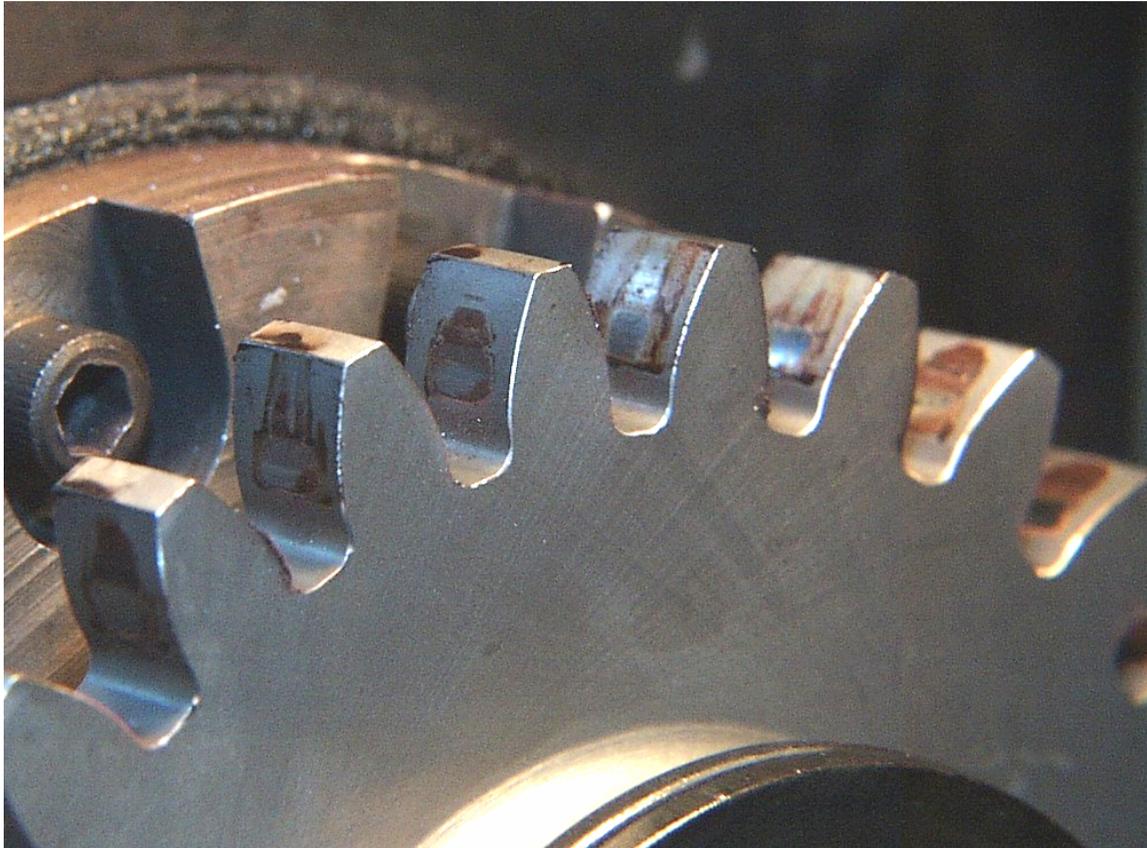
Figure 11.—Condition of the driven gear after 1 hr of testing for test number 7 having test conditions of no lubricant, 705 rpm shaft speed, 2 ft-lb torque, and ambient air atmosphere.

To provide another baseline for comparison, one gear test was conducted using no lubricant on the test gears. The atmosphere was ambient air. The running speed was somewhat higher than for the other testing. The test was conducted for 1 hr comprising 42,000 shaft revolutions. As was expected, wear of the teeth occurred, and red colored wear debris was present at the end of the test (Fig. 11).
