NASA/TM—2005-214030

# Moisture-Induced Spallation and Interfacial Hydrogen Embrittlement of Alumina Scales

James L. Smialek  
Glenn Research Center, Cleveland, Ohio

Prepared for  
High Temperature Corrosion  
sponsored by Gordon Research Conferences  
New London, New Hampshire, July 24–29, 2005

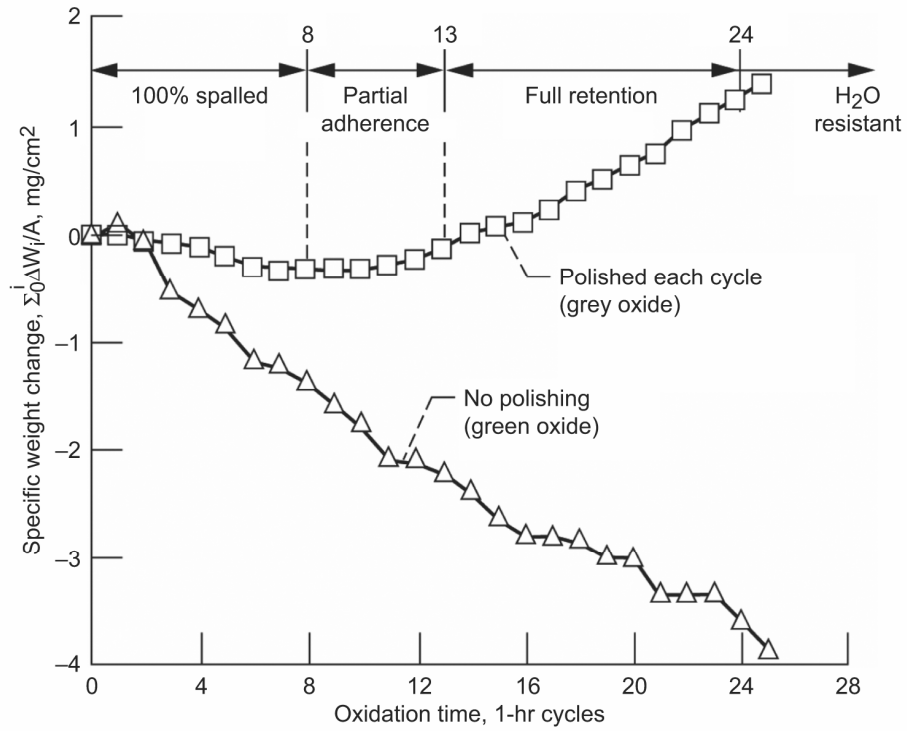
Figure 1.—Adherent  $\text{Al}_2\text{O}_3$  behavior induced in undoped NiCrAl during  $1120^\circ\text{C}$  cyclic oxidation. Cumulative weight change measured after 1 hour oxidation, then polished off and repeated, as compared to control (unpolished) sample, (from ref. 1).

The first few oxidation/polishing cycles showed classic, massive Al<sub>2</sub>O<sub>3</sub> scale spallation, with weight loss on each cycle. But after 8 such cycles, the weight loss was reduced, and transitioned to a weight gain at 10 cycles and complete, repetitive scale adhesion at 13 cycles (fig. 1). Subsequently, however, upon initial exposure to water during the wet sanding process, the scale was observed to completely peel off. A macrograph for samples purged for 15 cycles, illustrating the striking contrast in retained scale between the as-cooled and the water exposed sample, is shown in figure 2. The effect of moisture was to almost completely strip an otherwise intact scale.

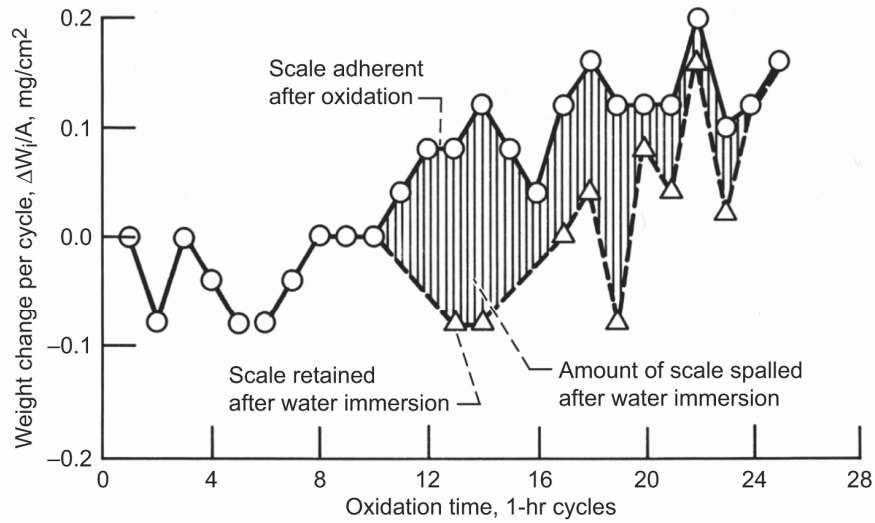
Figure 3.—Amount of additional spallation induced by water immersion (shaded area) for each oxidation/polishing cycle. (Undoped NiCrAl oxidized at 1120 °C in 1-hr cycles, from ref. 1).

This moisture effect was further monitored by plotting the weight change for each cycle before and after water exposure (fig. 3). Here some scatter exists in measuring the small weight change for just one hour heating, after repolishing each cycle. But it is clear that small weight losses or no changes occur when the scale spalled for the first ten cycles, while trending into more adhesion and eventual weight gains with more purging cycles. After 10 cycles, the net weight change after immersion indicates spallation of an originally intact scale. The extent of water-induced spallation is thus portrayed as the shaded area between the two curves. Finally, at 24 to 25 cycles, enough sulfur has been removed, decreasing from 10 down to 2 ppmw, allowing the scale to remain adherent even when exposed to water.

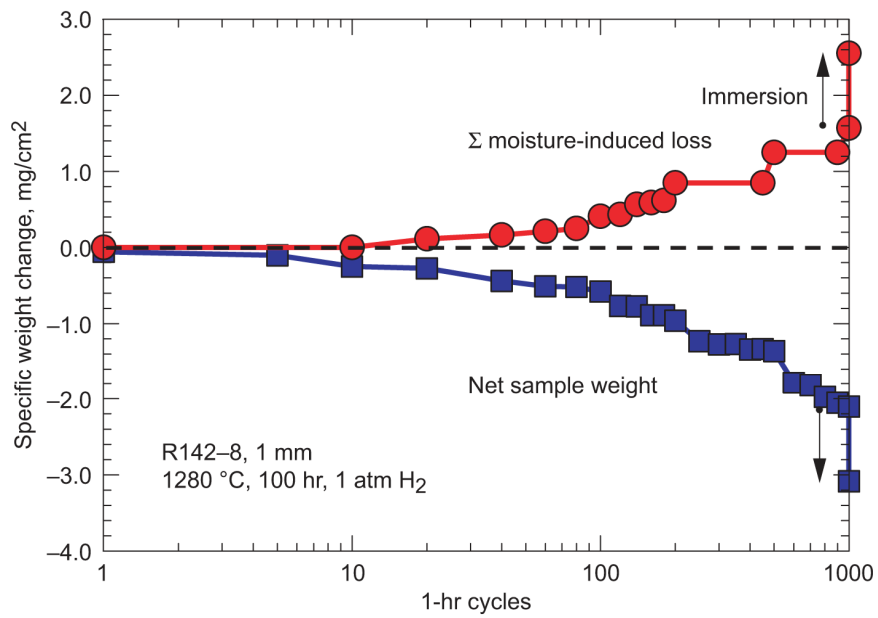
Figure 6.—Amount of additional spallation induced by moist breath exposure (upper curve) for René 142 oxidized at 1150 °C in 1-hr cycles. (Sample 142-6, 1 mm thick, annealed in 1 atm. H<sub>2</sub> at 1280 °C for 100 hr; vertical arrows show water immersion effect at 1000 hr).

from 6.1 down to 0.3 ppmw. However, despite relatively moderate weight losses after cycling the desulfurized sample for 1000 hr (fig. 6), further spallation was produced by moisture effects, i.e., breathing hot moist air on the samples after an initial weighing. The cumulative effect of such additional treatment can be seen as the upper curve. Its close symmetry to the net sample weight change is an indication of how moisture-induced secondary spallation may account for primary trends in the overall  $\Delta W/A$  cyclic oxidation response. This spallation was also visibly apparent in the series of macrographs corresponding to moist air treatments after various oxidation times, for both as received René 142 and for samples desulfurized by annealing in 1 atm  $H_2$  for 100 hr at 1280 °C (fig. 7(a) and (b)). Finally, the additional weight loss at 1000 hr, shown by the arrows in figure 6, was produced by water immersion after cooldown. This response is further illustrated in the before and after macrographs of figure 8.

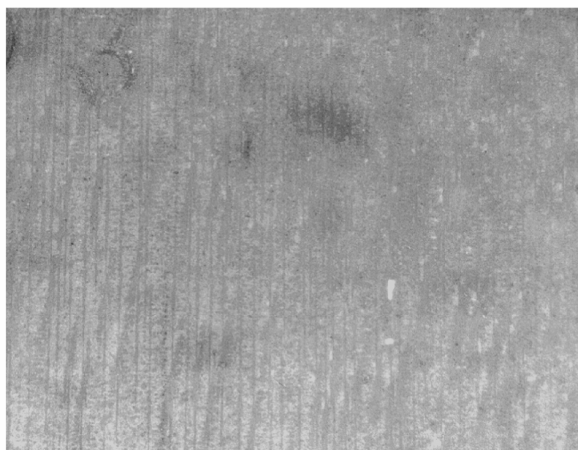
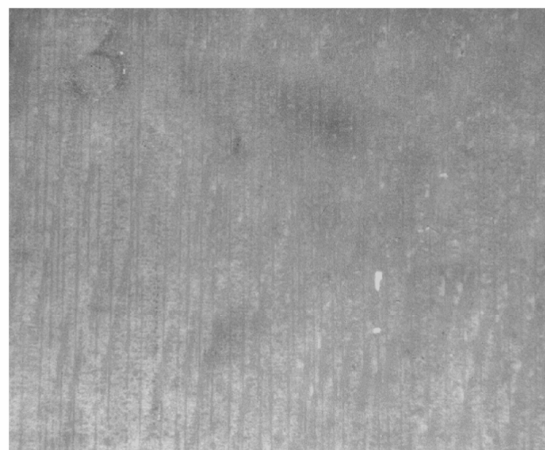
Figure 11.—Effect of water immersion on interfacial spallation for René N5+103Y after 500 1-hr cycles at 1150 °C: appreciable for (a) as-received and minimal for (b) hydrogen annealed (5% H<sub>2</sub>/Ar at 1250 °C for 100 hr) samples, corresponding to figure 10.

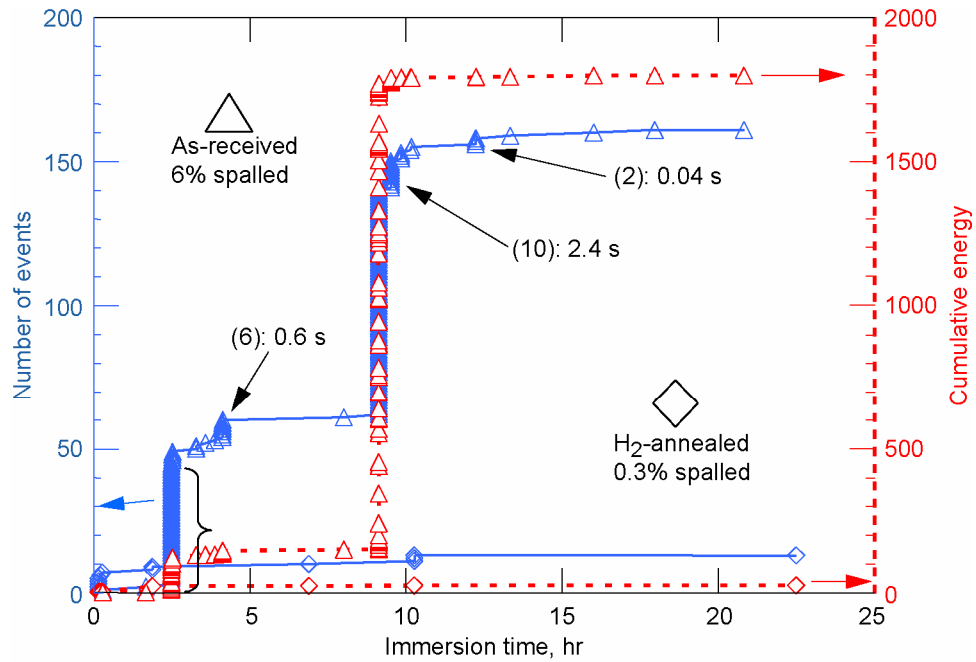
Figure 12.—Delayed failure and acoustic emission response of René N5 in long term water immersion of as-received (triangles) and hydrogen annealed (diamonds, 5% H<sub>2</sub>/Ar at 1250 °C for 100 hr) samples. (Doped with 100 ppmw Y and oxidized at 1150 °C for 1000 1-hr cycles, from ref. 7).

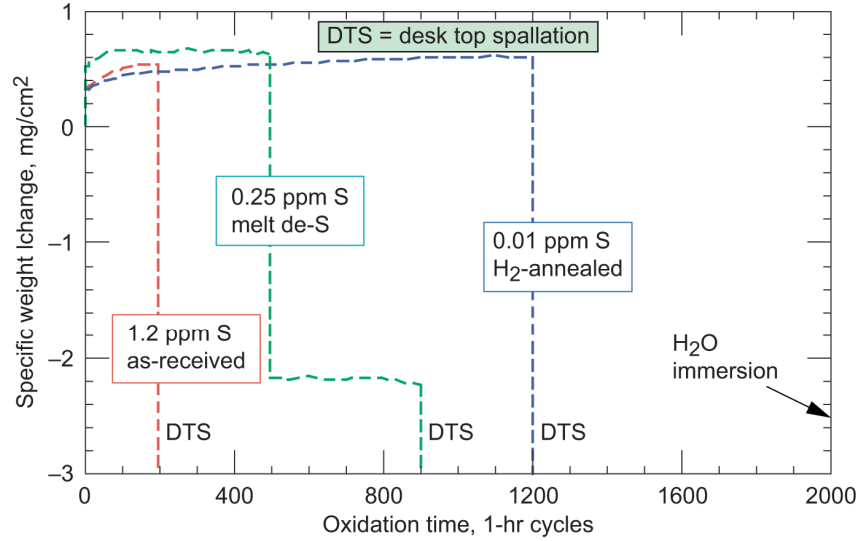
Figure 16.—The effect of sulfur content on the cyclic weight change and failure times for TBC's on PWA 1484. (No bond coat, 250  $\mu\text{m}$  thick, oxidized at 1100  $^{\circ}\text{C}$  using 1-hr cycles). Vertical drops indicate coating spallation, desktop spallation, and water immersion failures.

Plasma sprayed coatings have exhibited delamination in one intact free-standing wafer, seen in the macrographs of figure 15, rather than as the complex buckling and cracking shown above. Here a 250  $\mu m$  thick coating of APS 8YSZ was applied to both sides of grit blasted coupons of PWA 1484 with no bond coat, then cycled between 1100 and 80 °C each hr (ref. 7). The lifetime of these coatings was closely related to the sulfur content of the alloy (fig. 16), and it was therefore correlated with the cyclic oxidation

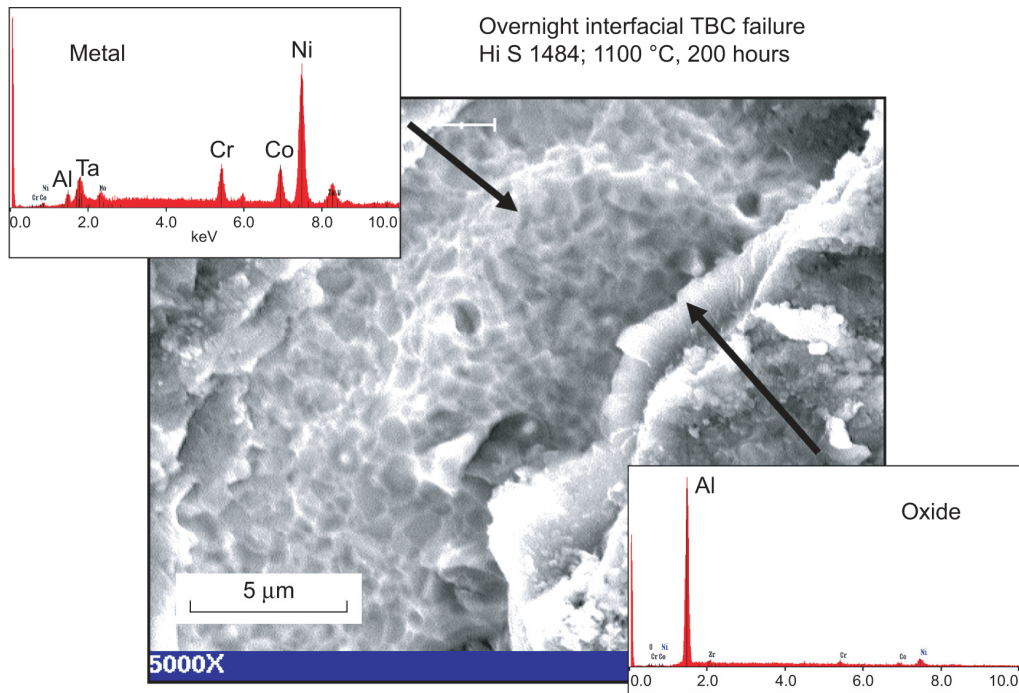
Figure 17.—Oxide imprints in metal and inner  $\text{Al}_2\text{O}_3$  scale identified at the interfacial failure sites in PWA 1484. (1.2 ppmw S, no bond coat, 250  $\mu\text{m}$  thick, oxidized at 1100  $^{\circ}\text{C}$  for 200 1-hr cycles, from figure 15).

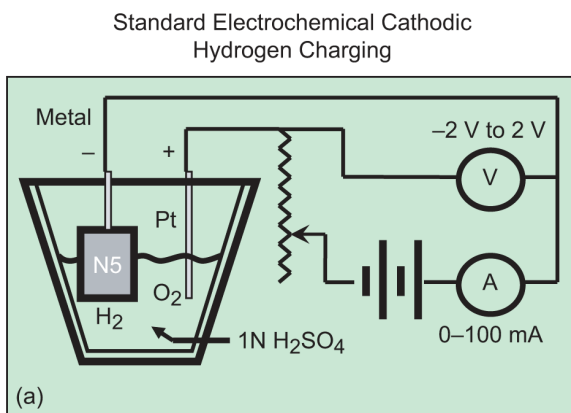
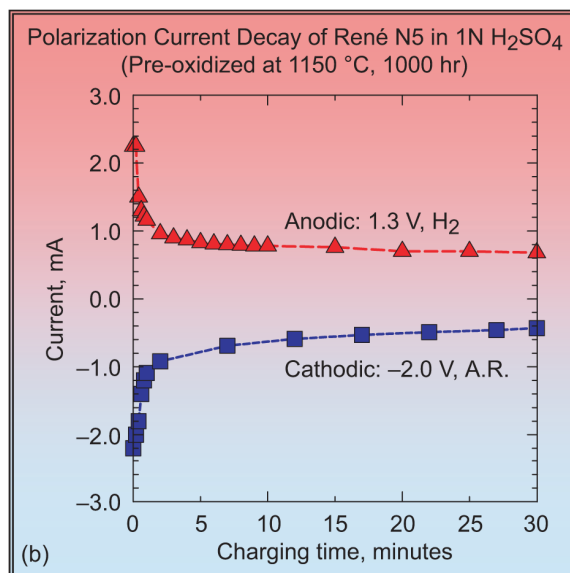
Figure 18.—Electrochemical hydrogen charging of pre-oxidized René N5 samples. (a) Cell schematic. (b) Typical current decay curves for anodic and cathodic polarizations in 1N H<sub>2</sub>SO<sub>4</sub> electrolyte at room temperature. (1150 °C, 1000 1-hr cycles, from the studies in ref. 6 and 7).

Rapid equivalent decay is evident in the current response curves for two René N5 samples at cathodic ( $-2.0 \text{ V}$ ) and anodic ( $2.0 \text{ V}$ ) polarizations (fig. 18) obtained for each leg by simply switching the output leads. The relative decay kinetics are also shown as normalized curves in figure 19. Here, similar response is observed for the three preoxidized samples, falling to about 25 to 40 percent of the initial currents after a few minutes. The as-polished unoxidized sample may take longer to build up concentration polarization effects because of the larger exposed metal surface areas.

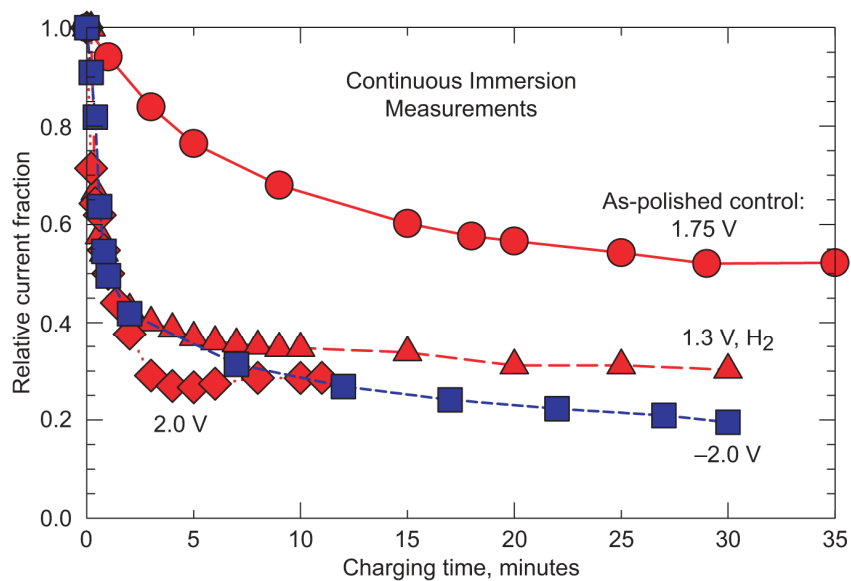
Figure 19.—Normalized current decay curves for pre-oxidized and bare René N5 coupons in 1N H<sub>2</sub>SO<sub>4</sub>.

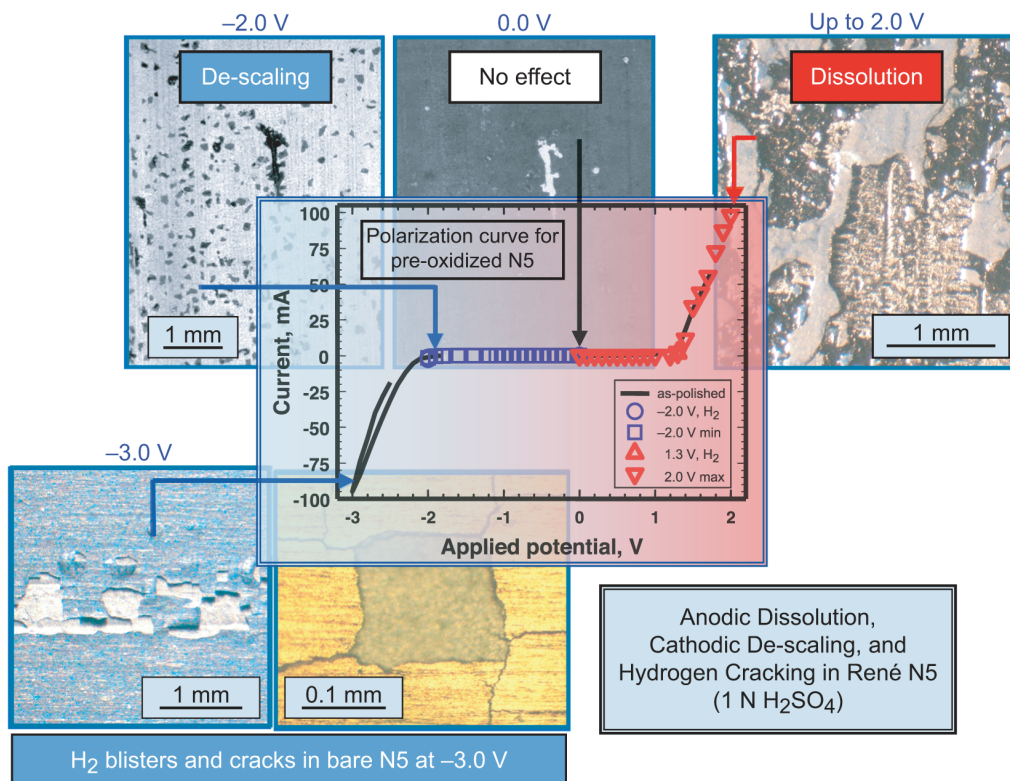
Figure 20.—Current response at 0.1 V stepped applied voltages (voltammogram), superimposed on macrographs illustrating: anodic dissolution of the alloy, null results at zero voltage, interfacial de-scaling at mild cathodic currents, and severe alloy blistering for extreme cathodic currents. (René N5+Y oxidized at 1150 °C, 1000 1-hr cycles, from the studies in ref. 6 and 7).

Therefore, to map the current/voltage characteristic response (cf. voltammogram), the current after a standard 1 to 2 minute decay period was plotted, as were longer term exposures at a constant voltage. The solid line (fig. 20) plots behavior of the as-polished N5 coupon, whereas the data points show the behavior of the coupons pre-oxidized for 1000 1-hr cycles at  $1150 \text{ }^\circ\text{C}$ . Samples labeled ( $\text{H}_2$ ) had been prepared by hydrogen annealing in 5% $\text{H}_2$ /Ar at  $1150 \text{ }^\circ\text{C}$  for 100 hr; whereas samples designated by (A.R.) had been oxidized in the as-received condition. Severe bubbling at the working electrodes and excessive (100 mA) currents were noted above 1.3 V or below  $-2.0 \text{ V}$ . This indicated substantial overvoltages for

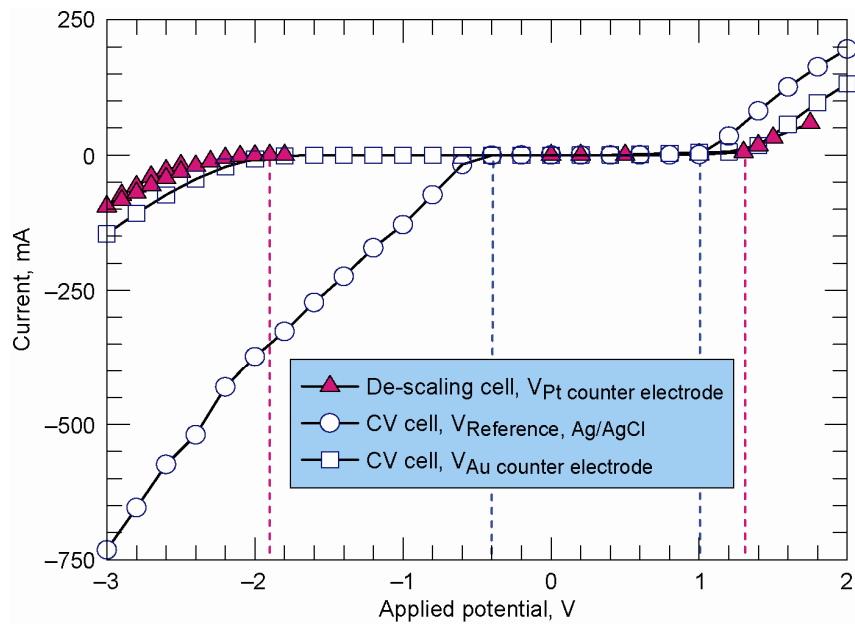
Figure 22.—Voltammograms obtained in a cell with Pt counter electrode compared to that obtained using an Ag/AgCl reference electrode, showing anodic/cathodic transitions at  $\sim 1.3$ – $1.9$  V and  $1.0$ – $-0.4$  V, respectively, in  $1N$   $H_2SO_4$ .

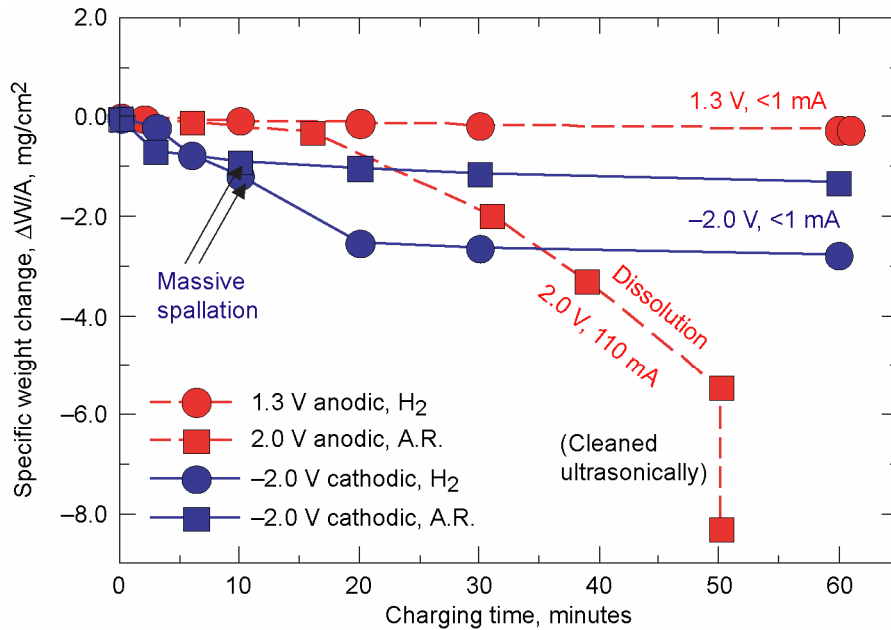
Figure 26.—Weight loss kinetics from anodic dissolution and cathodic de-scaling treatments in 1N H<sub>2</sub>SO<sub>4</sub>. Note small anodic effects below 2 V and large cathodic effects in the first 20 min.

The samples were also monitored by weight change periodically throughout the electrolytic treatments (fig. 26). The sample polarized at 1.3 V showed very little weight loss of <0.25 mg/cm<sup>2</sup> and very low currents of <1.0 mA. Anodic polarization at 2.0 V, however, produced a continuous and severe weight loss of >8 mg/cm<sup>2</sup> with high currents of 110 mA. Additional weight loss occurred by removing a sooty corrosion product by ultrasonic cleaning. Cathodic polarization at -2.0 V produced massive scale delamination, most evident after only 10 min, but at low currents <1.0 mA. By contrast, once the scale was removed, little further weight loss was observed. It is interesting to point out that the more adherent hydrogen annealed sample actually produced more weight loss than the corresponding as-received sample. This may be due to the larger original amount of intact scale available for cathodic de-scaling.

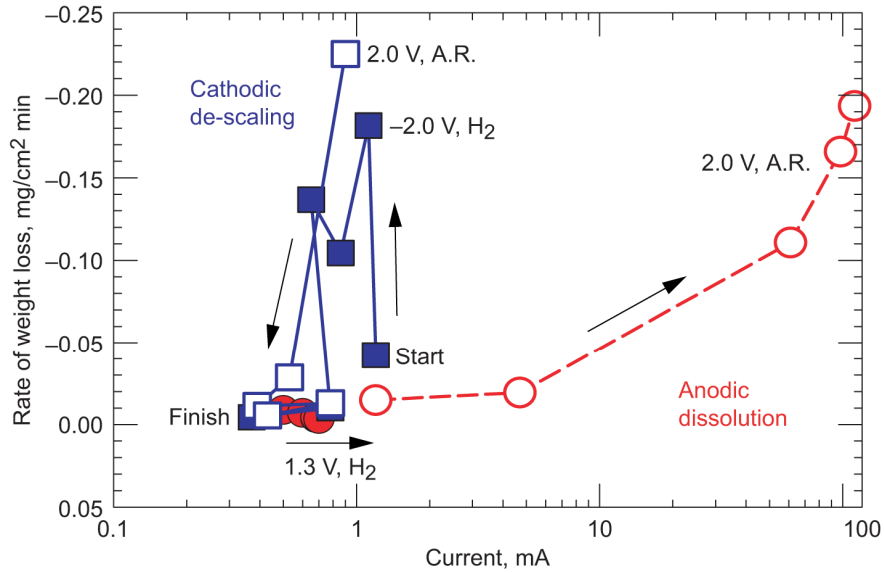
Figure 27.—Approximate rate of weight loss as a function of imposed current for polarization exposures in 1N H<sub>2</sub>SO<sub>4</sub>: increasing with increasingly higher anodic current; contrasted with discontinuous, initial spikes at comparatively low cathodic currents. (René N5+Y oxidized at 1150 °C, 1000 1-hr cycles).

The differences between anodic and cathodic weight change behavior can be further accentuated by mapping the rate of weight loss versus imposed current. For electrochemical dissolution, weight loss rate was reasonably commensurate with current for the anodic tests, performed at 1.3 or ramped to 2.0 V (fig. 26). In contrast, the cathodic tests performed at -2.0 V produced high initial weight losses. These subsided completely because very little spallation was possible after cathodic de-scaling (figs. 20 and 24).
