# Tapered Roller Bearing Damage Detection Using Decision Fusion Analysis

*Paula J. Dempsey  
Glenn Research Center, Cleveland, Ohio*

*Gary Kreider and Thomas Fichter  
The Timken Company, North Canton, Ohio*

A diagnostic tool was developed for detecting fatigue damage of tapered roller bearings. Tapered roller bearings are used in helicopter transmissions and have potential for use in high bypass advanced gas turbine aircraft engines. A diagnostic tool was developed and evaluated experimentally by collecting oil debris data from failure progression tests conducted using health monitoring hardware. Failure progression tests were performed with tapered roller bearings under simulated engine load conditions. Tests were performed on one healthy bearing and three pre-damaged bearings. During each test, data from an on-line, in-line, inductance type oil debris sensor and three accelerometers were monitored and recorded for the occurrence of bearing failure. The bearing was removed and inspected periodically for damage progression throughout testing. Using data fusion techniques, two different monitoring technologies, oil debris analysis and vibration, were integrated into a health mon

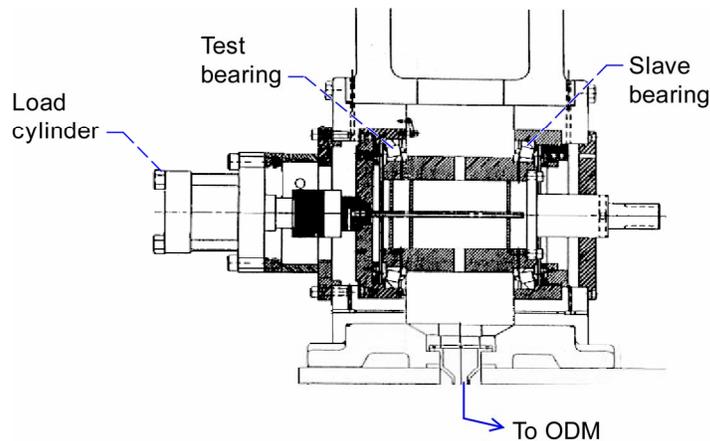
Failure progression tests were conducted in the Tapered Roller Bearing Health Monitoring Test Rig. The test rig is illustrated in figure 1. The test rig consists of a pair of single row tapered roller bearings supporting a shaft. One bearing is the test bearing and the other the slave bearing.

The test and support bearings are loaded in the axial direction with a hydraulic load cylinder. A 200 hp electric motor is used to drive the test system to the required rpm. There is a direct drive connection from the motor to the bearing shaft, with a small coupling shaft connecting the two that compensates for minor misalignment. Mobil Jet II oil (per MIL-L-23699 specifications) was used as the lubricant. Bearing geometry information is listed in table 1.

Figure 1.—Tapered roller bearing test rig.

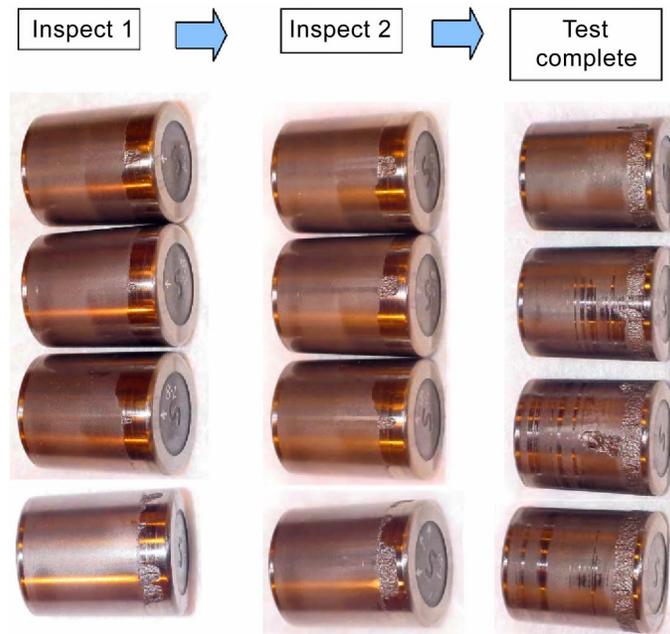
Figure 2.—Test 1 roller damage.

After the bearing races were damaged by running in contaminated oil containing steel powder particles for 2000 revolutions, they were then ultrasonically cleaned and installed in the test rig. The bearings were removed for inspection two times during the failure progression test. At test completion, the bearings had been subjected to 81 million cycles.

Photos of the damaged components were taken at each inspection interval and at test completion. Photos of the damage are shown in figures 2 through 5. After the first inspection interval, spalling was observed on several of the rollers and peeling was observed on the cup and cone. The spalls on the rollers increased in size during the second inspection, but the peeling on the cup and cone did not appear to increase significantly. At test completion, the spalls on the rollers increased significantly, the peeling on the cup and cone did not change, spalling began to occur on the cone and cage damaged was observed. It should be noted that the cage material of all bearings was steel plated with silver, and nonferrous particles were not analyzed by the ODM during all tests.

In figure 21 and referencing damage photos shown in figures 2 through 5, pitting damage to the cone was observed after inspection 2 and prior to test completion. The Model Output indicates shutdown due to cone damage within this timeframe.

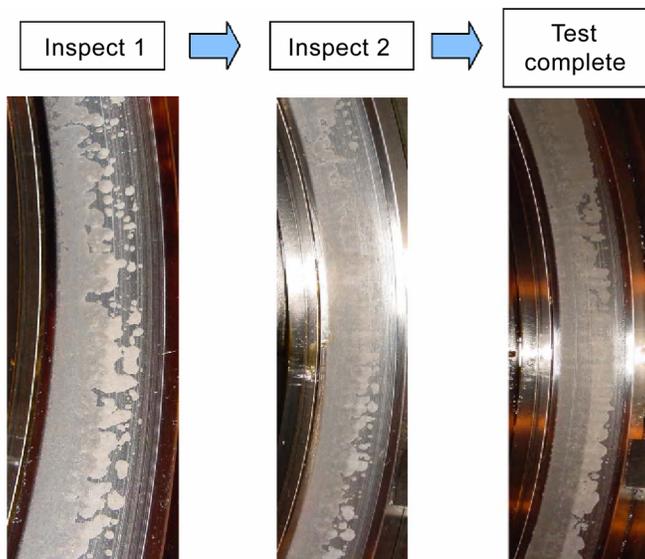
Figure 3.—Test 1 cup damage.

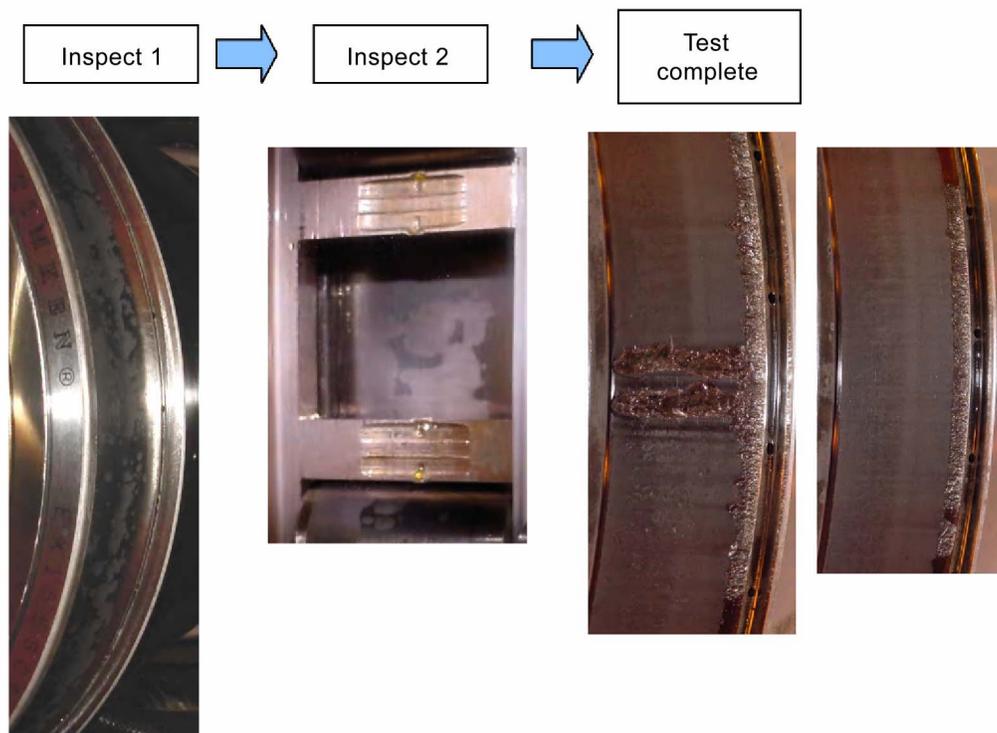
Figure 4.—Test 1 cone damage.

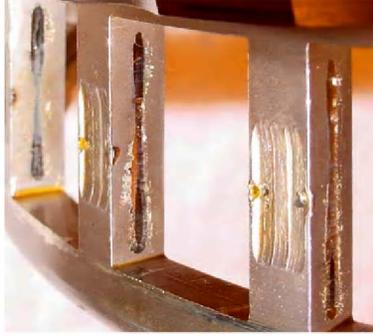
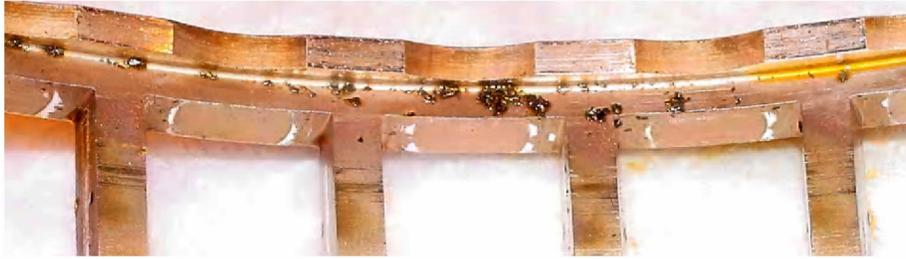
Figure 5.—Test 1 cage damage.

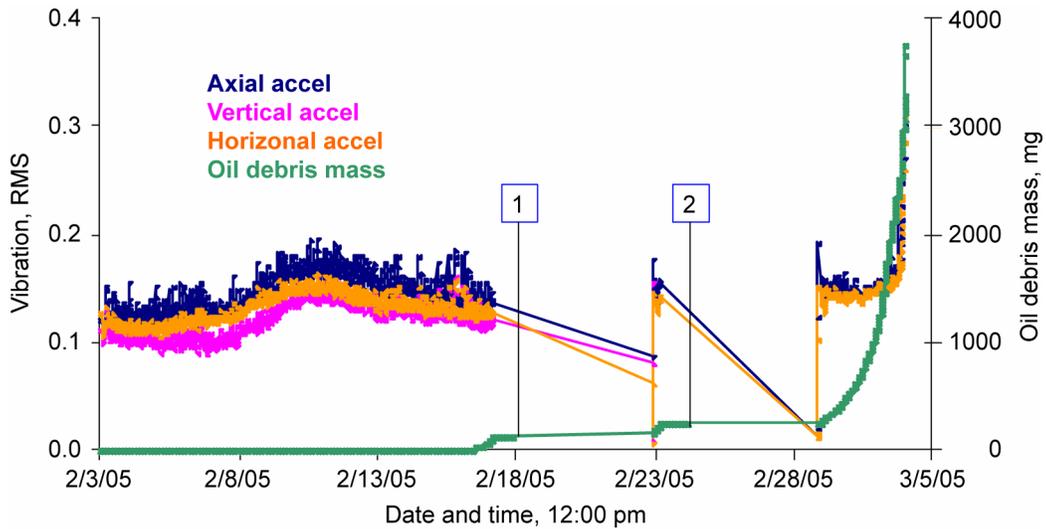
Figure 6.—Oil debris mass and vibration RMS during Test 1.

Figure 6 is a plot of the accumulated oil debris mass and the vibration RMS for accelerometers located in the axial (blue), radial vertical (pink), and horizontal (orange) planes. The RMS y-axis is on the left and did not exceed 0.34 for all three accelerometers. The ODM y-axis is on the right with maximum value of 3753 mg at test completion. The boxes labeled 1 and 2 identify when the bearings were removed for inspection. The RMS magnitude increased by a factor of 2 after inspection interval 2 as compared to the values measured after inspection interval 1. The oil debris accumulated mass measured at each inspection interval was 117.1 mg at the first inspection, 246 mg at the second inspection and 3753 mg at test completion.

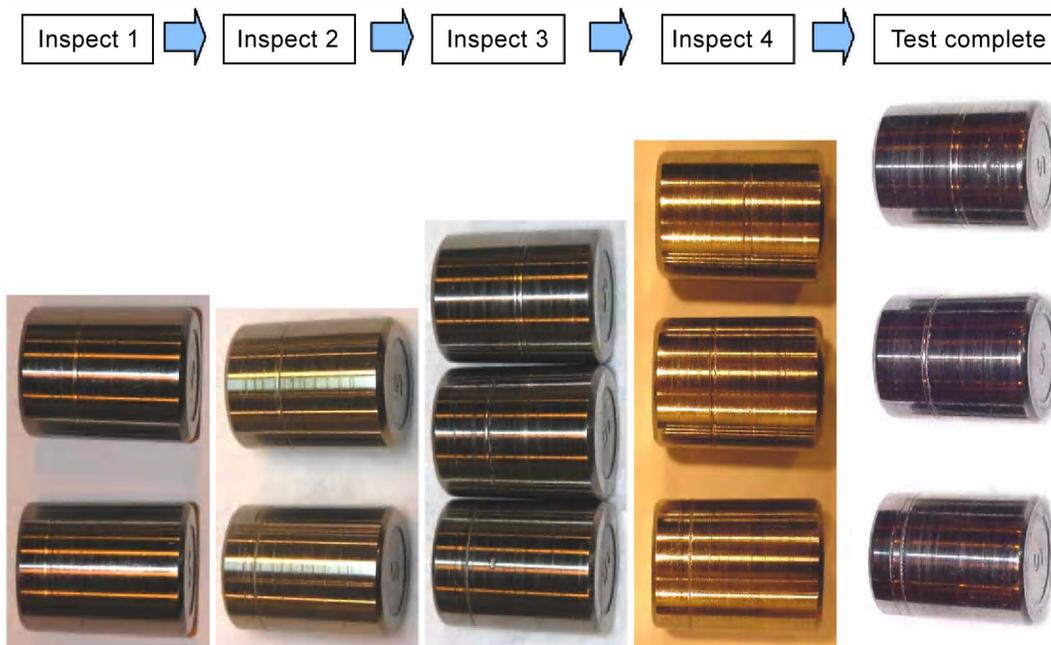
Figure 7.—Test 2 roller damage.

Photos of the damaged components were taken at each inspection interval and at test completion. Photos of the damage are shown in figures 7 through 11. After the first inspection interval, wear lines were observed on the rollers with the dents slightly increased in size. During the second inspection, small pits were observed on the cup and no significant damage was observed on the rollers. At the third inspection interval a large spall was observed on the cone and a few more wear lines on the rollers. At the fourth inspection interval, the cone spall increased in size. At test completion the cone spall doubled in size, the small pits observed on the cup at inspection 2 remained the same, and cage damage was observed.

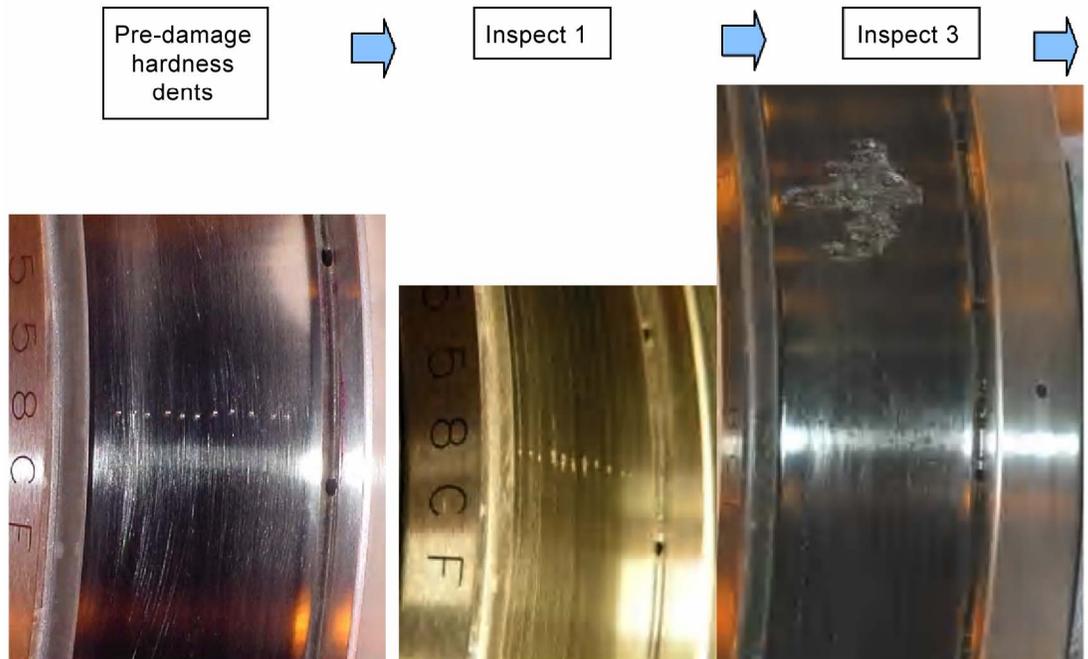
Figure 8.—Test 2 cone damage.

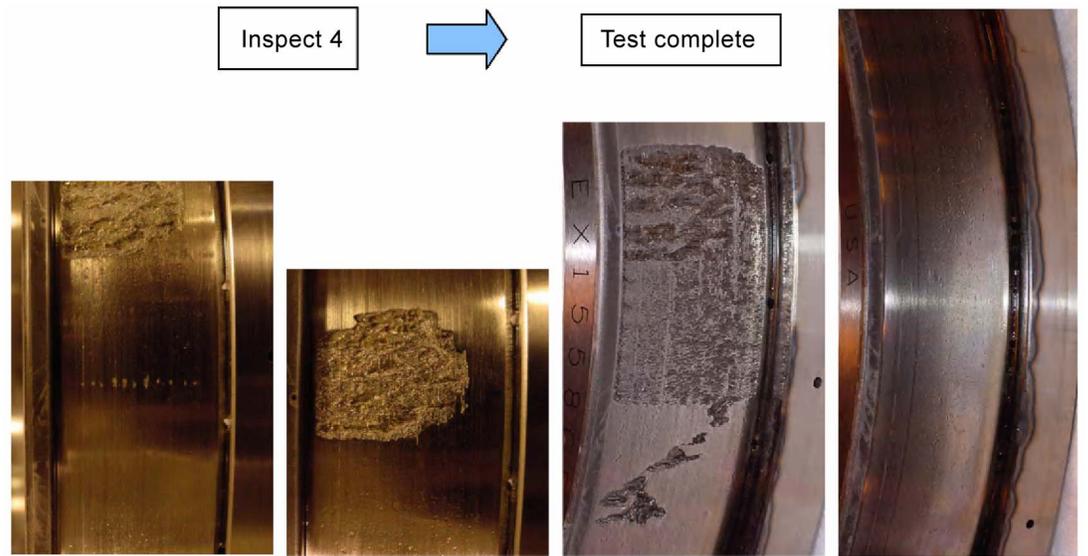
Figure 9.—Test 2 cone damage.

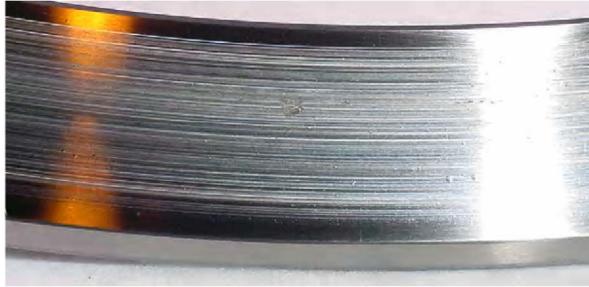
Figure 10.—Cup damage at test completion, observed after inspection 2, but did not progress.

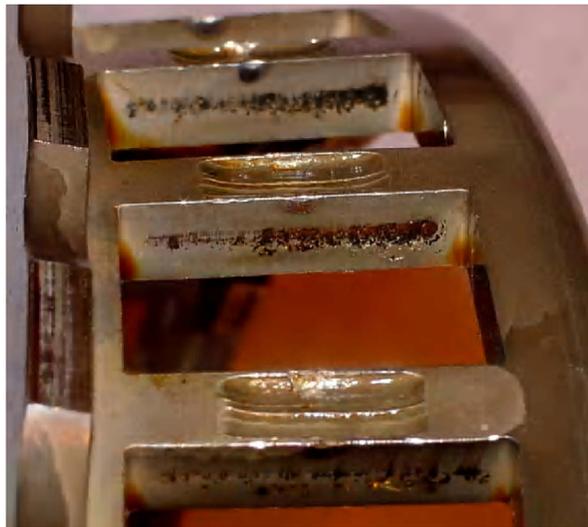
Figure 11.—Test 2 cage damage at test completion.

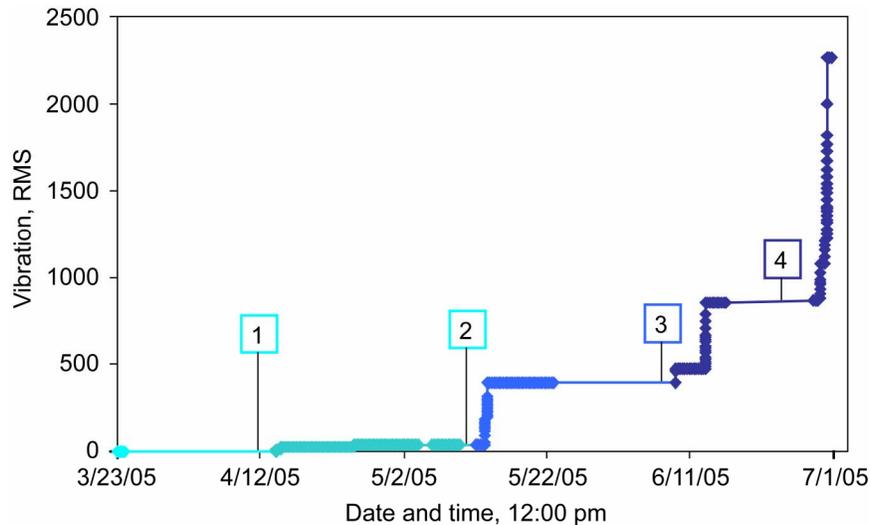
Figure 12.—ODM mass measured during Test 2.

Figure 12 is a plot of the oil debris mass measured during test 2. Accelerometer data was unavailable during test 2. The ODM y-axis is on the right with maximum value of 2265 mg at test completion. The boxes labeled 1 through 4 identify when the bearings were removed for inspection. The accumulated oil debris mass measured at each inspection interval was 5 mg at the first inspection, 39 mg at the second inspection, 394 mg at the third inspection, 860 mg at the fourth inspection and 2265 mg at test completion.

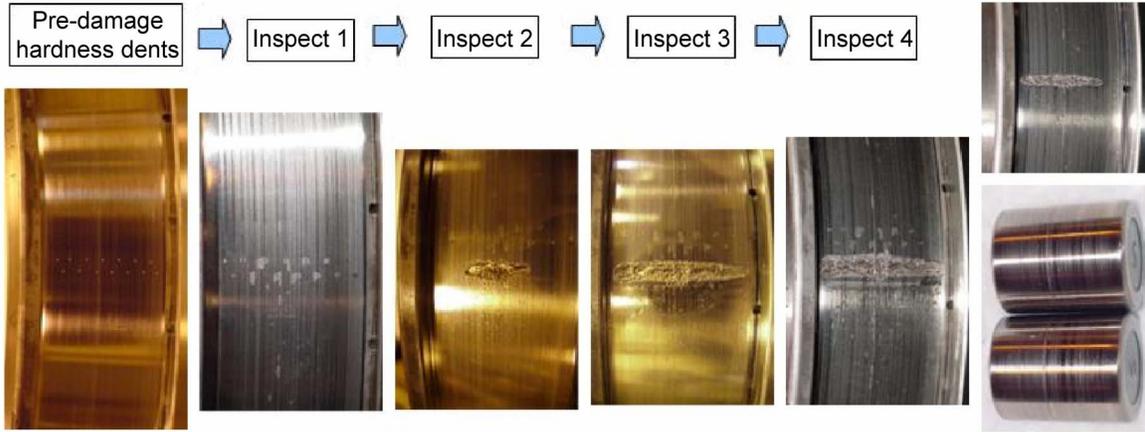
Photos of the damaged components were taken at each inspection interval. Photos of the damage are shown in figure 13. After the first inspection interval, no damage was observed on the bearing. In order to expedite failure, the raceway was again damaged near the original pre-damage hardness dents. During the second inspection, pitting damage began to occur near the location of the pre-damage dents and damage placed on the cone during inspection 1. At the third inspection interval, the damage observed on the cone during the second inspection grew into a large spall.

Figure 13.—Test 3 cone damage and roller damage.

Figure 18 is a plot of the defect frequencies calculated during test 3. Photos of the damage were shown in figure 13. After the first inspection interval, no damage was observed on the bearing and no change in defect frequencies was observed. Prior to inspection 2, pitting damage began to occur near the location of the pre-damage dents and damage placed on the cone during inspection 1, but the cone defect frequency BPFi did not show a significant increase. At inspection interval 3, the damage observed on the cone during inspection 2 grew into a large spall and the cone defect frequency BPFi increased significantly. Vibration data was unavailable during inspection interval 4. At test completion the cone defect frequency BPFi increased significantly as did the damage.

In figure 22 and referencing damage photos shown in figure 13, pitting damage to the cone was observed after inspection 1 and prior to inspection 2, and continued to grow in size until test completion. The Model Output indicates inspect due to damage between inspection 2 and 3, and shutdown due to damage between inspection 3 and 4.

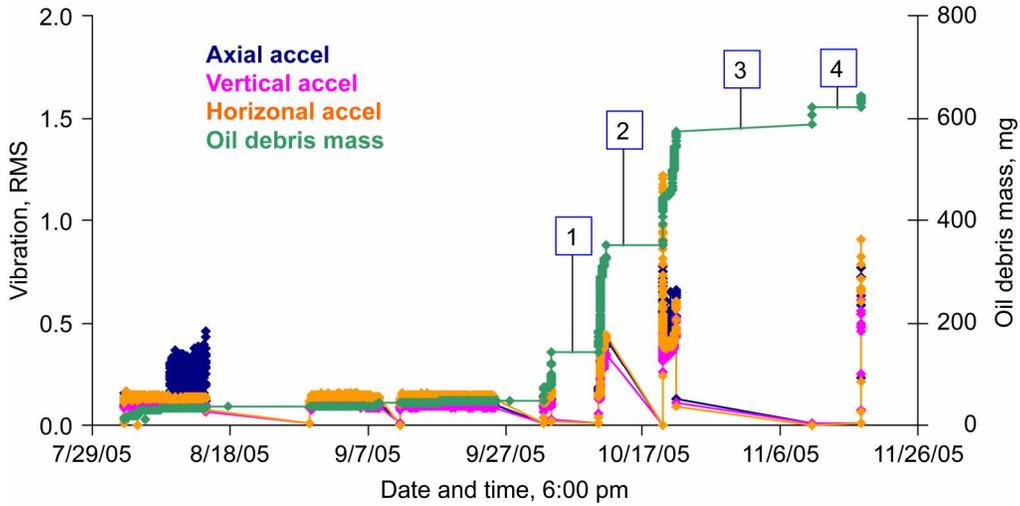
Figure 14 is a plot of the accumulated oil debris mass and the vibration RMS for accelerometers located in the axial (blue), radial vertical (pink), and horizontal (orange) planes. The RMS y-axis is on the left and did not exceed 1.22 for all three accelerometers. The ODM y-axis is on the right with maximum value of 643 mg at test completion. The boxes labeled 1 through 4 identify when the bearings were removed for inspection. The RMS magnitude increased after first, second and fourth inspections, as compared to the values measured prior to the first inspection. The oil debris accumulated mass measured at each inspection interval was 46 mg at the first inspection, 143 mg at the second inspection, 354 mg at the third inspection, 574 mg at the fourth inspection, and 643 mg at test completion.

Figure 14.—Oil debris mass and vibration RMS during Test 3.

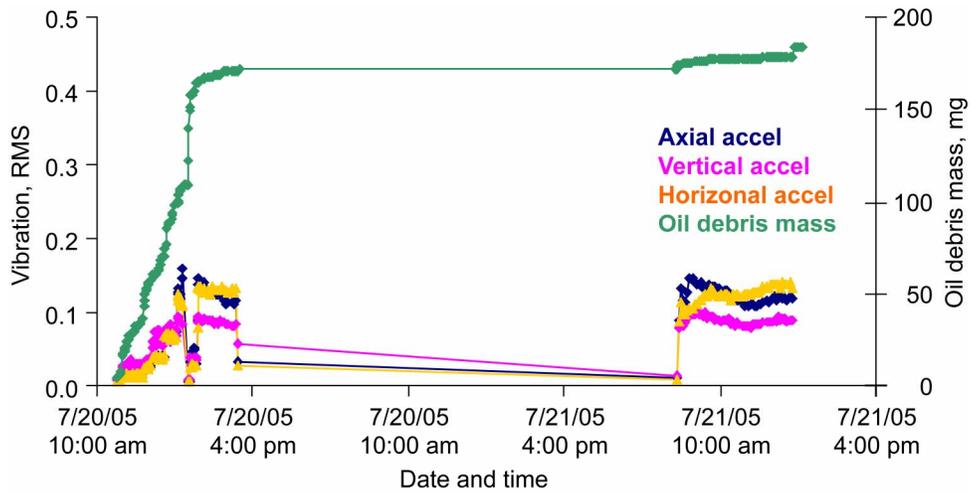
Figure 15 is a plot of the oil debris mass and the vibration RMS for accelerometers located in the axial, radial horizontal and vertical planes. The RMS y-axis is on the left and did not exceed 0.16 for all three accelerometers. The ODM y-axis is on the right with maximum value of 184 mg at test completion.

Figure 15.—Oil debris mass and vibration RMS during baseline test.

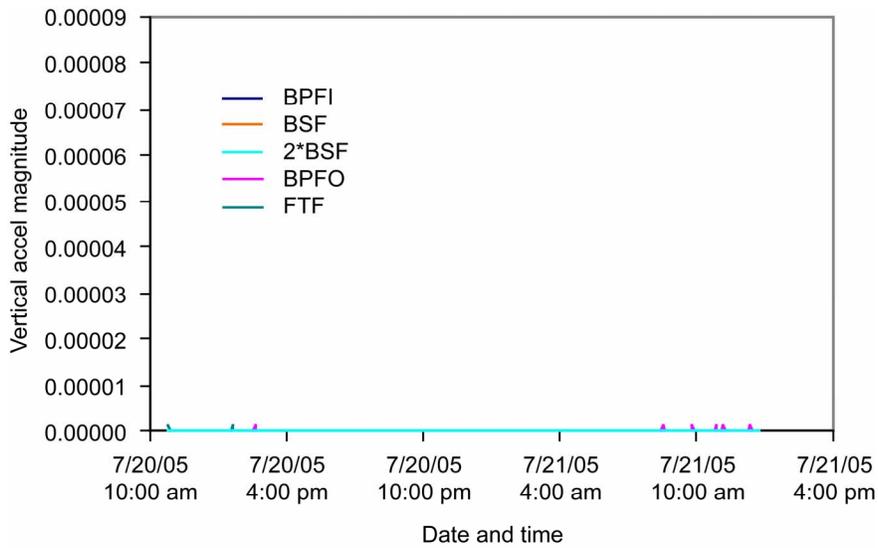
Three accelerometers were used for collecting vibration data during the tapered roller bearing failure progression tests. Of the three accelerometers used during testing, the vertically mounted accelerometer provided the best response and the analysis will be limited to this accelerometer. Also, note that vibration data was unavailable for test 2. Figure 16 is a plot of the defect frequencies during the baseline test. No damage was observed during the baseline test and no defect frequencies of any significance were observed during this test.

Figure 16.—Defect frequencies during baseline test.

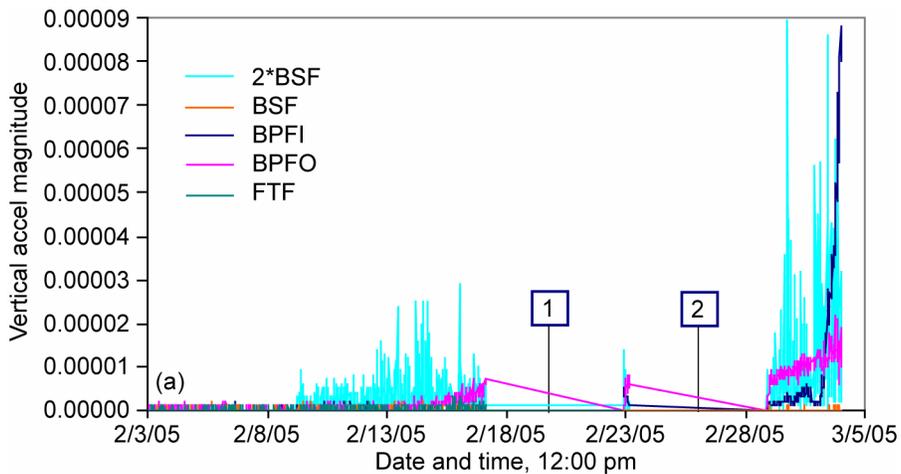
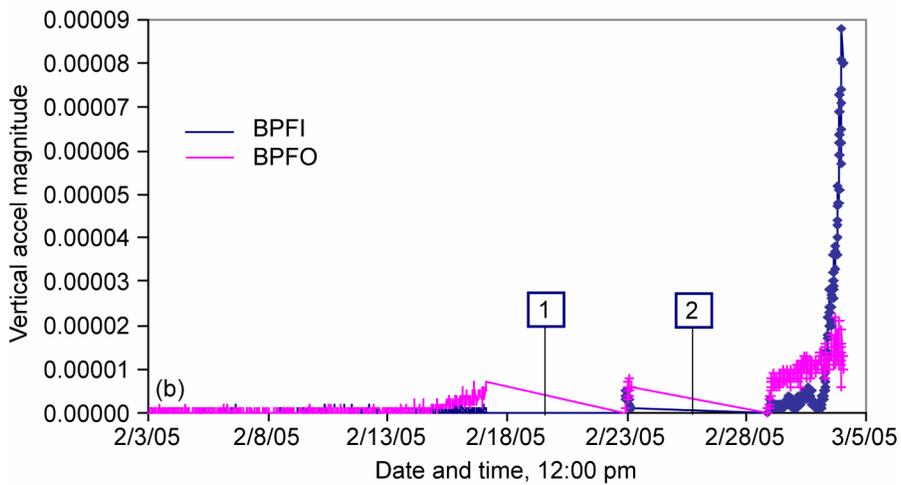
Figure 17 is a plot of the defect frequencies calculated during test 1. In figure 17(a), all defect frequencies are plotted; in figure 17(b), only BPFO and BPFI are plotted. Photos of the damage were shown in figures 2 through 5. After the first inspection interval, spalling was observed on several of the rollers  $2*BSF$  and peeling was observed on the cup BPFO and cone BPFI. The roller defect frequency  $2*BSF$  showed a significant increase. The cup defect frequency BPFO showed a slight increase and the cone defect frequency BPFI showed a minimal increase. The spalls on the rollers increased in size during the second inspection, but the peeling on the cup and cone did not appear to increase significantly. Only a minimal change was observed at the roller defect frequency. At test completion, the spalls on the rollers increased significantly, as did the magnitude of the roller defect frequency  $2*BSF$ . Spalling began to occur on the cone, and the cone defect frequency BPFI increased significantly. The cup defect frequency BPFO also showed a gradual increase although the peeling did not increase significantly.

Figure 17.—Defect frequencies during Test 1. (a) Defect frequencies. (b) BPFI and BPFO defect frequencies.

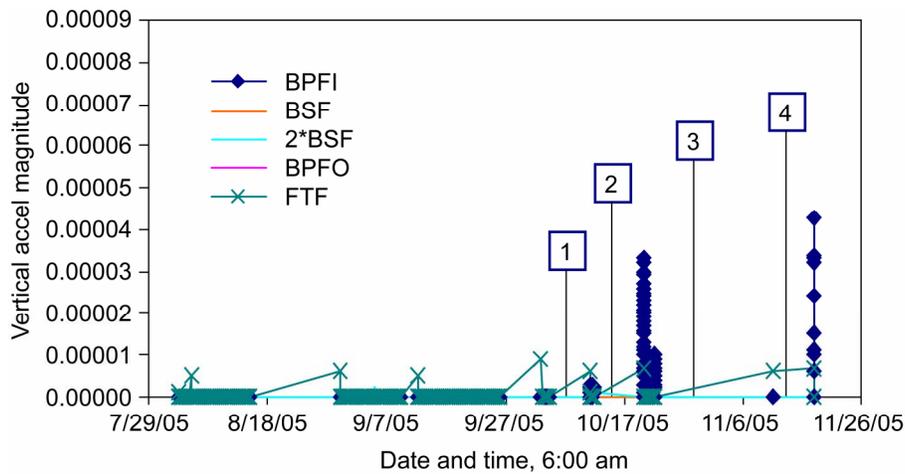
Figure 18.—Defect frequencies during Test 3.

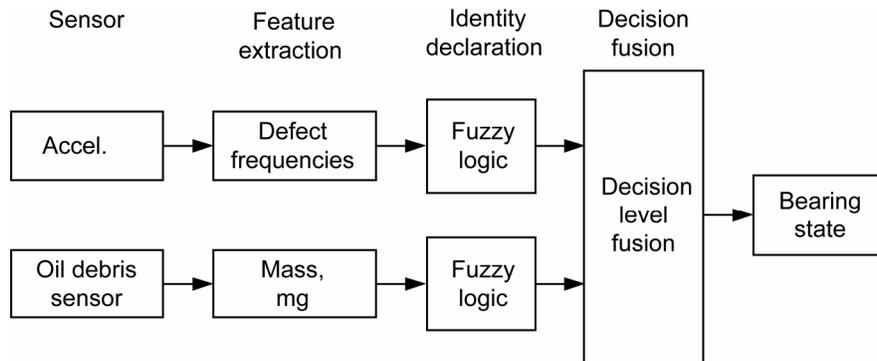
Due to the limited vibration bearing failure progression data available, a theoretical framework of a data fusion model as shown in figure 19 will be discussed. Development of a reliable fuzzy logic model to indicate the health of a component requires sensor data collected from the bearing when it was known to be healthy, and when it was known to be damaged. A minimum of 16 experiments with at least five with or without damage is required to verify the data used to build the model reflects the actual process (ref. 10). The model will continue to be developed as additional vibration bearing failure progression data becomes available.

Figure 19.—Data fusion framework.

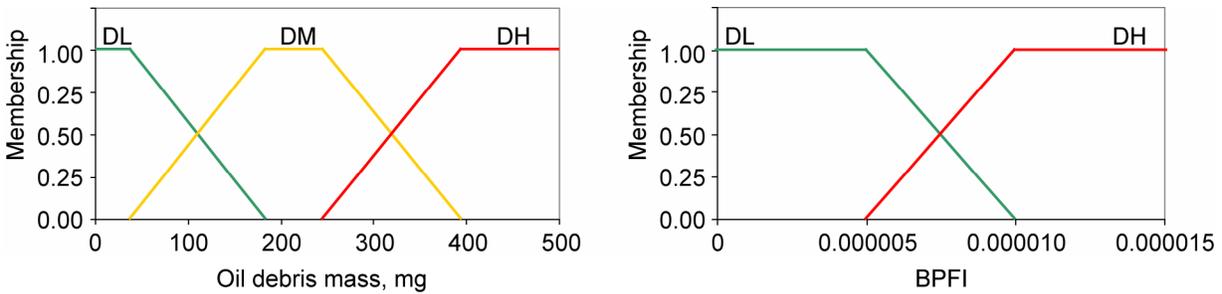
Figure 20.—Membership function.

The membership functions for oil debris mass and BPF1 defect frequencies are shown in figure 20. The data measured from the oil debris and vibration sensor during experiments with damage and with no damage were used to identify membership functions. Threshold limits for the accumulated mass are identified. This analysis will focus on the cone damage BPF1. Separate membership functions and rules could be identified for each type of failure such as cup damage BPF0 or ball/roller damage BSF. Additional defect frequencies can be added to a future model.

The mean of the maximum (MOM) was chosen as the defuzzification method. The MOM method finds the output with the maximum membership and takes the x-axis average of all points with this maximum membership value. The membership functions were based on the data collected during testing.

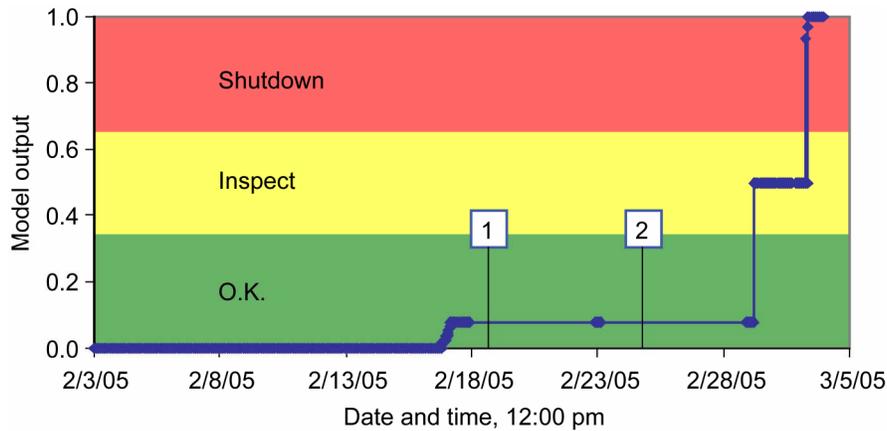
The output of the model for test 1 and 3 are shown in figures 21 and 22. The value 0.0 to 0.33 indicates the bearing is O.K. 0.33 to 0.66 indicates the bearing should be inspected and 0.66 to 1.0 indicates to shutdown the system, the bearing is damaged. The baseline data was plotted but not included and did not exceed 0.08, remaining in the O.K. region.

Figure 21.—Test 1 output of model.

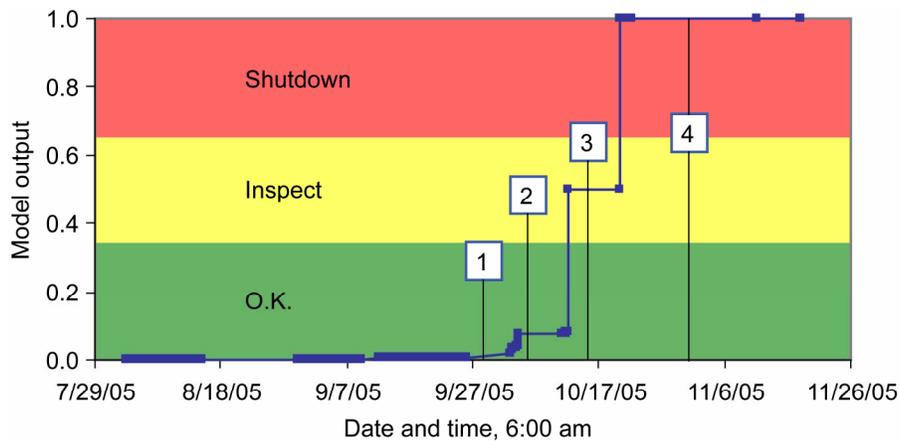
Figure 22.—Test 3 output of model.
