Optical Coatings and Surfaces in Space: MISSE

Alan F. Stewart
Alan.f.stewart@boeing.com
Boeing DES
8531 Fallbrook Ave. MC WA04
West Hills, CA 91304-3232

Miria M. Finckenor
miria.m.finckenor@nasa.gov
Environmental Effects Group
Mail Code EM50 Bldg. 4711 Room 100C
Marshall Space Flight Center, AL 35812

The space environment presents some unique problems for optics. Components must be designed to survive variations in temperature, exposure to ultraviolet, particle radiation, atomic oxygen and contamination from the immediate environment. To determine the importance of these phenomena, a series of passive exposure experiments have been conducted which included, among others, the Long Duration Exposure Facility (LDEF, 1985- 1990), the Passive Optical Sample Assembly (POSA, 1996-1997) and most recently, the Materials on the International Space Station Experiment (MISSE, 2001-2005). The MISSE program benefited greatly from past experience so that at the conclusion of this 4 year mission, samples which remained intact were in remarkable condition. This study will review data from different aspects of this experiment with emphasis on optical properties and performance.

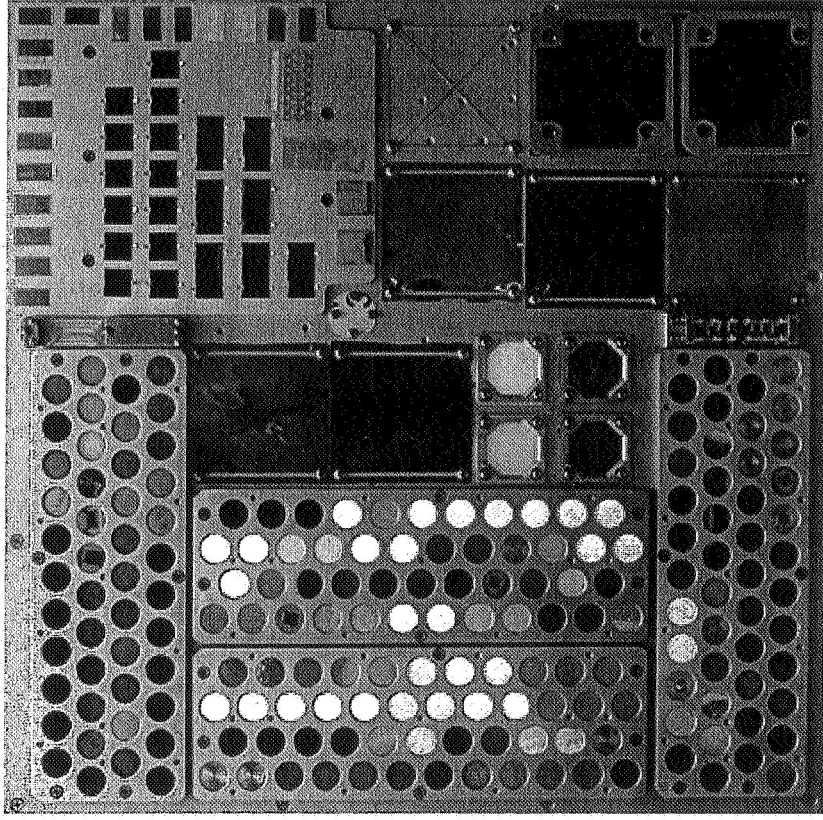
AO and Solar

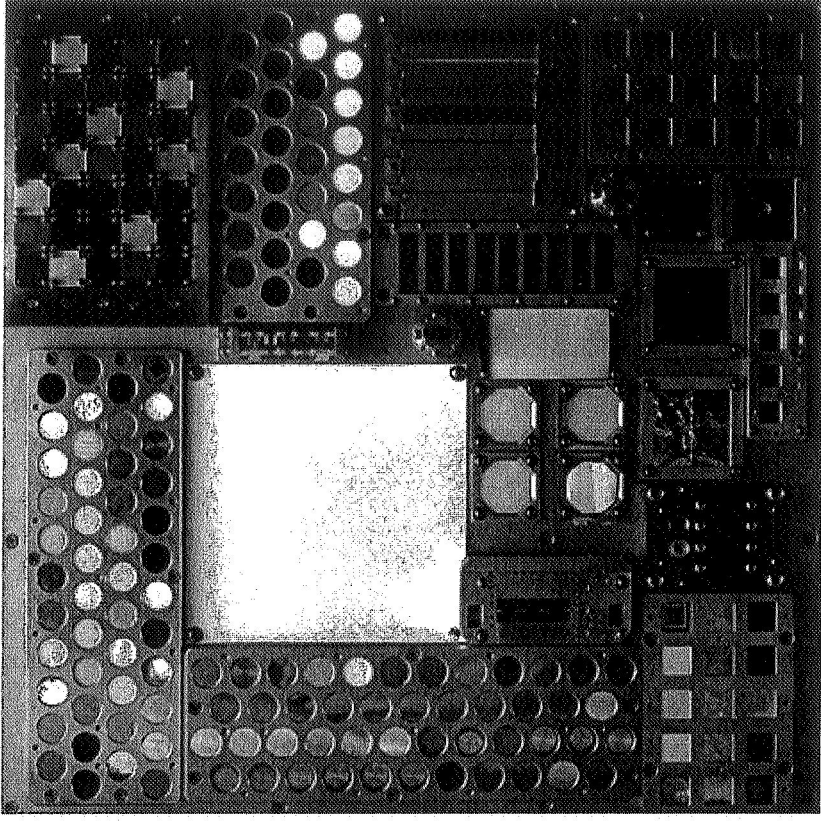
Solar exposure

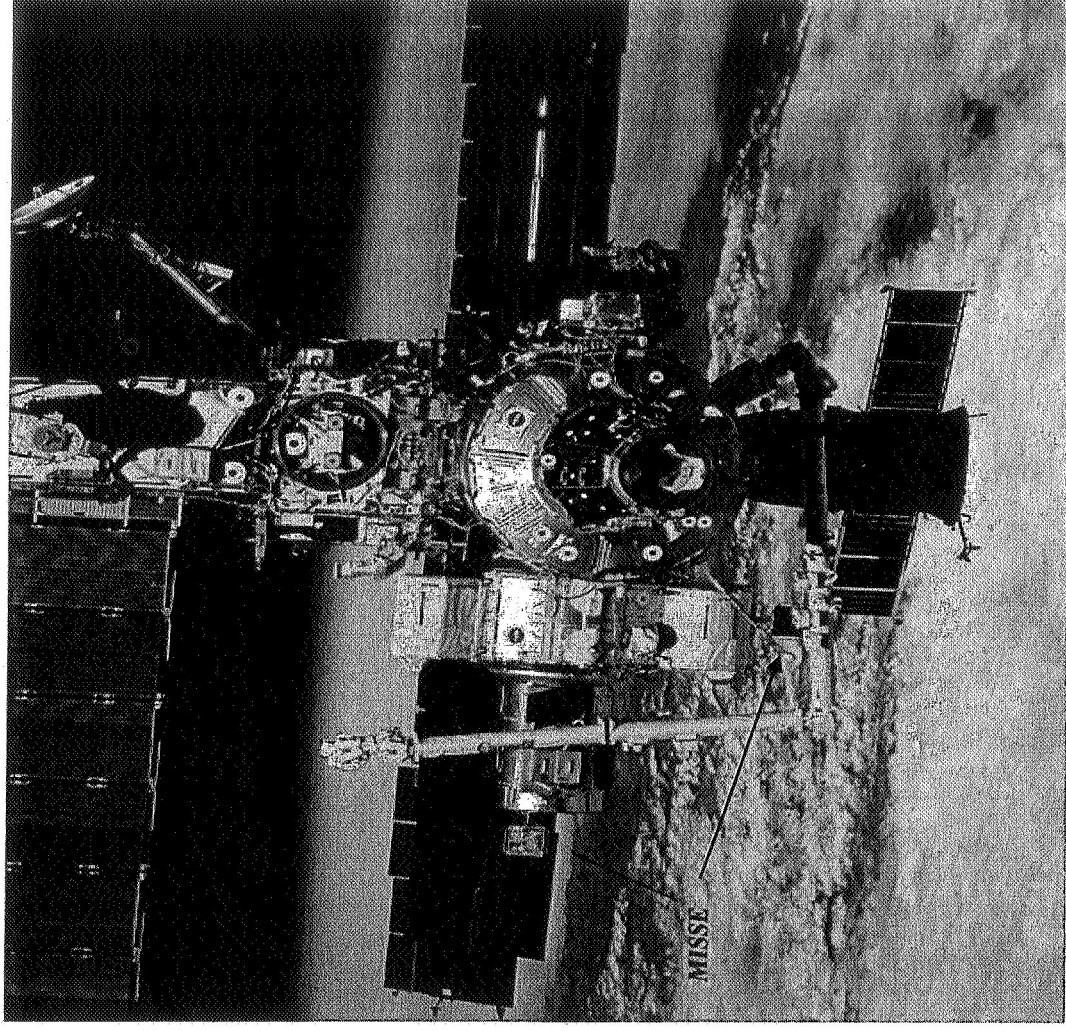
MISSE on the ISS

- Two Modules parked on the ISS for 3.9 years
- Two additional modules installed 7/06
 - 1 year exposure planned
- Locations selected for
 - min/max atomic oxygen
 - min/max solar
- EVA required for placement and retrieval
- Module integration at Boeing Seattle and Langley

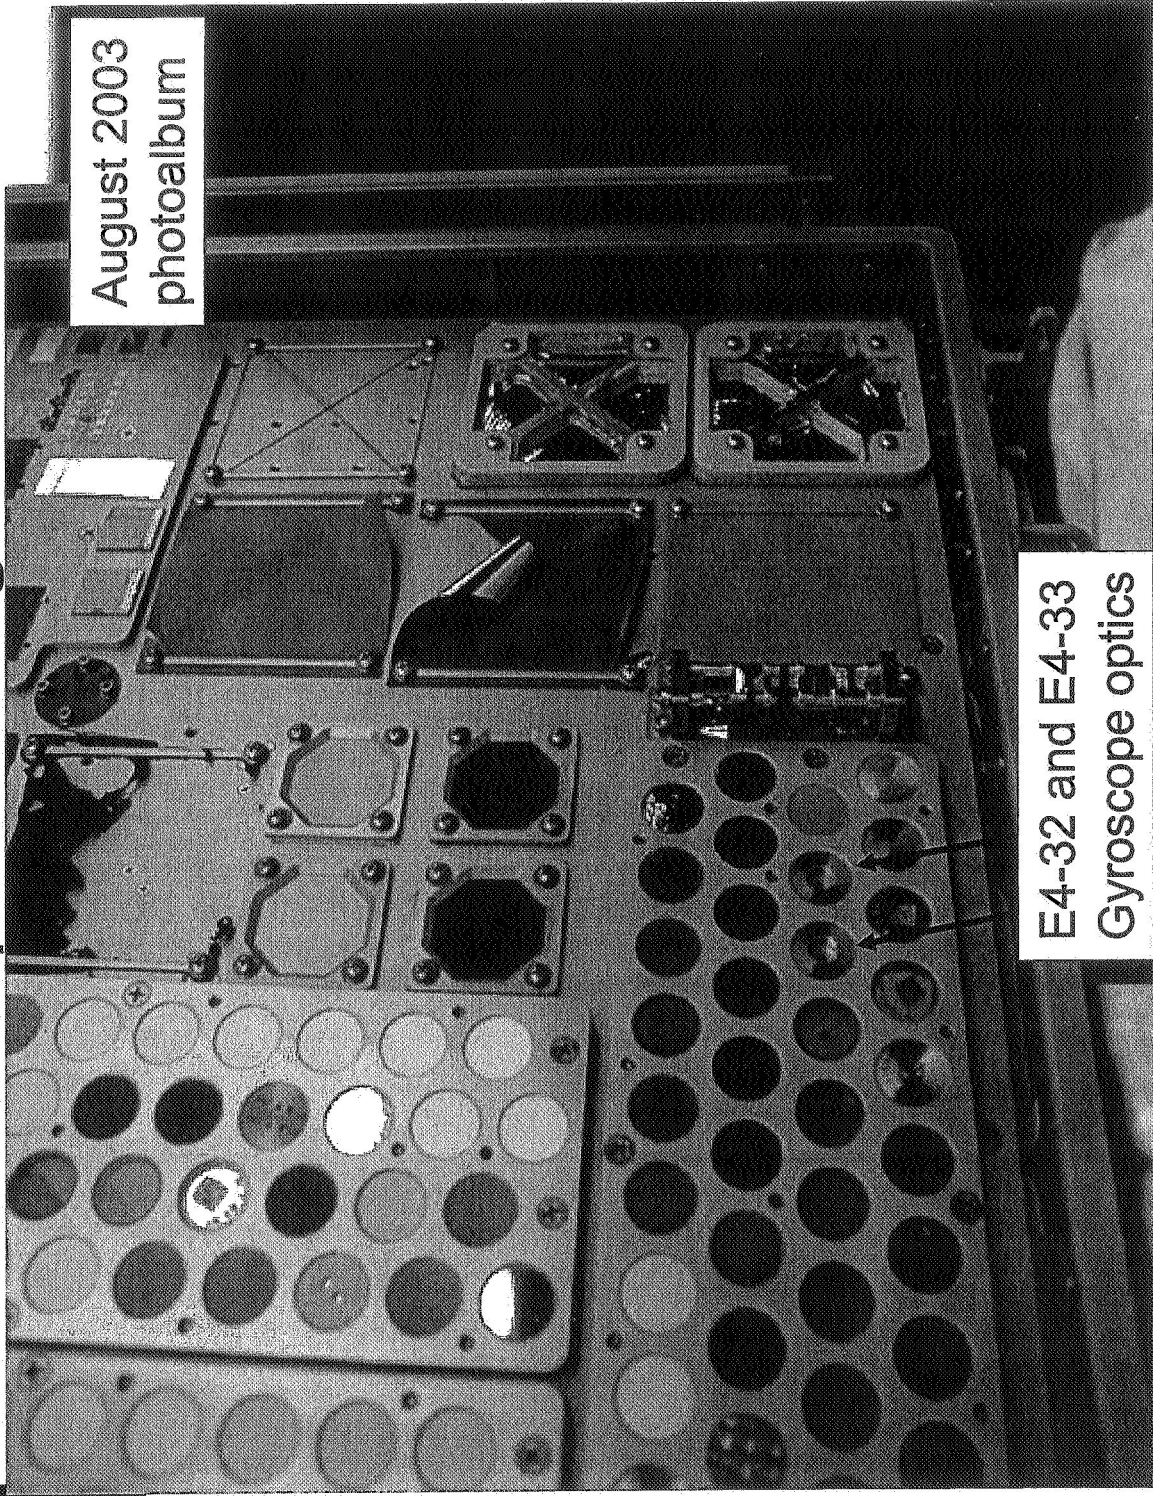
Samples in Flight

August 2003
photoalbum

E4-32 and E4-33
Gyroscope optics

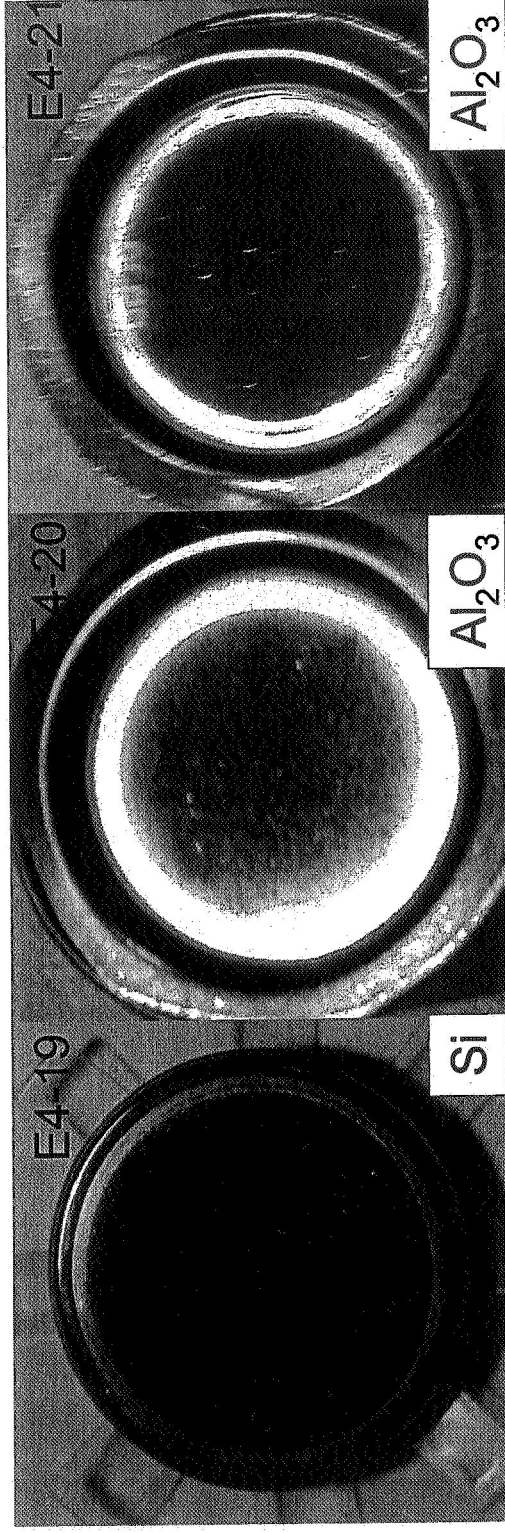
ZnSe/ThF₄ stack with Al₂O₃ overcoat
Showing resistance to abrasion at
contact to sample mount and debris

ZnSe/ThF₄ stacks showing abrasion at contact to sample mount and debris

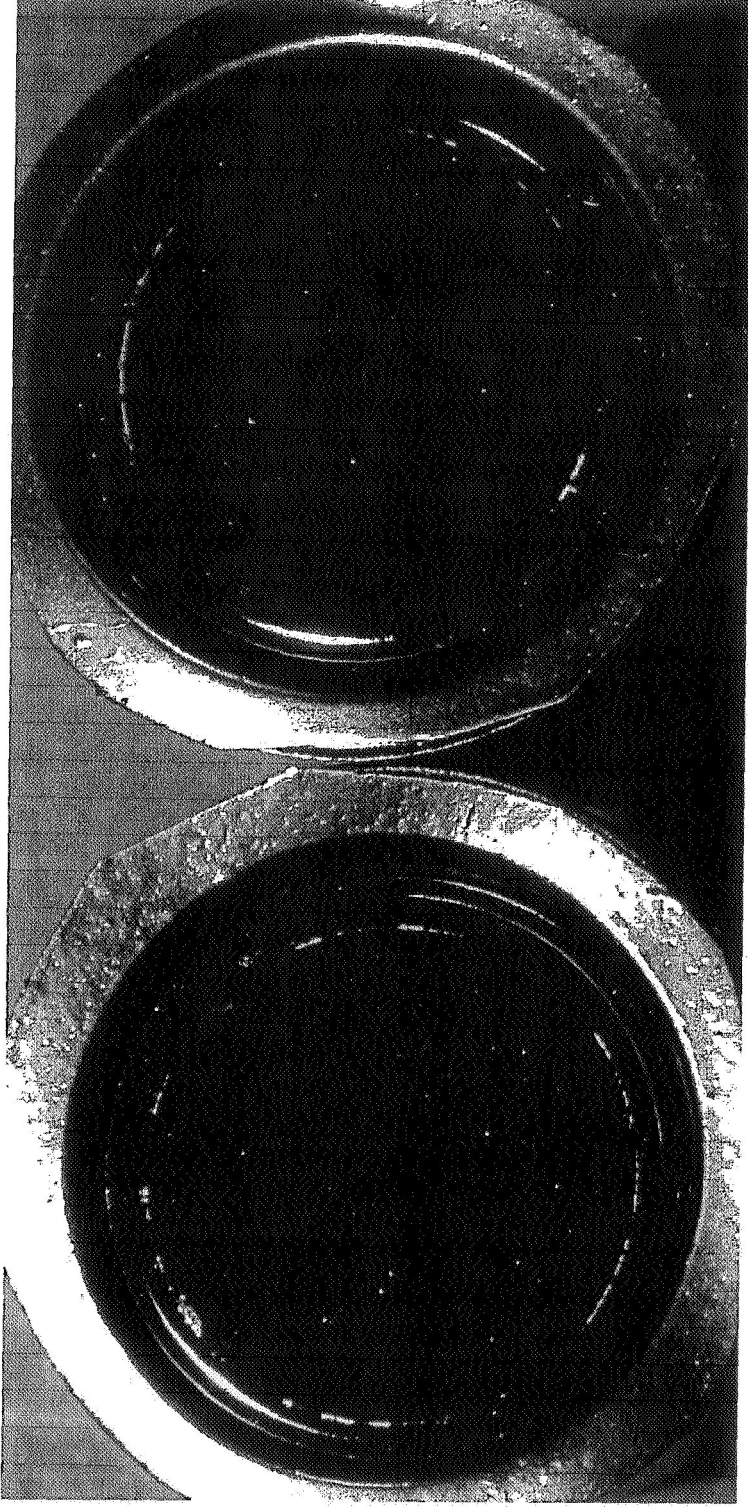
Si/Al₂O₃/SiO₂ Mirrors

E4-22

E4-23

Some tooling damage is evident in the contact area for the sample holder.

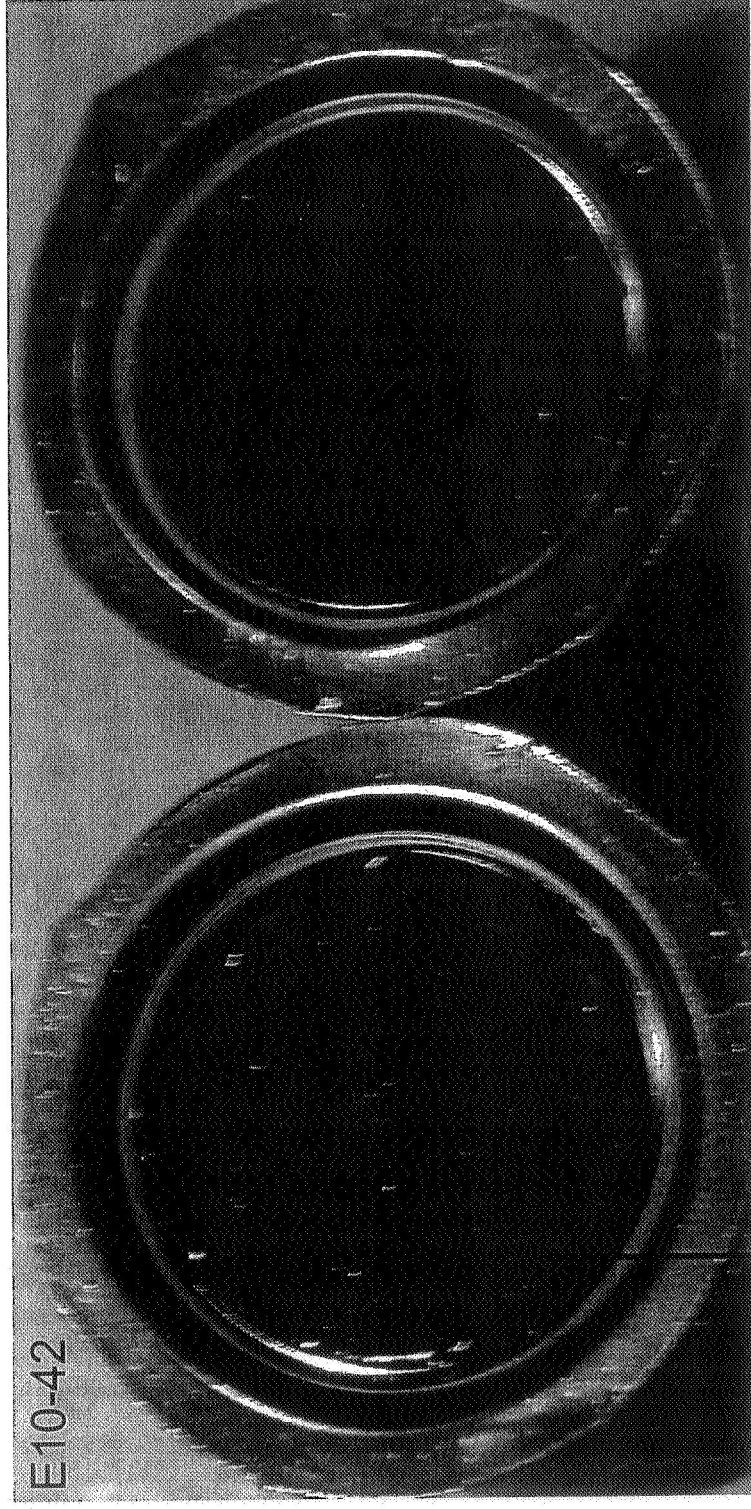
Si/Al₂O₃/SiO₂ Mirror Shows Contamination

Contamination layer is lighter in color than unexposed coating

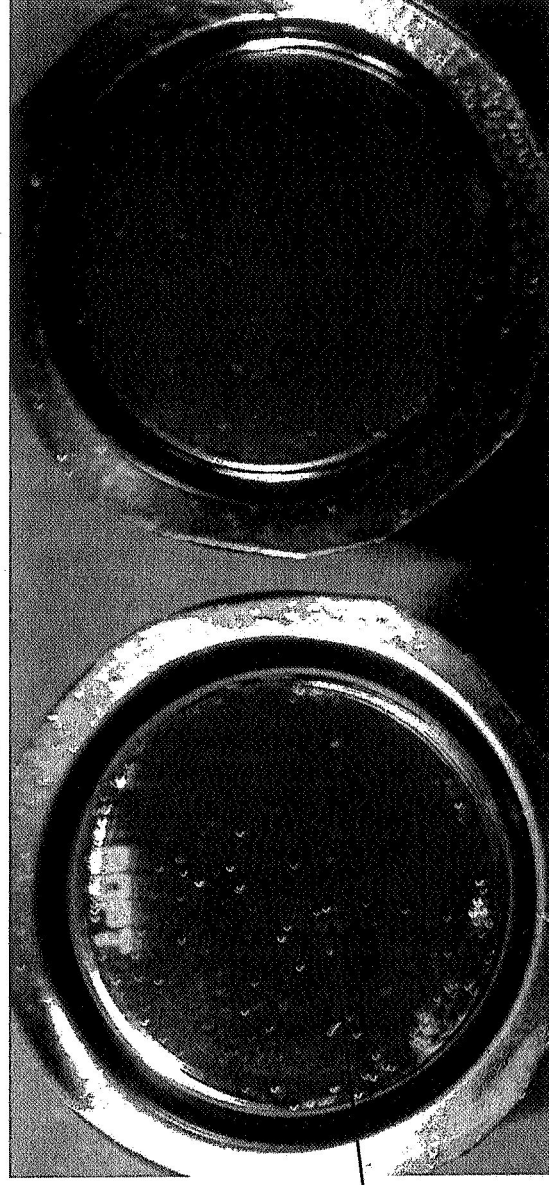
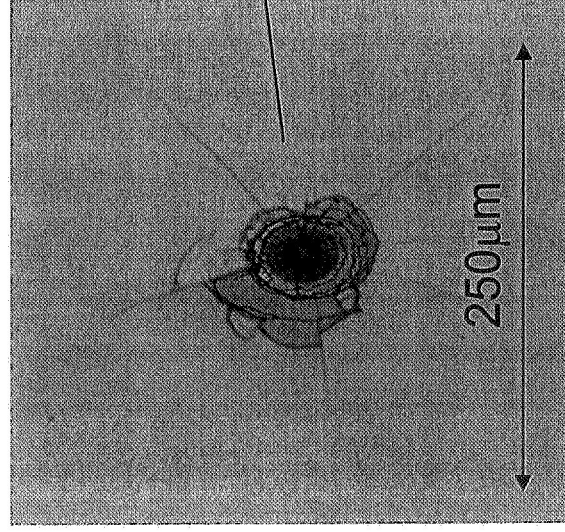
E10-41

Micrometeorite Impact!

ZnSe/ThF₄ coating on sapphire

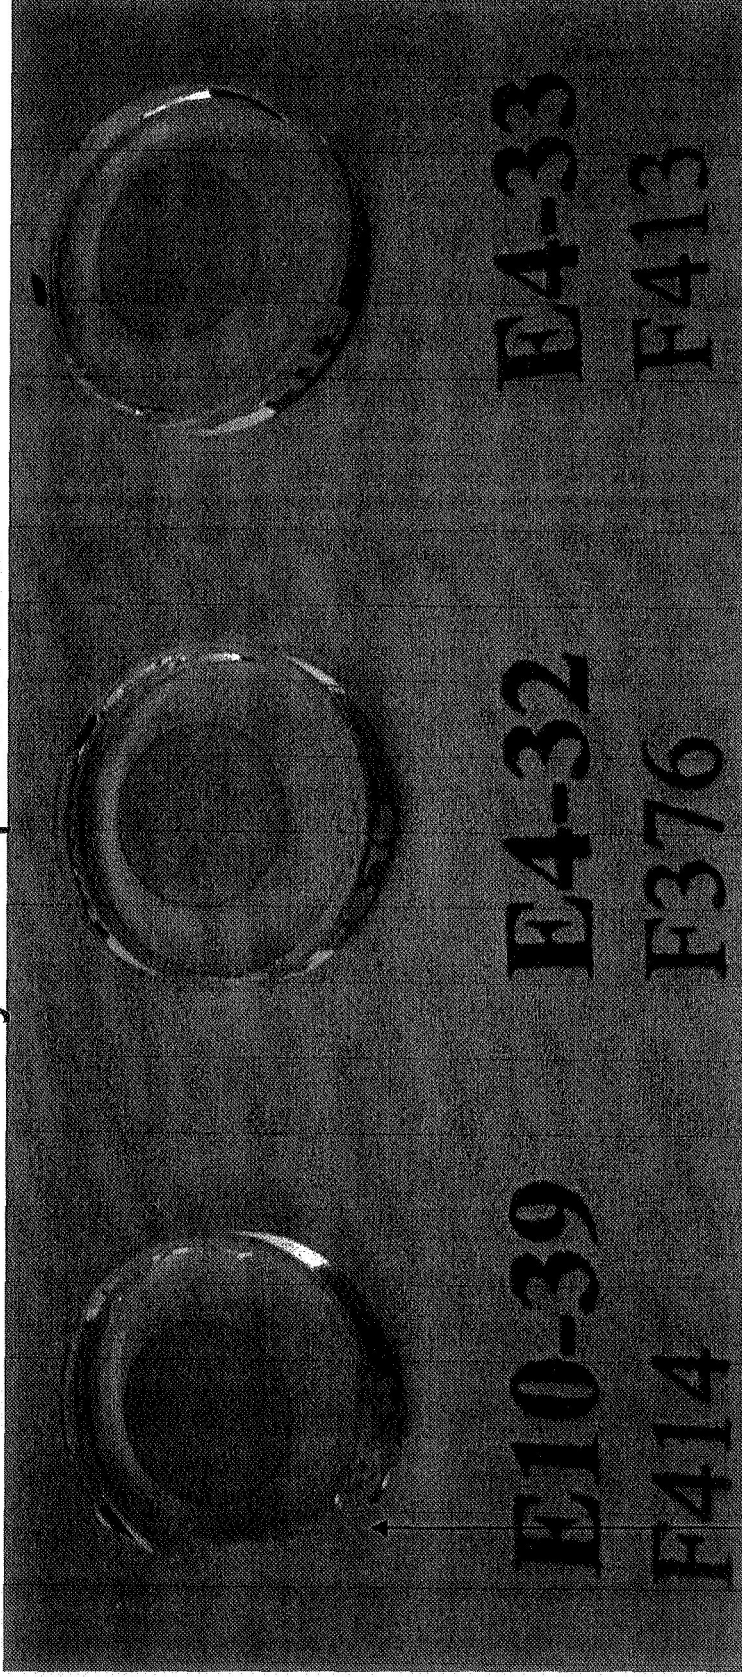
Laser Gyroscope Mirrors

Serious tooling damage!

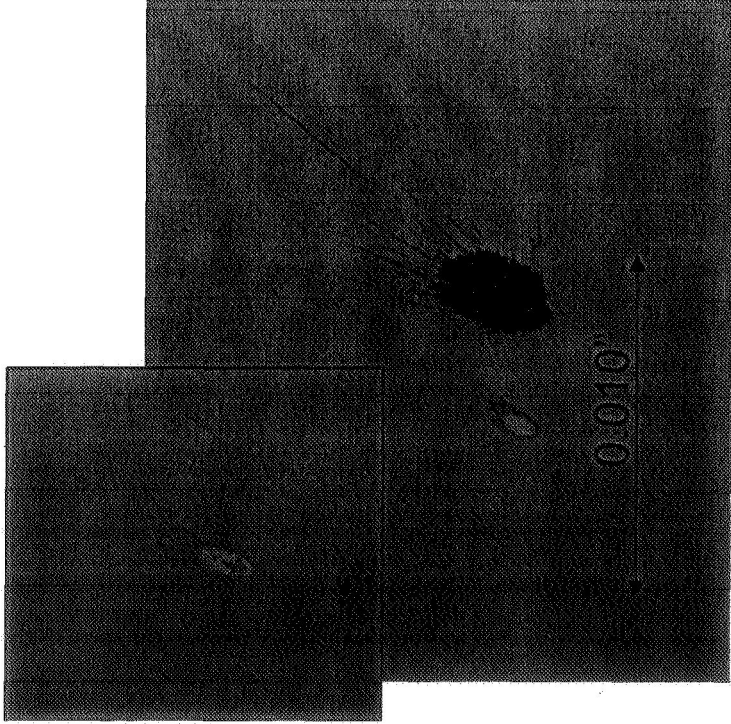
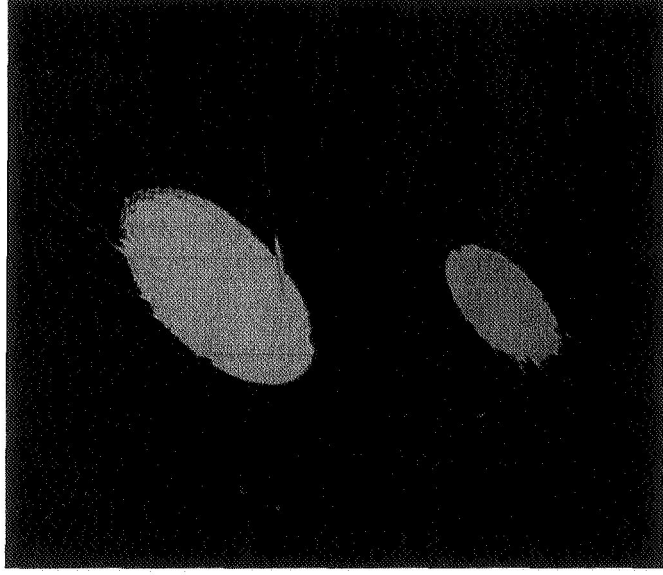
Laser Gyroscope Mirrors Showed "Liquid" Contamination

Surface contamination observed on
Flight samples showing:
Liquid nature of particle
Highly directional emission
