An Overview of Spray-On Foam Insulation Applications on the Space Shuttle's External Tank: Foam Applications and Foam Shedding Mechanisms

43rd Annual Technical Meeting of the Society of Engineering Science
The Pennsylvania State University
University Park, PA

August 14, 2006

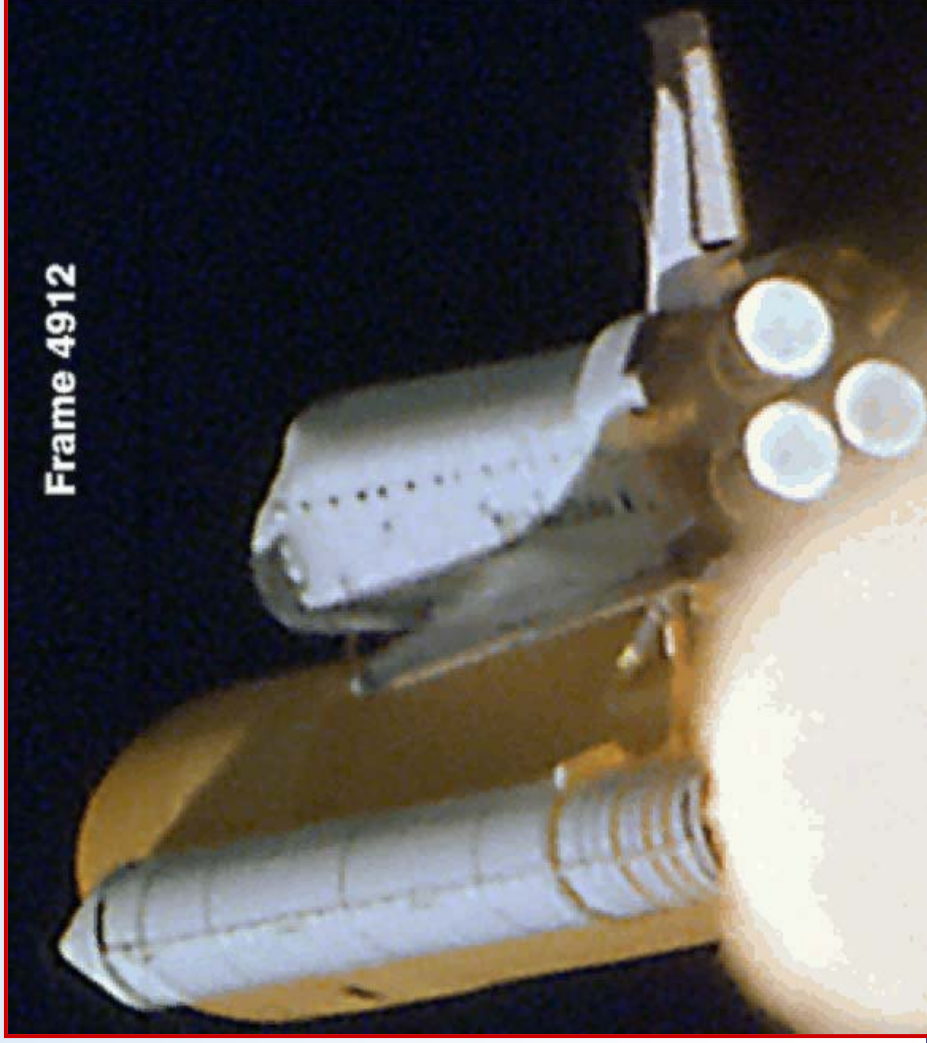
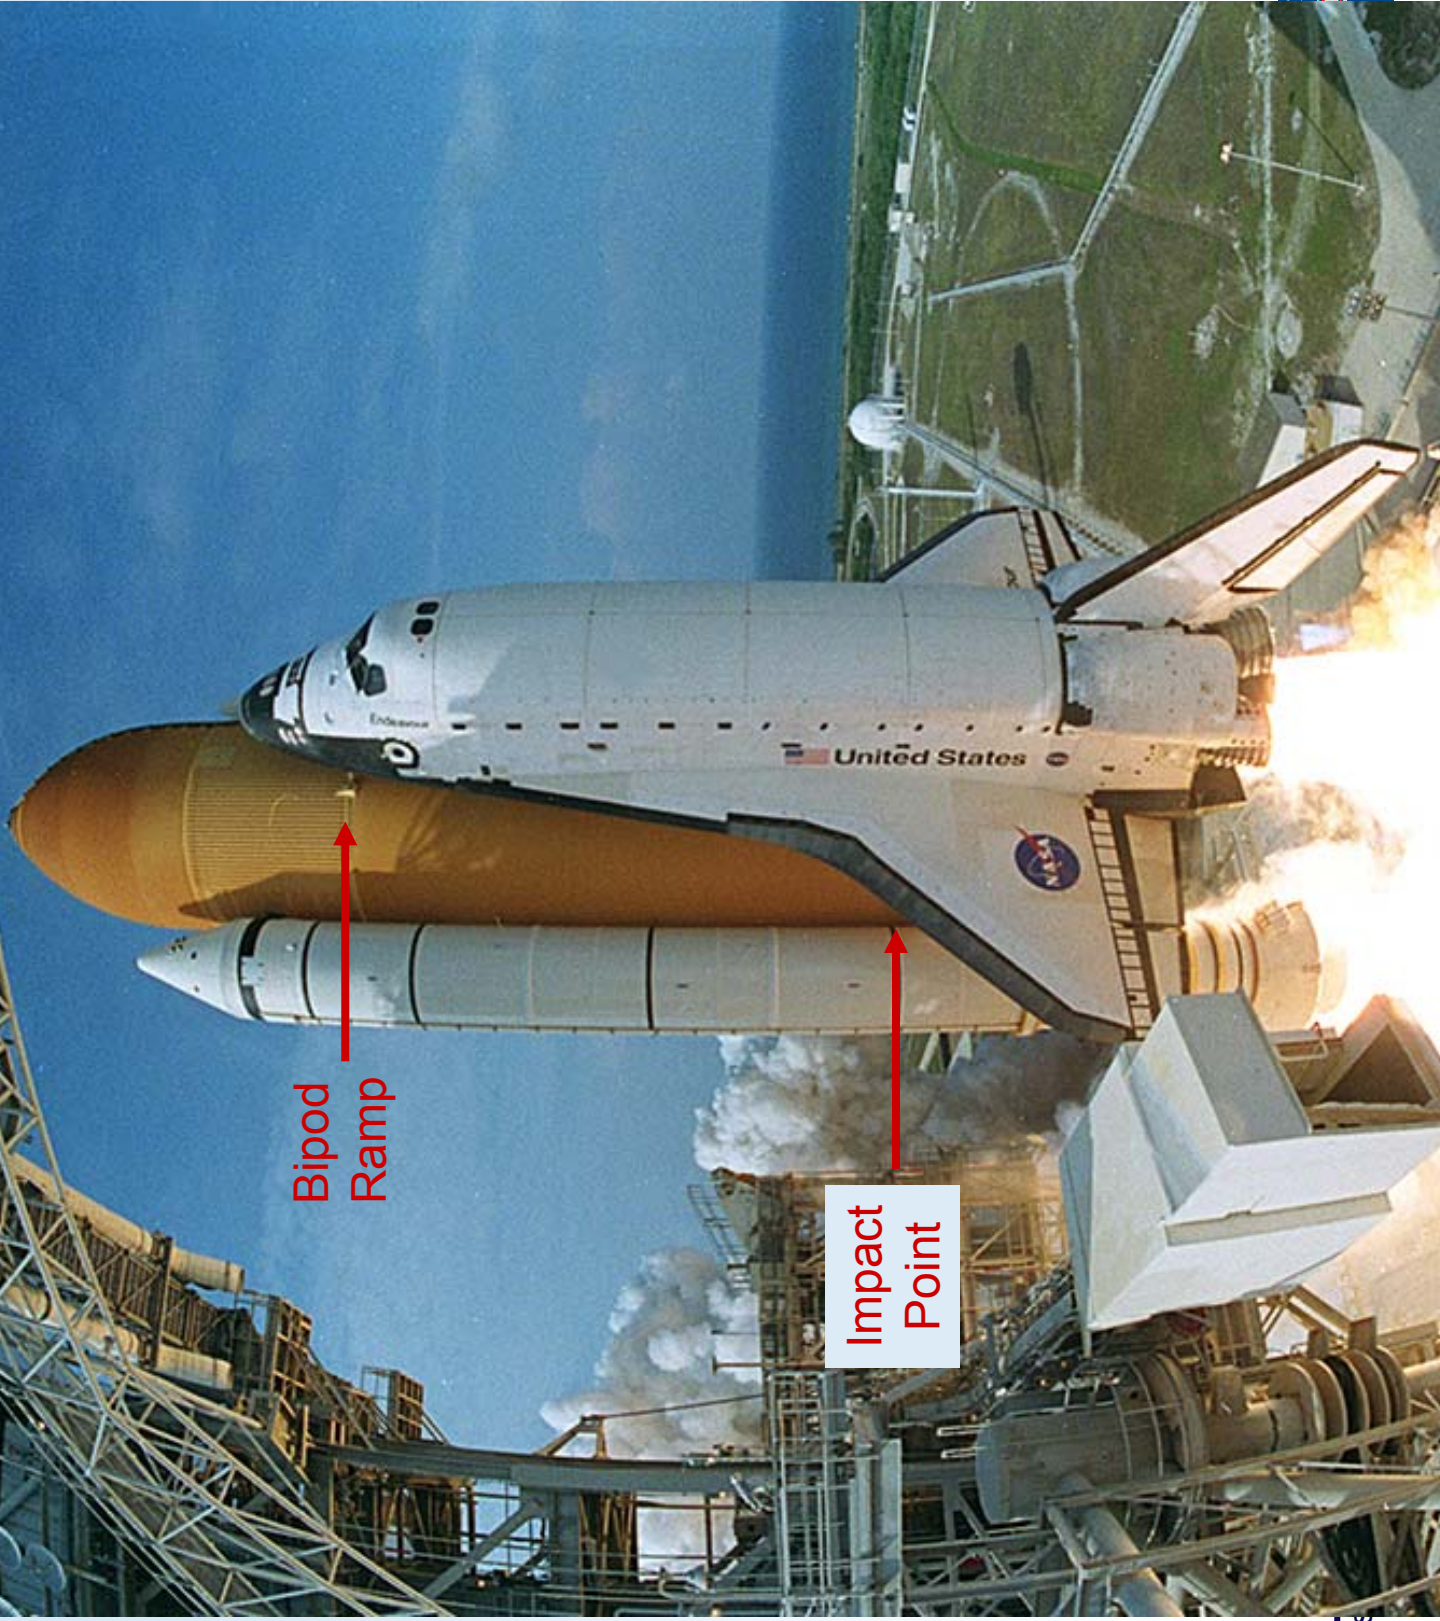
“the cause of the loss of Columbia and its crew was a breach in the Thermal Protection System on the leading edge of the left wing. The breach was initiated by a piece of insulating foam that separated from the left bipod ramp of the External Tank and struck the wing in the vicinity of the lower half of Reinforced Carbon-Carbon panel #8 at 81.9 seconds after launch.”

Bipod
Ramp

Impact
Point

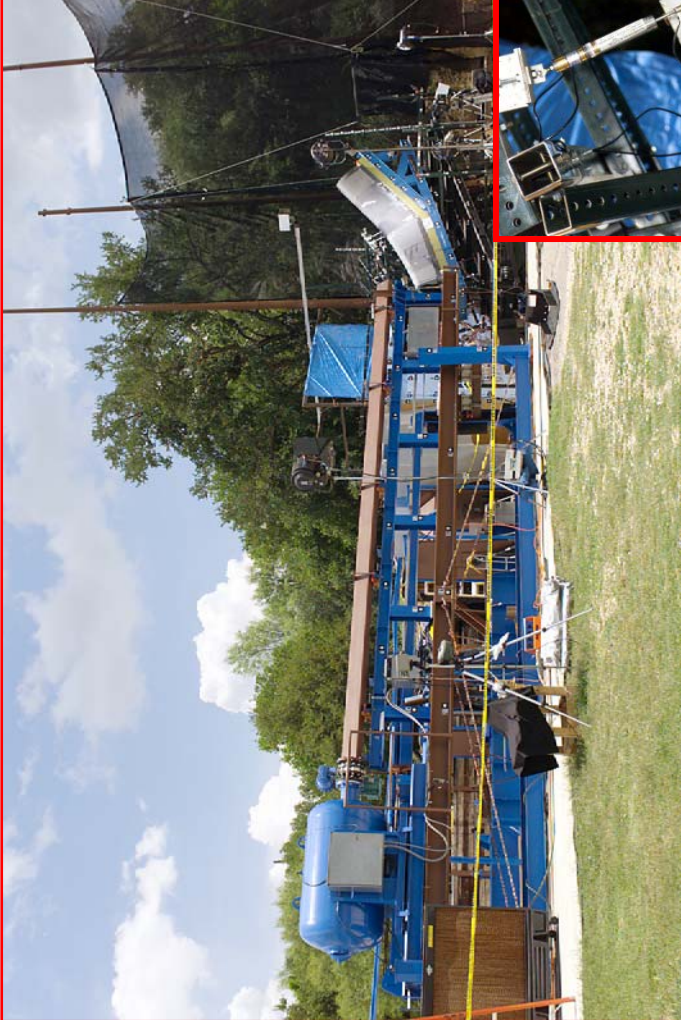
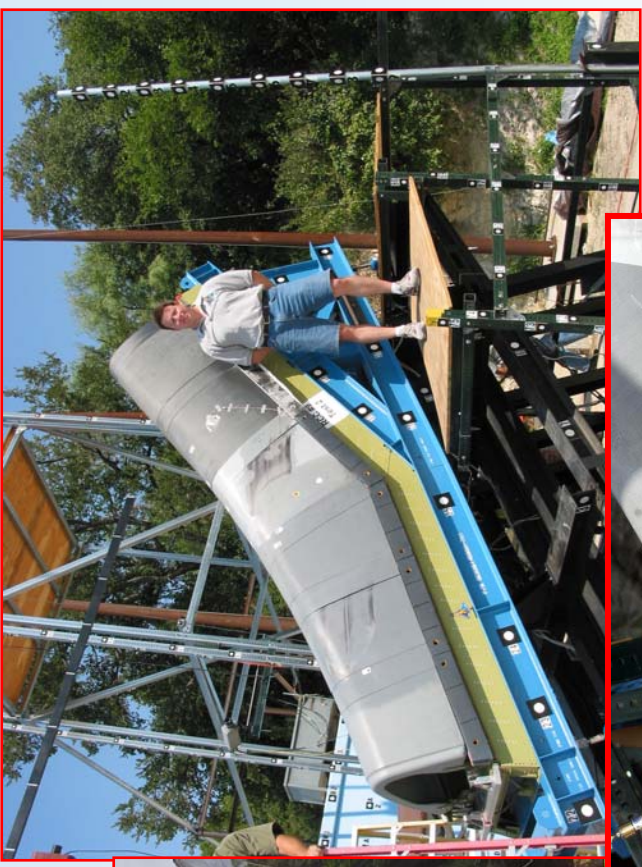
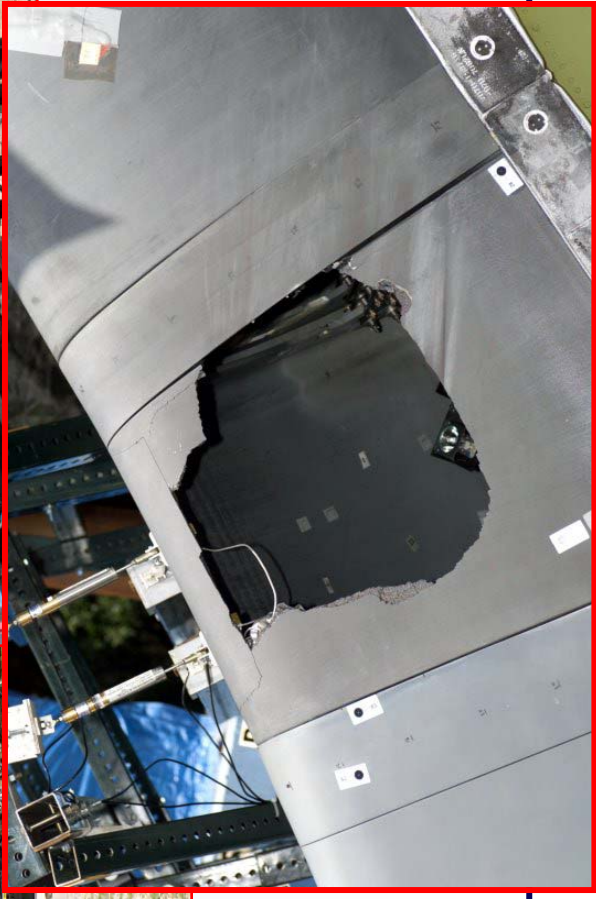
Post-Mission Testing Confirmed the Potential for Damage to Reinforced Carbon-Carbon Wing Leading Edge from Foam Impacts

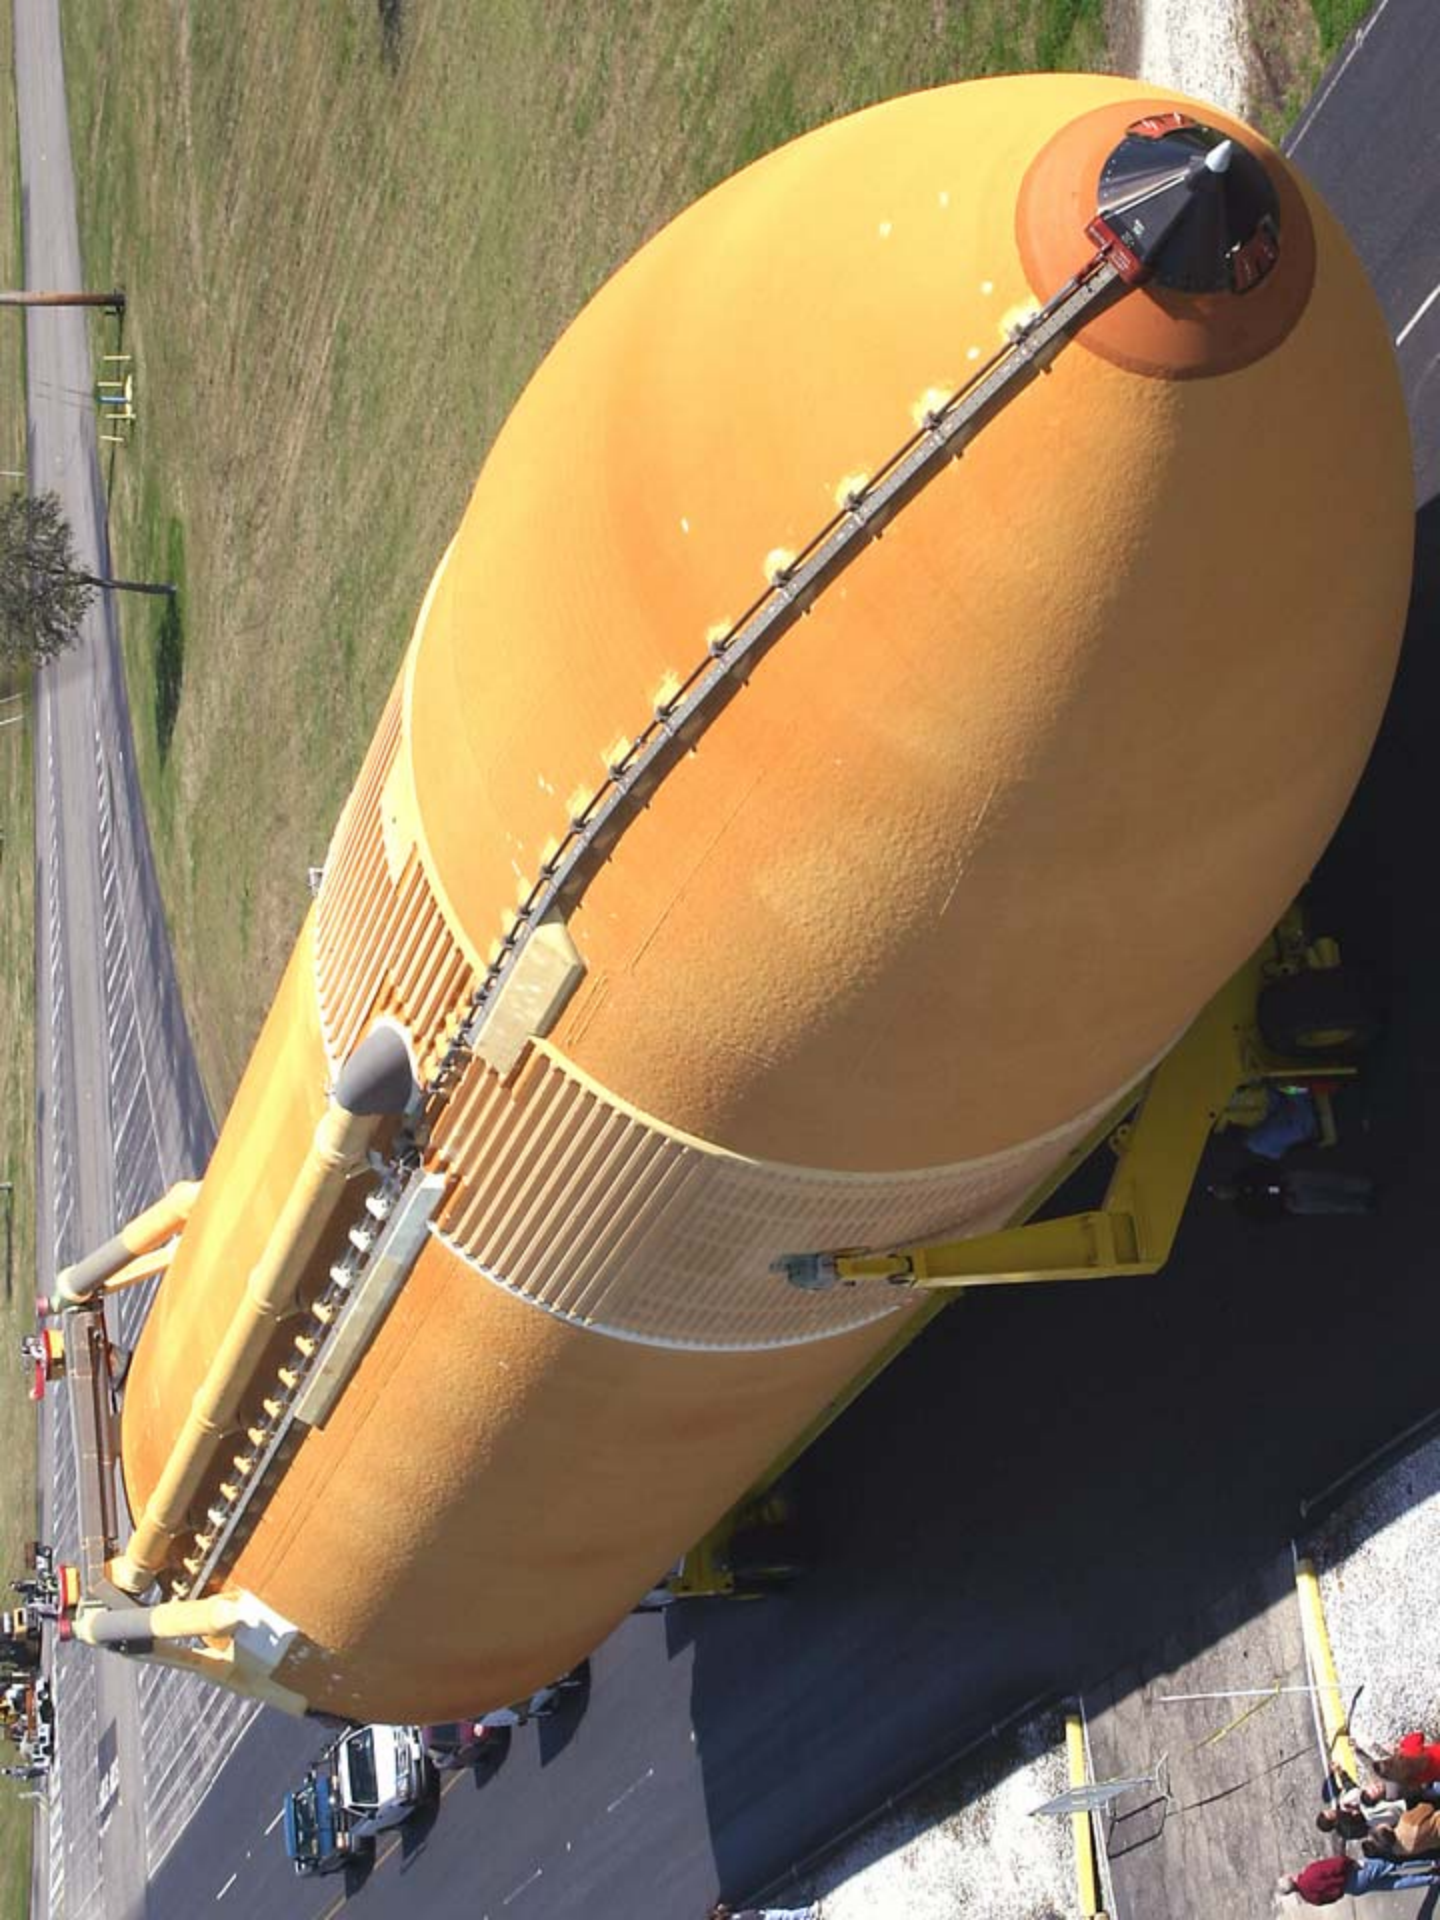
Thermal Protection System Overview

- LH2 Tank Dome
- NCFI 24-57
- Apex Closeout
- BX-250
- SLA 561

- Aft Interfaces / Cable Tray Covers/Fairings
- BX-250
- PDL-1034 closeouts
- SLA 561

- Aft Struts
- BX-250 or BX-265
- SLA 561

- LH2 Ice/Frost Ramps
- PDL-1034
- SLA 561

- LO2 Feedline Fairing
- SLA 561
- Intertank Acreage (Machined/Vented)
- NCFI 24-124

- LO2 P-AL Ramp
- BX-250

- LO2 Feedline
- BX-250
- PDL-1034 closeouts

- LH2 Tank Barrel
- NCFI 24-124

- Bipod Struts
- MA 255

- Bipod Closeouts
- BX-265

- Fwd and Aft Intertank Flange Closeouts
- BX-250 or BX-265

- LO2 Ice/Frost Ramps
- PDL-1034
- LO2 Tank Ogive / Barrel
- SLA 561
- NCFI 24-124

- Cable Trays & Fairings (LO2 Tank, I/T, and LH2 Tank)
- SLA 561

- Nose Cone (internal)
- MA 255
- PDL 1034

- Nose Cone
- Graphite / Phenolic

The Thermal Protection System is applied to the ET to maintain cryogenic propellant quality, minimize ice/frost formation, and protect the structure from ascent, plume, and re-entry heating

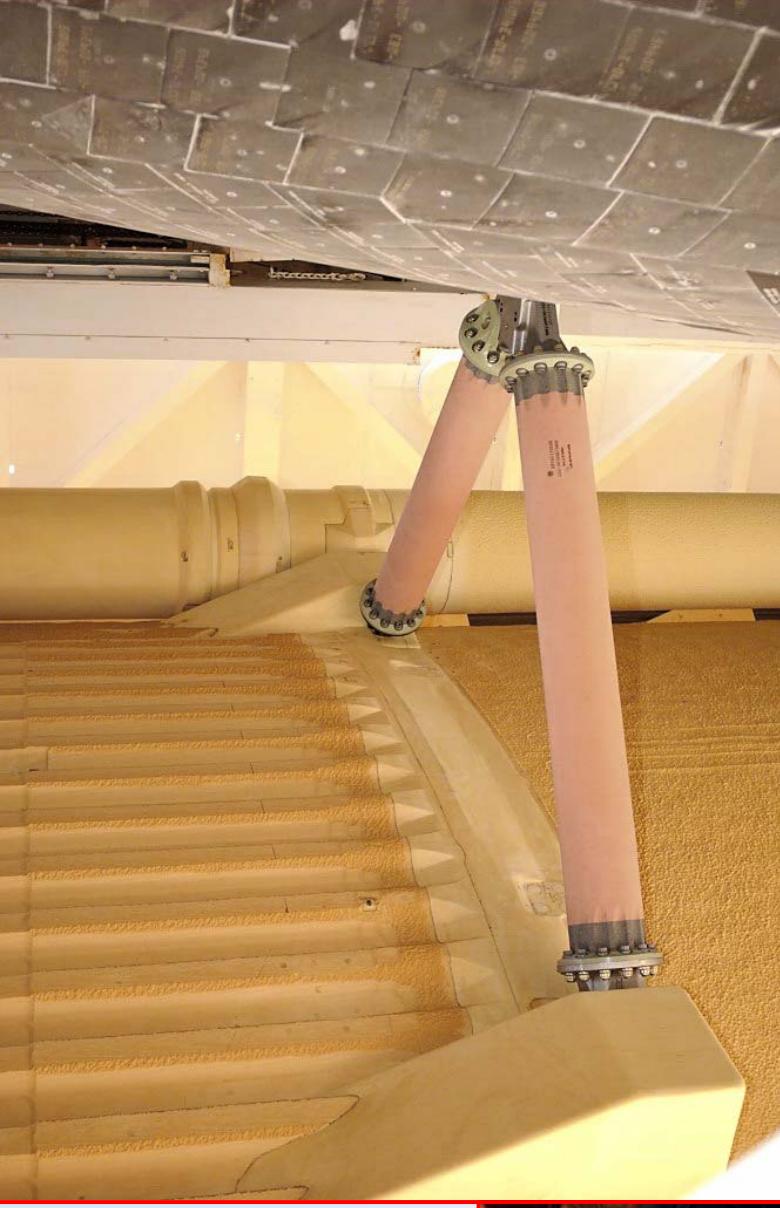
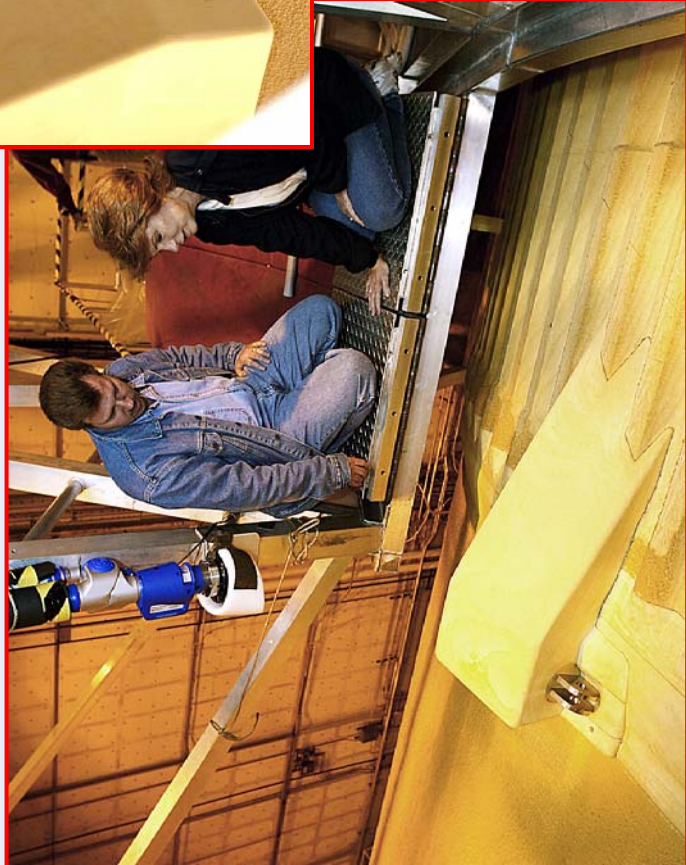
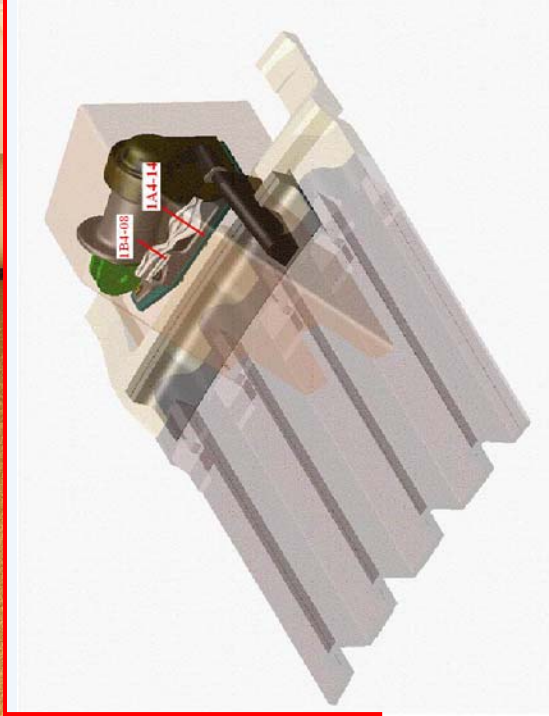
Bipod Fitting and Ramp Closeout

- Sprayed or molded around fittings/flanges where automated spraying is not possible.
- Manual Sprayed Close-outs: BX-265 (Polyurethane)
- Molded Close-outs: PDL-1034 (Polyurethane)

Redesigned the Bipod Closeout and Fitting

- Remove Foam Ramp
- Add Heaters (to prevent ice formation)
- Inconel fitting (higher temperature metal for external aerodynamic heating)
- Insulated fitting from cold cryogen with phenolic insulator

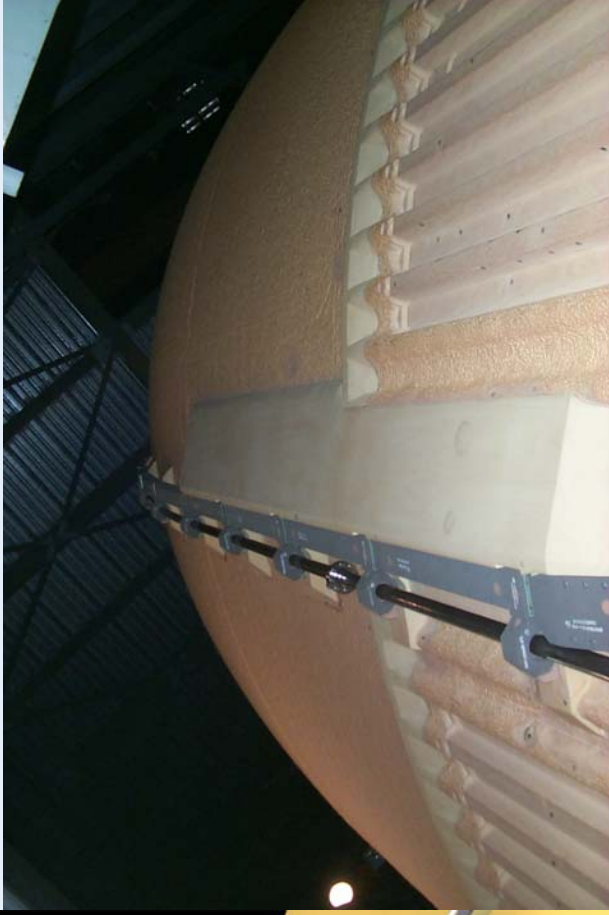
Protrusion Air Load (PAL) Ramp

Added early in Shuttle Program to avoid any potential aerodynamic instability resulting from the pressurization lines and cable tray

Removed the LOx and LH₂ PAL ramps

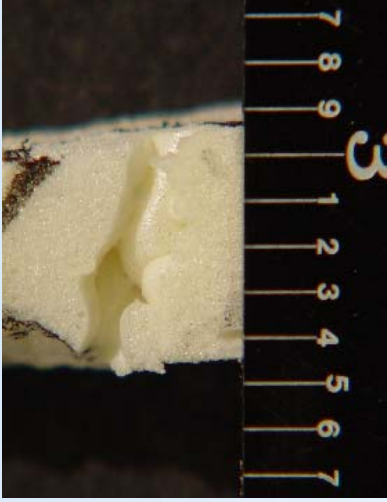
Rollover

- *Rising foam overlaps and creates long pocket*

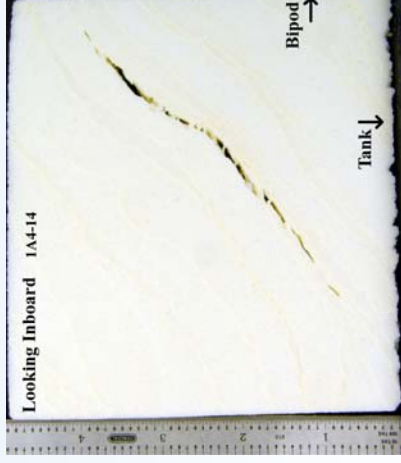
Knitline Delamination

- *Incorrect overlap time.*
- *Second pass applied too thin or too thick.*

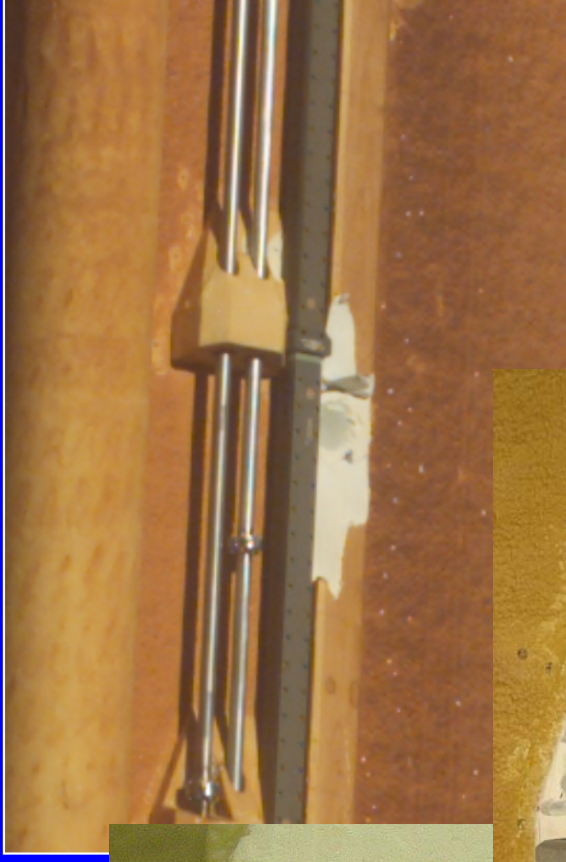
STS-114

Sub-layer Cracking, Crack Propagation and Subsequent Delamination from Substrate

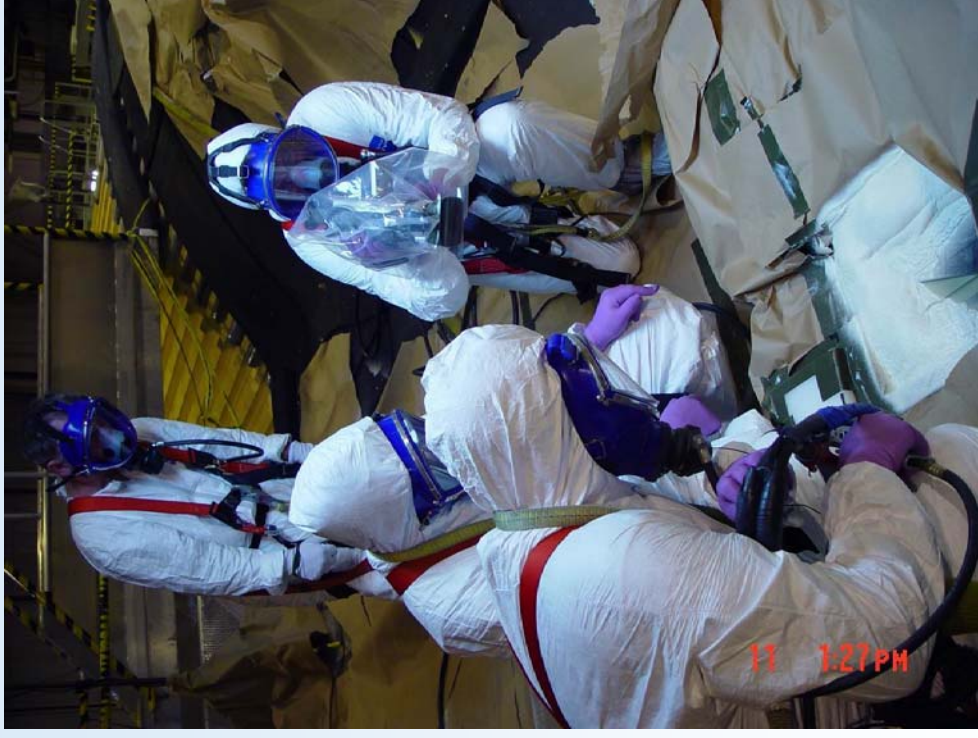
**Redesigned Bipod Closeout
Mockup Spray in Progress**

- Rigorous process validation with dissections
- Tightened spray parameters:
 - Temperature
 - Relative humidity
 - Time between subsequent spray passes
- Two operators for all sprays (“second set of eyes”)
- Witness panels and high-fidelity mockups
- Video reviews

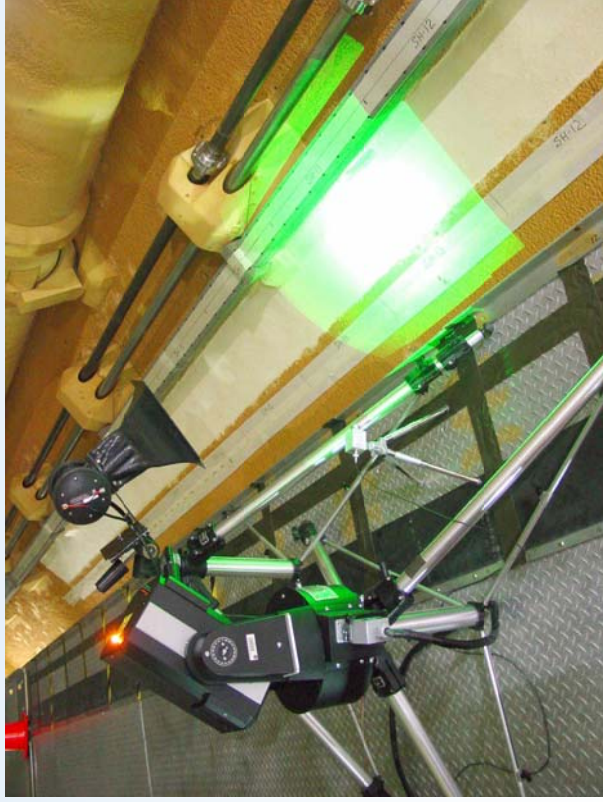
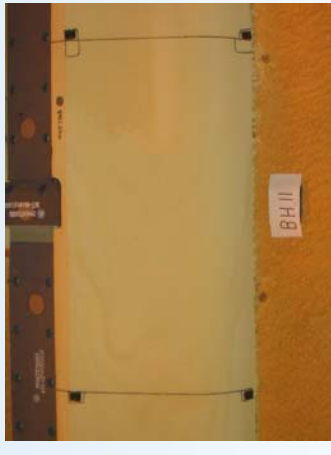
Improving ability to detect voids/flaws in foam applications

- Non-destructive evaluation (NDE) techniques being developed for ET foam
 - Backscatter X-ray
 - Terahertz
 - Shearography
- Inspection techniques have not yet been certified, data used for engineering information only
