Nondestructive Methods and Special Test Instrumentation Supporting NASA Composite Overwrapped Pressure Vessel Assessments

AIAA-2007-2324

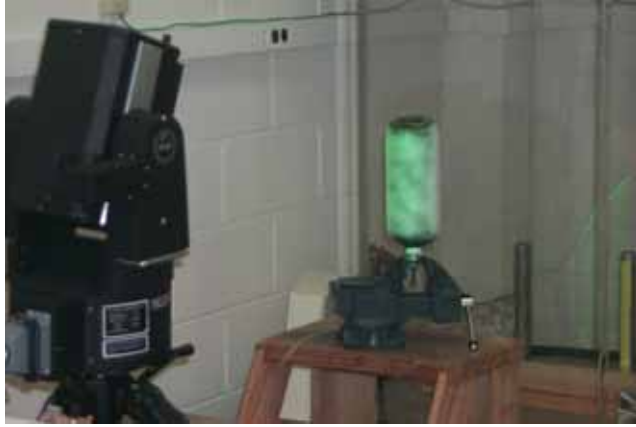
Figure 1. Shearography setup.

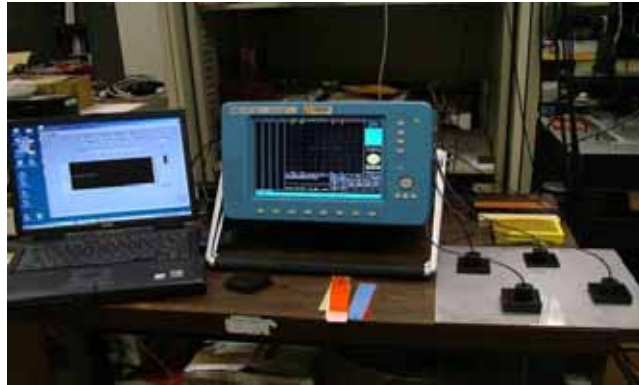
Figure 11. Eddy current inspection system for COPV composite thickness measurement

eight on the larger gaseous helium tanks. The coils, shown in the right-hand side of Figure 11, are each enclosed in a housing 1-in. in diameter and 0.75-in. tall. Each coil has been placed on an insulating surface (Delrin[®] sheet) over a stainless steel conductor. In this laboratory environment, the simple geometry mimics the Kevlar composite over a COPV with a metal. A laptop computer is used to acquire and archive the data in real-time during testing. In the figure, the normalized impedance of the four coils is displayed in the four dots in the center of the MIZ-27 screen. The signals have been nulled, or balanced, at the respective composite thicknesses seen by each probe and rotated such that a change in lift-off results in a vertical deflection of the eddy current signal. The probe response is digitized and stored on the laptop computer, while the vertical components of the signals are displayed in a strip chart on the computer screen. A separate analog input channel is reserved to acquire timing information from the pressurization tests.

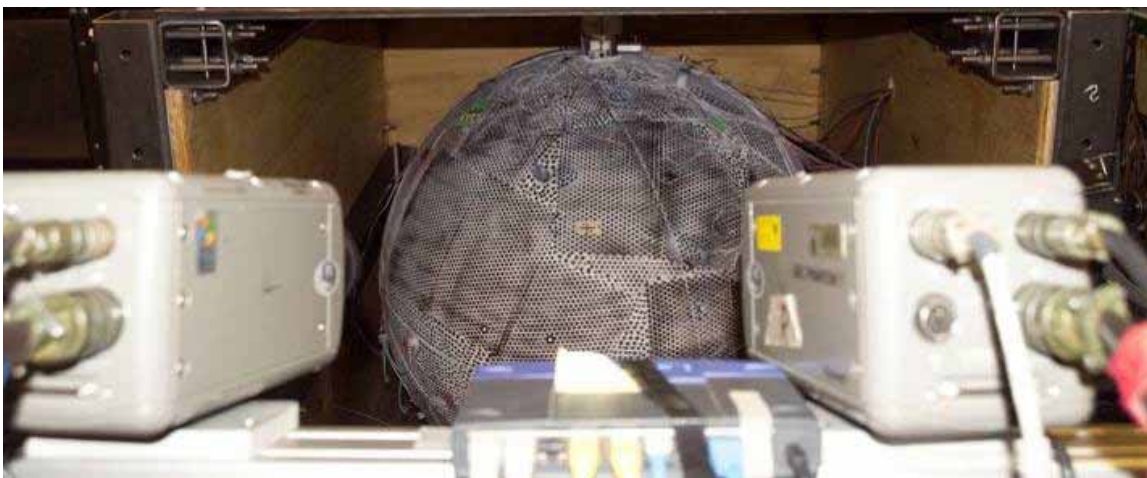
Figure 16. Digital image correlation camera view of COPV (Black dots sprayed over area of interest).

For the typical WSTF COPV installation (Figure 16), digital high-speed Phantom^{®***} v7.0 cameras were used at a resolution of 512 x 512 pixels, giving a recording speed ranging from 100 to 3000 frames per second (fps). Lower speeds were used for some tests due to the negative heating affect that supplemental lighting had on other COPV surface mounted instrumentation. The Phantom cameras act as a stereo pair to create a volume of area in which the ARAMIS software can take measurements. The volume varies with the calibration method and field of view. This camera setup consisted of 35-mm lenses with the cameras at a typical angle of 15.7 degrees, giving a measuring volume of 1060 mm/875 mm/875 mm. To calibrate for this volume, the camera resolution was set at 800 x 1200 pixels, and a 1200 mm NIST-traceable calibration cross was rotated and moved in specified locations to calibrate the sensor. After successful computation, the calibration deviation was below 0.04 and the angle variance was larger than the 15 degrees required for a successful calibration. The cameras used inter-range instrumentation group (IRIG) time for synchronization, which provided accuracy within 1 microsecond between images. The pattern sprayed on the vessel consisted of a white background with 0.25-in. black dots sprayed on the surface viewed, as noted in Figure 16. The system was particularly useful in indicating overall principal strain fields that developed higher in the COPV pressurization range as indicated in Figure 17 and indicating surface fiber failure near burst. The system also provided excellent strain data in areas where conventional strain gauges were not installed and correlated well to these, as indicated in Figure 18, except where cables or other instrumentation interfered.

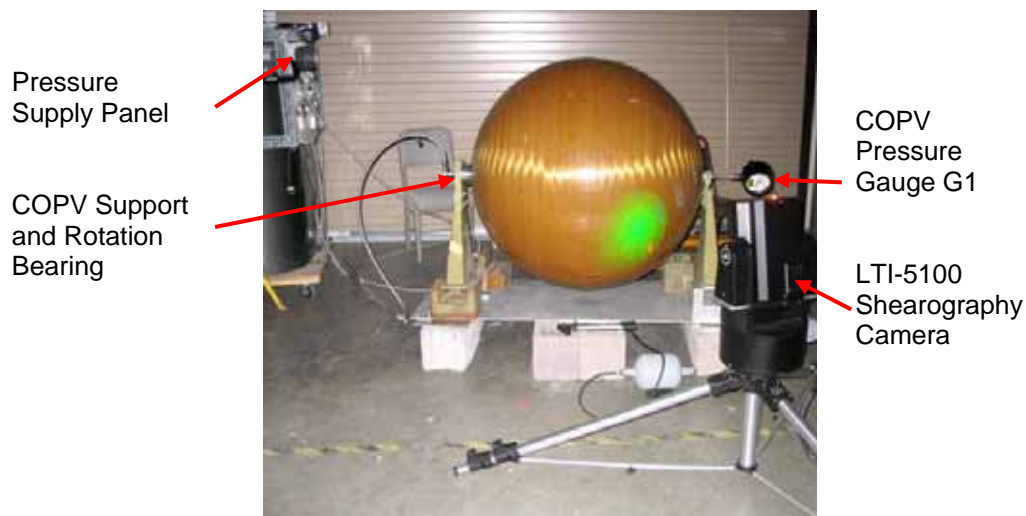
Figure 19. LTI SC-5100 system being applied to Kevlar COPV.

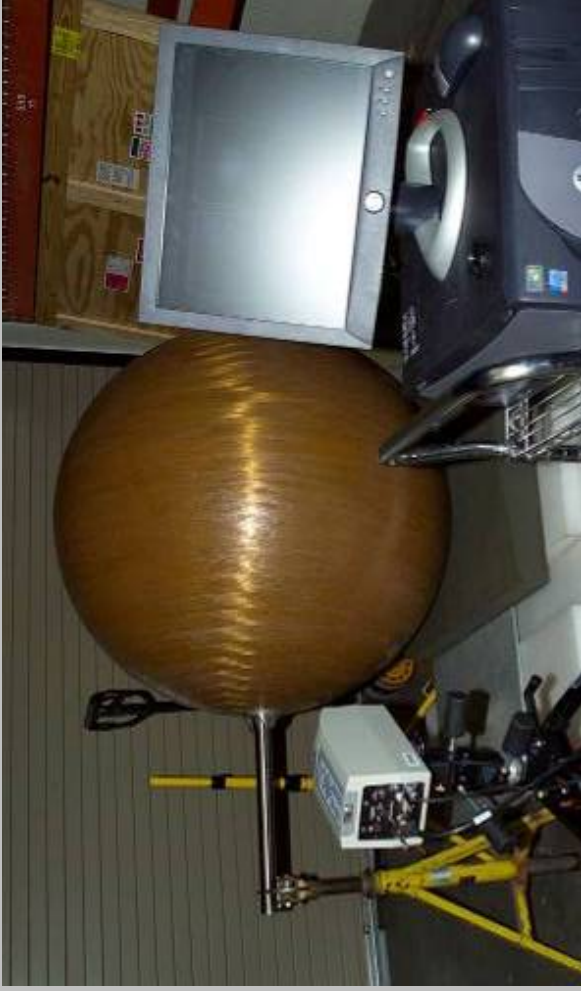
Figure 1

- Sectioned COPV with defects for use as a standard
- 1 – 4: delaminations of Kevlar fibers
 - Defects 5 & 6: hole drilled into the liner

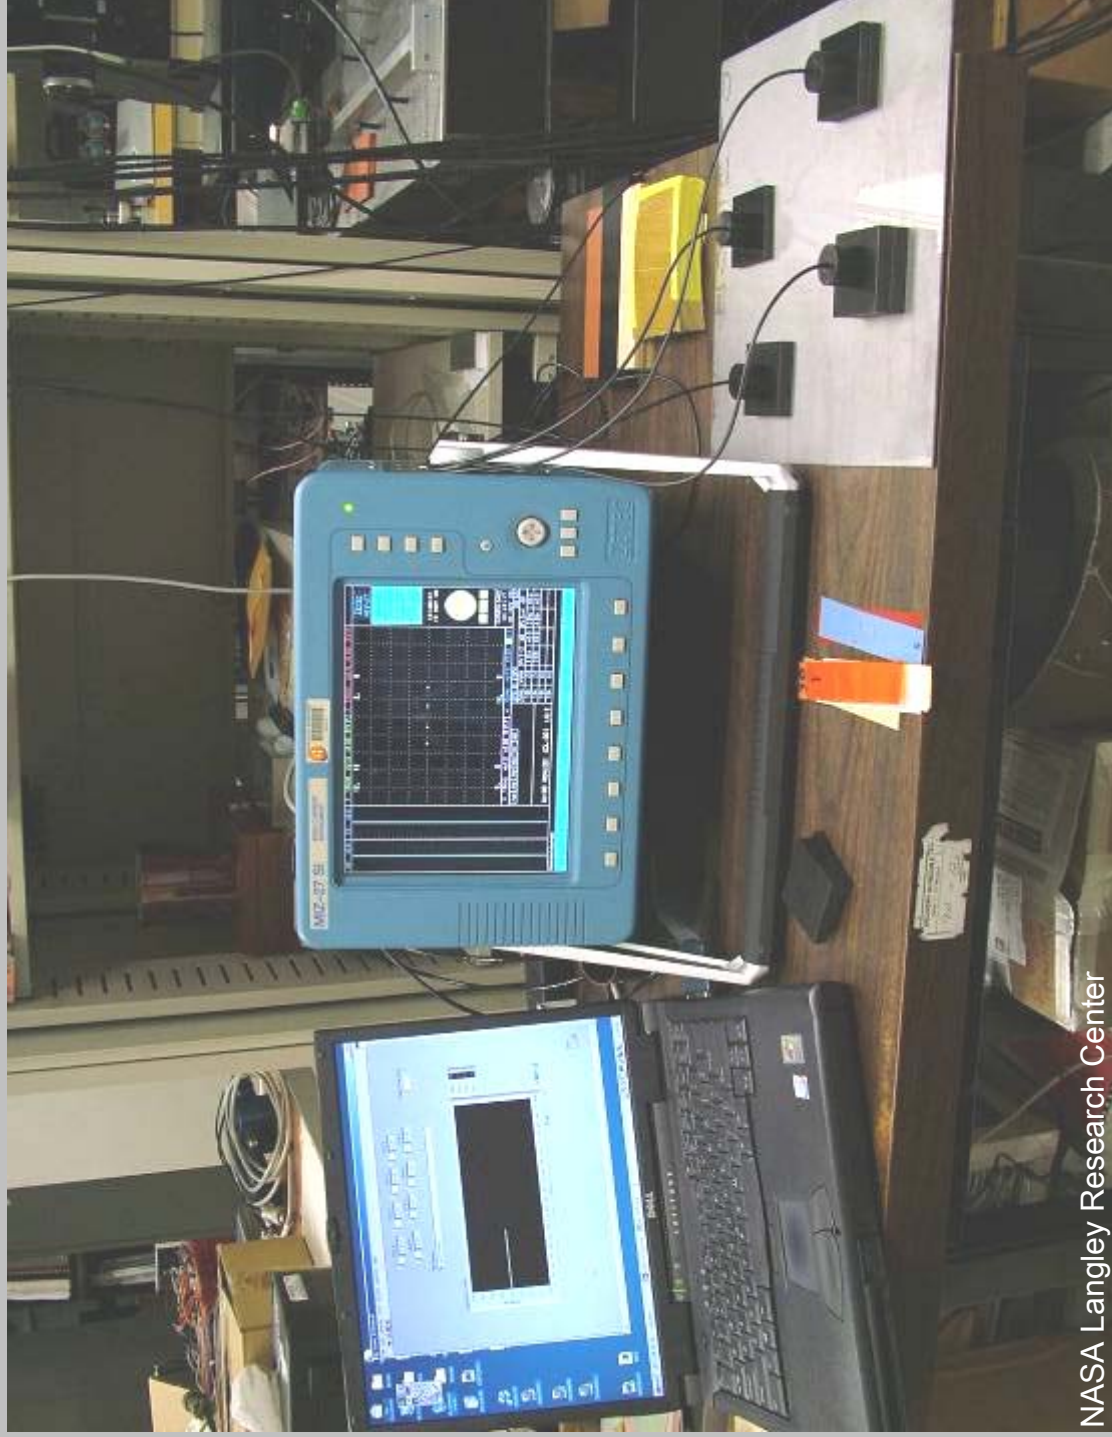
Eddy current system for real-time COPV composite thickness
