A Method to have Multi-Layer Thermal Insulation Provide Damage Detection

Design and testing of a multi-layer thermal insulation system that also provides debris and micrometeorite damage detection is presented. One layer of the insulation is designed as an array of passive open-circuit electrically conductive spiral trace sensors. The sensors are a new class of sensors that are electrically open-circuits that have no electrical connections thereby eliminating one cause of failure to circuits. The sensors are powered using external oscillating magnetic fields. Once electrically active, they produce their own harmonic magnetic fields. The responding field frequency changes if any sensor is damaged. When the sensors are used together in close proximity, the inductive coupling between sensors provides a means of telemetry. The spiral trace design using reflective electrically conductive material provides sufficient area coverage for the sensor array to serve as a layer of thermal insulation. The other insulation layers are designed to allow the sensor's magnetic field to permeate the insulation layers while having total reflective surface area to reduce thermal energy transfer. Result

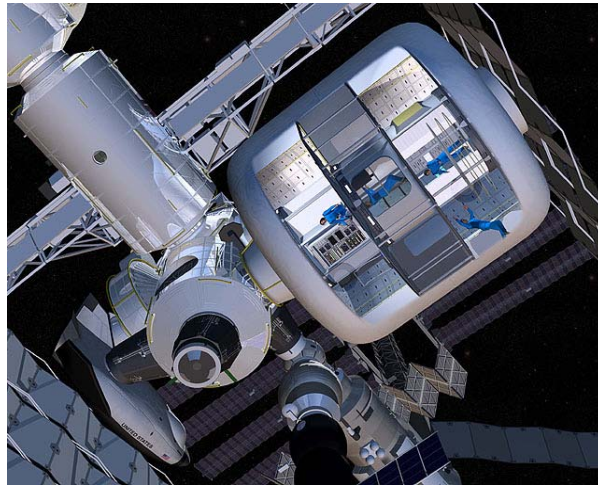
Figure 1. TransHab inflatable/deployable habitat module

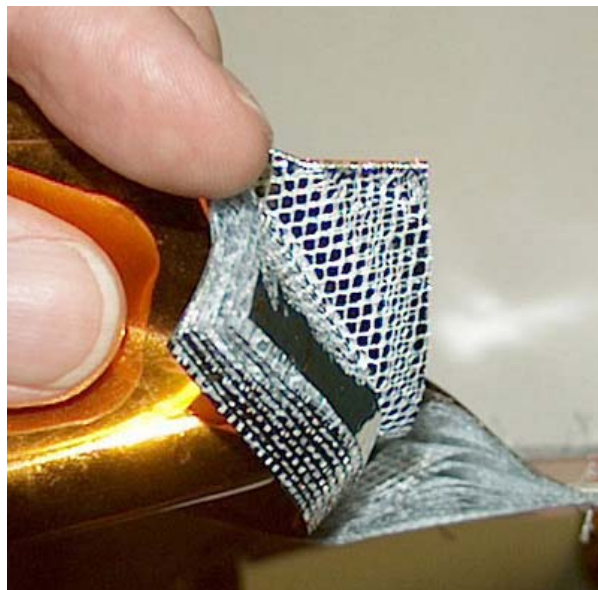
Figure 2. Multi-layer Insulation (MLI) construction

Inflatable habitat designs also require extensive multilayer insulation for thermal control. The multi-layer thermal insulation (MLI) blankets limit heat transfer from internal components and the conductive thermal effects from the space environment. Multi-layer insulation is comprised of multiple layers (sometimes as many as 15) of very thin (< 0.0025 mm) low emittance films such as Mylar or Kapton. The films are typically completely metallized on one or both sides and separated with a spacer material such as Dacron to prevent contact of the adjacent metalized layer.⁷ An example multi-layer insulation is shown in Fig. 2.

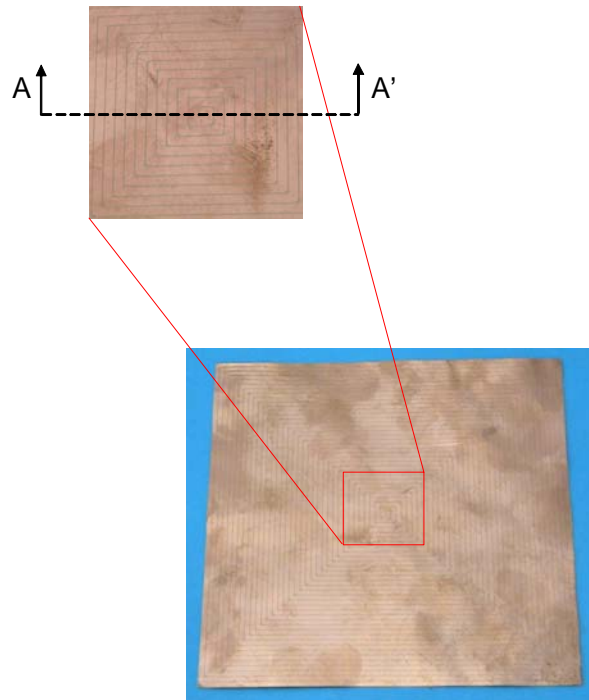
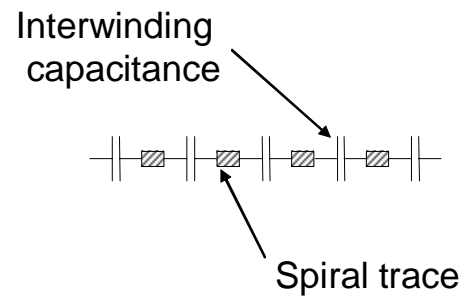
a) Sensor and enlarged view of trace

b) Cross Section A-A' schematic

Figure 3. Open-circuit electrically conductive spiral trace sensor used for damage detection

The base design of the sensor presented herein is an open-circuit electrically conductive spiral trace. The sensor is shown in Fig. 3. A schematic of the sensor cross-section A-A' is shown in Fig. 3b that illustrates the capacitance between neighboring sensor traces.¹¹ When the sensor is made electrically active, it creates a magnetic field along its trace and an electric field between contiguous traces. Its physical behavior when electrically active is similar to that of an inductor (storage of a magnetic field) electrically connected to a capacitor (storage of an electric field) in that it will produce a harmonic magnetic field of its own. In a manner similar to magnetic field response sensors, the changes in frequency, amplitude and bandwidth of the magnetic field produced by the sensor can be correlated with one or more measurands. The only difference is that the new class of sensors incorporates electrically open circuits that do not need a single electrical connection. The open-circuit electrically conductive spiral trace sensors can also be considered as magnetic field response sensors. The sensor geometry or dielectric coatings can be tailored for many different measurement applications.

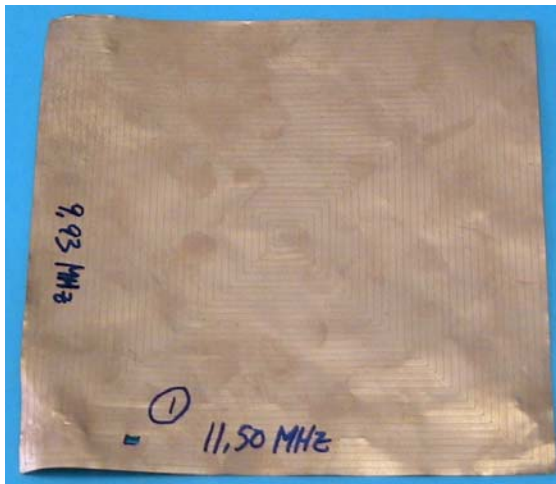
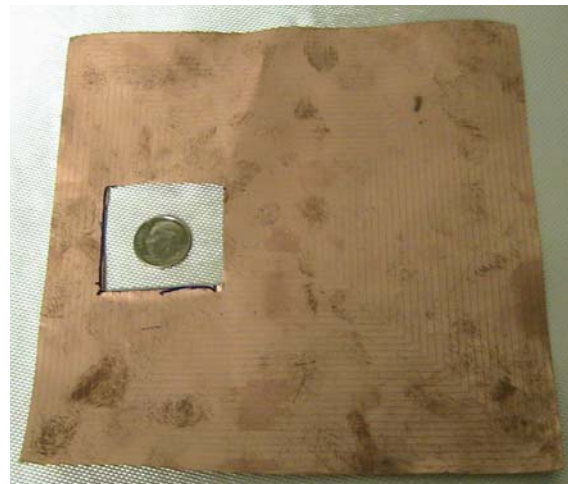
a) Damage to sensor with one 2 mm hole

b) Damage to sensor with one 2.5 cm hole

Figure 4. Sensors damaged with single hole

Preliminary testing of the array consisted of securing nine individual sensors in the array using Kapton tape at their corners, Fig. 6a. This allowed one sensor that was previously damaged, Fig. 4a, to be placed at different locations in the array. Tests were performed to ascertain how well the shift in response frequencies could be used to determine where in the array a sensor had been damaged. These tests were also used to verify the final array design, Fig. 6b.

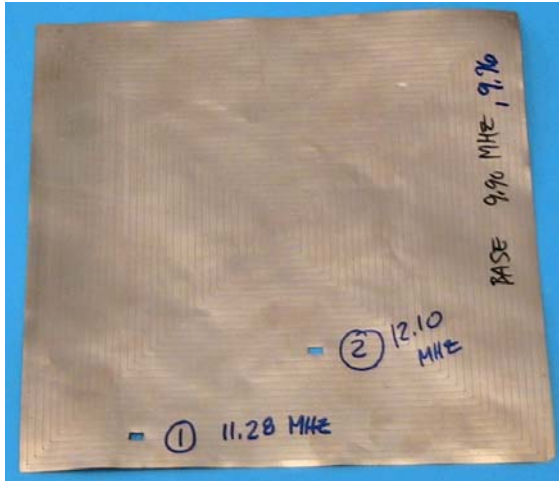
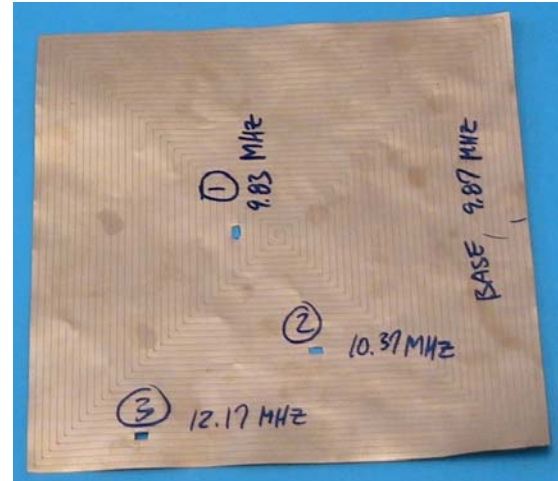
a) Sensors with two 2 mm punctures

b) Sensors with three 2 mm punctures

Figure 5. Measured frequencies of damage detection sensor for multiple punctures

Figs. 5a and 5b show sensors that had two and three punctures, respectively. The holes are numbered in order of puncturing the sensor. In both cases, the lowest frequency of each new set of inductive coupled concentric circuits changed. In Fig. 5a, the sensor response frequency changed from its undamaged baseline of 9.90 MHz to 11.28 MHz after a 2 mm hole was placed along its perimeter. When a second 2mm hole was placed in its middle, the lowest response frequency changed to 12.10 MHz. Three cuts were made in the sensor of Fig. 5b. The undamaged response of 9.87 MHz was changed to 9.83 after the first hole and then to 10.37 and 12.17 after holes 2 and 3, respectively.

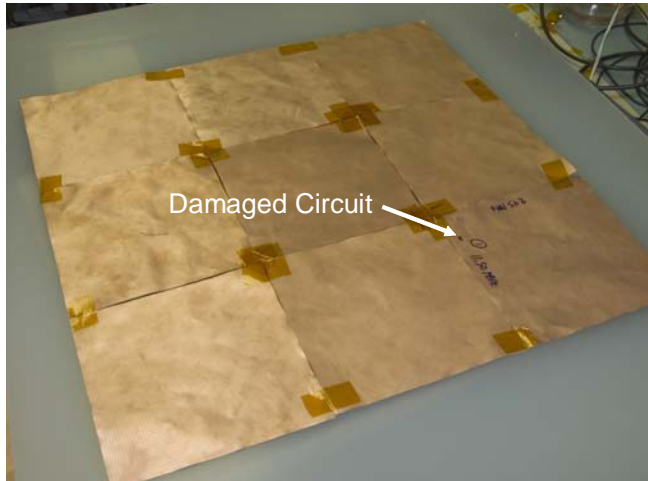
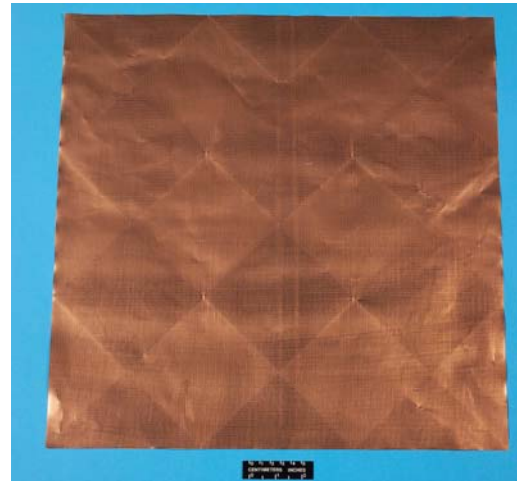
a) Array used for preliminary testing

b) Array used for Hypervelocity Impact Testing

Figure 6. Damage detection array (3 sensors x 3 sensors)

Nine sensors (3 columns by 3 rows) were used to form the damage detection array layer of the multi-layer insulation. Spacing between the sensors was 0.13 mm. Two arrays are shown in Fig. 6. Nine open-circuit electrically conductive spiral trace sensors were directly deposited onto a non-conductive substrate. No electrical connections were used between sensors on the array. Eliminating the connection facilitates scaling the method to a larger surface area. The distribution of sensors provided sufficient coverage of the reflective metallic coating to serve as a thermal protection layer. Use of the array for thermal protection will be discussed in a subsequent section of this paper.

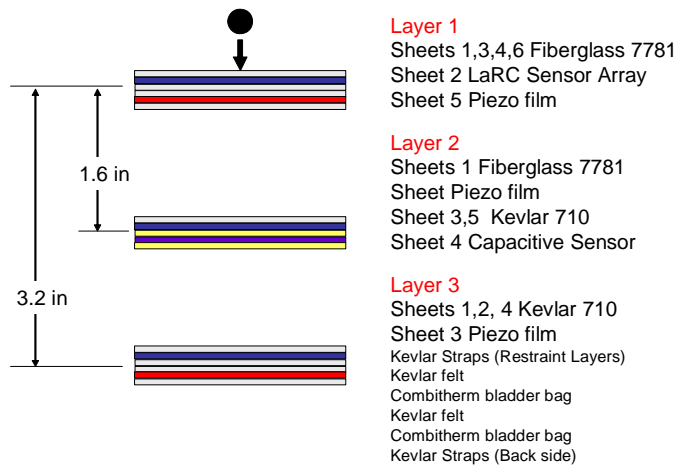
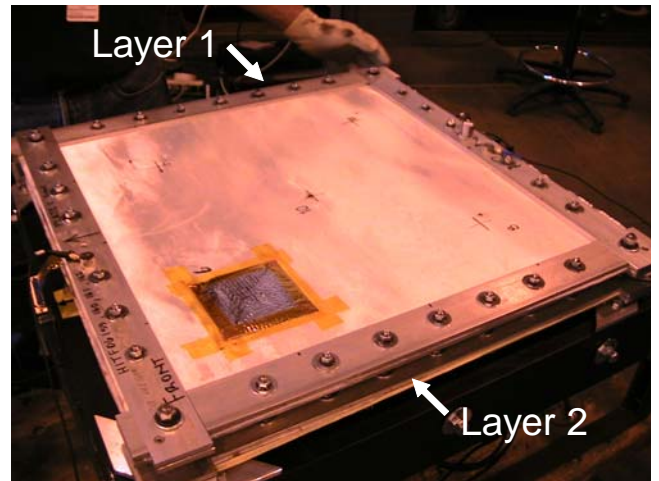
a) Schematic of first hypervelocity impact test article layers

b) First hypervelocity impact test article layers

Figure 7. Test article and schematic of first test article layers

The first test article is shown in Fig. 7b. Aluminum frames were used to support the shielding layers. The 0.50 caliber chamber was used. A schematic of the test chamber is shown in Fig. 8a. A projectile is propelled as follows. At one end of a pump tube, a first-stage of smokeless powder is ignited. The exploding charge results in a rapidly expanding gas that moves a piston in the chamber breech. The piston rapidly compresses a light gas column (e.g., hydrogen) as it moves to the other end of the tube where there is a tapered-bored high pressure coupling that stops the piston. Mounted in the coupling is a sabot that holds a projectile. The high pressure gas breaks the burst disk causing the sabot and the projectile to be propelled down the launch tube. In the expansion chamber, the gas pressure is reduced and the sabot separates into two pieces in the expansion chamber as the projectile moves toward the target. Arresting plates in the expansion chamber prevent the sabot pieces from hitting the target. The frames were then attached to a support that was fastened to the bottom of the target chamber as shown in Fig. 8b.

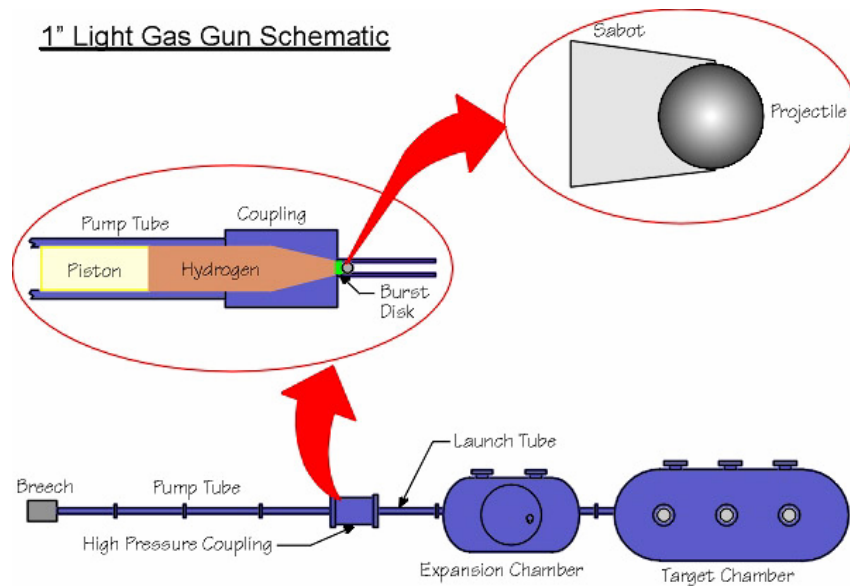
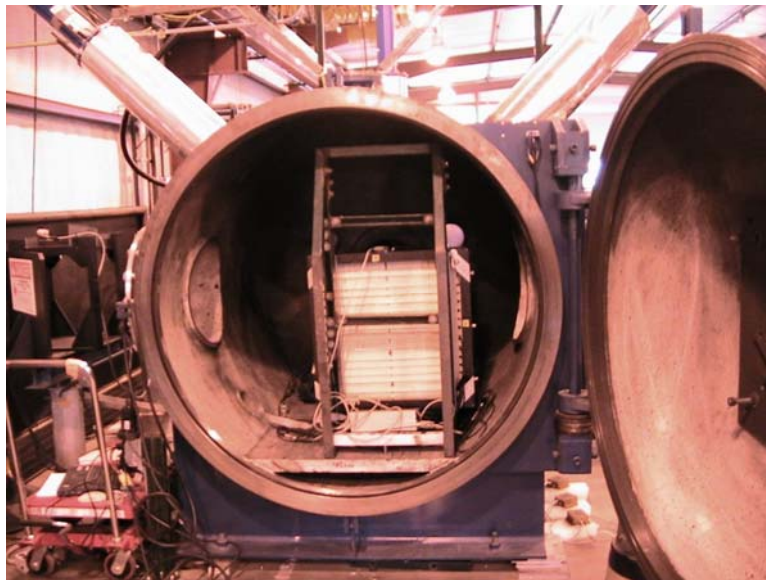
a) Schematic of hypervelocity test chamber.

b) Test article mounted to support in target chamber

Figure 8. Hypervelocity test chamber and test article inside target chamber.

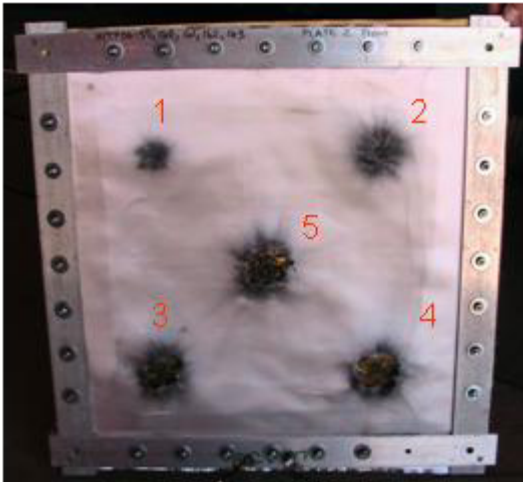
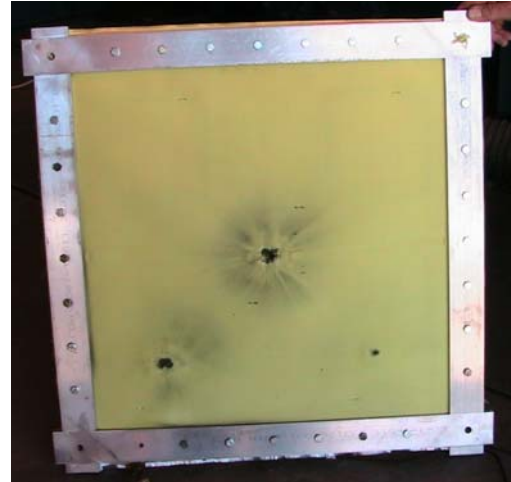
a) First test article having sensor array No. 2 after impact tests 1-5

b) Second test article having sensor array No. 5 after impact tests 6-10

Figure 9. Damage to test articles. Impact positions are annotated on 9a.

The layers having the Langley sensor array for test articles 1 and 2 are shown in Figs. 9a and 9b, respectively after all impact tests were complete. Impact locations are annotated on the first test article. Sensors 7, 1, 5, 3 and 9 are located at impact locations 1, 2, 3, 4 and 5, respectively. All five projectiles from test 1-5 penetrated the first layer of test article 1 (LaRC array No. 2). The resulting damage to sensor array No. 2 were approximately round 0.4, 0.5, 0.8, 0.8 and 0.9 cm dia. holes at impact locations 1, 2, 3, 4 and 5, respectively. Only the last three larger diameter projectiles penetrated the second layer of the second test article. Damage was more severe to array No. 5 placed in the second test article. Array No. 5 is shown in Fig. 10 after testing. Sensor 5 (location 3) had a 6.3 cm rip. A hole 5.6 cm by 0.8 cm with a 4.6 cm rip and smaller rips were found on sensor 3 (location 4). Damage to sensor 9 (location 5) consisted of a 1.8 cm by 1.8 cm hole with a 3.4 cm rip and 3.6 cm rip.

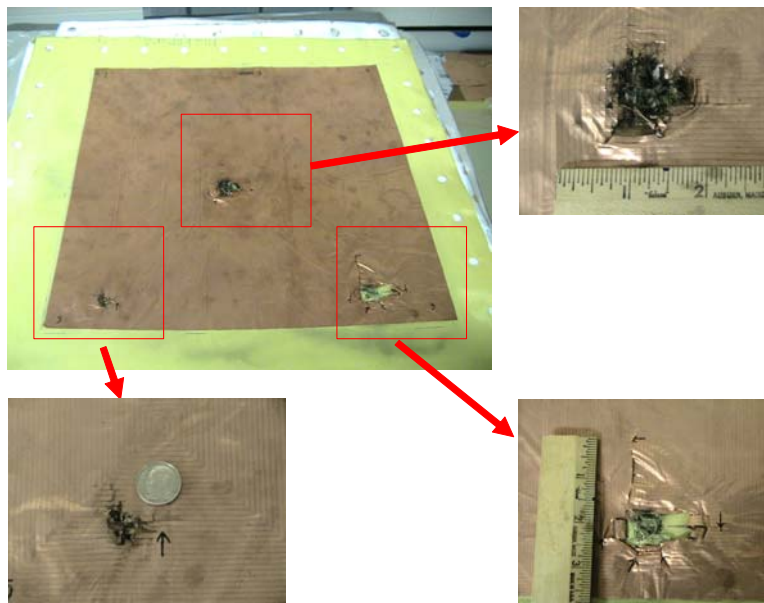
Figure 10. Magnetic field response sensor array after completion of tests 6 -10.

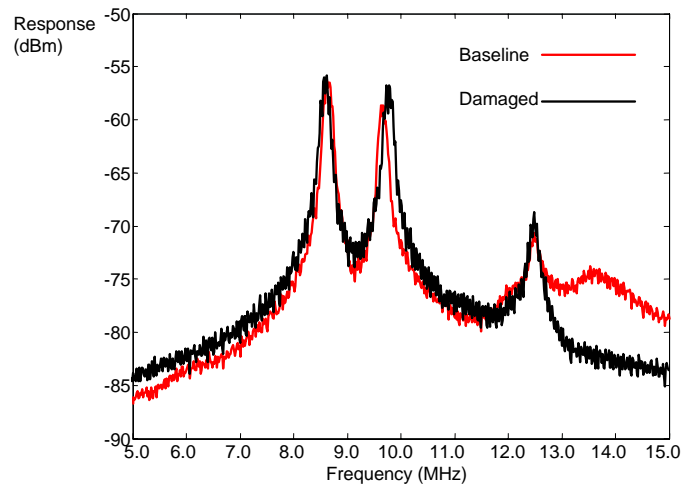
Figure 11. Sensor 9 of Array 2 response change due to hypervelocity impact tests 1 - 5.

Baseline responses prior to impact testing and after all tests were complete are shown for sensor 9 of array No. 2 (impact tests 1-5) and sensor 3 of array No. 5 (impact tests 6-10) in Figs. 11 and 12, respectively. In Fig. 11, the second peak frequency increased by 0.25MHz and the response amplitude decrease 5-9 dBm beyond 13 MHz as a result of impact tests 1-5. Sensor 3 of Array 5 had a more pronounced change to its response. The first two response peaks were reduced over 12 dBm in magnitude. The third peak frequency increased by 0.5 MHz while its magnitude decreased by more than 20 dBm. Peaks 4 and 5 have shifted by over 1 MHz each.

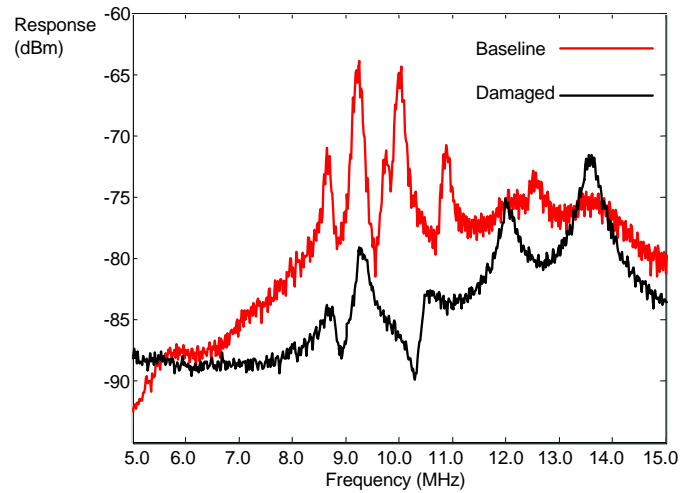
Figure 12. Sensor 3 of Array 5 response change due to hypervelocity impact tests 6 - 10.

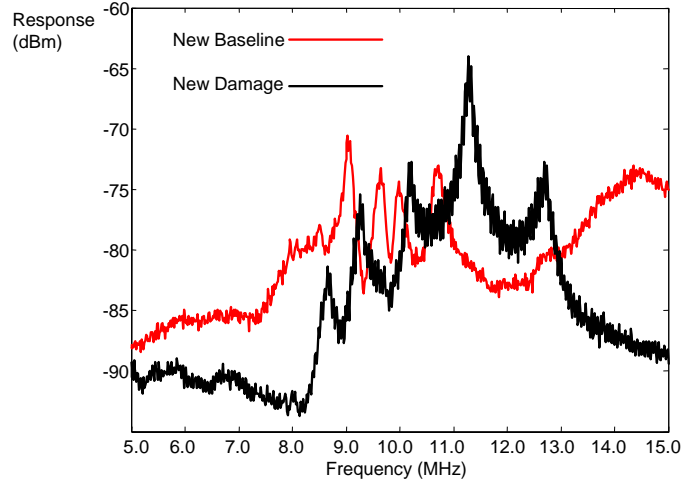
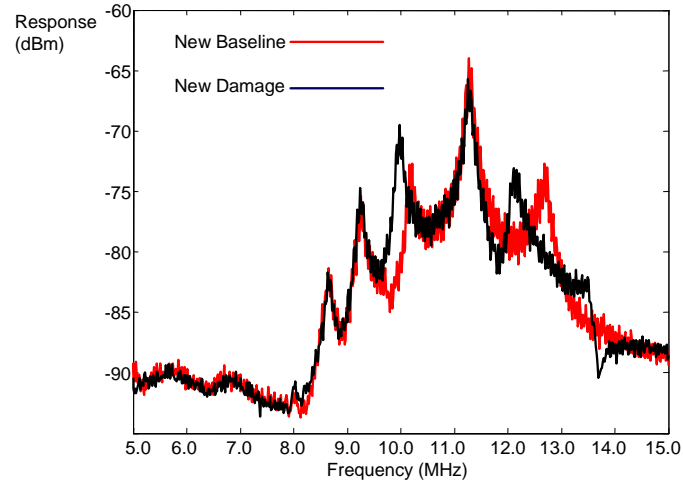
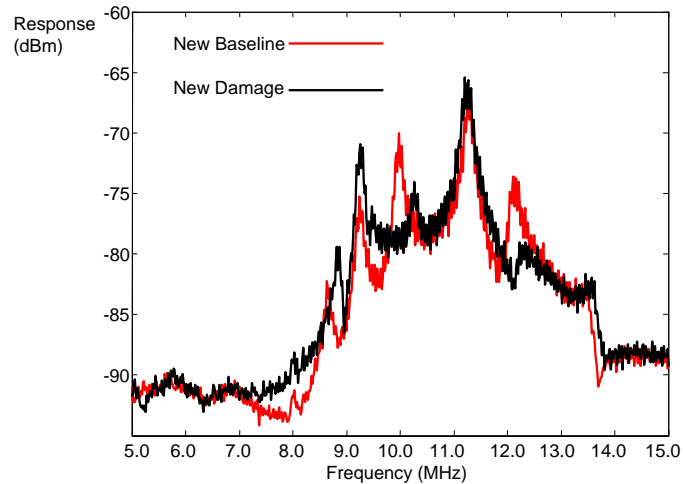
a) Sensor 5 response without any damage and response after it has been damaged.

b) New sensor 5 baseline after it has been damaged and response of sensor 5 after sensor 3 has been damaged.

c) New sensor 5 baseline after sensor 3 has been damaged and response of sensor 5 after sensor 9 has been damaged.

Figure 13. Sequential damage to Array 6 measured at sensor 5. Damage occurs to sensors 5, 3 and 9 in that respective order.

Because the piezo layers prevented real-time analyses of the sequential damage, the post-test damage observed on array No. 5 was replicated sequentially on array No. 6 back at Langley. Figs. 13 - 15 present the responses measured at sensors 5, 3 and 9 as a result of sequential damage to sensor 5, 3 and 9 of array No. 6 that replicated the sequence of damage from the hypervelocity impact tests. The response of each sensor changed as a result of damage to it. In addition to response changes resulting from the damage to itself, each sensor's response changed when other sensors in the array were damaged. The response changes were more pronounced at the damaged sensor. The sensor that was damaged had largest frequency shifts and largest changes in area under the frequency response curve. The change in the area under response curve is proportional to the Euclidean norm of the difference between response magnitude before and after a damage event.

Table 5 presents the Euclidean norms from three damage events occurring sequentially at sensors 5, 3 and 9 using responses measured at sensors 5, 3 and 9. Each row of the table represents a new damage event. Comparison of Figs. 13a, 14a and 15a, shows that the largest shifts in resonant frequency when sensor 5 was damaged are those measured at sensor 5. The Euclidean norms for this event are in the first row of the table. The largest norm of 194.5 was from the response of sensor 5. Each damage event for any sensor on the array created a new response baseline for each sensor. The next damage event was damage to sensor 3. Comparison of Figs. 13b, 14b and 15b shows the largest resonant frequency shifts resulting from damage to sensor 3 are in the response measured at sensor 3. The Euclidean norm from the second damage event, row 2 of Table 5, is larger at sensor 3. The last row of Table 5 shows the results from the last damage event. The largest norm is from the change in the response of sensor 9. The inductive coupling of the sensors also served as a means of telemetry. The coupling allowed damage to occur at one sensor and be detected at another. To locate damage, two independent methods can be used. The first method is to identify the sensor having the largest shift in its resonant frequencies. The second method is to identify the sensor with the largest Euclidean norm produced using the change in response magnitude. During the impact tests at White Sands Test Facility, an antenna placed at sensor 8 allowed real-time indications of damage to sensor 3, 5 and 9.

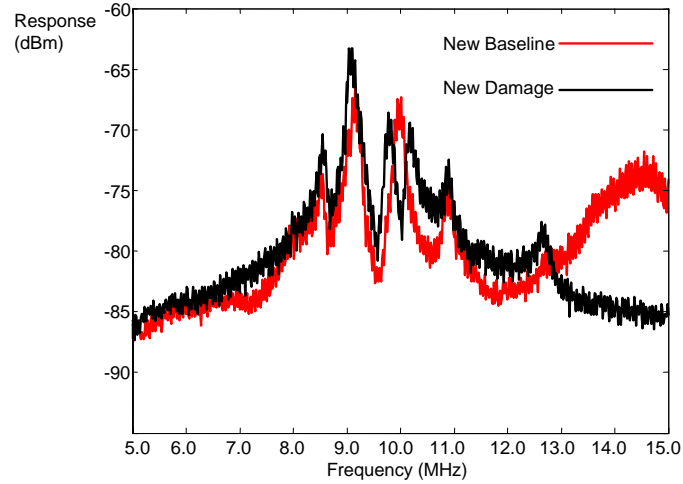
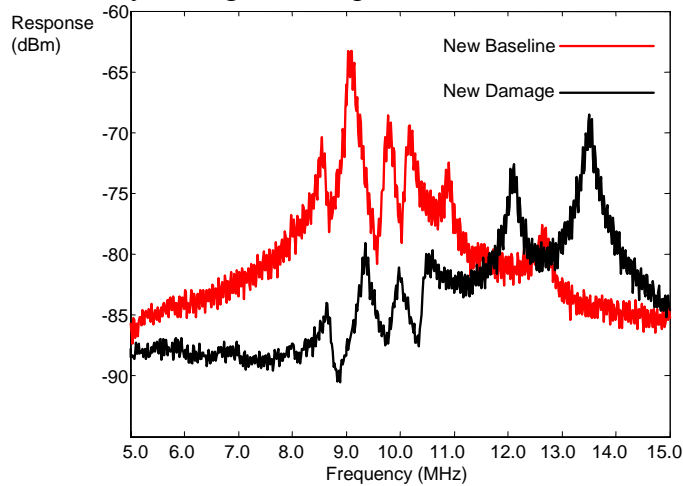
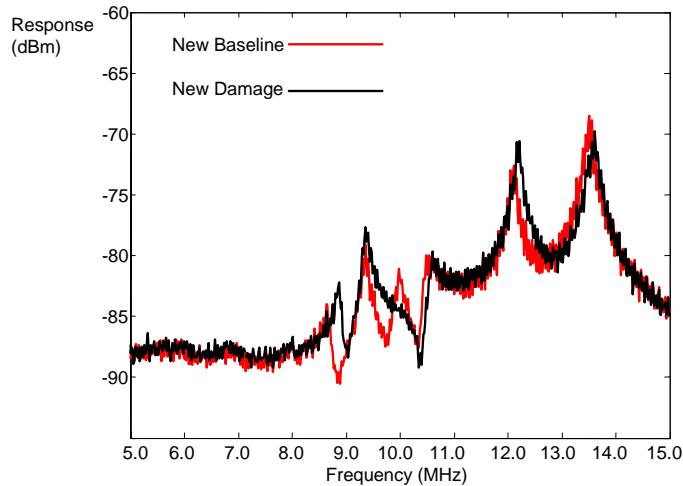
a) Sensor 3 response without any damage and response after sensor 5 has been damaged.

b) New sensor 3 baseline after sensor 5 has been damaged and response of sensor 3 after it has been damaged.

c) New sensor 3 baseline after it has been damaged and response of sensor 3 after sensor 9 has been damaged.

Figure 14. Sequential damage to Array 6 measured at sensor 3. Damage occurs to sensors 5, 3 and 9 in that respective order.

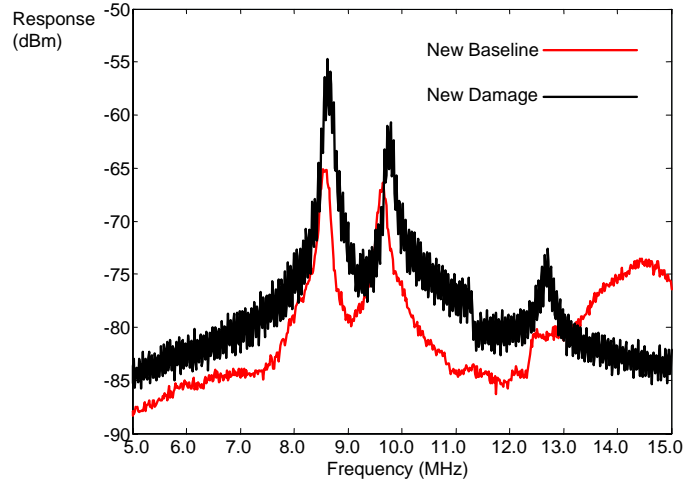
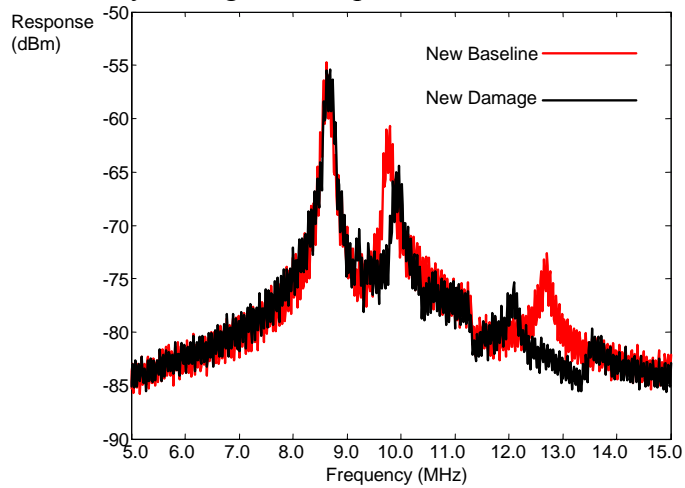
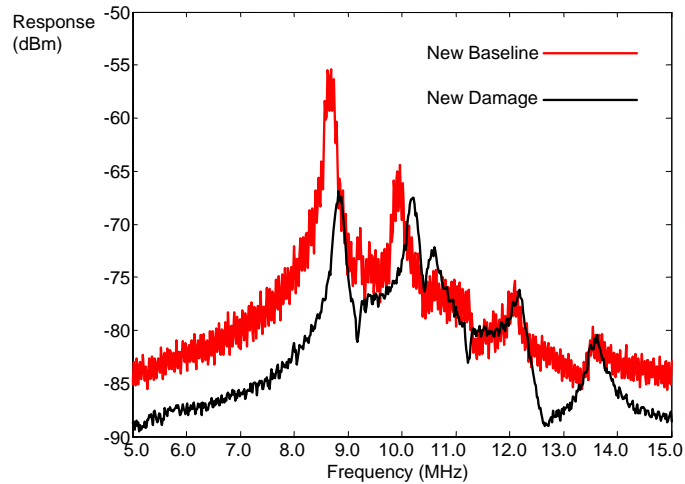
a) Sensor 9 response without any damage and response after sensor 5 has been damaged.

b) New sensor 9 baseline after sensor 5 has been damaged and response of sensor 9 after sensor 3 has been damaged.

c) New sensor 9 baseline after sensor 3 has been damaged and response of sensor 9 after it has been damaged.

Figure 15. Sequential damage to Array 6 measured at sensor 9. Damage occurs to sensors 5, 3 and 9 in that respective order.

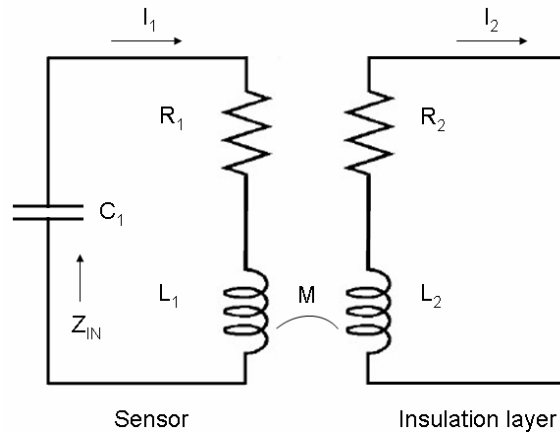
Figure 16. Model of effect of insulation layer with a continuous metallic covering on sensor response

The circuit design shown in Fig. 16 is used for the other thermal insulation layers. The circuit design is necessary to prevent the sensor response from being absorbed in the continuous metallic surface layers. To operate as an integral part of the multi-layer shell, the sensors must maintain sufficient signal response amplitude to assure a measurable response. During developmental testing it was determined that a magnetic coupling between the sensor and the MLI metalized film existed and resulted in an attenuated response from the sensor. The coupling was attributable to eddy currents in the metalized film produced by the magnetic field of the inductor. These currents flow in a direction opposite to that of the sensor current and have the effect of decreasing the inductance and signal response. This phenomenon is accurately described by Lenz's law; *The electromotive force (emf) induced in an electric circuit always acts in such a direction that the current it drives around a closed circuit produces a magnetic field which opposes the change in magnetic flux.* For our application, eddy currents were induced in the metallic surface of the MLI layer by the magnetic field of the sensor. The induced current flowed in a direction opposite to that of the inductor current.¹² This resulted in a negative mutual coupling between the currents, effectively reducing the magnetic field response.

The effect is similar to a transformer where the primary and secondary circuits represent the sensor and the metalized surface, respectively. The circuit diagram in Fig. 16 represents this effect. The induced current in the

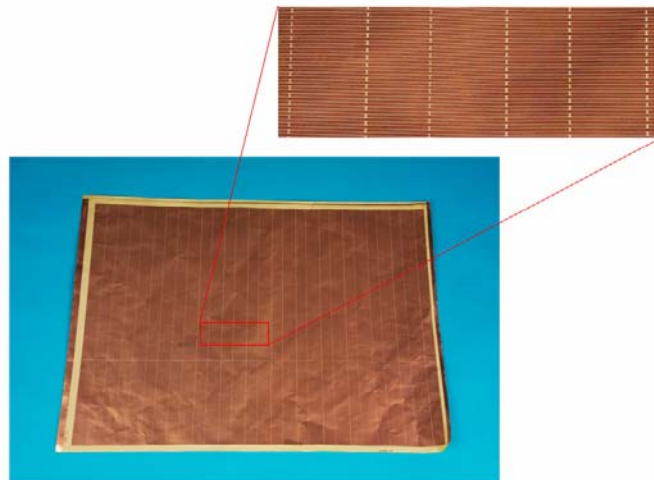
Figure 17. New MLI layer design that reduces development of Eddy currents.

To impede the eddy current flow in the other insulation layers and the associated emf, a new MLI layer was designed to include a staggered pattern of small copper traces. The prototype used for our test and evaluation is shown in Fig. 17. The traces were 2.54 cm x 0.1cm. The separation between adjacent traces was 0.13 mm. The design concept predicted the individual trace element would provide minimum surface area for the flow of eddy currents, while collectively providing a comparable surface emissivity (ϵ) with that of the conventional solid sheet over the same per unit square area. For this evaluation the new effective surface area was 89% copper and 11% Kapton. The original material has an effective surface emissivity of 0.10, while the new pattern provides an effective emissivity of 0.18. With the use of improved manufacturing techniques, the design would be capable of achieving 95% coverage by providing smaller separations between traces.

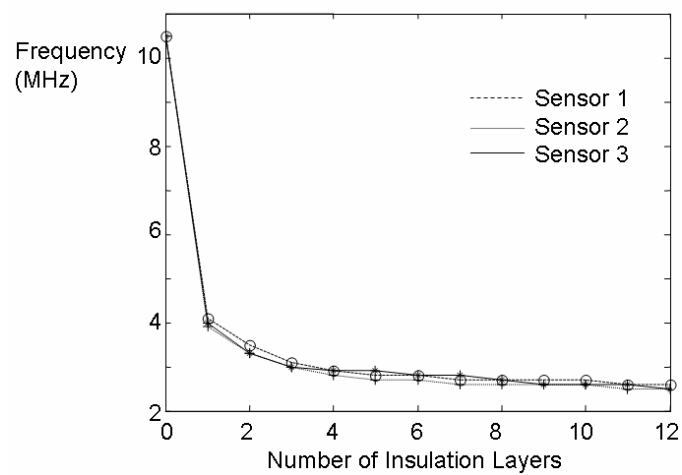
Figure 18. Response frequency shift with addition of insulation layers

Results of using the new MLI layer design on individual sensors are shown in Fig. 18. Twelve layers of the new MLI were individually placed on top of sensors having baseline frequencies of approx. 10.4 MHz. After each layer, the sensor response frequency was measured. The MLI was not directly adhered to the sensor, but allowed to contact the non-conductive Kapton surface of the sensor. The addition of the first layer created a 6 MHz decrease in the sensor resonant frequency. The next three layers combined resulted in an additional decrease of 1 MHz. The remaining 8 MLI layers combined reduced the frequency by less than 0.5 MHz. These tests were performed on 3 sensors. The testing leads to the conclusion that sufficient numbers of patterned MLI layers could be utilized in applications with the sensors presented in this paper to achieve the same thermal efficiency as would be required with conventional MLI layers.

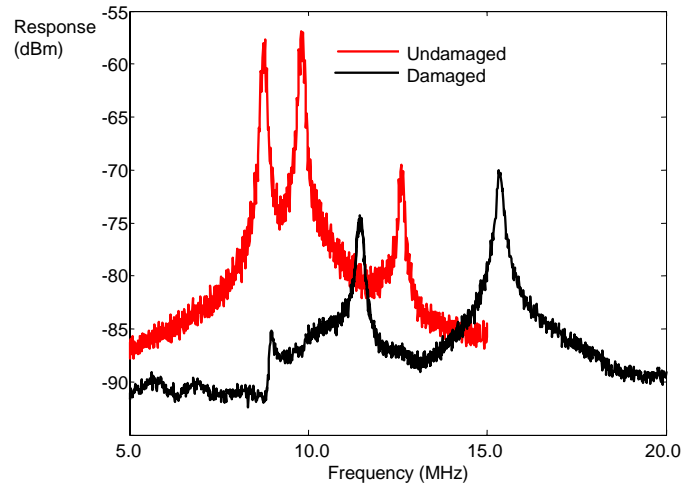
Figure 19. Response measurement at Sensor 9 of Array 4 before and after damage to sensor 9.

Results of using the new MLI layer design on top of the damage detection array are shown in Figs. 19 and 20. In Fig. 19 are responses from a undamaged array and an array that has a 4 cm by 4 cm hole in its center sensor. The lowest baseline is approximately 8.8 MHz for the undamaged array. When the middle sensor is damaged with a 2.9 cm by 2.6 cm hole, the lowest response resonant that is at least 10dBm higher than the noise is at 11.4 MHz. This comparison was repeated with two of the new MLI layers placed on top of the array. Undamaged, the lowest response frequency was 3.5 MHz. A lowest response frequency of approximately 7.7 MHz was measured for an array having a damaged sensor. The results of using the new MLI design on the damaged and undamaged array sensors shows that thermal insulation system (Sensor array layer and new design of the other layers to reduce the effect of eddy currents) presented in this paper is capable of providing damage detection to the thermal insulation of an inflatable habitat.

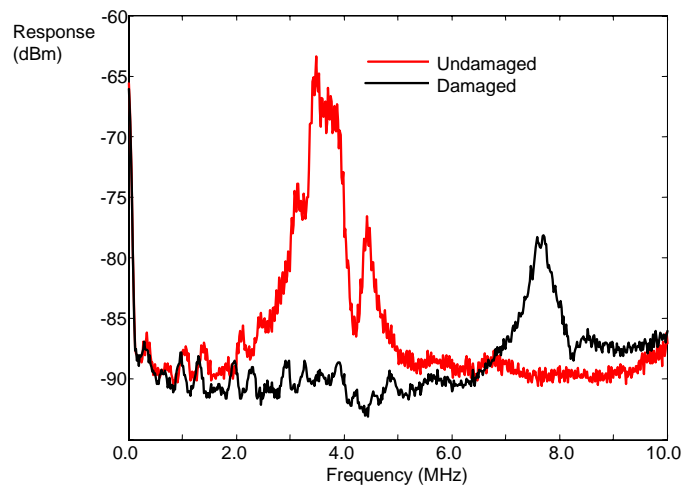
Figure 20. Response measurement at Sensor 9 of Array 4 with two insulation layers before and after damage to sensor 9.
