Double Lap Shear Testing of Coating-Modified Ice Adhesion to Space Shuttle Component Surfaces

Michael G. Ferrick, Nathan D. Mulherin, Barry A. Coutermarsh,
Glenn D. Durell, Leslie A. Curtis, Terry L. St. Clair, Erik S. Weiser,
Roberto J. Cano, Trent M. Smith, Charles G. Stevenson, and
Eloy C. Martinez

December 2006

Prepared for National Aeronautics and Space Administration

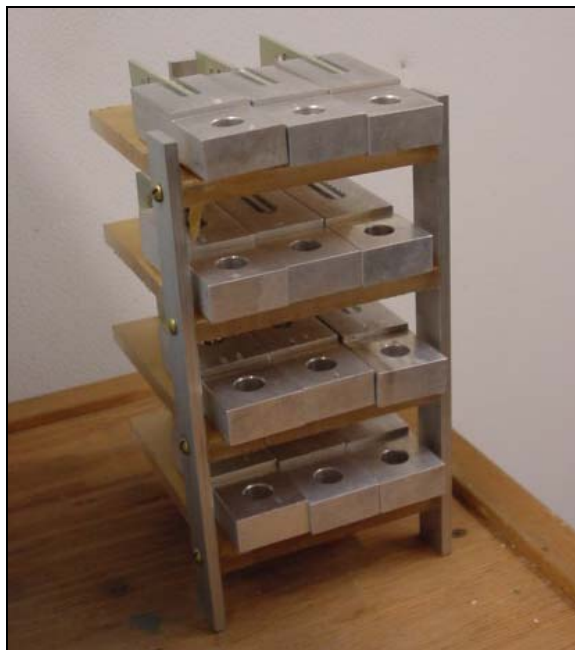
Figure 7. M4, M5, and control samples in the coldroom at -15°C prior to transport to the test chamber, 30 May 2006.

Following Ferrick et al. (2006), each test specimen was a single coupon measuring 1 in. (2.5 cm) wide, 4 in. (10.2 cm) long, and 0.125 in. (0.317 cm) thick. Ice that was 0.125 in. (0.317 cm) thick adhered to the full width on two sides of the test coupon with a total initial contact area of 2.9 in.² (18.7 cm²). For consistency this ice was initially grown as strong as possible, and then subjected to temperature decreases comparable to those of the LO₂ feed line bracket. Sample preparation required a full day prior to the start of testing. Each test coupon was placed in a DLS fixture, and tape dams were applied to hold water in place during freezing. These molds were pre-cooled to $\approx 1^{\circ}\text{C}$, and pre-cooled distilled/de-ionized/de-aerated water was injected. The samples were then placed in a cold box at $-10^{\circ} \pm 0.1^{\circ}\text{C}$ ($14^{\circ} \pm 0.2^{\circ}\text{F}$) and isolated under an insulating cover to promote slower freezing. Ice growth and cool-down to the cold-box temperature occurred over 4–5 hours. Following ice growth, samples were placed in the coldroom outside the cold box and allowed to equilibrate at -16°C (3°F) for about 2 hours. Figure 7 depicts a typical set of frozen samples in the coldroom.

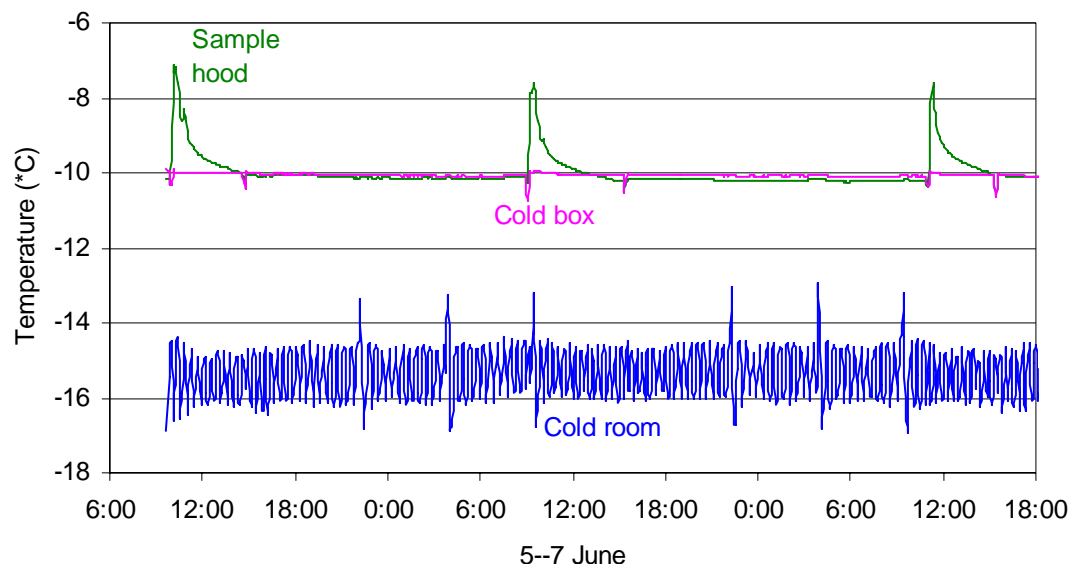
Figure 8. Temperatures under the insulated cover, in the surrounding cold box, and in the larger coldroom during growth of three sample sets, 5–7 June 2006.

Three ice growth periods during 5–7 June 2006, shown in Figure 8, are typical of sample freezing in the cold box followed by coldroom temperature reduction. Sample placement in the cold box provided heat that consistently raised the temperature under the insulating cover to about -7°C (19°F). This maximum temperature was followed by an asymptotic temperature decrease over a 4-hour period, when sample freezing and equilibration at -10°C were complete. The removal of samples from the cold box was reflected by a temperature oscillation both under the cover and inside the cold box. Coldroom temperatures were not as stable as those of the cold box, continuously oscillating $\pm 1^{\circ}\text{C}$ about the mean, with periodic defrost cycles causing larger excursions.

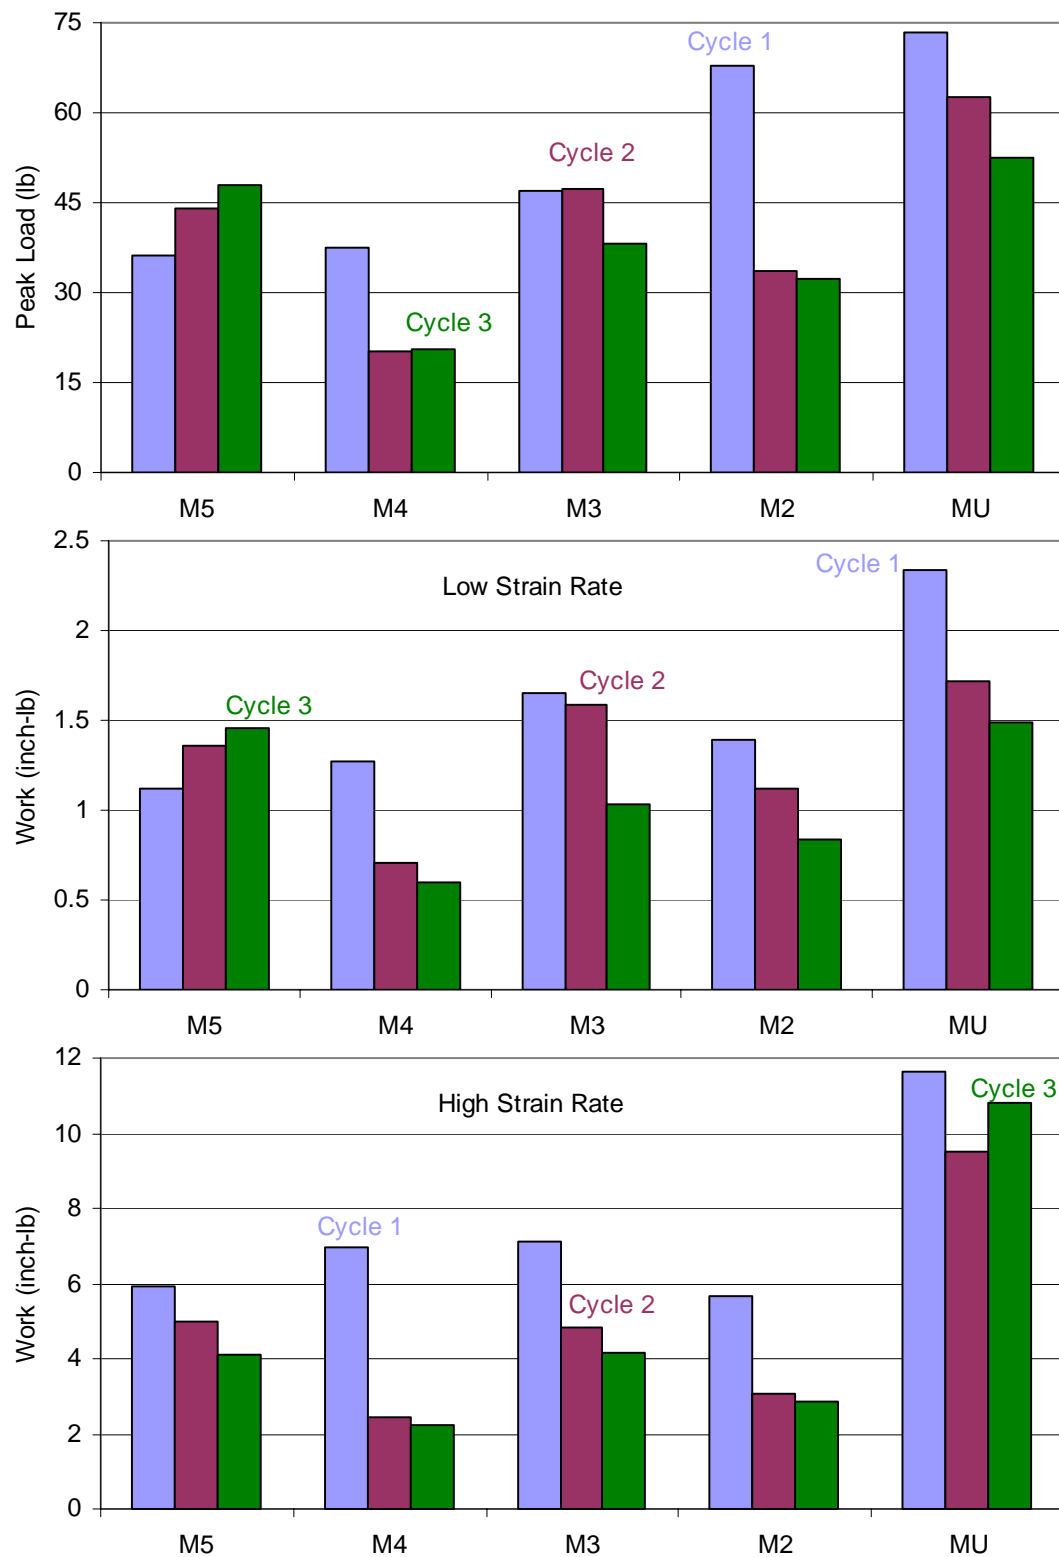
Figure 12. Average peak load (top), average work at low strain rate (middle), and average work at high strain rate (bottom) for all MP-55 coating variations over three cycles of phase 1 testing.

displayed similar trends through three cycles. Variations M3 and MU contained the same quantity of MP-55, but the performance measures indicate greater ice adhesion with the addition of UF-8TA, clearly favoring the M3 coating. M5 had a slight edge over the other MP-55 variations in most adhesion measures for cycle 1, while M4 was far superior when these measures are compared over three cycles. M5 and M4 peak load and total work are compared by individual coupon through three cycles in Figures 14 and 15, respectively. The peak load variability of the M5 samples increases with cycle, while the variability in M4 is essentially constant. Similarly, the total work variability of M5 samples also increases with cycle, but the M4 total work magnitude and variability decrease with cycle.
