NASA/CR-2007-214885/VOL3

Hypervelocity Impact (HVI)

Volume 3: WLE Small-Scale Fiberglass Panel Flat Target C-1

*Michael R. Gorman and Steven M. Ziola
Digital Wave Corporation, Englewood, Colorado*

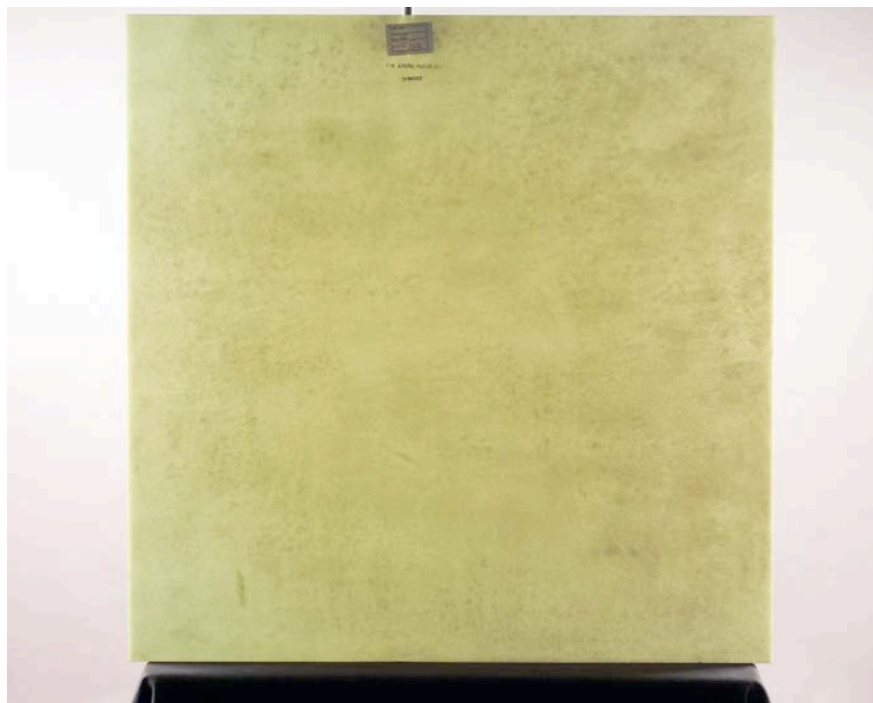
Target C-1 consisted of a 34" x 34" 20-ply fiberglass panel (Figure 1). L-shaped angles added to the back of the fiberglass panel were used to attach the target to a target support stand.

Figure 1: Fiberglass Panel Target C-1. Front View.

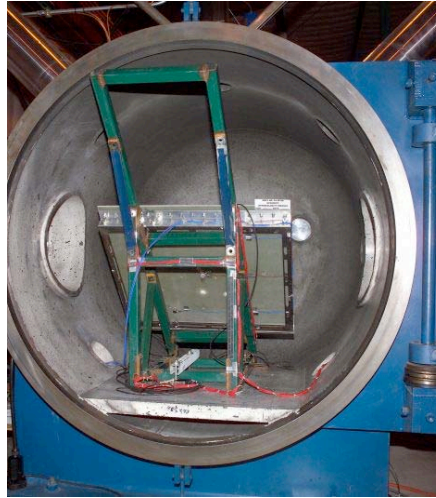
There were a total of 19 shots fired. The impact angle of the shots was 90 degrees from the surface of the target for shots #1 - 10 and 45 degrees for shots #11 - 19 (Figure 2 and Figure 3).

Figure 3: Fiberglass Panel Target C-1 with 45 deg Impact Angle. Back side View.

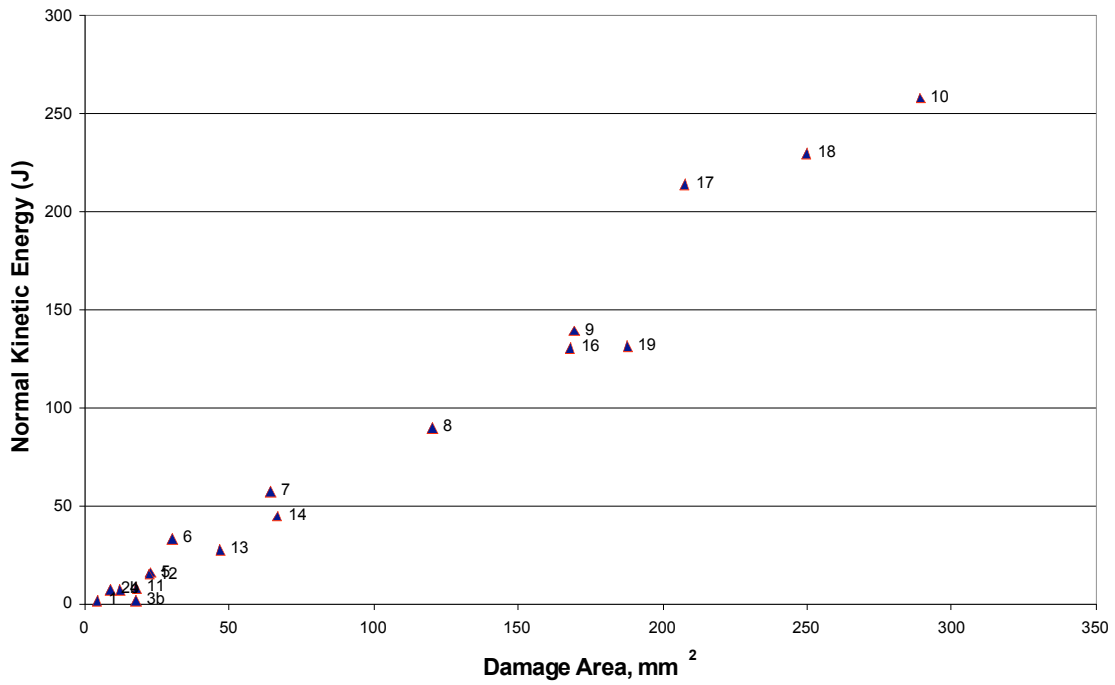
As can be seen in Figure 11 and Figure 12, the normal kinetic energy correlated better than the total kinetic energy with damage area.

Figure 12: C-1 Normal Kinetic Energy vs. Fiber Damage Area

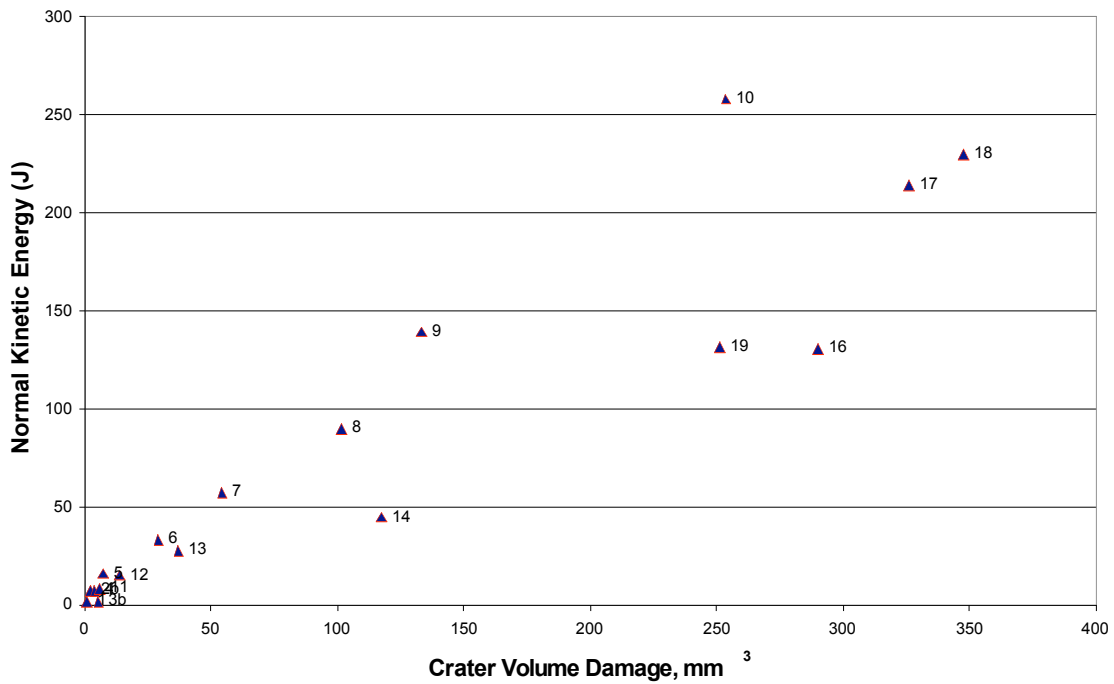
In Figure 13 and Figure 14, the total kinetic energy correlates with crater volume damage better than the normal kinetic energy.

Figure 14: C-1 Normal Kinetic Energy vs. Crater Volume Damage

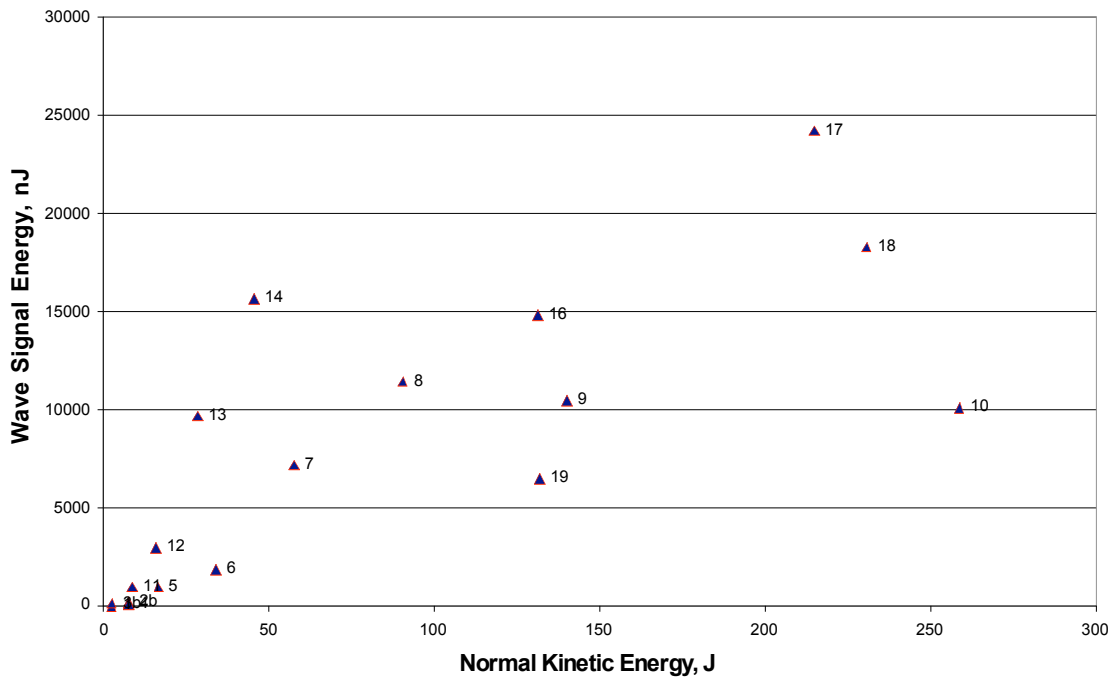
Wave signal energy correlates with normal kinetic energy better than with total kinetic energy as can be seen in Figure 15 and Figure 16.

Figure 16: C-1 Wave Signal Energy vs. Normal Kinetic Energy

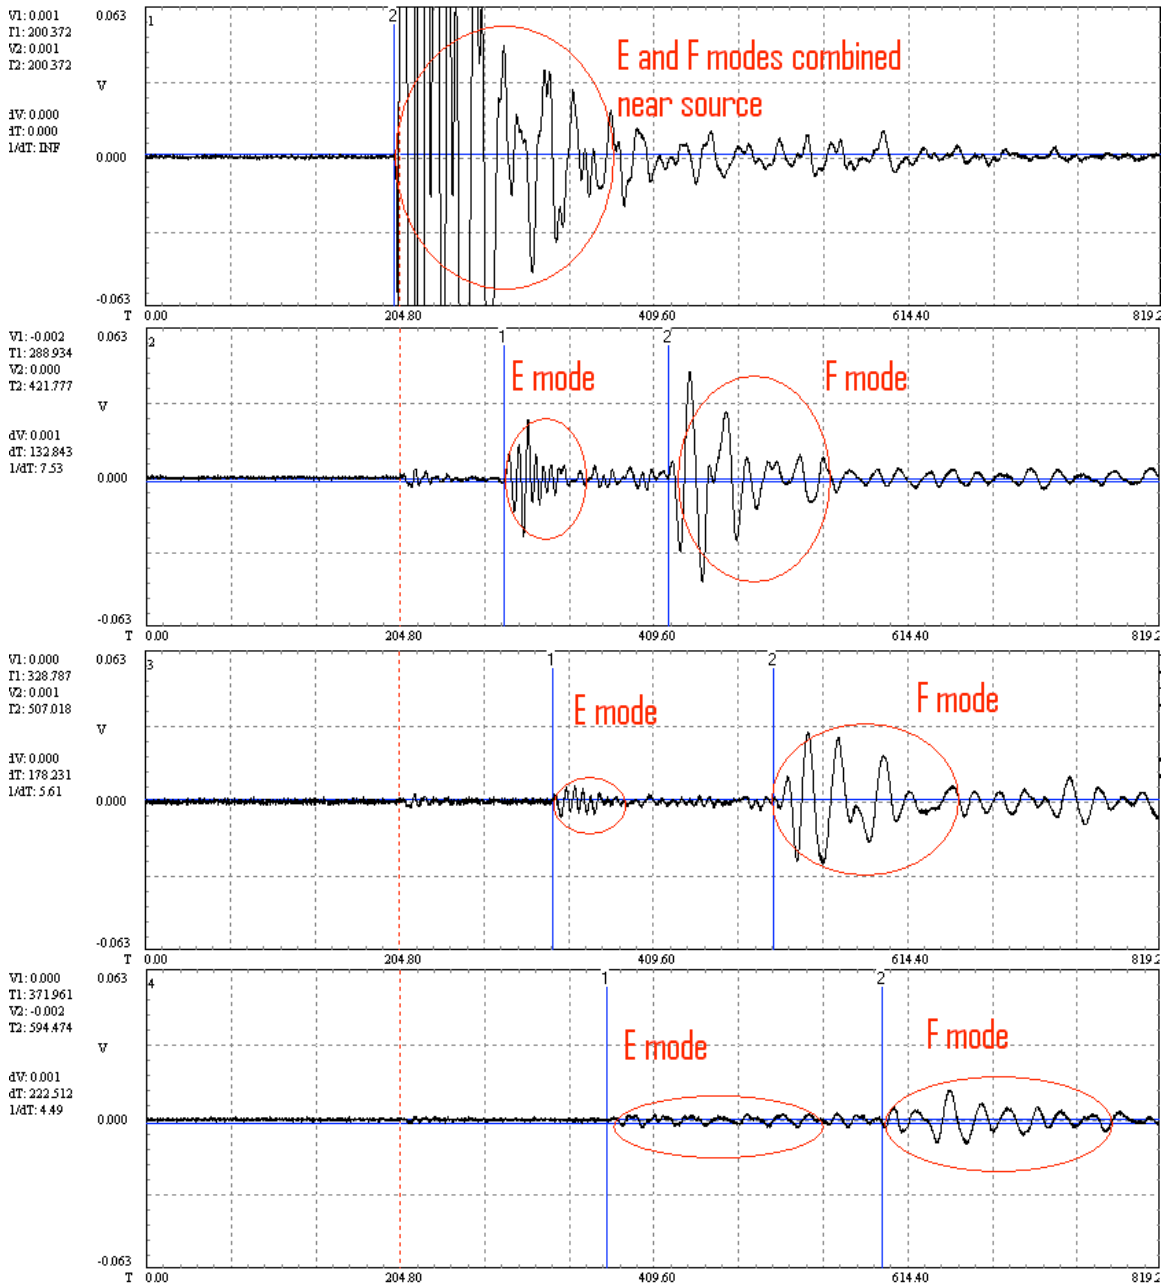
Wave speed was determined by performing a lead break at one sensor and measuring the time it took for a direct wave to arrive at another sensor at a known distance away. Figure 18 shows a lead break signal at sensor 1. The extensional wave arrived at sensor 1 at $t_1 = 200.4 \mu\text{s}$ and at sensor 2 at $t_2 = 288.4 \mu\text{s}$. The sensors were located 14 inches apart which gave a velocity of $0.16 \text{ in}/\mu\text{s}$ in the x-direction. Performing this calculation in the y-direction and the diagonal gave extensional wave velocities of $0.16 \text{ in}/\mu\text{s}$ and $0.14 \text{ in}/\mu\text{s}$, respectively. Figure 19 is a diagram of the sensor layout.

Figure 18: C-1 Lead Break Near Sensor 1 on Sensors 1, 2, 3, and 4 for Shot #1 Pretest

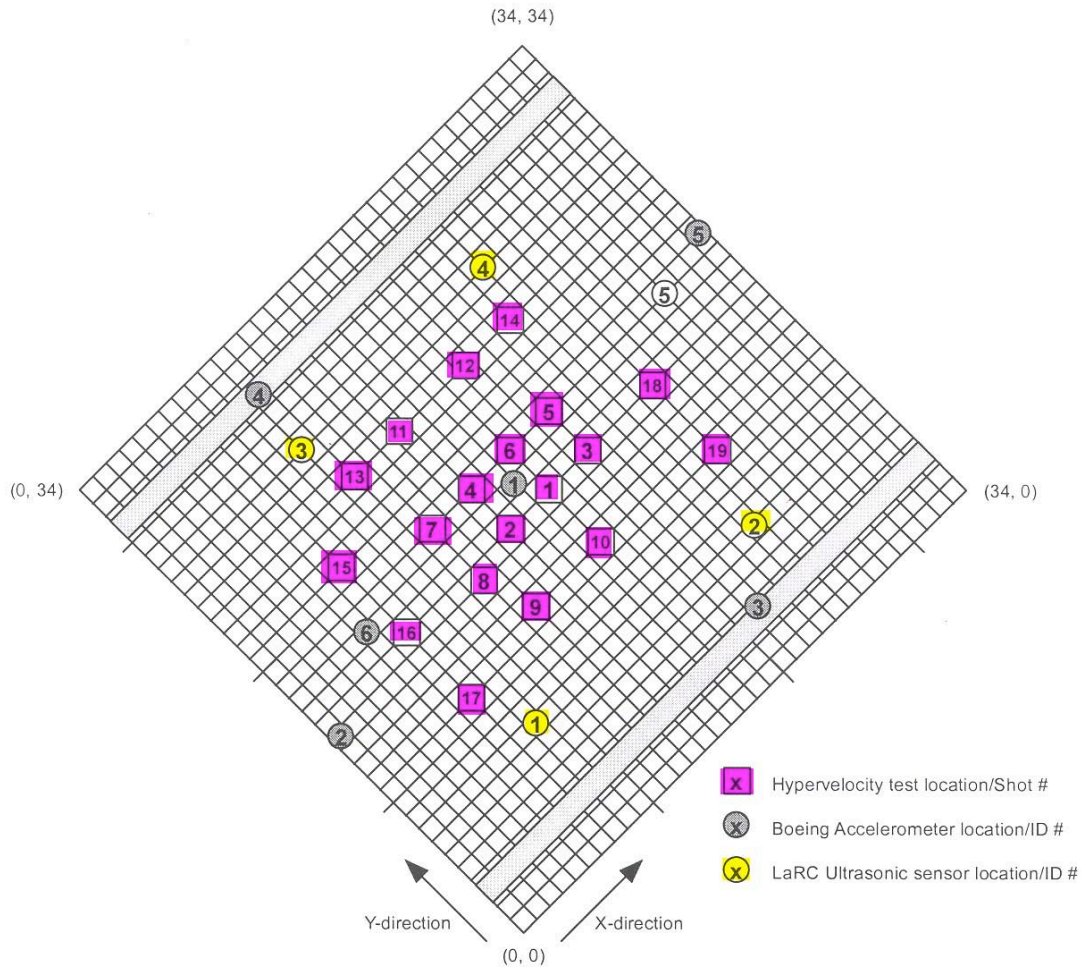
Figure 19: C-1 Diagram of Sensor Locations. Front View. (Repeat of Figure 5.)

Acoustic emission sensors are highlighted in yellow with the following coordinates:

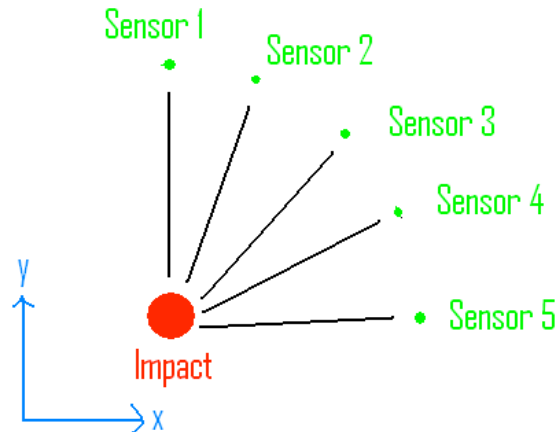
homogenous and isotropic, the wave signal energy would be the same for all sensors. If the material were orthogonally isotropic fiberglass, however, the wave signal energy would be strongest along the direction of the fibers. Thus, the wave signal energy would be largest for sensors 1 and 5 and smallest for sensor 3. The ratio of the attenuated signal to the non-attenuated signal would be the correction factor for that angle.

Figure 20: Sensor Array for Observing Diagonal Attenuation

An exact scaling factor for every sensor on every impact would require more effort in the present case than it would be worth, but the effect on the data of the diagonal attenuation can be approximated. It can be shown that the data points that seemed to be outliers would in fact have been more in line with the other data points in the KE plots by considering how many sensors are aligned with each impact point and fiber directions and observing that, for similar kinetic energies, the impact positions that were aligned with both fibers and sensors had the higher wave signal energies.
