## ***High Resolution Millimeter Wave Inspecting of the Orbiter Acreage Heat Tiles of the Space Shuttle***

*J.T. Case<sup>1</sup>, S. Kharkovsky<sup>1</sup>, R. Zoughi<sup>1</sup> and F. Hepburn<sup>2</sup>*

*<sup>1</sup>Applied Microwave Nondestructive Testing Laboratory (amntl)  
Electrical and Computer Engineering Department  
University of Missouri-Rolla  
Rolla, Missouri 65409*

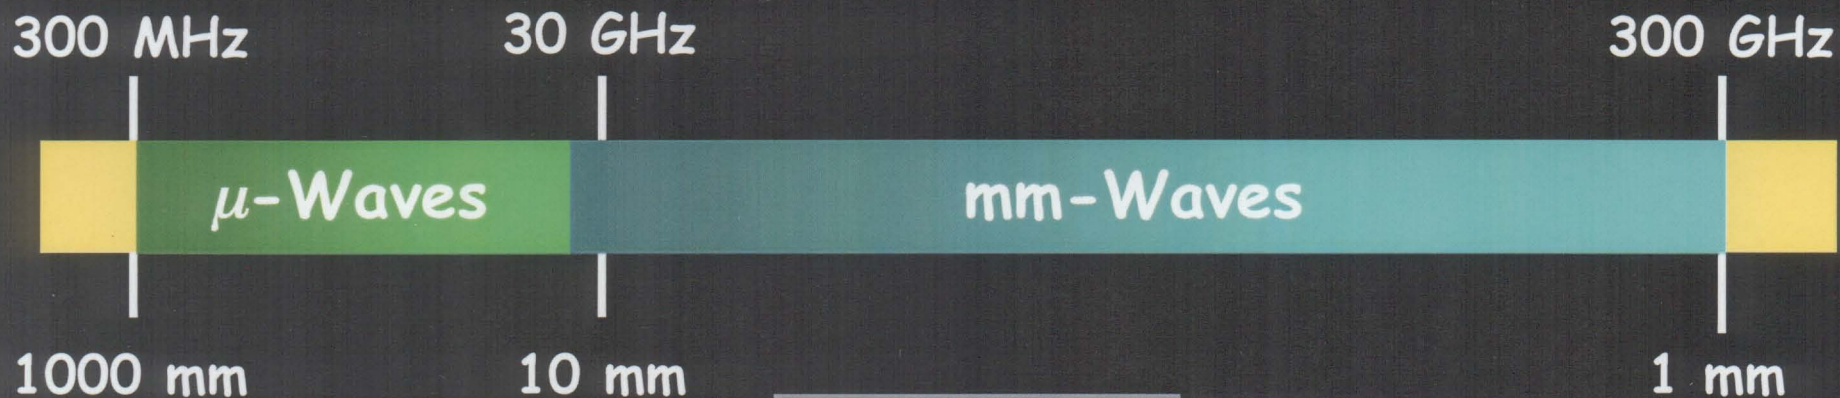
**K-Band** **Ka-Band** **V-Band** **W-Band** **D-Band** ---  
18-26.5 26.5-40 50-75 75-110 110-170

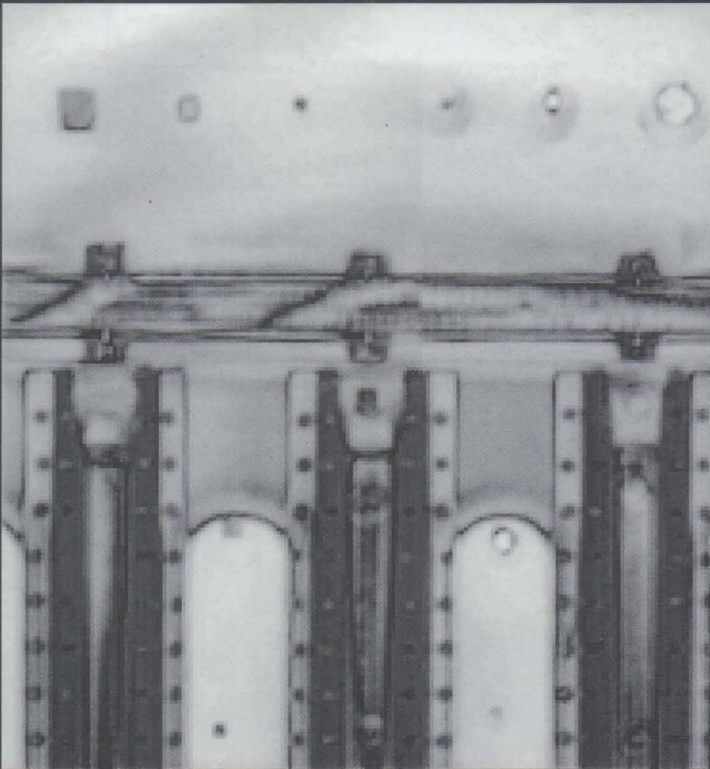
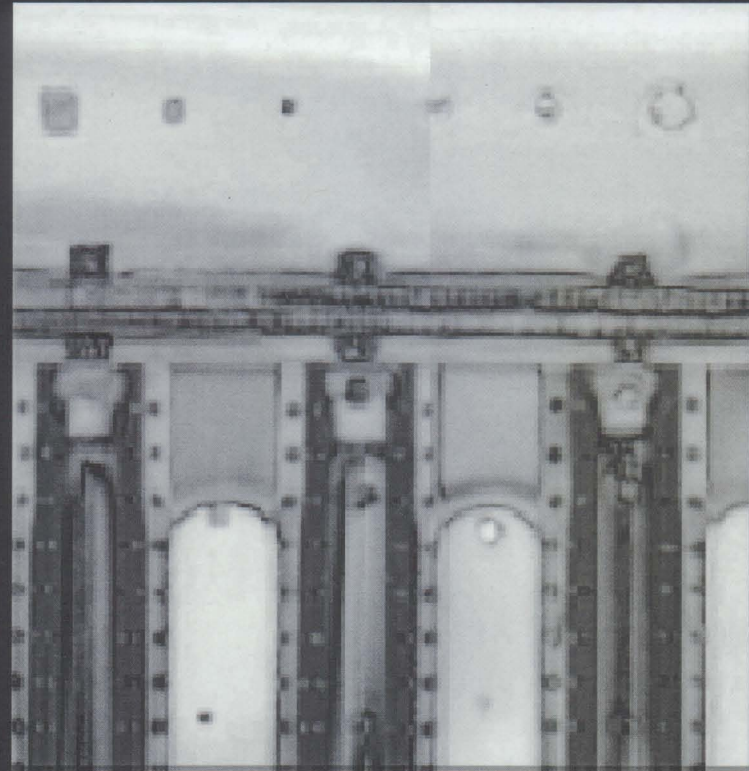
# POD Panel - 150 GHz

Perpendicular

Parallel

Focused at Substrate

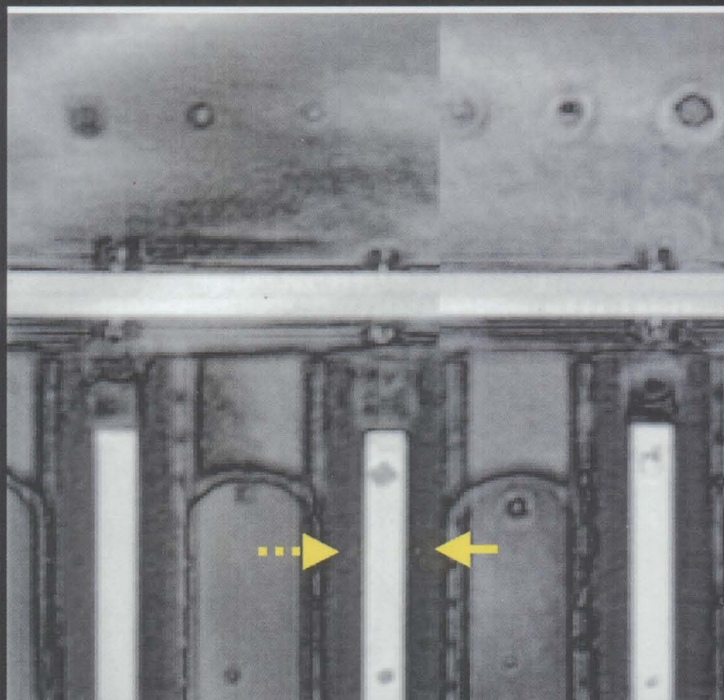
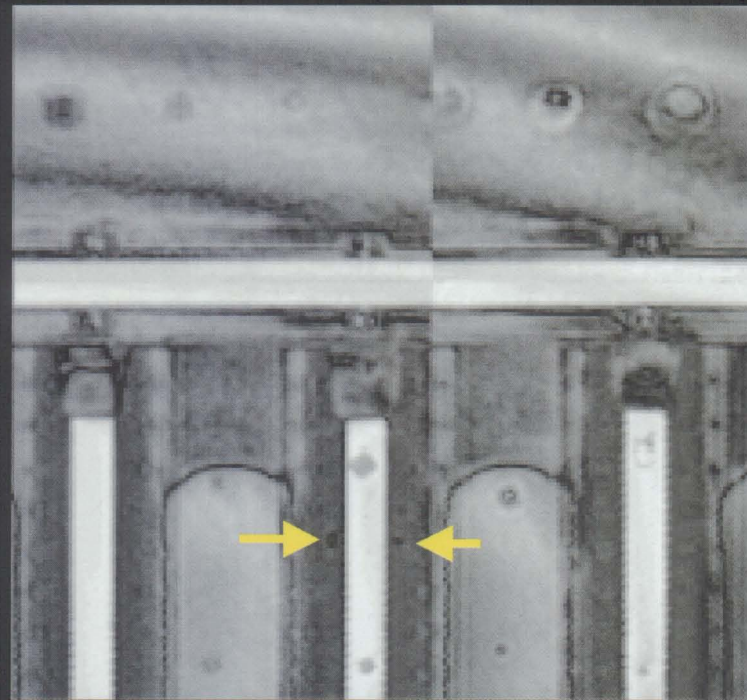
# POD Panel - 150 GHz

Perpendicular

Parallel

Focused at  $\sim 2.12$  above Substrate

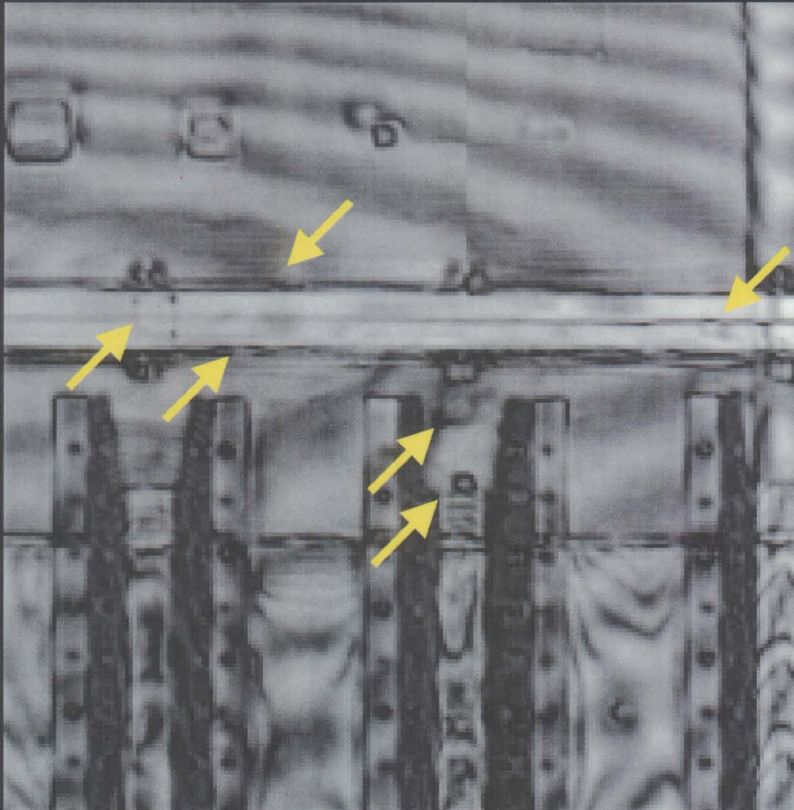
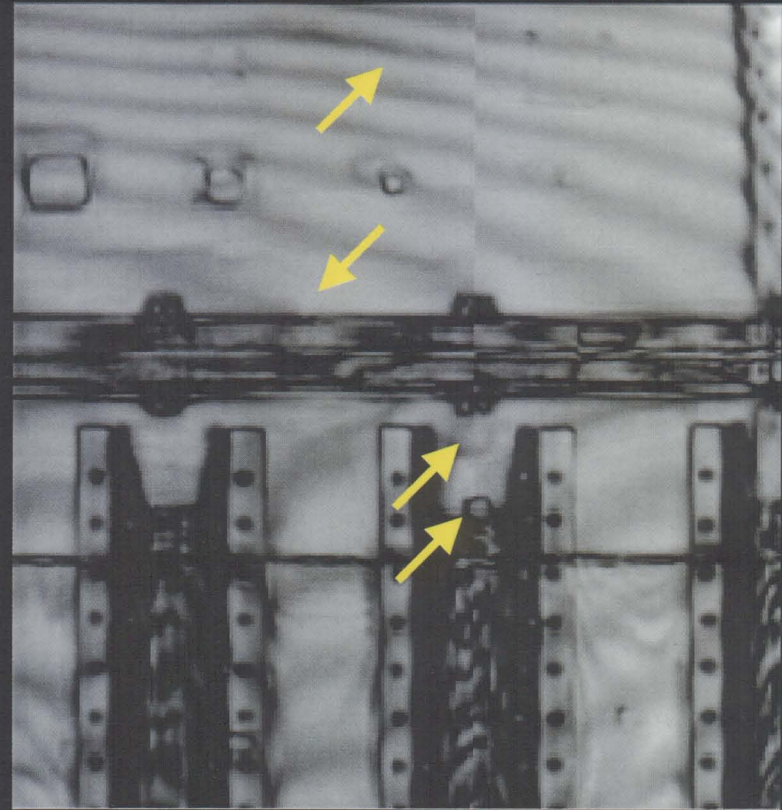
# PAL Ramp – 150 GHz

Focused at Conethane

Focused at Substrate

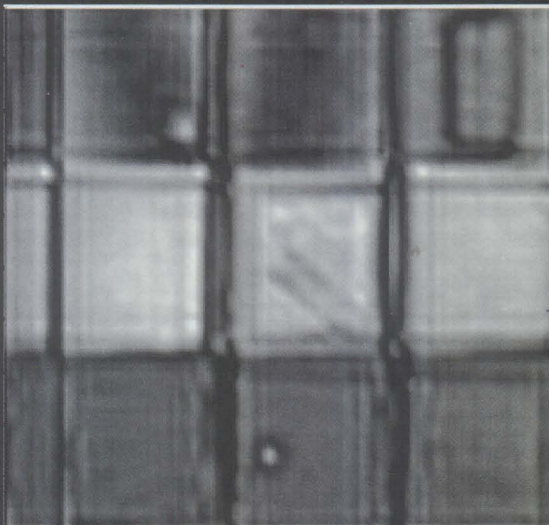
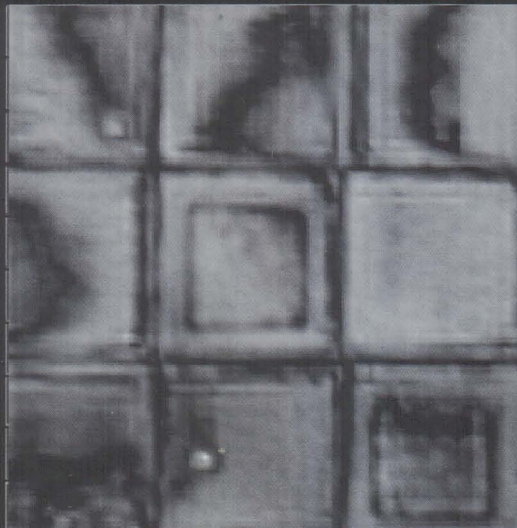
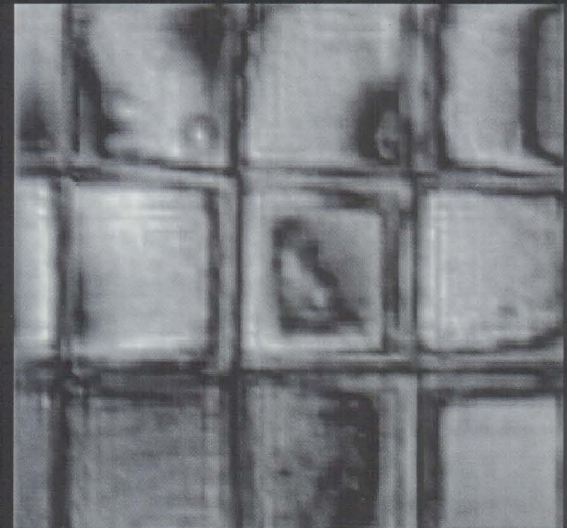
# Heat Tiles

Ka-Band  
33.5 GHz

V-Band  
67 GHz

V-band  
70 GHz

All with small horn antennas.

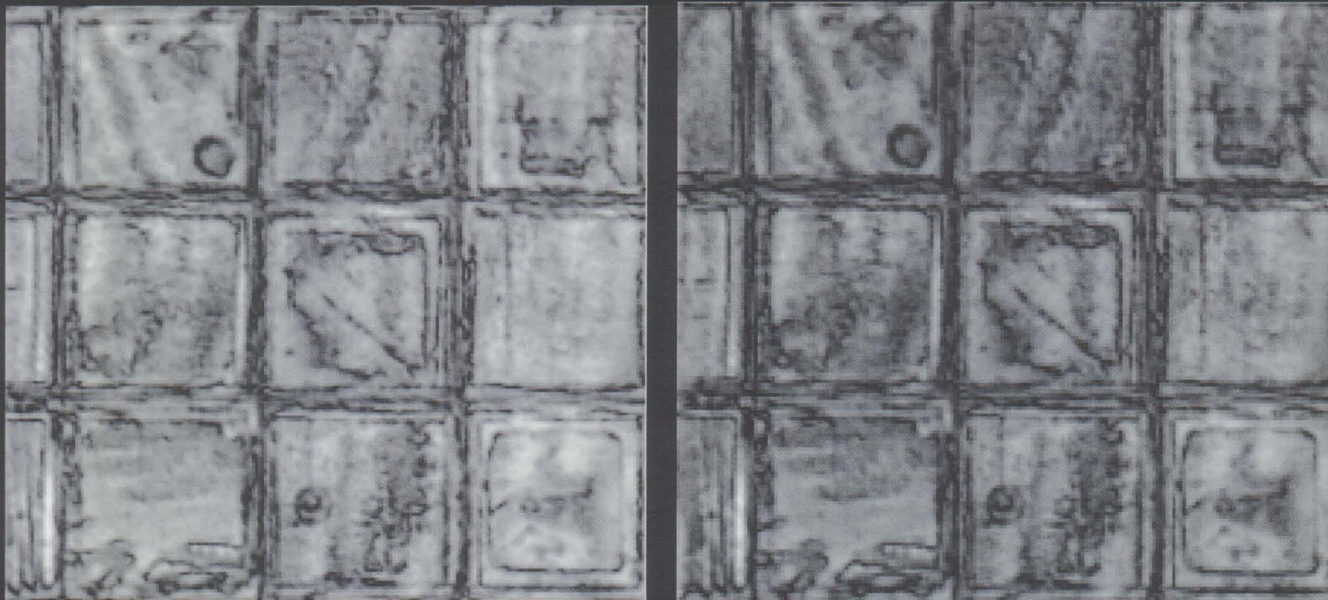
# Heat Tiles

D-band  
150 GHz

Using a focusing lens antenna.

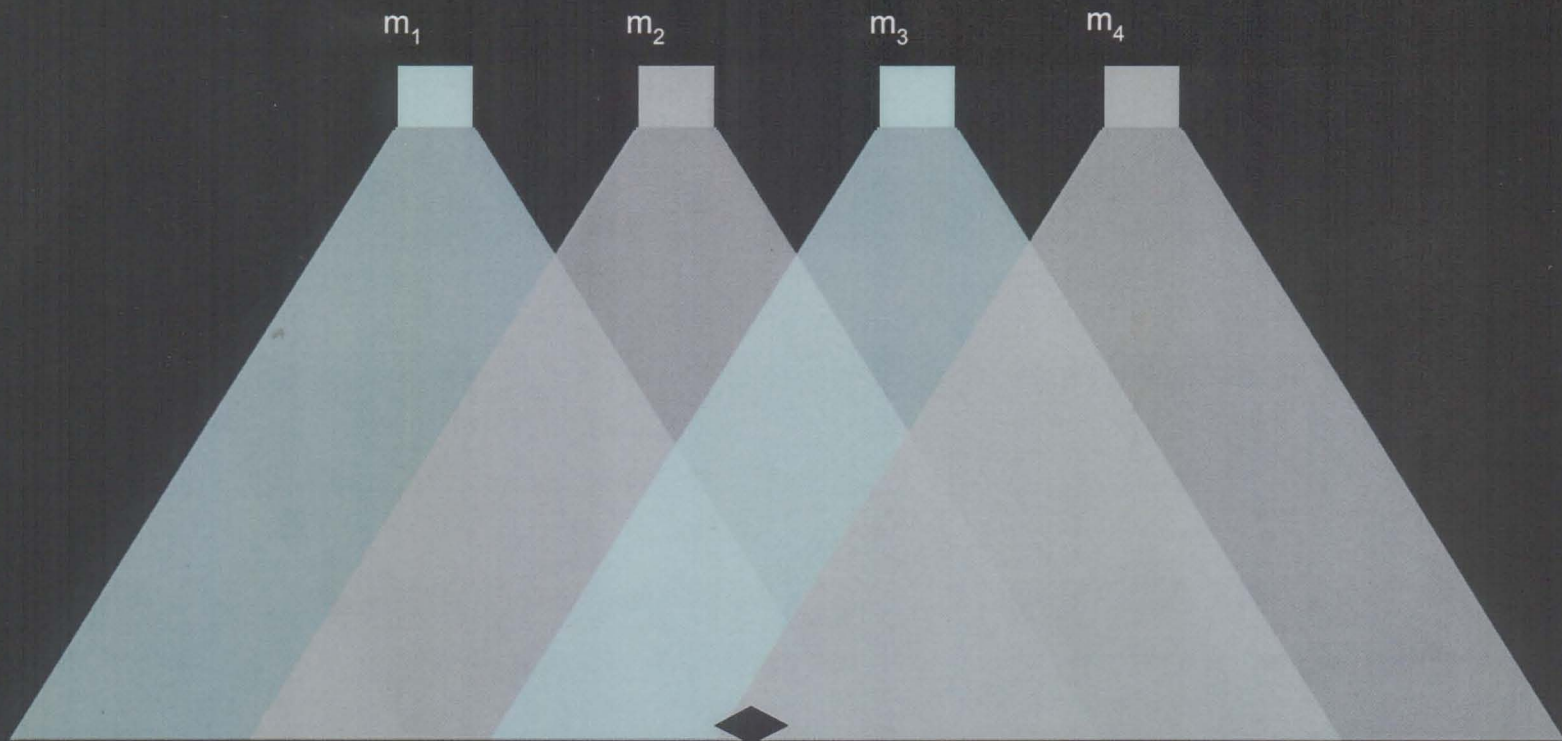
# Synthetic Aperture Focusing

Antenna Motion Direction

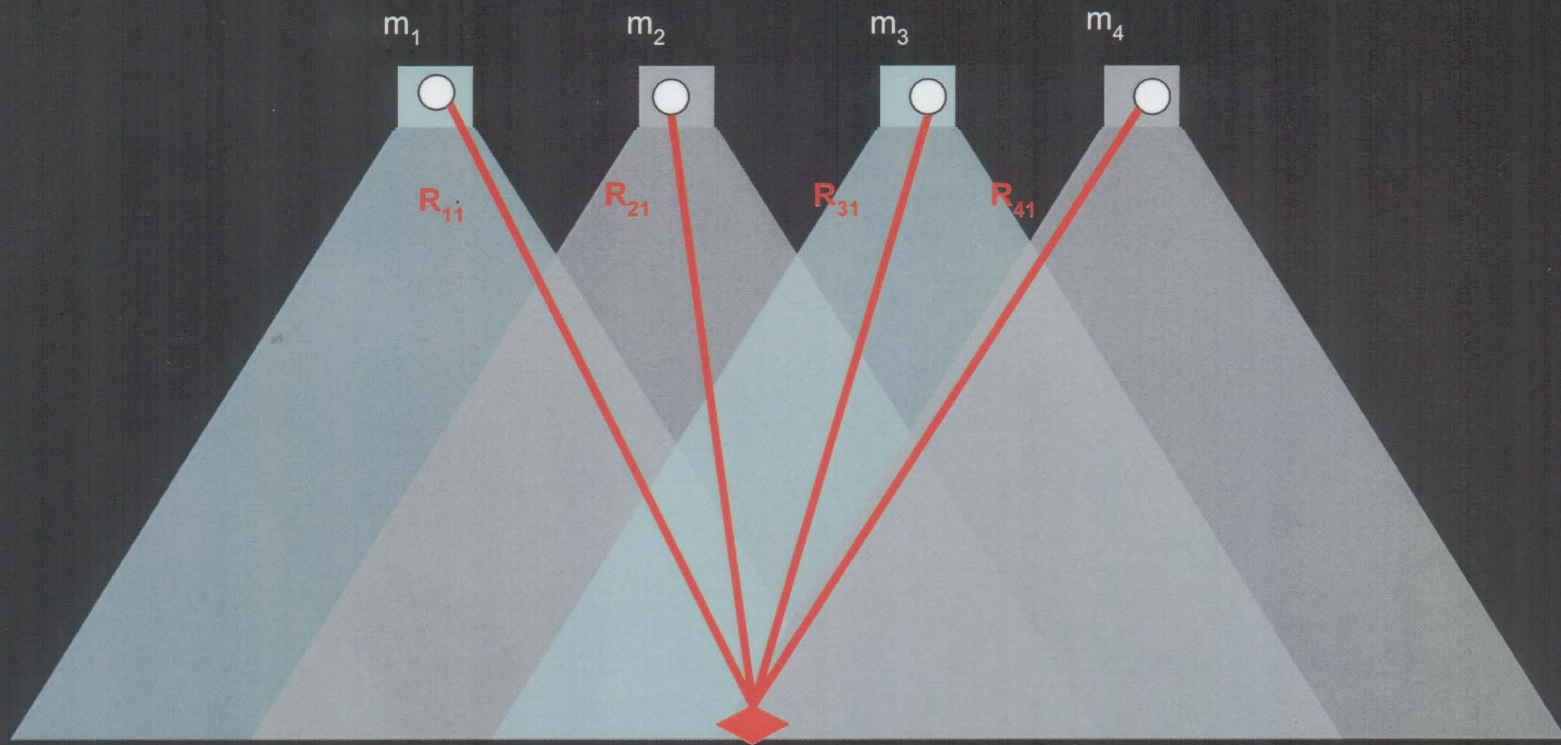
# Synthetic Aperture Focusing

Antenna Motion Direction

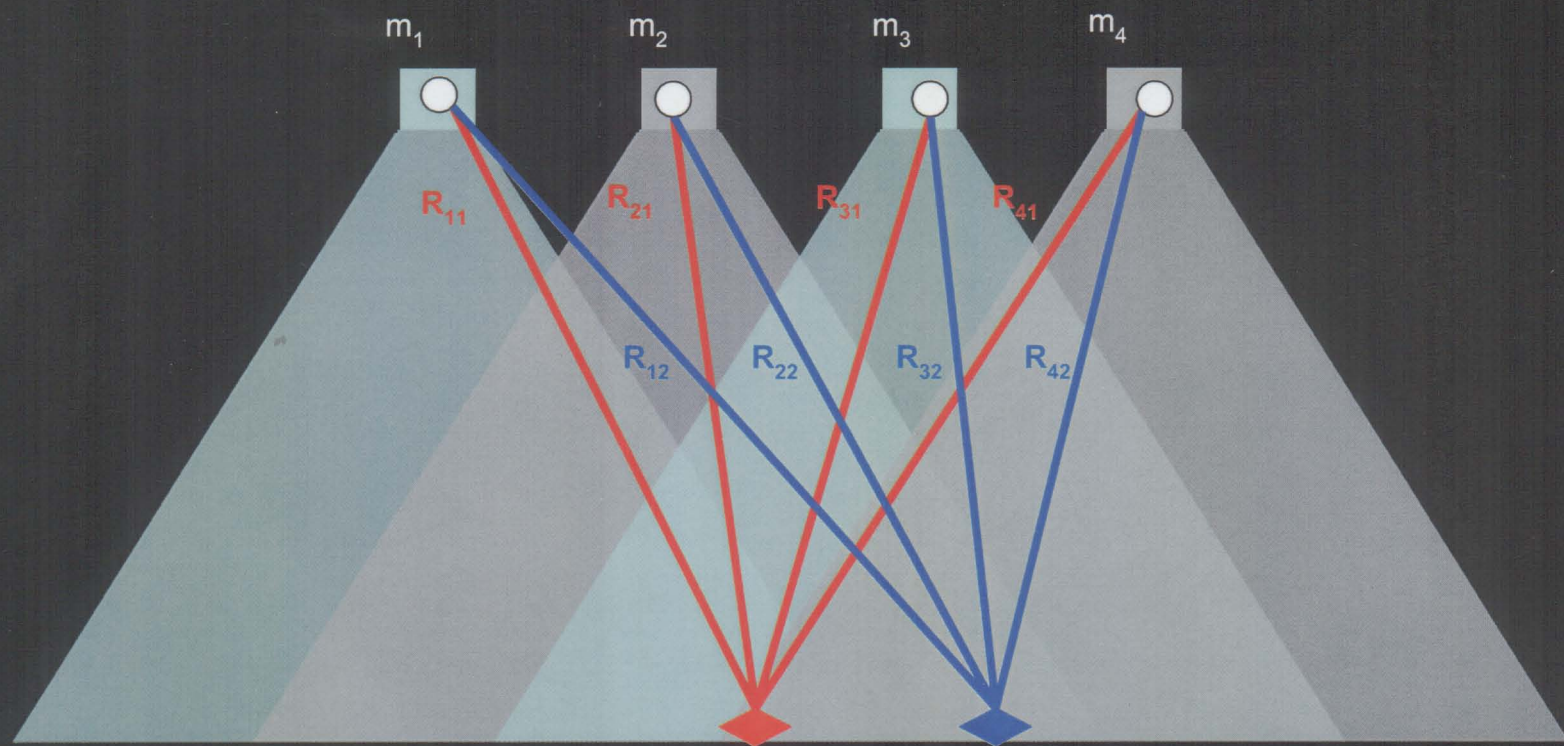
# Synthetic Aperture Focusing

Antenna Motion Direction

$$s_k = \sum_{i=1}^4 m_i \exp(j2\beta R_{ik})$$
