NASA/CR—2008-215216

Investigation of Flow Instabilities in the Inlet Ducts of DP-1C VTOL Aircraft

Jan Lepicovsky
ASRC Aerospace Corporation, Cleveland, Ohio

June 2008

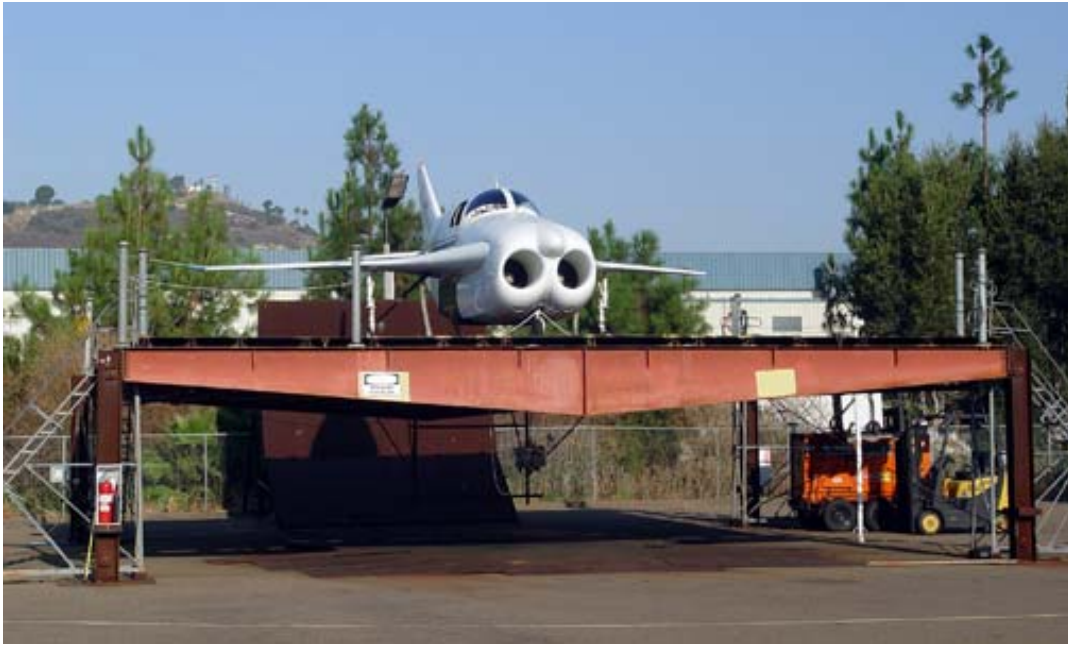
Fig. 1-1 DP-1C aircraft on an elevated platform for OGE testing.

The inlet instability tests were carried out for two basic ‘flight’ conditions: (1) out-of-the-ground effects (OGE) and (2) in-ground effects (IGE). The OGE tests were carried out on a raised platform with a deployed bare nose wheel (Fig. 4-1). The IGE tests were executed for three configurations: (1) a deployed bare nose wheel, (2) deployed faired nose wheel, and (3) removed nose wheel (simulating retracted nose undercarriage). The IGE test configurations are shown in Figs. 4-2 through 4-4.

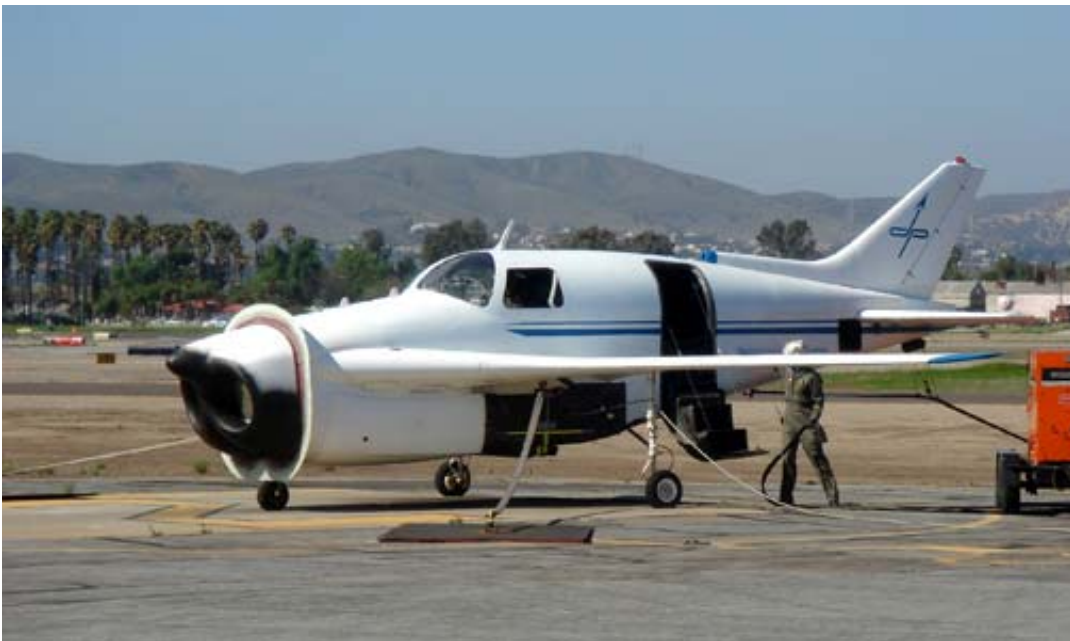
Fig. 1-2 Inlet fence to prevent hot gas ingestion.

further forward (Ref. 3). In case of the airplane DP-1C, several attempts to prevent the hot flow lift up by inserting a 'roof' above the nose wheel did not prevent the engine stalls. Also a fence around the inlets (Fig. 1-2), which simulated a similar arrangement on the Bell X-14, did not succeed in elimination of engine stalls. Later on, laser-sheet flow visualization tests were carried out to map the flow around the engine inlets; however, no firm conclusion was reached about the cause of the engine stalls. A detailed description of these experiments is presented in Ref. 4.

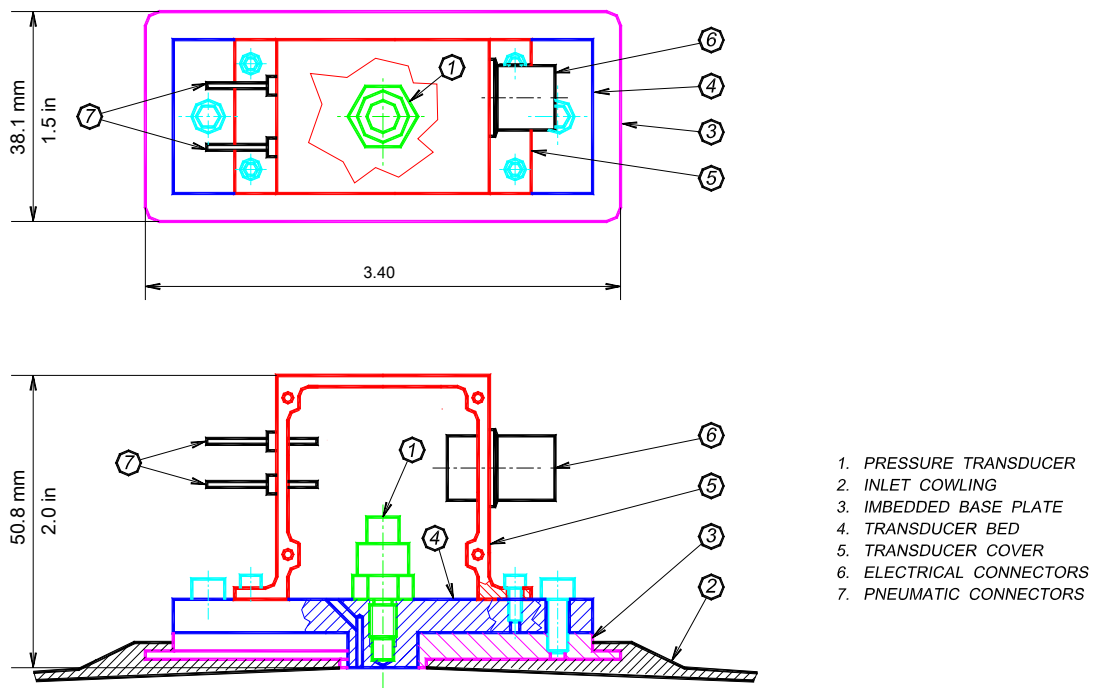
Fig. 2-1 Transducer module assembly for DP-1C tests.

The pressure modules, which were eventually installed in the inlets of aircraft DP-1C, were designed with the same philosophy as those developed for NASA testing. A drawing of the pressure module is shown in Fig. 2-1. The miniature pressure transducer (part 1 in Fig. 2-1) is mounted on a transducer bed (part 4) in such a way that the sensitive diaphragm of the transducer is about 1 mm away from the flow surface of the engine inlet. The transducer cover (part 5) protects the transducer against mishandling and supports electrical (part 6) as well as pneumatic (part 7) connectors. Fine electric wires and the back pressure tube of a miniature pressure transducer, both sensitive to possible damage, are attached to cover connectors and thus protected from the excessive loads often encountered with installations of bare transducers only. The electric wires and back pressure tube are not shown in Fig. 2-1. Components of a pressure module prior to assembly are shown in a photograph in Fig. 2-2, a pressure transducer mounted on the transducer bed is shown in Fig. 2-3, and finally a view of a partially assembled pressure module is in Fig. 2-4, where electric wires and connecting tubes to cover connectors are clearly visible.

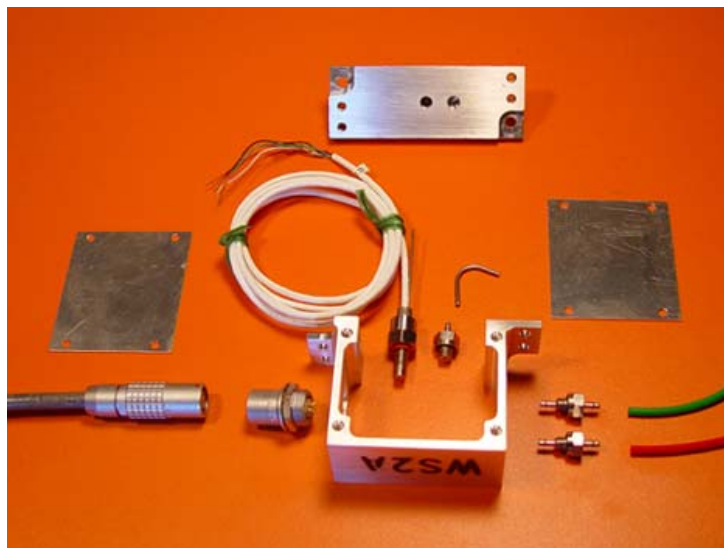
Fig. 2-2 Components of the transducer module.

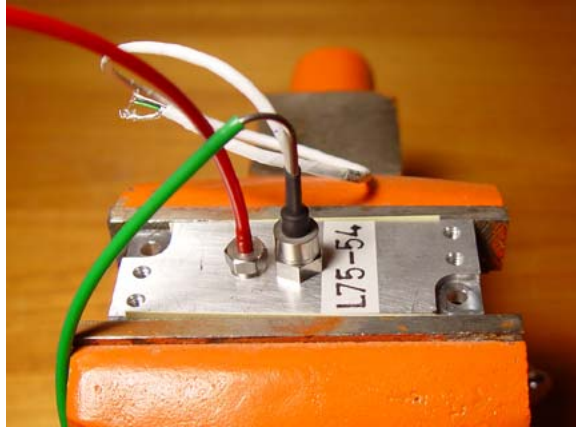
Fig. 2-3 Wall pressure module under construction.

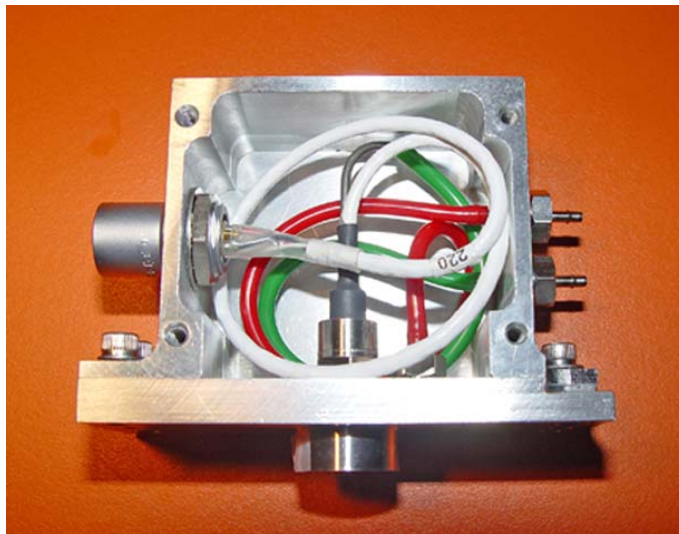
Fig. 2-4 Partially assembled wall pressure module.

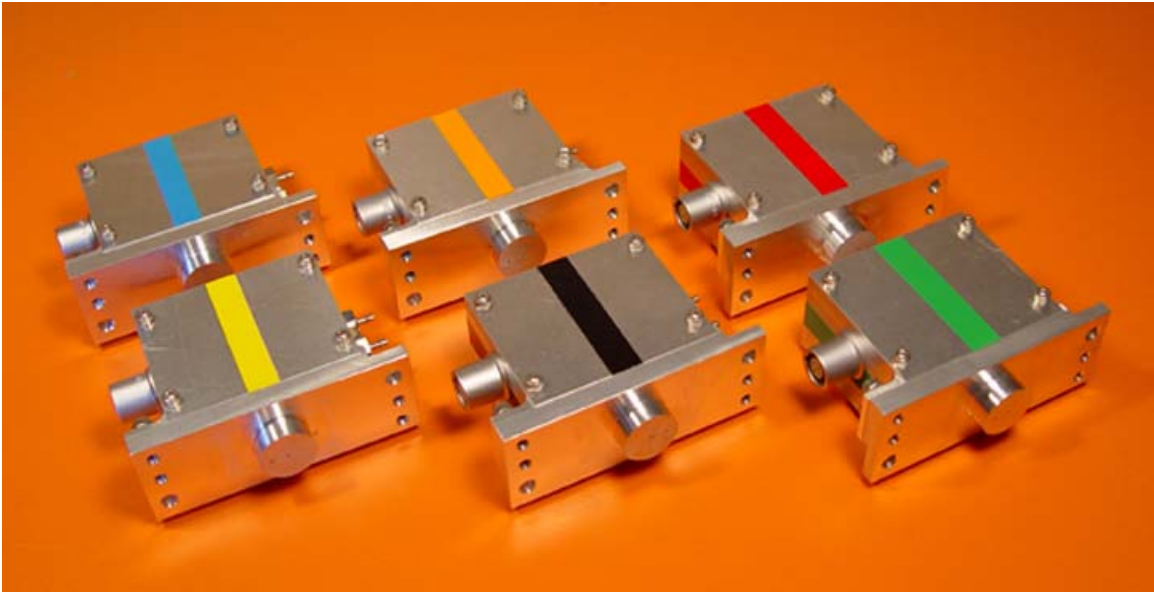
Fig. 2-5 Assembled wall pressure modules (side view).

After the assembly of the transducer module was completed, the cover side walls were closed with two lids. The metallic cover is also an excellent shield against electromagnetic interference. Two views of all pressure modules fabricated are in Figs. 2-5 and 2-6. Pressure modules were color coded and labeled for easy identification. All pressure transducers used had a range $\pm 35 \text{ kPa}$ ($\pm 5 \text{ psid}$). Modules labeled *WS1A, B, C* were furnished with Kulite transducers *XCS-190-5D*, modules *WS2A, B* were furnished with extended temperature range transducers Kulite *XTE-190-5D*. Finally module *WS3A1* was equipped with transducer *XCS-190-5D*; however the static tap had a larger diameter than the rest of the modules (1.5 mm versus 0.75 mm) in order to increase the frequency range of this module.

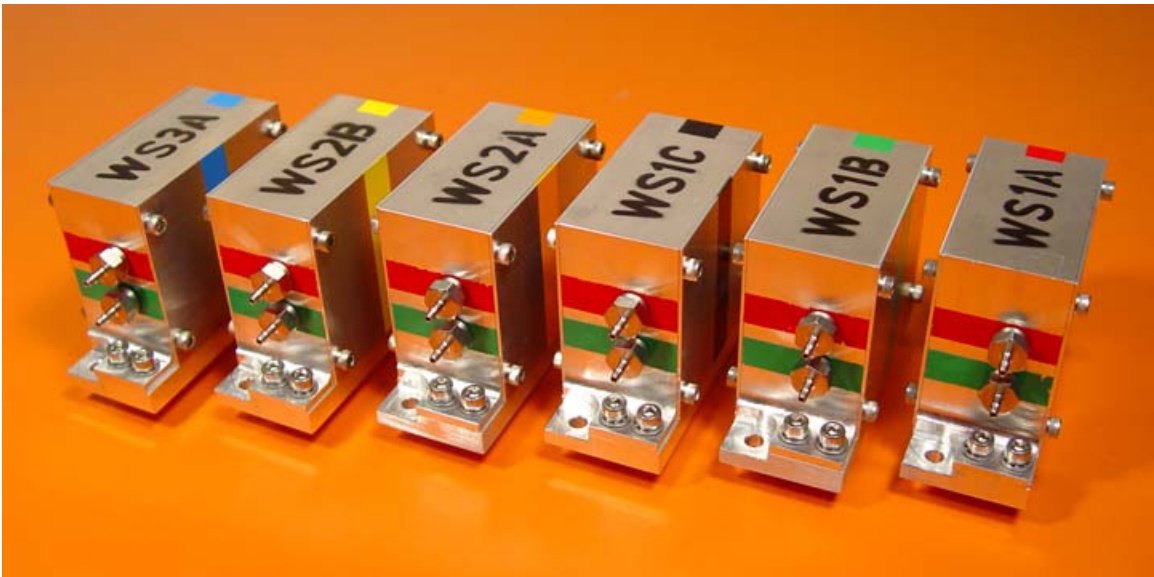
Fig. 2-6 Assembled wall pressure modules (view from 'pneumatic end').

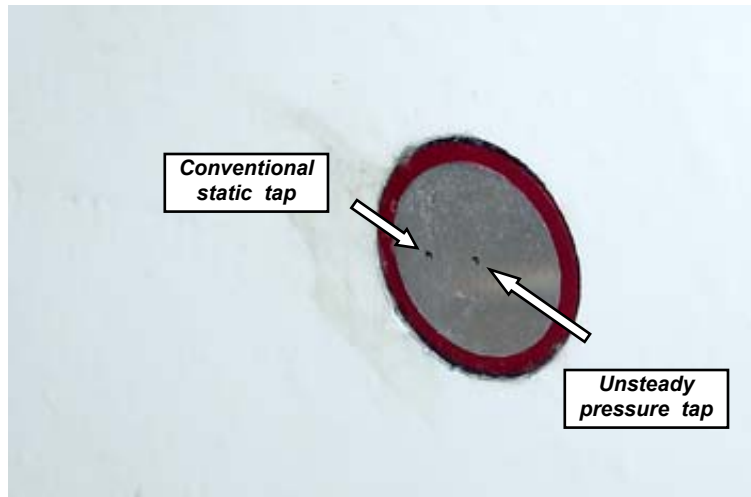
Fig. 2-7 Pressure module mounted in an inlet wall (view from inlet).

The pressure module also contains a conventional static tap the serves to verify the average pressure levels measured by the miniature pressure transducer. Transducer signals tend to drift sometimes, and therefore a ‘sanity’ check by the static pressure tap is highly recommended. Both pressure taps can be seen in Fig. 2-7 where a ‘flow’ face of a mounted pressure module is shown.

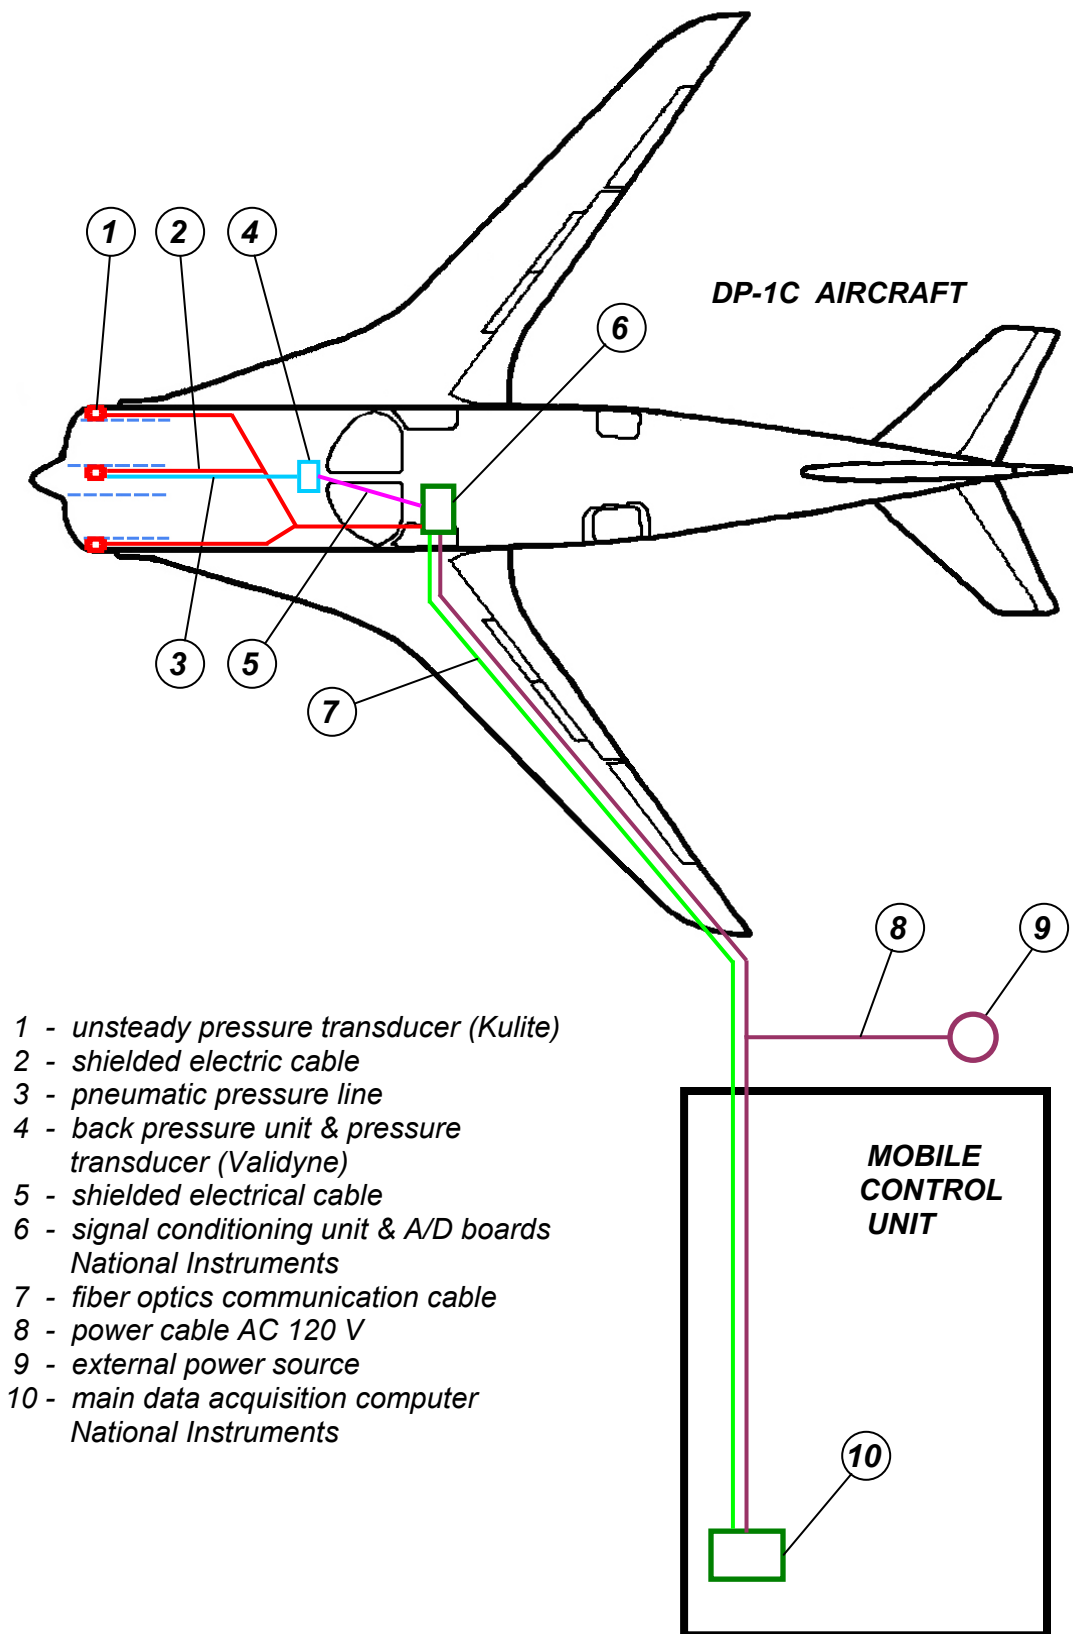
Fig. 3-1 Basic instrumentation layout for DP-1C inlet instability tests.

A schematic drawing of the entire data acquisition setup is shown in Fig. 3-1. The aircraft inlets were instrumented with six pressure modules (Pos. 1 in Fig. 3-1). The pressure transducers were powered and their signals were recorded by a National Instrument (NI) unit *PXI 1010* (Pos. 6). The connections were provided by four-wire shielded cables (Pos. 2). The pneumatic conventional taps were connected by tubing (Pos. 3) to individual Validyne *P855* pressure transducers (Pos.4). The low-frequency Validyne transducers were powered and their signals were recorded by the unit *PXI 1010* (Pos. 6) via shielded cables (Pos. 5). The data acquisition unit *PXI 1010* was controlled remotely by a NI unit *PXI 1000B* (Pos. 10), which was located in the Mobile Control Unit. The connection between both PXI units was provided via fiber optics cable (Pos. 7). Finally, both units were powered by an external generator (Pos. 9) supplying a voltage of 120 V via a grounded power cabled (Pos. 8).

Signals from rotational speed pickups *NI* (fan revolutions) for each engine were also acquired by the NI unit *PXI 1010*. Connections for these two signals are not shown in Fig. 3-1. All the signals acquired were recorded by the same unit, and therefore the signals have a common time datum base, and all the signals recorded are mutually synchronized.

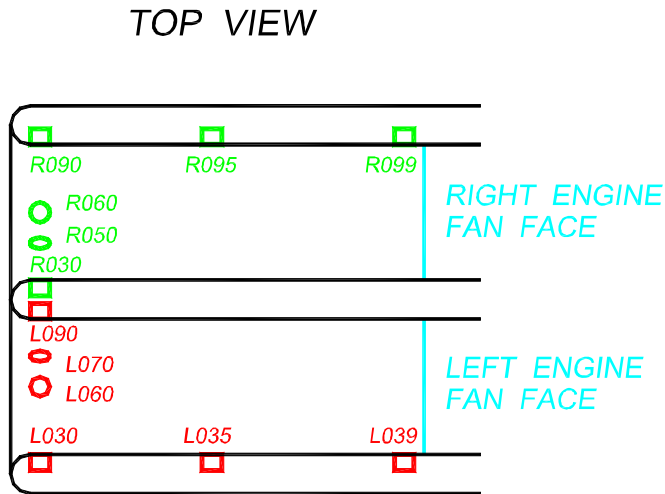
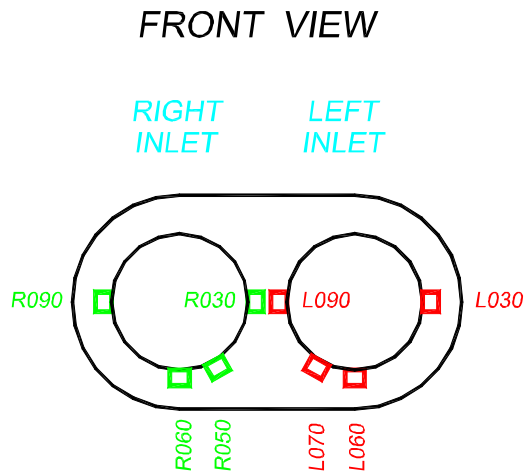
Fig. 3-2 Layout of measurement ports in DP-1C inlets.

A layout of the measurement ports made in both engine inlets is presented in Fig. 3-2; altogether 12 measurement ports were made. A table shown in Fig. 3-3 lists all the relevant dimensions. Pressure modules must be mounted flush with the flow surface to measure the wall static pressure correctly. Any protrusion or cavity at the module face, relative to the flow surface, will generate pressure fluctuations or at least noise levels that are not present in the undisturbed flow. The thickness of the DP-1 inlet cowling varies between 1.0 mm and 1.5 mm (40 and $60\text{ }\mu\text{inch}$). In addition to varying thickness, the cowling surface is curved. To assure that pressure modules are mounted correctly, it was decided to implant a metal base plate into the cowling, and to attach a pressure module to this base. The base plate is shown in Fig. 2-1 (part 3) and Fig. 3-4 (part 1). For a proper plate insertion, the edge of the central hole in the base plate was first aligned with the flow surface of the cowling, and then the plate was laminated to the cowling on the opposite surface of the cowling. By this method, all the base plates were correctly placed on the cowling even in locations where the curvature of the surface was quite high. A finished measurement port, ready for pressure module insertion, is shown in Fig. 3-5. Mounting of a pressure module in port *L030* is depicted in Fig. 3-6. Two pressure modules, mounted in ports *L030* and *L035*, with electrical and pneumatic connections in place are shown in Fig. 3-7. A view of a measurement port from inside an inlet duct with a pressure transducer inserted in the inlet wall was already shown in Fig. 2-7. Ports with base plates that were not used for a particular test run were closed with plugs flush with the inner wall of an inlet duct. An outside view of such plugs is shown in Fig. 3-8. A photograph of instrumented inlets prior mounting of the front cowling is in Fig. 3-9. Finally, Figs. 3-10 and 3-11 show the instrumented left and right inlets, respectively, with a front cowling mounted on the aircraft.

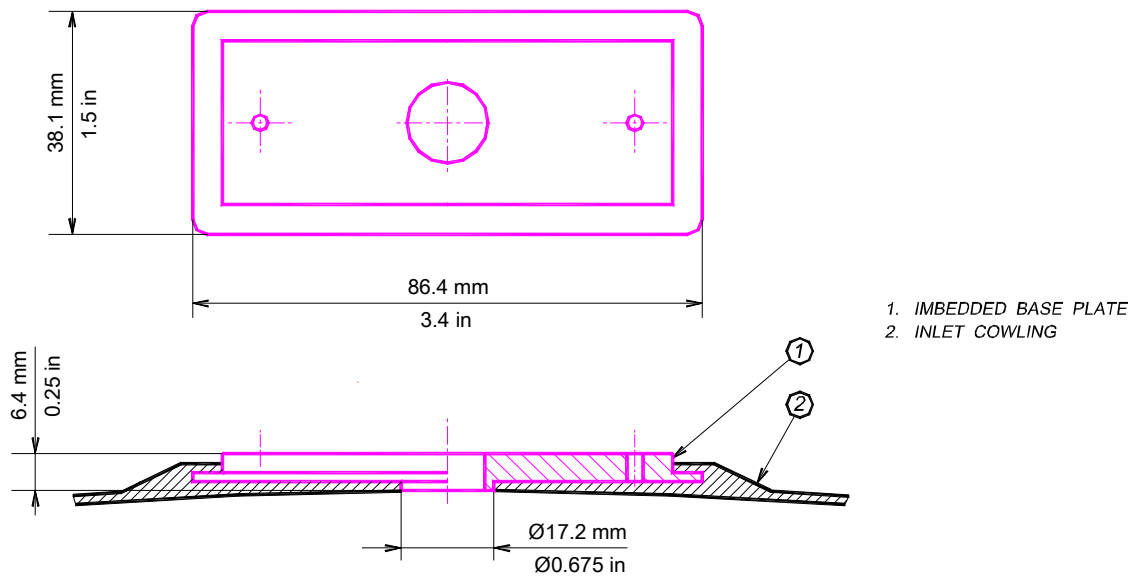
Fig. 3-4 Base plate laminated to inlet cowling.

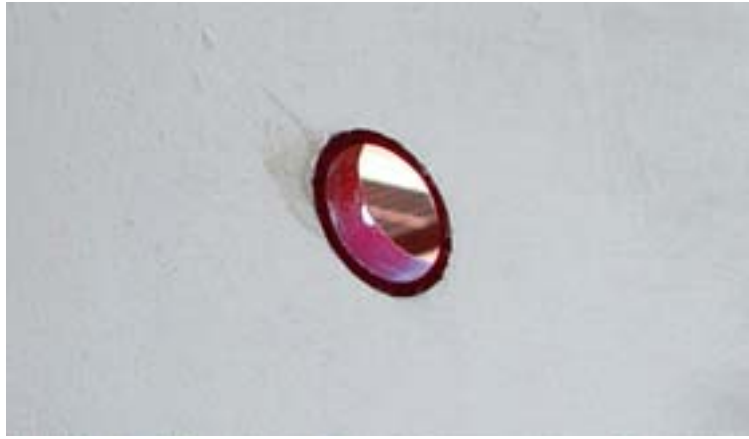
Fig. 3-5 Access port in the left inlet wall (view from inside of inlet duct).

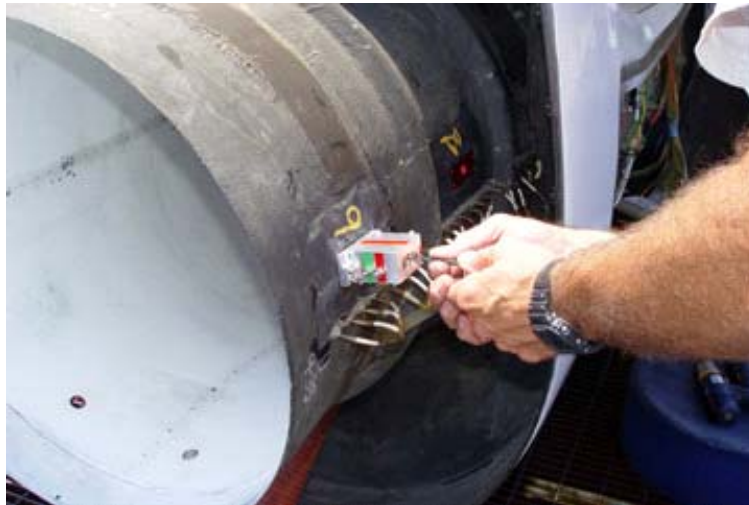
Fig. 3-6 Mounting of pressure module on the outer side of an inlet wall.

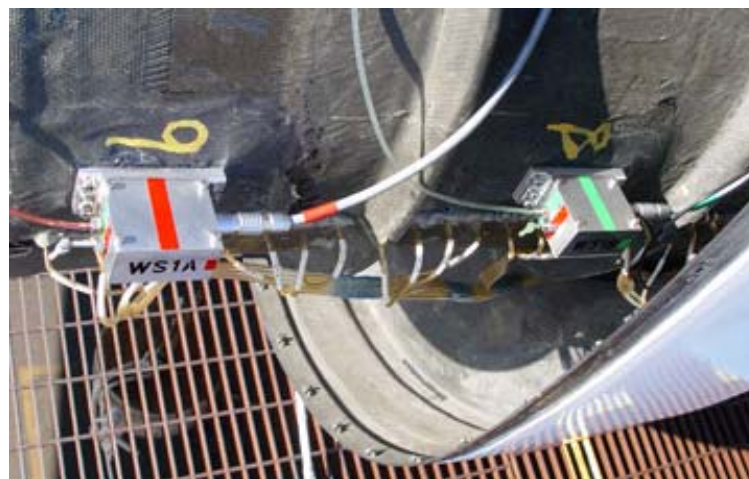
Fig. 3-7 Pressure modules plugged into ports L030 and L035.

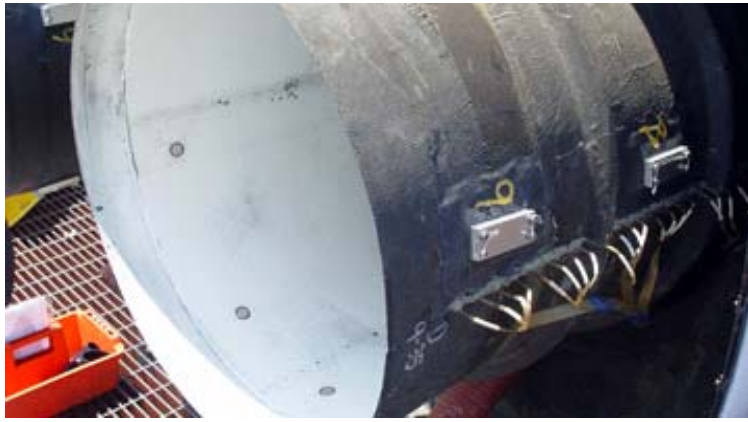
Fig. 3-8 Unused access ports closed with wall plugs.

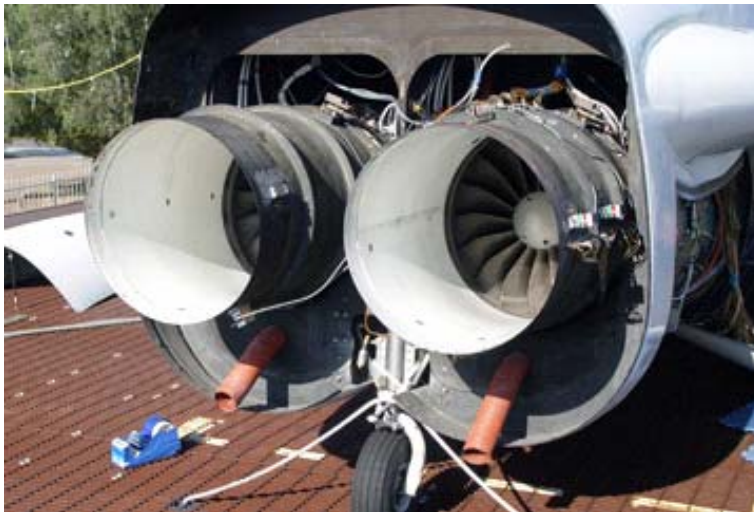
Fig. 3-9 View of instrumented inlets with front cowling removed.

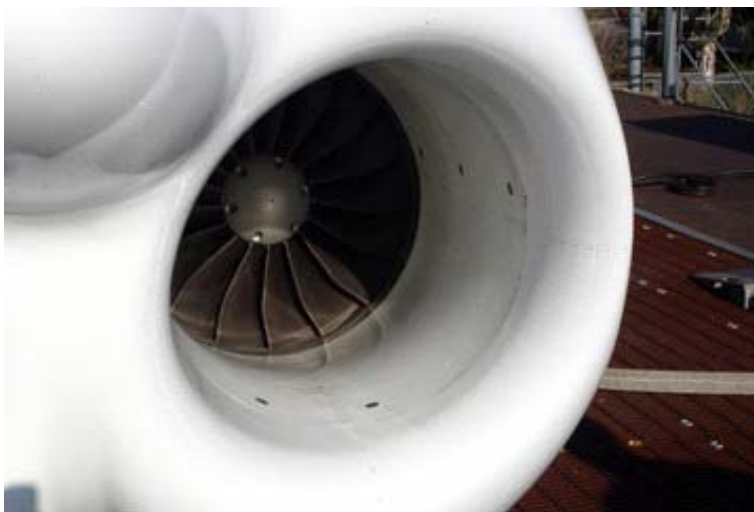
Fig. 3-10 Fully instrumented left engine inlet.

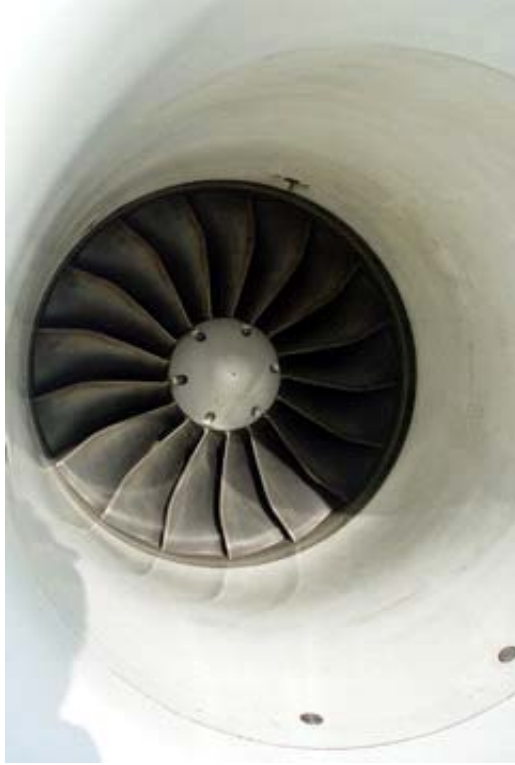
Fig. 3-11 Fully instrumented right engine inlet.

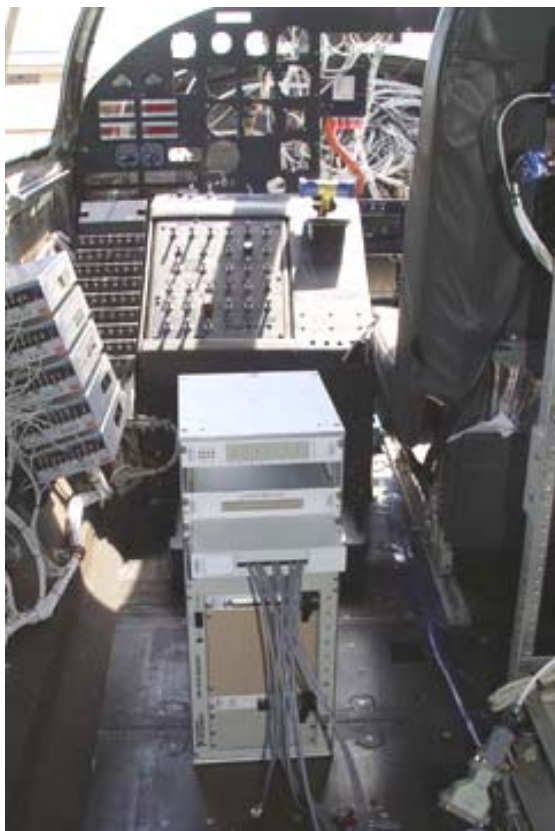
Fig. 3-12 Data acquisition unit *PXI-1010* on board during shake down tests.

The main data acquisition unit *PXI-1010* was located on board the DP-1C aircraft. The photograph in Fig. 3-12 depicts the unit on the aircraft floor during shake down tests of communication with the main computer located in the Mobile Control Unit (MCU). For the actual testing, the unit was squeezed behind the pilot seat as seen in Fig. 3-13. An overall view of the entire test site is shown in Fig. 3-14; the MCU is on the left hand side of the photograph, the DP-1C aircraft in on the raised platform for the OGE testing. A view of the tested aircraft from the MCU cockpit is in Fig. 3-15. The controlling program for the instability tests was written in *LabVIEW 8.5*. An image of the main screen of the controlling program is captured in Fig. 3-16.

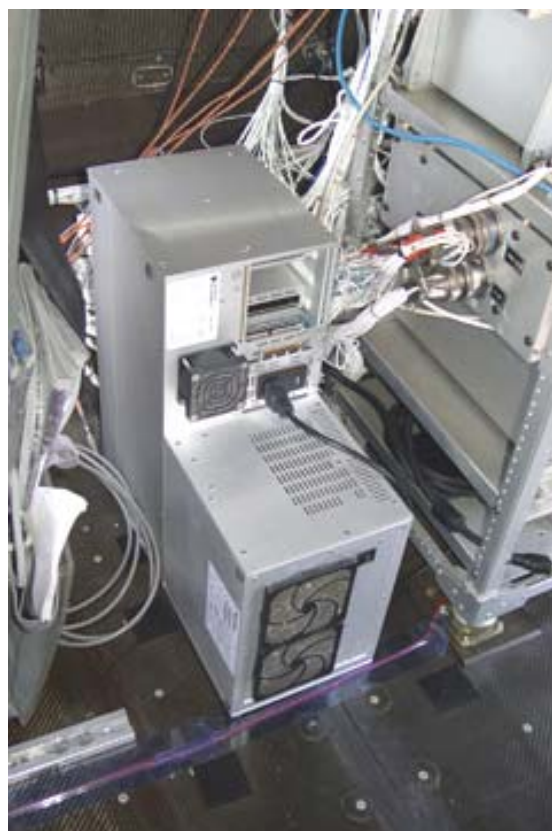
Fig. 3-13 Unit *PXI-1010* at its final location behind the pilot seat.

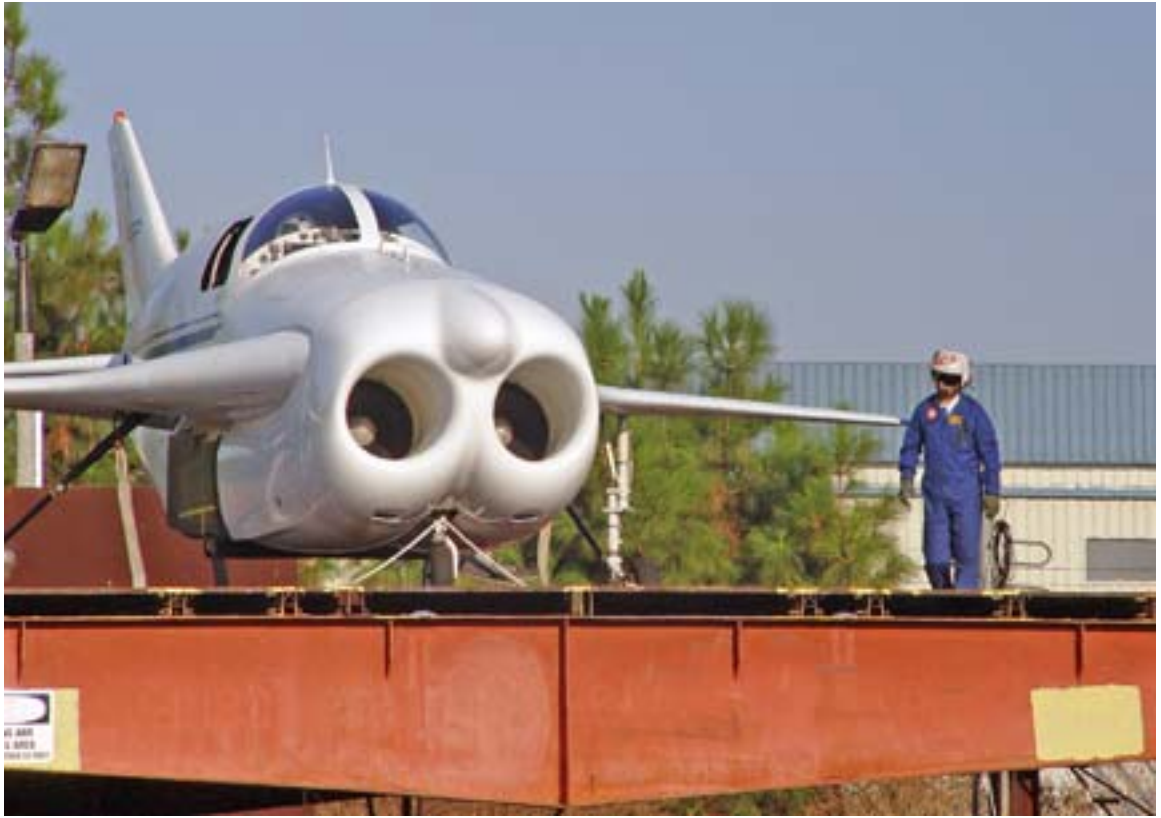
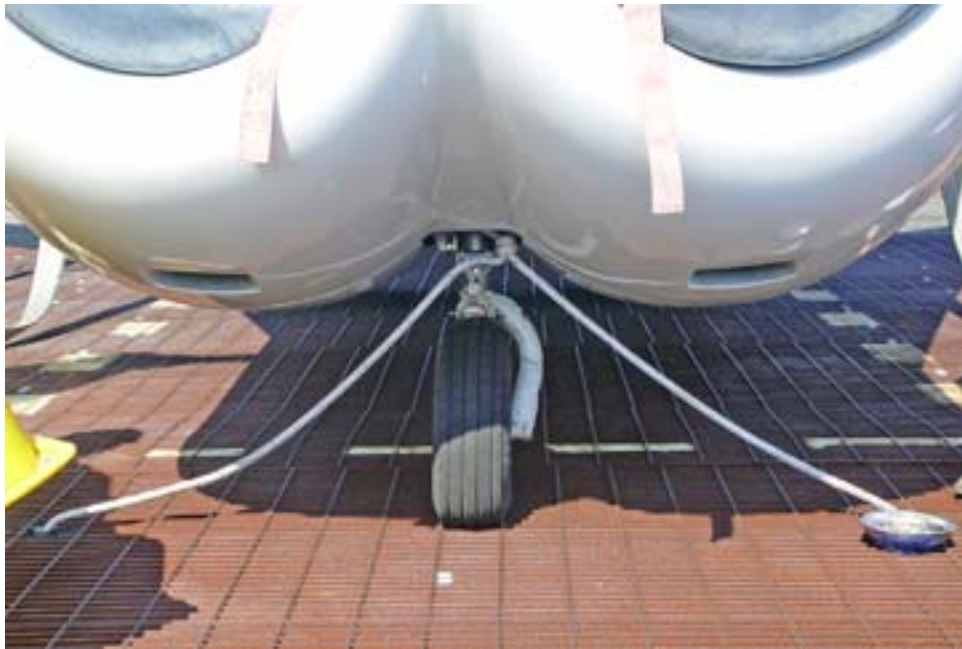
Fig. 4-1 Configuration with deployed bare nose wheel for out-of-the-ground effect tests.

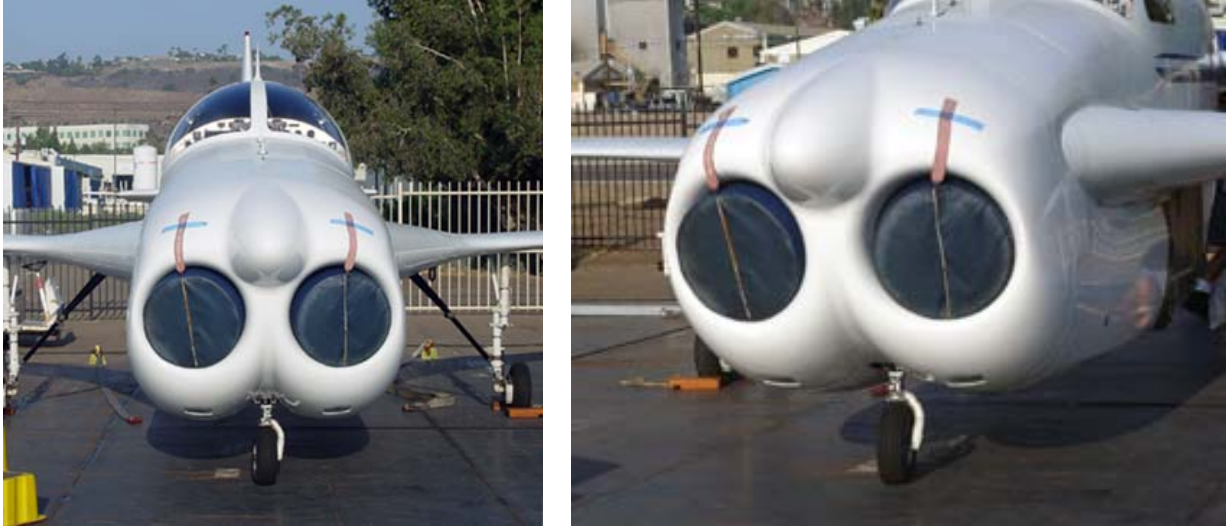
Fig. 4-2 Configuration with deployed bare nose wheel for in ground effect tests.

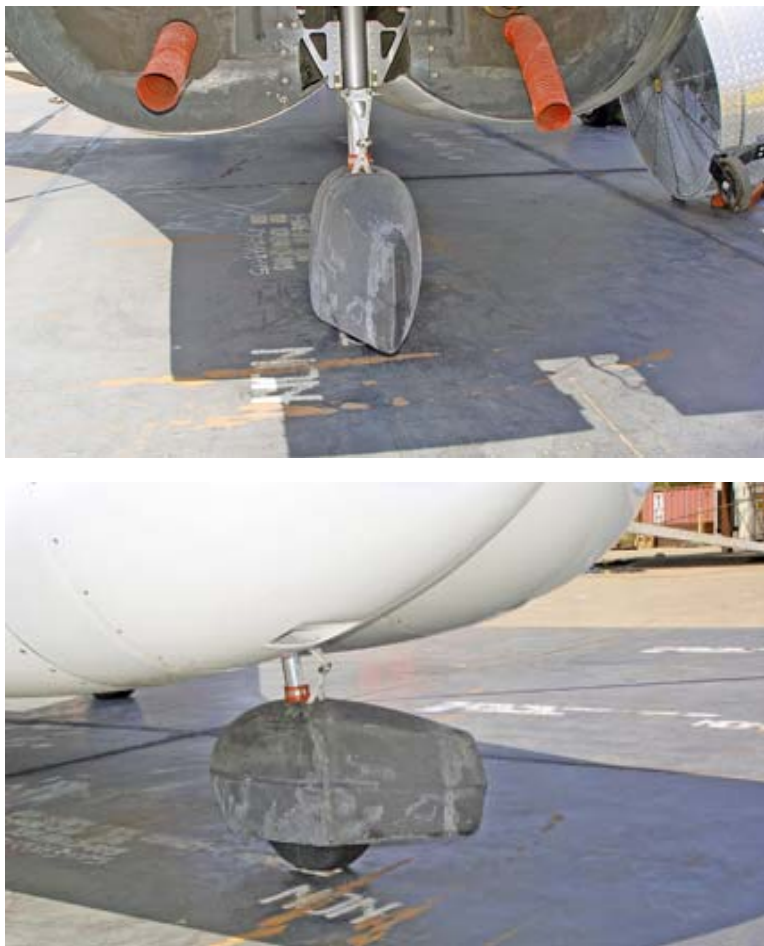
Fig. 4-3 Configuration with deployed faired nose wheel for in ground effect tests.

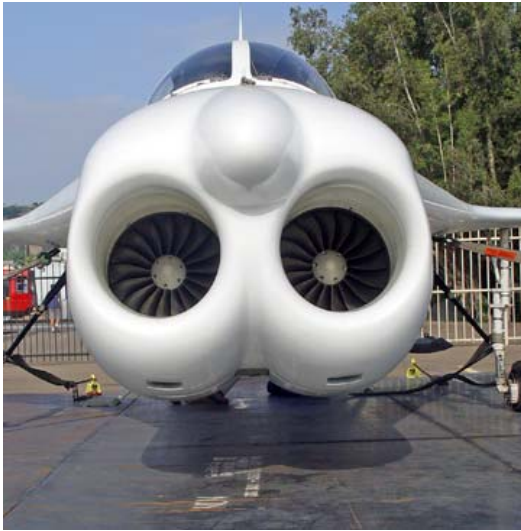
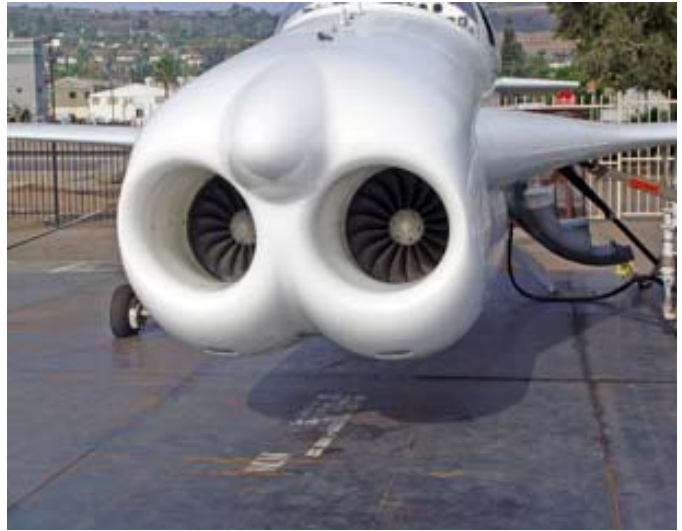
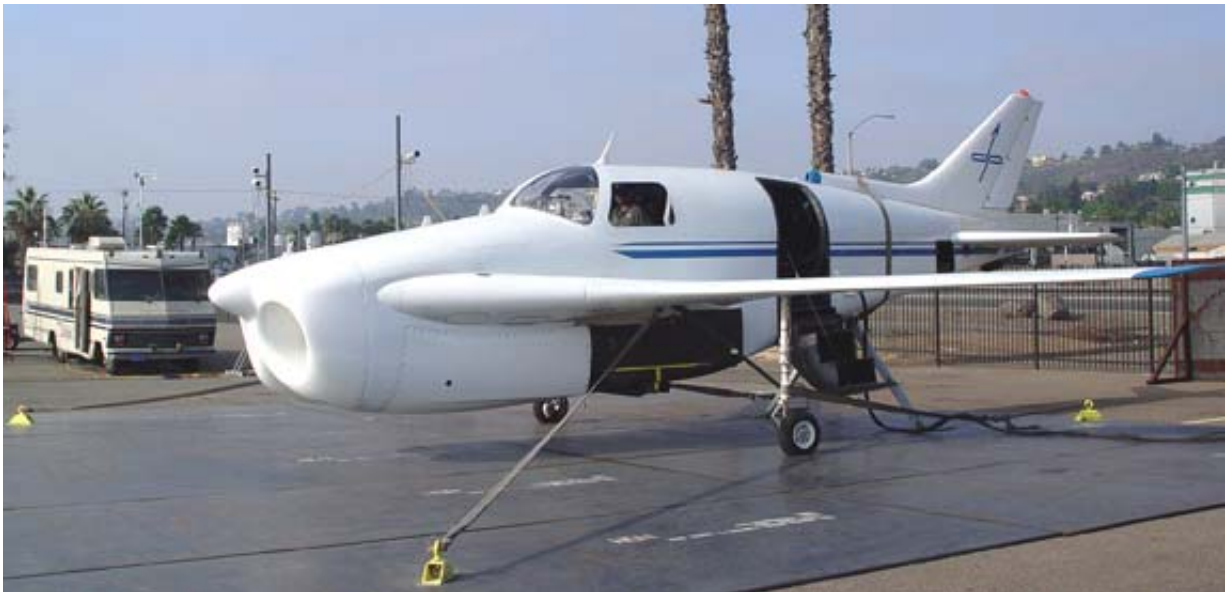
Fig. 4-4 Configuration with removed nose wheel for in ground effect tests.

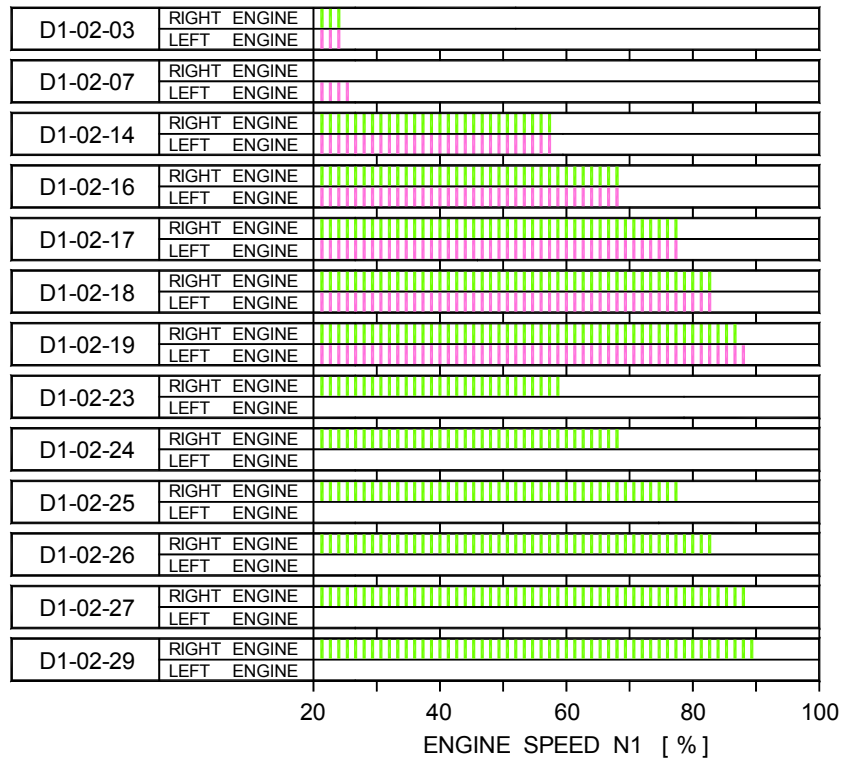
Fig. 4-5 Out-of-the-ground effects -- selected test conditions for deployed bare nose wheel.

A summary of selected test runs carried out during the inlet instability tests is presented in Figs. 4-5 through 4-8. The OGE tests carried out on the raised platform are presented in Fig. 4-5. As seen in this figure, the OGE tests were performed with both engines running simultaneously, as well as for a single engine, left or right, operating. The tests carried out on the ground (IGE) are presented in Fig. 4-6 for the deployed bare nose wheel, in Fig. 4-7 for the deployed faired nose wheel, and finally in Fig. 4-8 for the nose wheel removed.

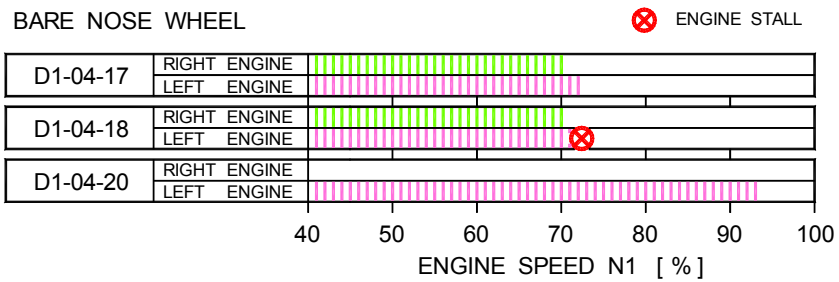
Fig. 4-6 In-ground effects -- selected test conditions for deployed bare nose wheel.

No engine stalls were observed for the OGE conditions. For the IGE conditions, however, several engine stalls were recorded. There is no obvious pattern for engine stalls. From nine recorded engine stalls, seven stalls were experienced for the left engine and two stalls for the right engine. The engine stalls happened for engine speeds between 60% and 82%, with either both engines or a single engine running. Sometimes the engines ran at a higher speed than one for which they stalled in other runs. In one case, two stalls separated only by 300 ms occurred on the same engine. There was no detectable correlation of nose wheel configuration with engine stalling. The entire phenomenon of engine stalls appears to be somewhat random.

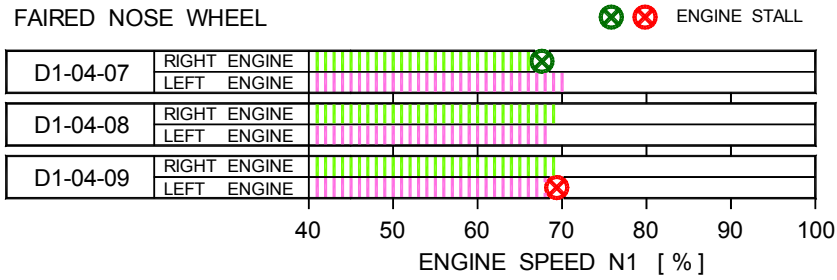
Fig. 4-7 In-ground effects -- selected test conditions for deployed faired nose wheel.

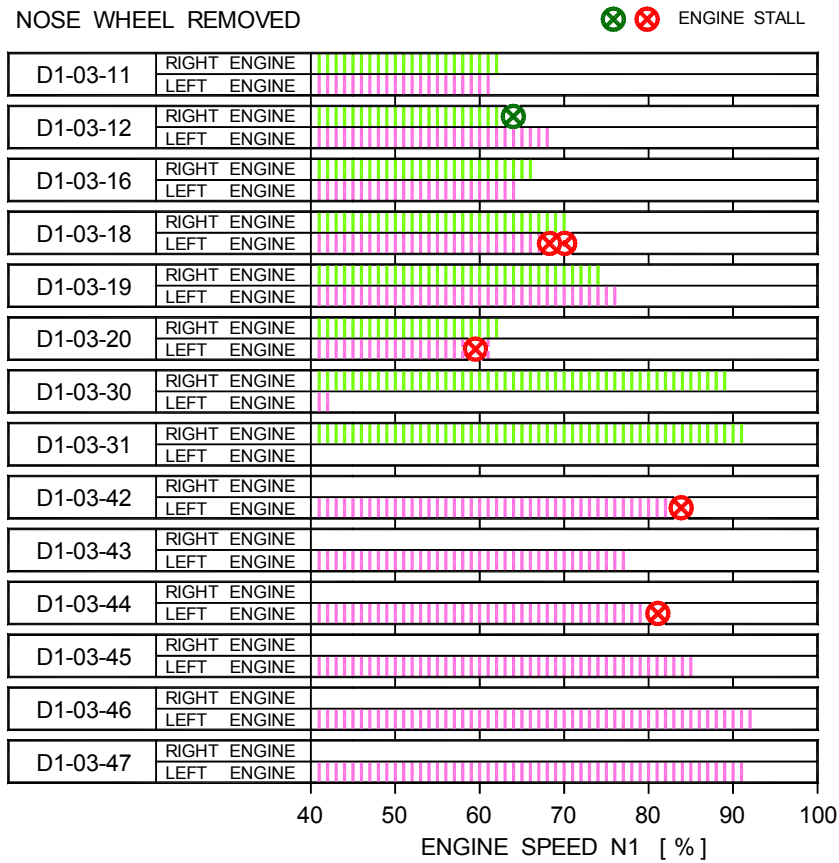
Fig. 4-8 In-ground effects -- selected test conditions for nose wheel removed (retracted).

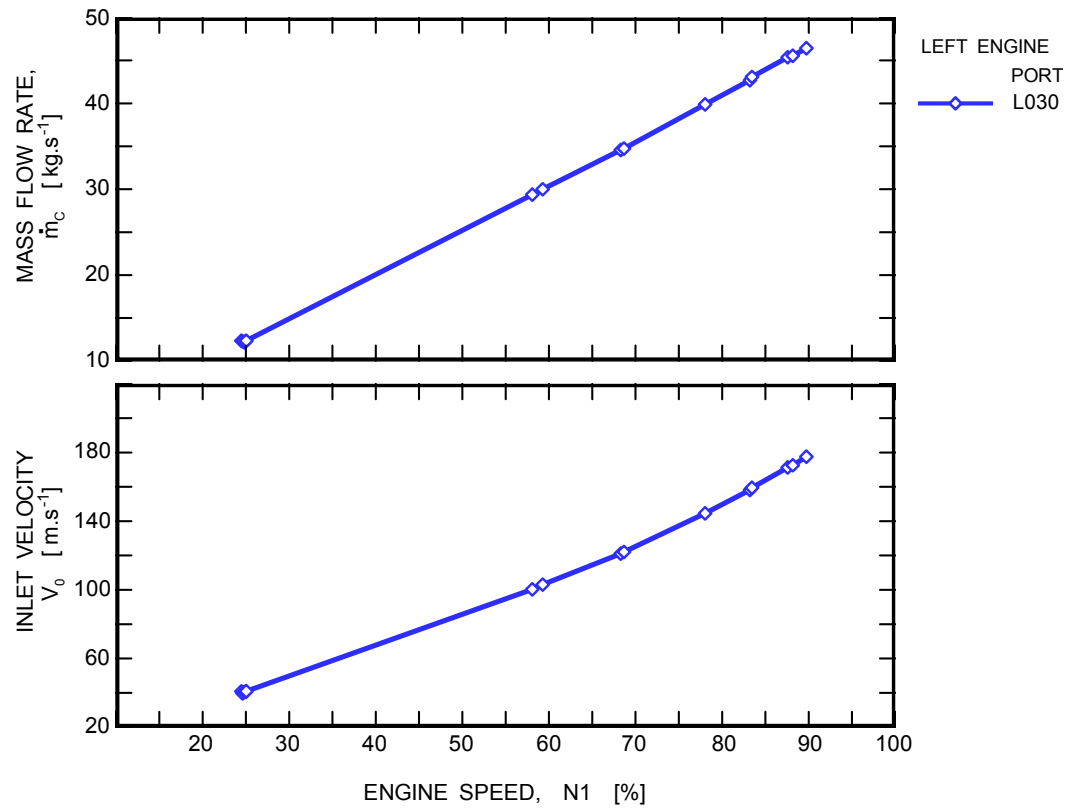
Fig. 5-1 Engine mass flow rate and inlet flow velocity as functions of engine speed.

There were no pop stalls recorded or observed for the out-of-the-ground effects while the both engines were operated up to 90% of the full speed. The unsteady pressure data, recorded at left engine inlet port *L030* were used to estimate the engine mass flow rate and inlet flow velocity as a function of engine speed. These estimates were based on a recorded ambient pressure, temperature, and humidity, and on a static pressure measured at a single port in the engine inlet. Consequently, the effects of possible non-uniform static pressure distribution around the inlet lip are not reflected in these estimated values. Measured engine mass flow rate and inlet flow velocity were corrected for the standard day conditions and are presented in Fig. 5-1. As seen in this figure the maximum corrected engine mass flow rate recorded was 46.3 kg/s for 90% of the engine speed, and the corresponding maximum inlet flow velocity was 198.2 m/s. The engine mass flow rate presented is in all likelihood slightly higher than the actual value, because no boundary layer effects, 'vena contracta', or possible flow separation around the inlet lip were considered here.

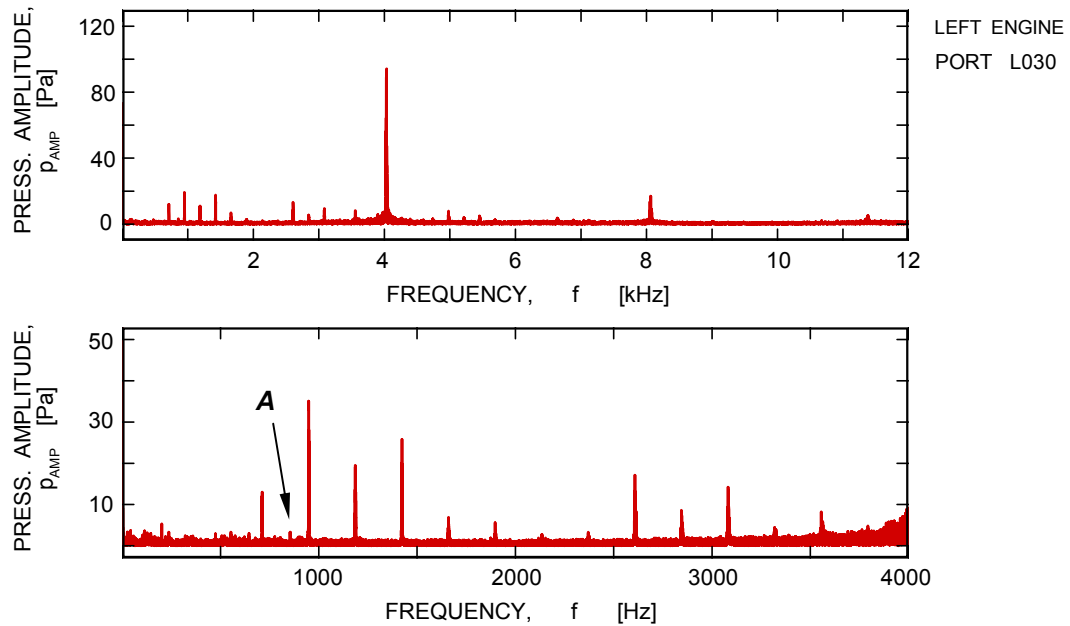
Fig. 5-2 Frequency spectra of pressure fluctuations taken at port *L030* for left engine speed *NI* of 87.5 % (test run *D1_02_19*).

Unsteady pressure spectra for ports *L030* (inlet lip of the left engine) and *R050* (inlet lip of the right engine) are presented in plots in Fig. 5-2 and 5-3. These spectra were generated using data of test run *DI_02_19*. The upper plot in each figure is for the frequency range up to *12 kHz*, whereas the lower plot has a range to *4 kHz* only, which is just up to the first harmonic of the blade passing frequency for the given engine speed. The upper plots clearly show that the pressure oscillations at a frequency of the first and second harmonics of the fan blade passing frequency (BPF) propagate upstream through the entire inlet duct up to the lip. The right engine exhibits pressure oscillations that are a little more intense than those of the left engine. As seen in the lower plots, the harmonics of the rotor shaft frequency (RSF) are stronger for the right engine (Fig. 5-3), in particular the 3rd, 4th, 5th, 12th, 13th, and 16th harmonics. Of course the 17th RSF harmonic is also the 1st BPF harmonic. Asynchronous frequencies, that are not RSF or BPF harmonics, can be detected in pressure spectra of both engine inlets. These frequencies are labeled *A* for the left engine (Fig. 5-2), and *B* or *C* for the right engine (Fig. 5-3).
