NASA/CR—2008-215216

Investigation of Flow Instabilities in the Inlet Ducts of DP-1C VTOL Aircraft

Jan Lepicovsky
ASRC Aerospace Corporation, Cleveland, Ohio

June 2008

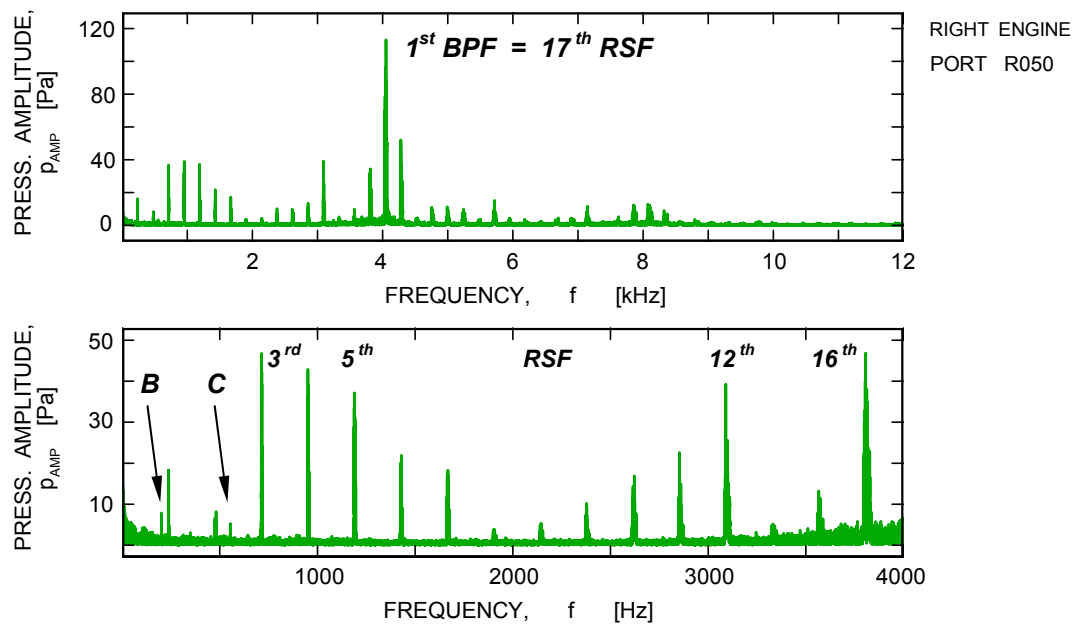
Fig. 5-3 Frequency spectra of pressure fluctuations taken at port *R050* for right engine speed *NI* of 87.9 % (test run *D1_02_19*).

Unsteady pressure spectra for ports *L030* (inlet lip of the left engine) and *R050* (inlet lip of the right engine) are presented in plots in Fig. 5-2 and 5-3. These spectra were generated using data of test run *DI_02_19*. The upper plot in each figure is for the frequency range up to *12 kHz*, whereas the lower plot has a range to *4 kHz* only, which is just up to the first harmonic of the blade passing frequency for the given engine speed. The upper plots clearly show that the pressure oscillations at a frequency of the first and second harmonics of the fan blade passing frequency (BPF) propagate upstream through the entire inlet duct up to the lip. The right engine exhibits pressure oscillations that are a little more intense than those of the left engine. As seen in the lower plots, the harmonics of the rotor shaft frequency (RSF) are stronger for the right engine (Fig. 5-3), in particular the 3rd, 4th, 5th, 12th, 13th, and 16th harmonics. Of course the 17th RSF harmonic is also the 1st BPF harmonic. Asynchronous frequencies, that are not RSF or BPF harmonics, can be detected in pressure spectra of both engine inlets. These frequencies are labeled *A* for the left engine (Fig. 5-2), and *B* or *C* for the right engine (Fig. 5-3).

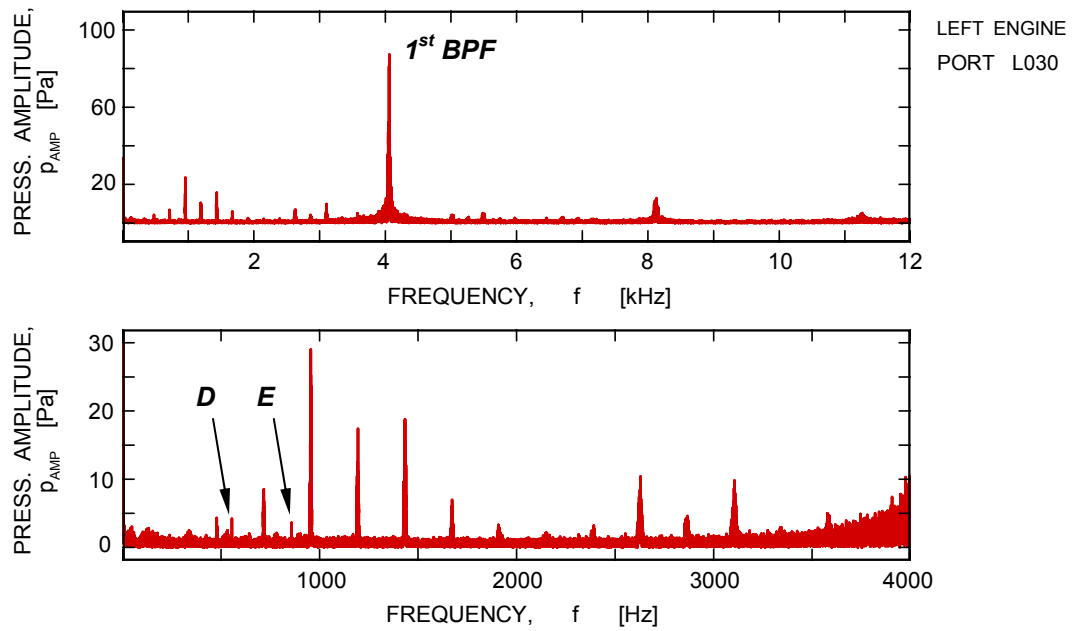
Fig. 5-4 Frequency spectra of pressure fluctuations taken at port *L030* for left engine speed *NI* of 88.2 % (test run *D1_02_27*).

Spectra for three sensors located along the length of the left engine inlet duct (Ports *L030*, *L035*, and *L039*) are presented in Figs. 5-4 through 5-6. These spectra were generated for test run *DI_02_27*. On comparing the upper plots in these figures, it is obvious that the amplitude of the blade passing frequency (1st BPF) oscillations increases significantly closer to the engine fan face. The amplitude increases from *90 Pa* at the inlet lip (Port *L030*, Fig. 5-4) up to *420 Pa* just in front of the engine fan (Port *L039*, Fig. 5-6). Contrary to it, the RSF harmonics below the blade passing frequency, presented in lower plots, maintain more or less the same amplitudes. Amplitudes of asynchronous frequencies, labeled *D* and *E*, increase slightly closer to the engine fan. The origin of these asynchronous frequencies is not clear; their amplitudes are less than *10 Pa*. Flow or pressure disturbances of such small amplitude will not, for sure, instigate any engine instability, as is manifested by the smooth engine operation under the OGE conditions up to the full engine speed.

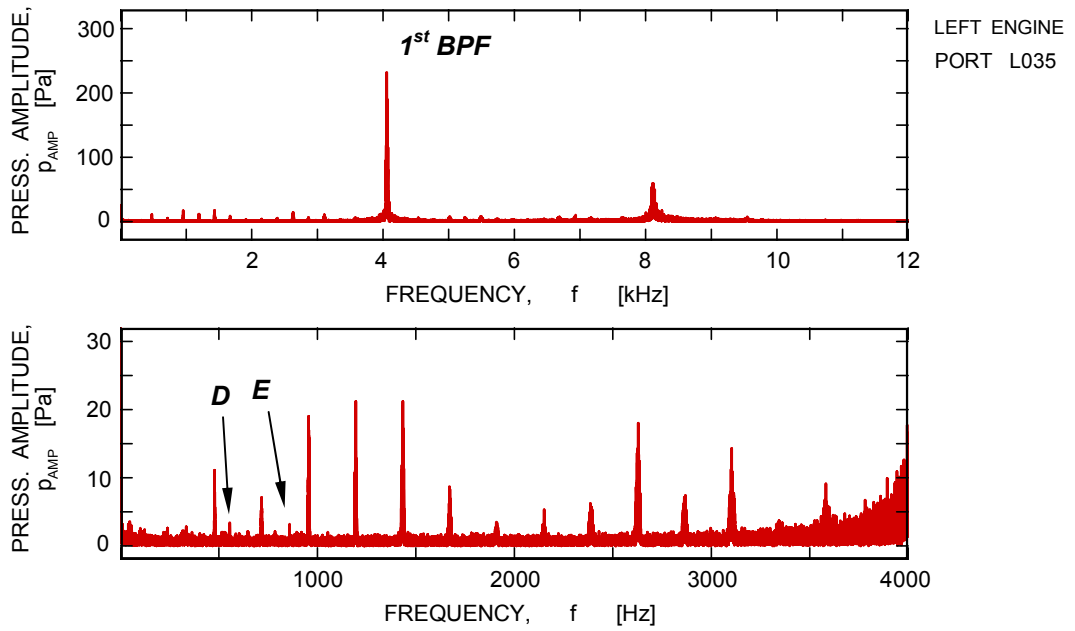
Fig. 5-5 Frequency spectra of pressure fluctuations taken at port *L035* for left engine speed *NI* of 88.2 % (test run *D1_02_27*).

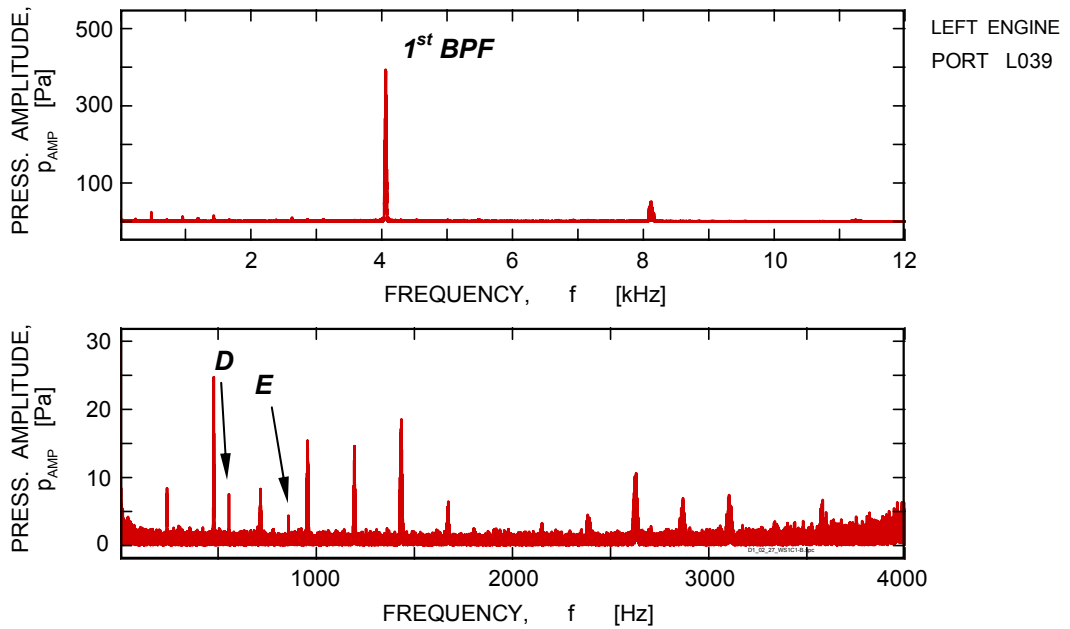
Fig. 5-6 Frequency spectra of pressure fluctuations taken at port *L039* for left engine speed *NI* of 88.2 % (test run *D1_02_27*).

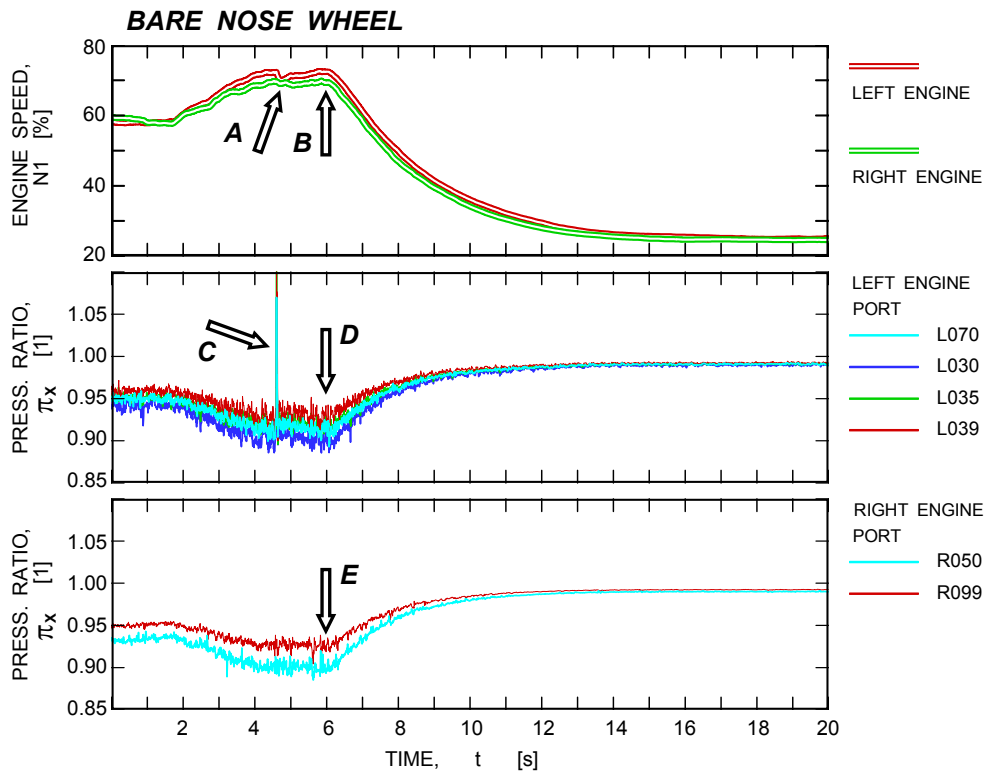
Fig. 6-1 Engine stall test D1-04-18; entire recorded segment of 20 s.

In order to better understand the time sequence of pressure changes during an engine stall, test run *D1-04-18* will be explored in detail. The entire 20 s long run is depicted in Fig. 6-1. The plots show the history of speeds of both engines (the upper plot), the associated history of pressure changes recorded by four pressure transducers in the left inlet duct (the middle plot), and finally two pressure traces recorded in the right inlet duct. Locations of pressure transducer modules in both inlet ducts were presented in Fig. 3-2.

As seen in Fig. 6-1, both engines accelerated from about 60% to 70% speed, the left engine (red curve) being slightly faster. At about 72% speed, the left engine stalled (small dip in the red speed curve, arrow *A*), while the right engine was running smoothly. Approximately 1.5 seconds after the engine stall the pilot throttled back both engines (arrow *B*), and the engines decelerated to 25% speed. As seen in the middle plot, wall pressures in the left inlet duct were initially decreasing at the beginning of the record as the engine accelerated, and then a sudden pressure spike (arrow *C*) appeared indicating the engine stall. Wall pressure traces in the right inlet duct (the bottom plot) do not exhibit a pressure spike, which indicates no stalling of the right engine. After the engines were throttled down (arrows *D* and *E*), the wall pressures in both inlet ducts increased to nearly an ambient pressure level. Pressure levels measured close to the fan face (ports *L039* and *R099*) are slightly higher than pressure levels at the inlet lips (ports *L030* and *R050*) due to a mild diffusion of the inlet ducts.

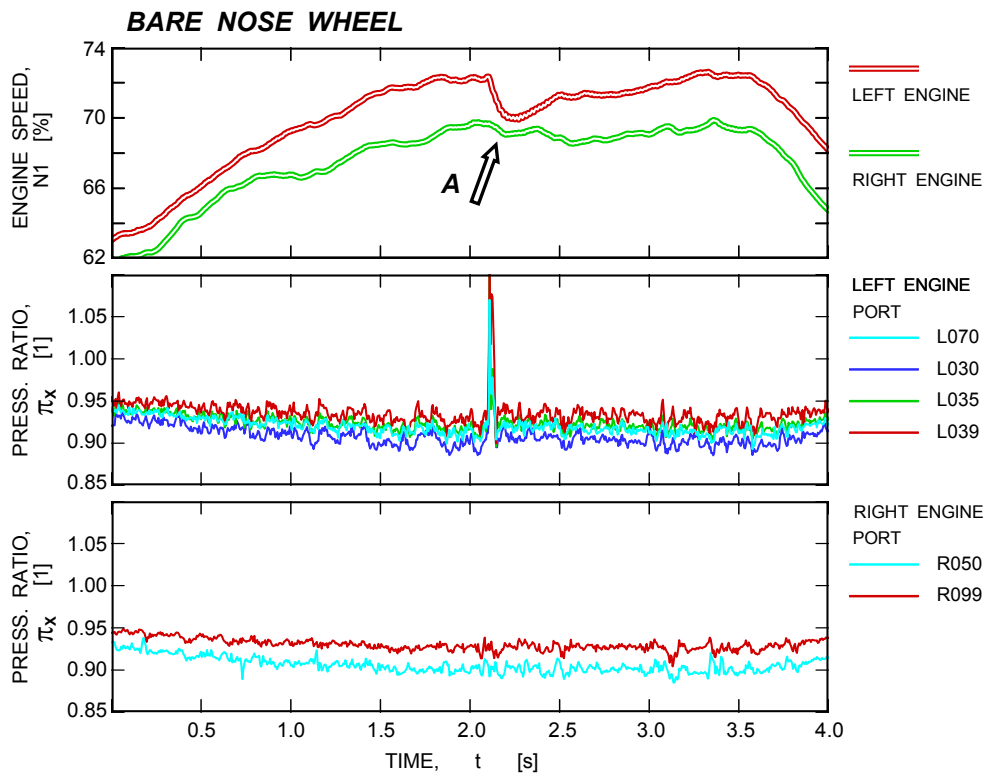
Fig. 6-2 Engine stall test D1-04-18; plotted time interval of 4 s.

To improve the time resolution and readability of the plots, the data are replotted for a smaller time interval centered about the pressure stall spike. First the time interval was reduced to 4 s, as shown in Fig. 6-2, and also the scale of fan revolutions was refined. A sudden drop in the speed of the left engine is now clearly visible (arrow *A*, red line). The fan velocity reaches its local minimum in about 0.2 s from the instant of the stall start, then the speed increases rapidly for about 0.3 s, and finally after additional 0.7 s the fan speed is back at its prestall level.

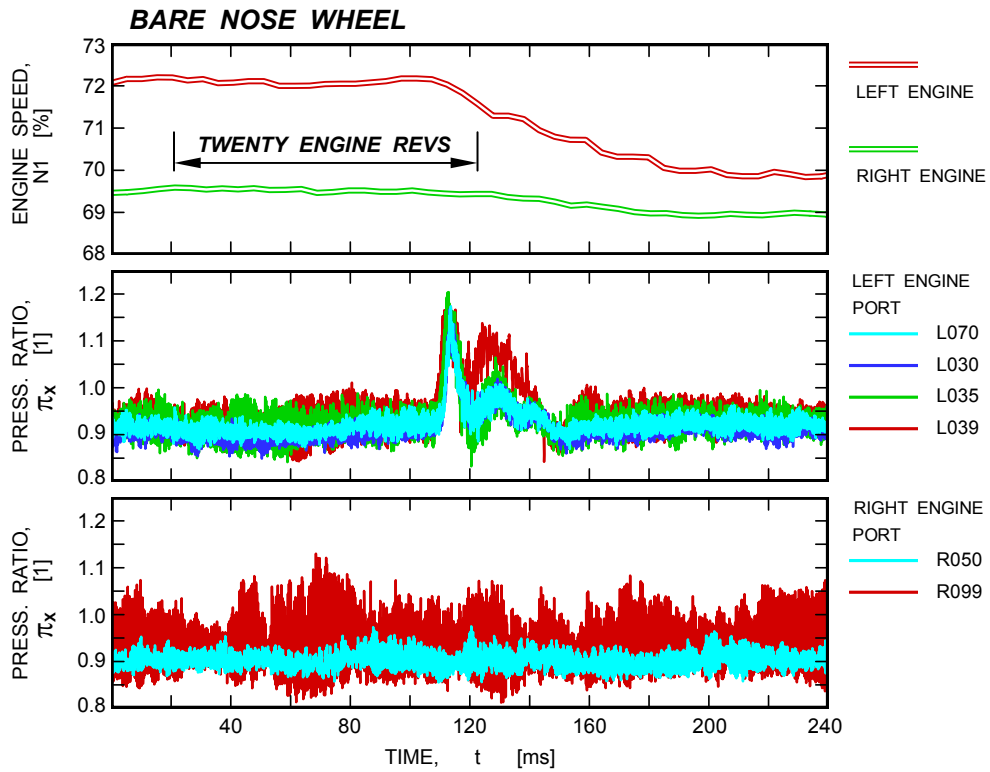
Fig. 6-3 Engine stall test *D1-04-18*; plotted time interval of 240 ms; unfiltered pressure data.

The time resolution was further increased to observe the changes in pressure signals. Figs. 6-3 and 6-4 depict time interval of 240 ms. The period of one engine revolution for the 70% speed is about 5.4 ms, which means that the plots depict an interval of 44 engine revolutions. Engine revolution averaging, as described above, is still suitable for engine speed graphs because of the relatively slow changes in the engine speed. However, in the case of pressure data such averaging may suppress important details in the fast changes of pressure fluctuations. Therefore, the pressure data in Fig. 6-3 is plotted as acquired. As seen in this figure, the pressure traces are very wide now, due to the fluctuations generated by fan blades. The width or ‘fuzziness’ of the traces is a measure of signal unsteadiness. For the left engine, the traces from all pressure transducers are of the same width. For the right engine, however, the situation is different. The signal measured in front of the fan (port *R099*) exhibits much higher unsteadiness than the one taken at the inlet lip (port *R050*). As stated earlier, the pressure transducer module plugged into port *R099* (*WS3A1*) was designed for a higher frequency

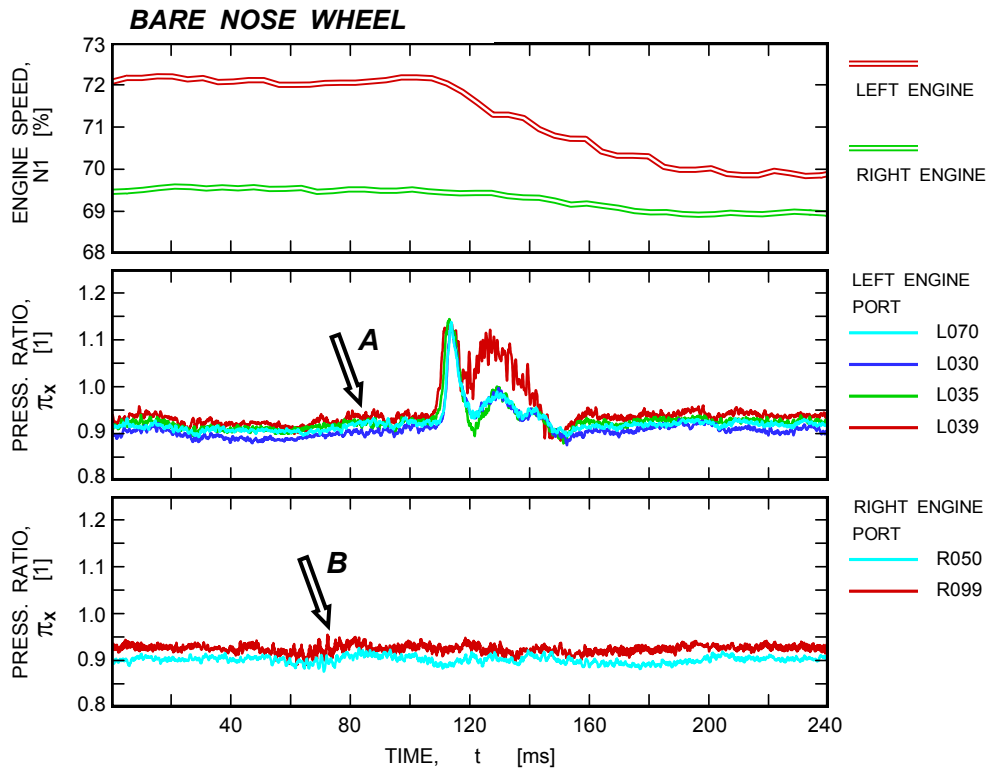
Fig. 6-4 Engine stall test *D1-04-18*; plotted time interval of 240 ms; filtered pressure data $f_{LP} = 1000$ Hz.

response than the rest of the modules, and thus it captures a wider spectrum of pressure fluctuations. To improve the graph readability, the pressure signals were filtered with a low pass filter with a cut-off frequency of 1000 Hz . A low pass filter removes high frequency fluctuations from a signal, but also introduces a certain small time delay. Because all the pressure data presented were filtered with the same cut-off filter, the time delay is identical for all the signals. Consequently, the mutual time relation among all pressure signals is not affected by filtering. Filtered data are presented in Fig. 6-4, where the individual pressure traces can be easily observed. There is no visible disturbance in pressure data of the left engine ahead of the engine stall (arrow *A*). There is an increased level of unsteadiness on the right engine pressure signals (arrow *B*), about 40 ms ahead of the left engine stall. It is not clear, however, if this had anything to do with the left engine stalling.

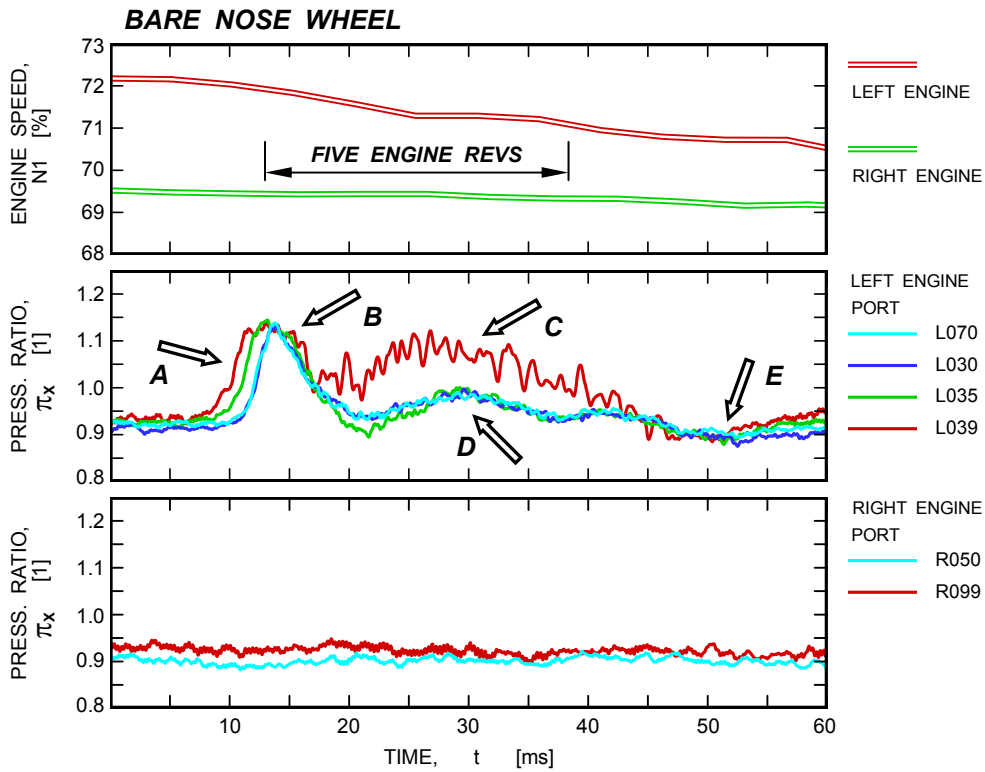
Fig. 6-5 Engine stall test *D1-04-18*; plotted time interval of 60 ms; filtered pressure data $f_{LP} = 1000$ Hz.

A sequence of pressure changes in the inlet duct can be detected in Fig. 6-5. The interval depicted in this plot is reduced to 60 ms . It is difficult to reconstruct the flow behavior based solely on the wall static pressure data (total pressure or velocity data would have been more definitive); nevertheless, the following scenario is most probable. Ahead of the pressure surge the pressure level in front of the fan is slightly higher than that at the inlet lip which indicates undisturbed flow through a mildly diffusing inlet duct (red line versus blue line). Once the engine stalls, a pressure burst (arrow *A*) propagates from the fan face (port *L039*, red line) through the inlet duct (port *L035*, green line) towards the inlet lip (ports *L030* and *L070*, dark and light blue lines). The pressure level in the entire duct increases significantly, and then for a short period the flow in the inlet duct stops (all pressures in the inlet duct are equal). While there is a little flow in the inlet duct, the pressure level in the entire duct is uniformly dropping (arrow *B*). After that, the pressure level at the fan face increases again (arrow *C*), whereas the pressures at the inlet lip and mid channel are more or less steady (disregarding small very low frequency oscillations), and close to the ambient pressure level (arrow *D*). Such a static pressure distribution may indicate reverse flow in the inlet duct, which lasts for about 30 ms (approximately 6 engine revolutions). Finally, the flow stops again (all pressures in the inlet duct are equal), and inflow in the fan starts again (arrow *E*) as the engine resumes normal operation.

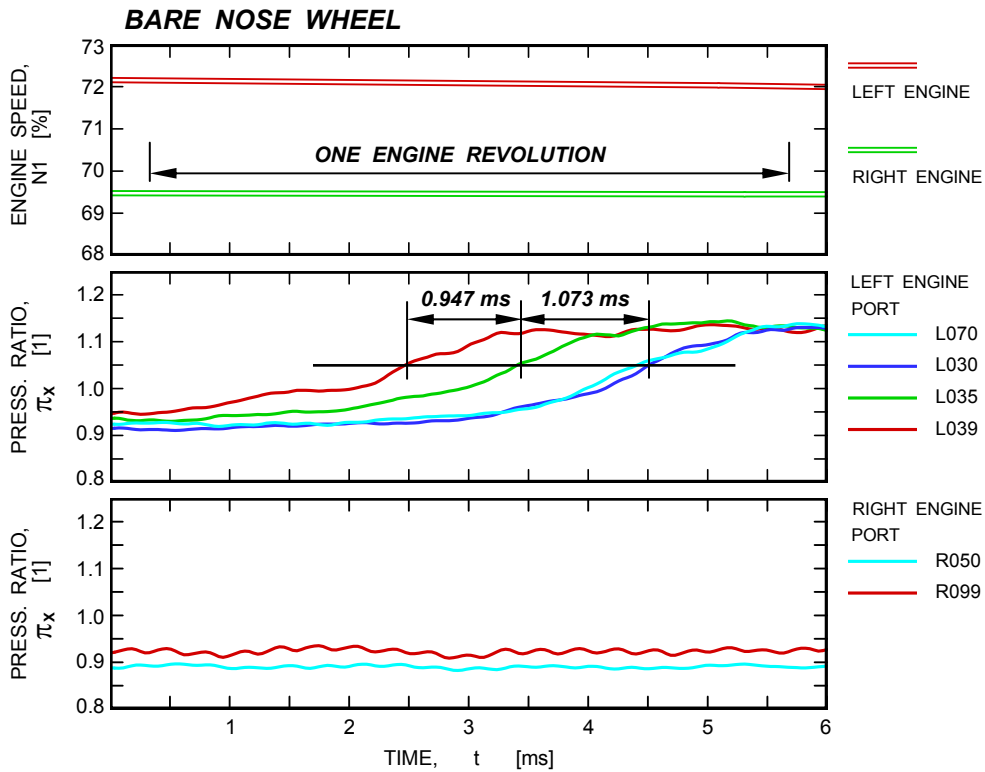
Fig. 6-6 Engine stall test *D1-04-18*; plotted time interval of 6 ms; filtered pressure data $f_{LP} = 1000$ Hz.

The propagation speed of the pressure burst can be determined reliably by measuring the time interval for the pressure burst to travel from one measurement port to another. As indicated in Fig. 6-6, the pressure burst for a pressure level of $\pi_x = 1.05$ spreads from port *L039* to port *L035* in 0.947 ms , and it takes an additional 1.073 ms for the burst to reach port *L030*. The average propagation velocity of the pressure burst is 289.2 m/s (948.8 fps). This is a propagation velocity relative to the inlet surface, not relative to the incoming flow; of course, a pressure disturbance propagates in air with the speed of sound, which in the case of test *DI_04_18* was about 349 m/s , based on the measured total (ambient) temperature of 303 K . The measured speed of the pressure burst relative to the inlet walls was 289 m/s , which implies that the air inlet velocity could not be higher than 60 m/s . In the case of the OGE operation (Fig. 5.1) the inlet flow velocity was about 135 m/s at the relative engine speed of 72%. Obviously, the pop stall occurrence must decrease the inlet flow velocity significantly.

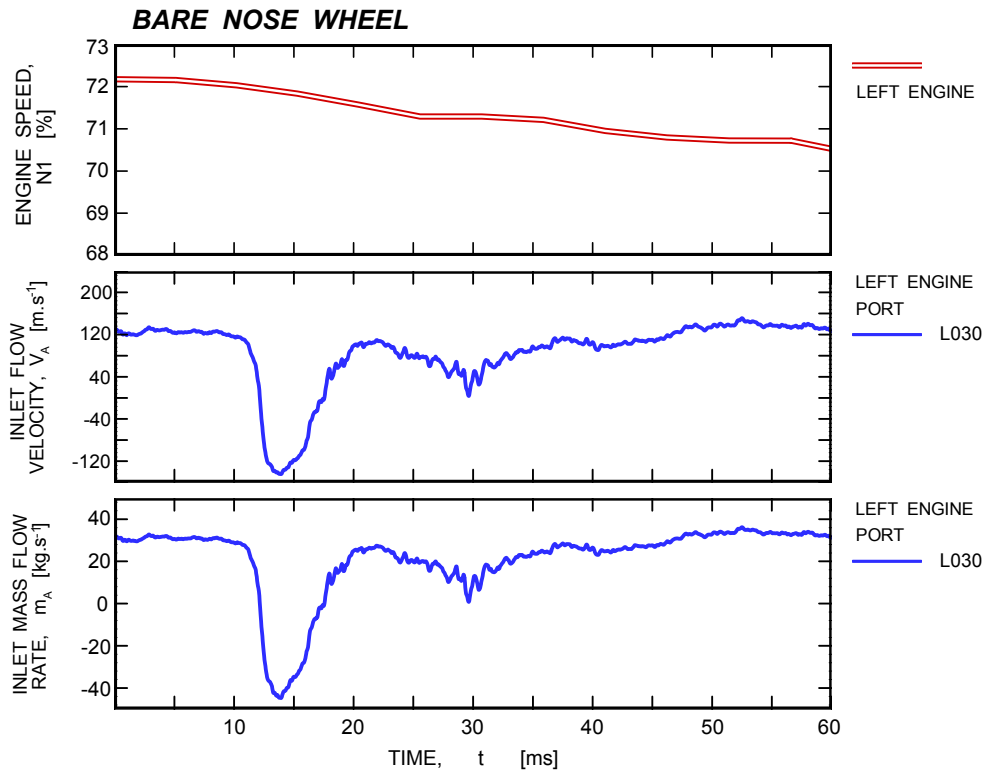
Fig. 6-7. Mass flow rate and inlet velocity variations during engine stall test D1-04-18; filtered data $f_{LP} = 1000$ Hz.

Variations of the inlet flow velocity for the pop stall occurrence were calculated using a wall pressure signal detected at port *L030*, and the measured ambient (total) conditions. A procedure similar to that used to determine the engine mass flow rate for the OGE tests (Fig. 5.1) was employed again, this time however for the unsteady static pressure input. Results of these calculations are presented in Fig. 6-7. As seen here, the inlet flow velocity, and consequently also the engine mass flow rate, drops to zero or even to very low negative values, for a short period of about *5 ms*, just after the pressure burst reaches the inlet duct lip. During *2 ms* of this rapid inlet velocity deceleration from about *130 m/s* to zero was an instant when the inlet velocity passed the level of *60 m/s*, which most likely was the instant for which the burst propagation velocity of *289 m/s* was determined. Results presented in Fig. 6.7 correlate very well with the description of inlet flow behavior, which was based on pressure changes depicted in Fig. 6-6, and was described above.

Values of the mass flow rate and inlet velocity during the instant of the pop stall back flow appear to be extremely high; however, it all happens in a very short time interval. The design pressure ratio of the PWC 535A engine is about *1.84*, thus there is a sufficient pressure buildup behind the fan rotor to drive the flow back once the fan is stalled. Also, the back flow through the inlet duct lasts for only about *5 ms*, and during that period the accumulated air mass pushed back through the inlet is less than *0.15 kg*.

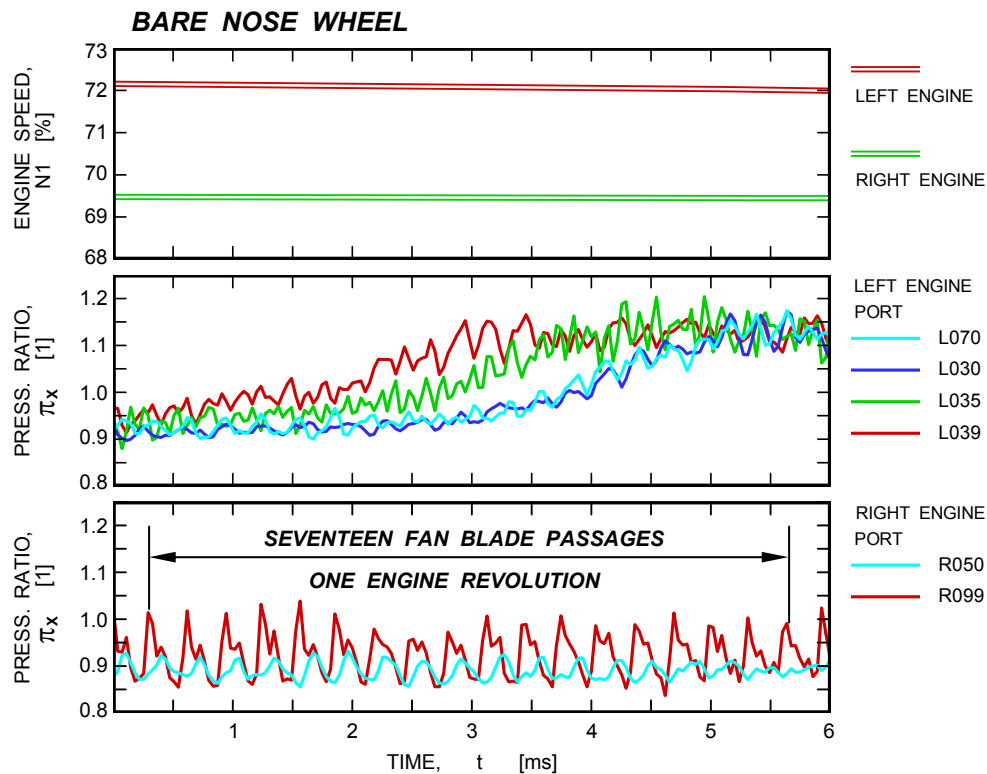
Fig. 6-8 Engine stall test D1-04-18; plotted time interval of 6 ms; unfiltered pressure data.

Finally, the shortest segment of data (*6 ms*) presented in Fig 6-6 is shown once again in Fig. 6-8; however, this time unfiltered data are shown. As seen in this figure, in particular in the data for the right engine, the data acquisition setup has a sufficiently high sampling frequency to distinguish blade potential flow fluctuations ahead of the engine fan. As marked in this figure, effects of all *17* blades are clearly captured during one fan revolution. It is worthwhile to note that the fan blade potential flow fluctuations can be detected as far as at the inlet lip (port *R050*).

even for several seconds of data ahead of the stall (e.g. Figs. 6-8 and 6-10). It appears that the inlet disturbance which leads to engine stalls is not manifested by changes in the wall static pressure distribution of the inlet flow. Also, it should be mentioned that stalls of both engines at the same time were never recorded.

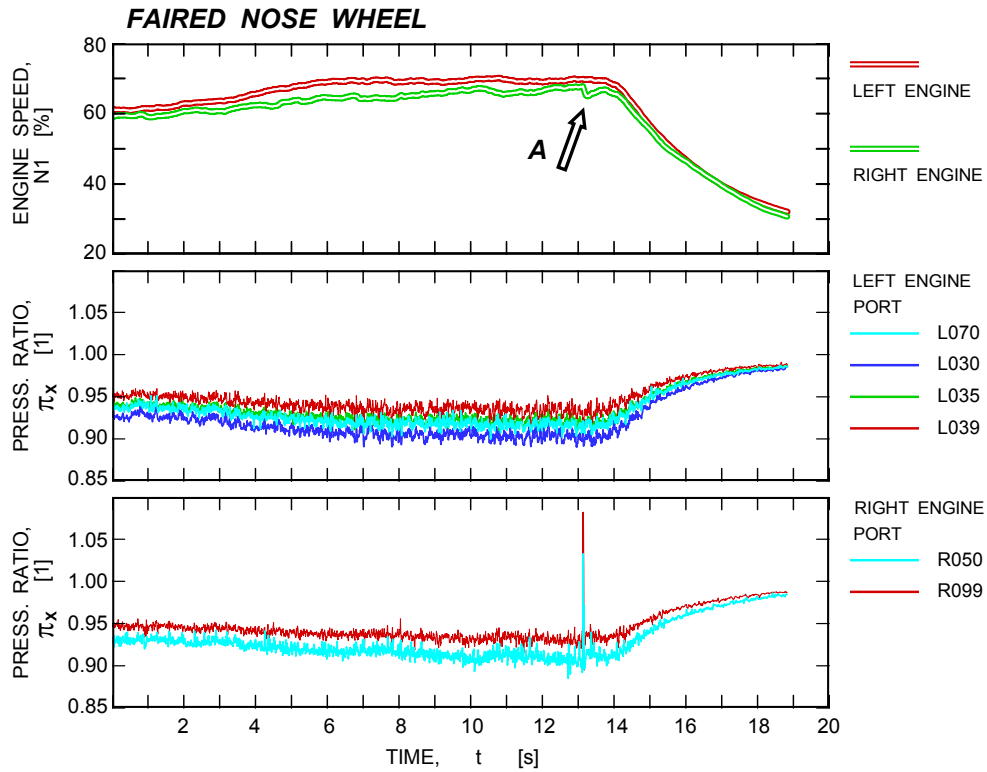
Fig. 6-9 Engine stall test *D1-04-07*; entire recorded segment of 18 s.

Two out of the nine recorded engine stalls occurred on the right engine. One of these stalls, which occurred for the configuration with the faired nose wheel, is depicted in Figs. 6-9 and 6-10. Basically, there is no visible difference in the right engine response to an inlet disturbance compared to the left engine response. Engine stall was manifested by a rapid drop in the engine revolution level (arrow *A* in Fig. 6-9), followed by a recovery to normal operation conditions. As in all previous cases this recovery was interrupted by throttling the engines. The right engine stall is replotted on a finer time scale in Fig. 6-10. The pressure trace recorded at the inlet port close to the fan face (port *R099*) exhibits higher instabilities than was the case for a similar port on the left inlet (port *L039*). The reason for it is the wider frequency range of the *WS3A1* pressure module as discussed earlier.

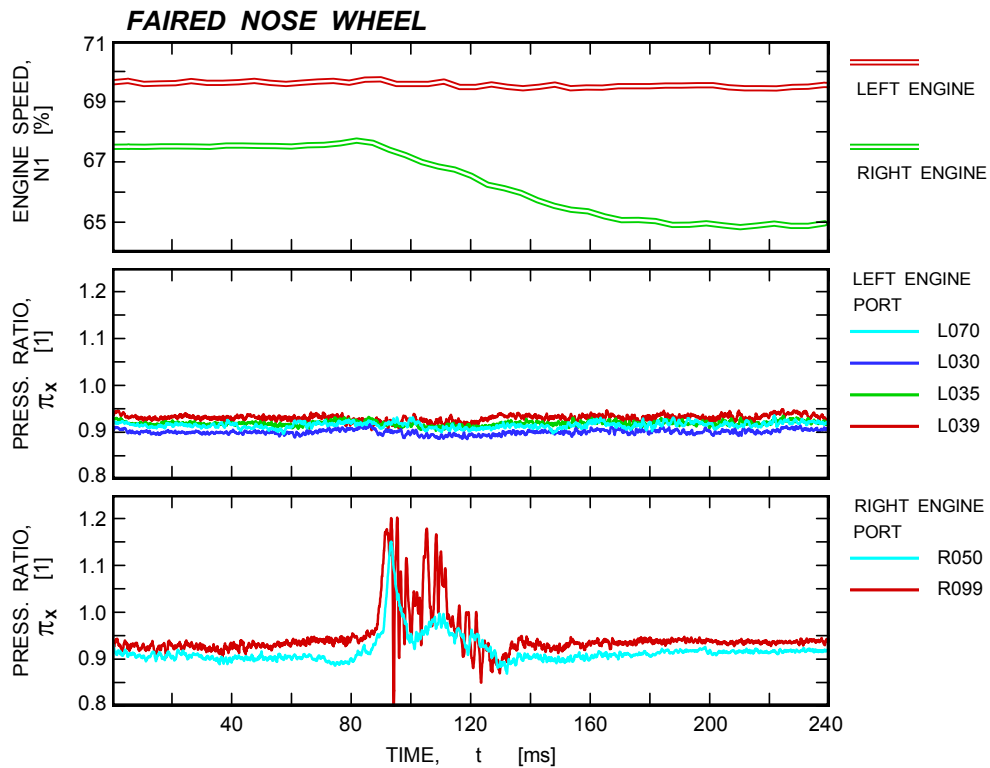
Fig. 6-10 Engine stall test *D1-04-07*; plotted time interval of 240 ms; filtered pressure data $f_{LP} = 1000$ Hz.

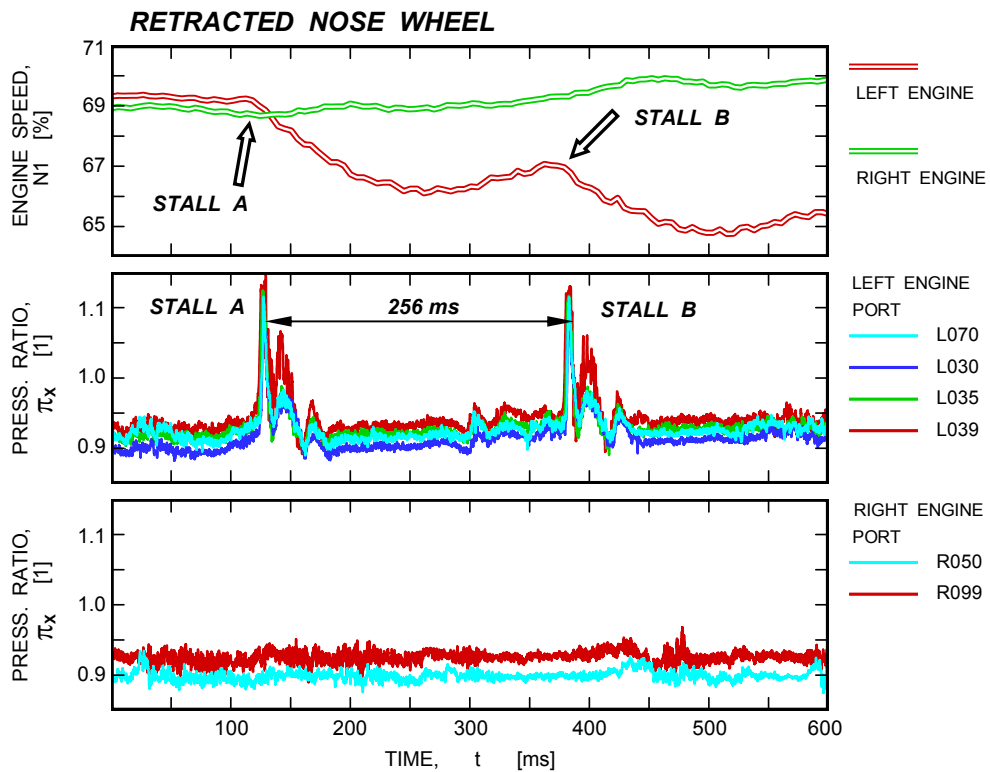
Fig. 6-12 Engine stall test *D1-03-18*; plotted time interval of 600 ms; unfiltered pressure data.

An extremely interesting data set was recorded for the configuration with the nose wheel retracted (record *DI-03-18*). During this test run, two pop stalls were recorded as presented in Fig. 6-11 (arrows *A* and *B*). The left engine stalled twice in a row, with only *256 ms* separating the stalls, as depicted in Fig. 6-12. The stall pressure bursts are labeled *Stall A* and *Stall B* for later identification. Surprisingly, *Stall B* occurred during the recovery phase of *Stall A* at visibly lower engine speed than the one at the *Stall A* instant. This may indicate that engine stalls are not set off by continuous or a long time scale event, but by some sudden intermittent disturbance in the inlet flow. If, for example, the engine stall is set off by a ground vortex intrusion in the inlet, then in this case the pressure burst and outflow from the inlet generated by *Stall A* did not blow the ground vortex away from the inlet, but the vortex returned back in the inlet, set the *Stall B*, and then finally was blown away by the burst generated by *Stall B*. It appears that after *Stall B*, the engine was recovering to normal operation, but was terminated by throttling both engines (arrow *C* in Fig. 6-11).

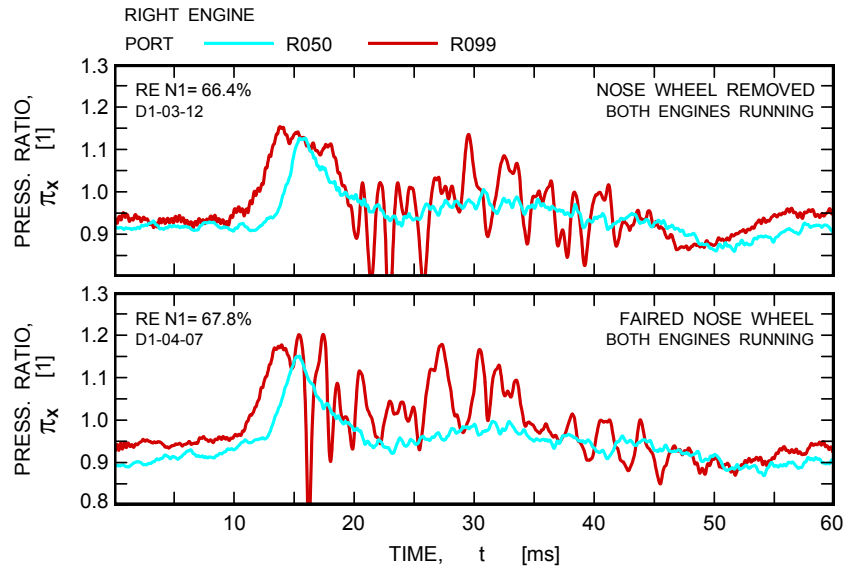
Fig. 7-2 Selected test conditions of right engine stalls.

In-the-ground effect test runs for all three nose wheel configurations for which engine stalls were recorded are summarized in Figs. 7-1 and 7-2 for the left engine and for the right engine, respectively. Segments of data *60 ms* long were chosen for this comparison. The charts in these figures are arranged in an increasing order of the stall engine speed, regardless of nose wheel configuration. The nose wheel configuration is marked in each chart. Also, the test run labels are given in each chart which allows a quick cross reference to the summary of test runs presented in Figs 4-6 through 4-8. Viewing the charts in Figs 7-1 and 7-2 clearly indicates that the nose wheel configuration has little or no effect on the engine stall response and its effect on the inlet flowfield fluctuations. The character of the inlet flowfield is basically the same for all the data sets presented, except that the intensity of the pressure fluctuations increases with increasing engine speed at which the stall occurred. As seen in the lowest two charts in Fig. 7-1 (left engine running alone and stalling at *80%* speed and higher), the intense pressure fluctuations detected in front of the fan face (port *L039*, red line) spread upstream even beyond the mid point of the inlet duct (port *L035*, green line). A rough estimate of the period of these fluctuations and its ratio to the engine revolution period indicates that these fluctuations are probably generated by a rotating stall cell on the fan rotor. For example, for the left engine at *82.7%* speed (*DI-03-42*), the ratio of periods is *45%*, and for the right engine at *67.8%* speed (*DI-04-07*), the ratio is *28%*. These values are within a commonly accepted range of rotating stall cell speed to engine shaft speed ratio of *25%* to *60%*.

An important fact to be noticed in these figures is that there is no detected instability in the inlet duct wall static pressures prior to the arrival of pressure bursts caused by to engine stalls. It is true that only *10 ms* of data (about two engine revolutions) are shown ahead of the burst, but no static pressure instability was observed
