## **RSRM Segment Train Derailment and Recovery**

Robert H. Taylor Jr., Paul K. McConnaughey, David E. Beaman and Dennis R. Moore  
Marshall Space Flight Center  
Huntsville AL

### **ABSTRACT**

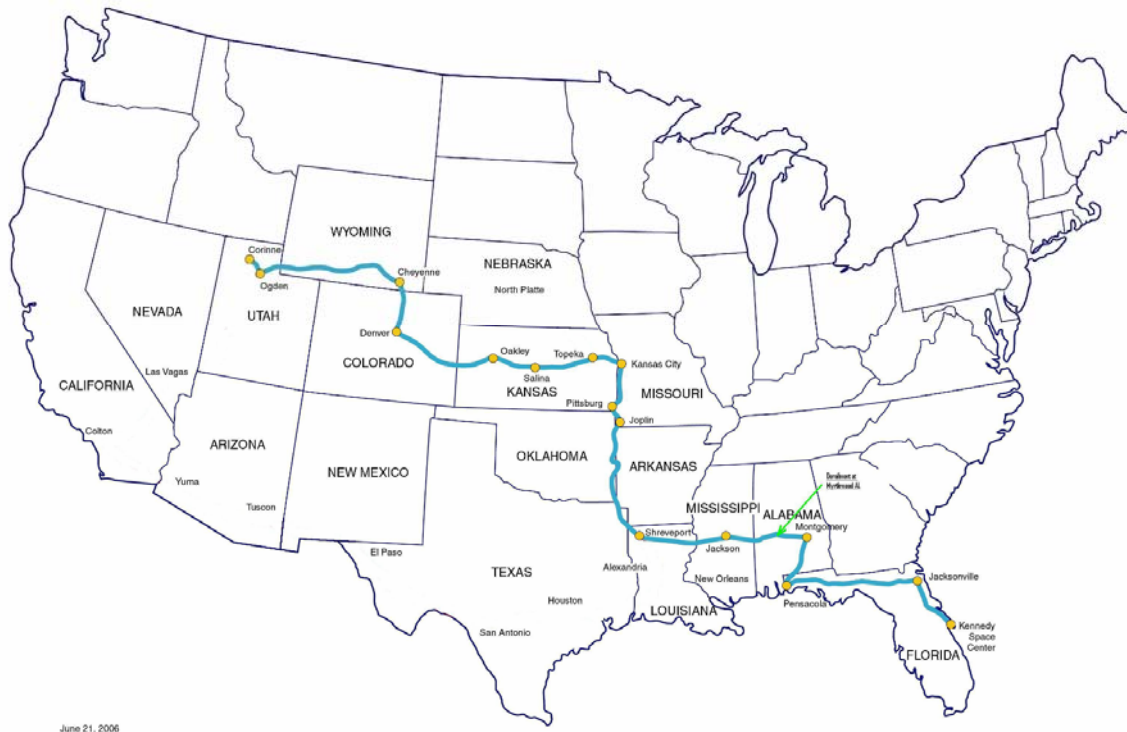
Figure 1. Space Shuttle Solid Rocket Motor Segment Transportation Route

The train configuration as it left the ATK Promatry production facility is shown below in Figure 1. This cross country trek typically takes 12 days and covers over 2000 miles and 8 states as shown in Figure 1. The Timeline for this shipment is shown in Table 1.

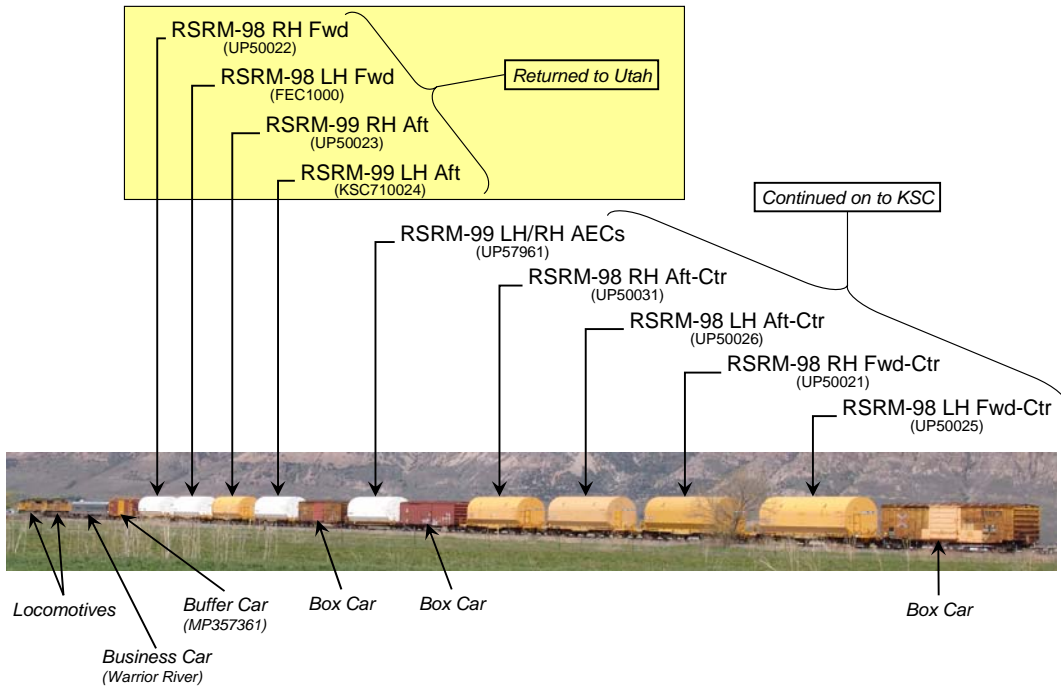
Figure 2. Train Configuration

Two locomotive engines are employed and a Business car houses the team of engineers assigned to oversee the shipment as shown in Figure 2.

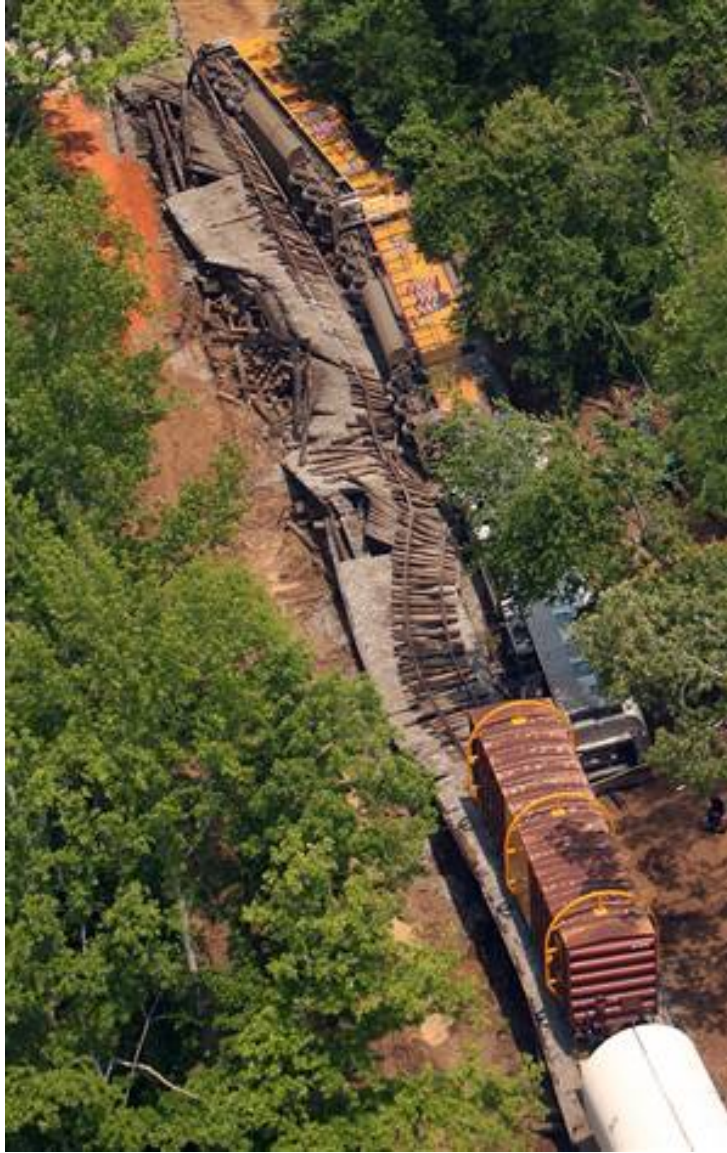
Figure 3. Aerial Photo of Derailment Site

On May 2, 2007, the train carrying eight segments of the space shuttle's solid rocket boosters derailed in Myrtlewood, Alabama, after a trestle collapsed. The derailment was in a remote stretch of track near Myrtlewood, about 110 miles (175 kilometers) southwest of Birmingham. The train was carrying the RSRM 98 center and forward segments (STS-120) and RSRM 99 aft segments (STS-122). Each segment weighs approximately 300,000 lbs. and is protected by a white or yellow colored fiberglass cover during shipment. Initially, it was not known if the segments had been seriously damaged. Four segments (the 98A and 98B Forward segments and the 99A and 99B Aft Segments) dropped approximately 10 feet when the trestle collapsed, one of which rolled off the collapsed trestle onto its side. Shown in Figures 3-7 below are photos taken at the site the day of the collapse.

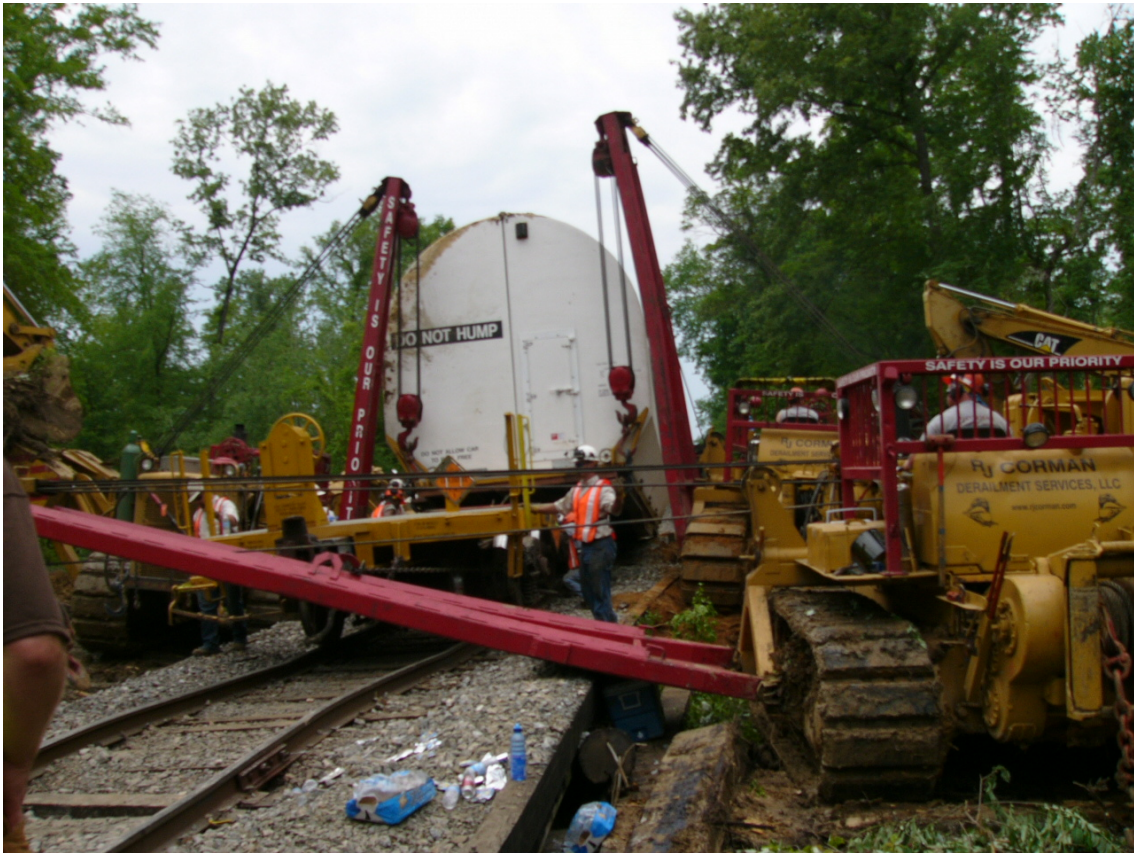
Figure 8. Man and Machines

Hours after the incident, teams from ATK, NASA, local emergency responders as well as large derailment recovery team from R.J. Corman Railroad Group arrived on the scene to begin the process of righting the locomotives, business car and rolled segment. Like building a Model HO train track, these highly specialized teams and equipment filled in the swampy ground, rebuilt the rail bed and laid short pre-built track sections to roll the involved cars to a safe holding area. The remaining cars including the four center segments were still on undamaged track and were rolled back to a secure yard several miles down the track. This coordination of people, machines, trains and train tracks is represented in Figure 8.

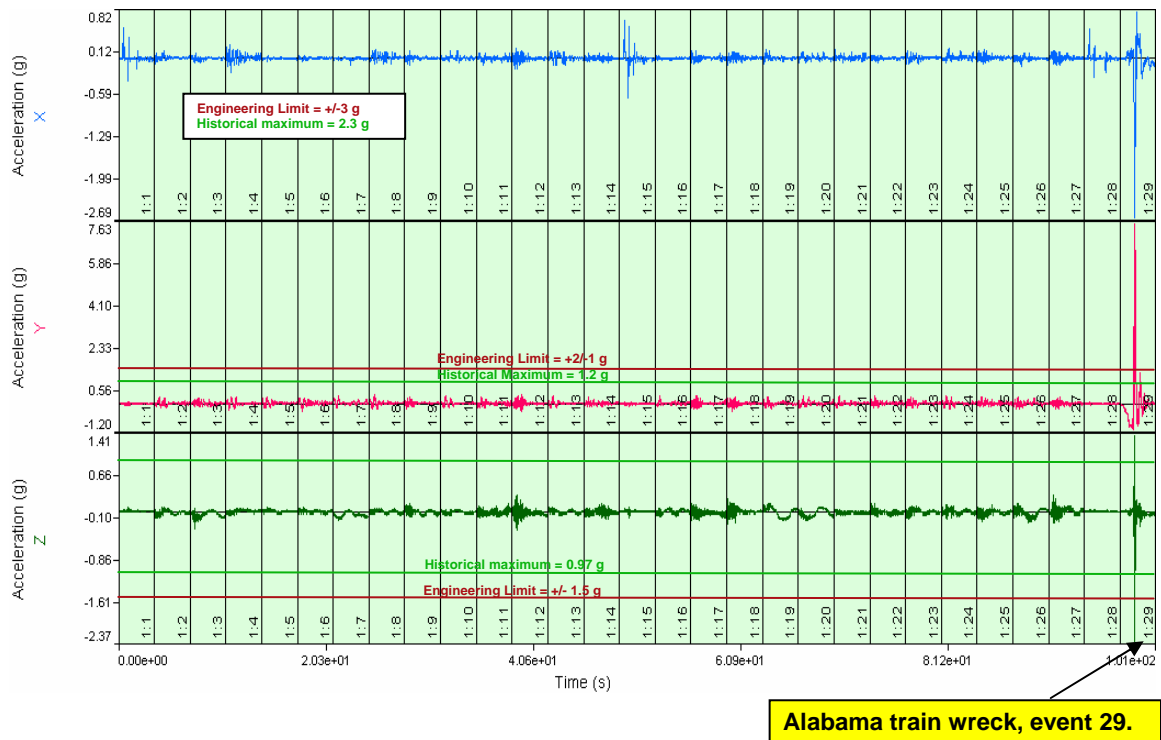
Figure 9. RSRM 98a Forward Segment EDR Data – file 98af02.udf

The EDR data from these segments are presented in Table 3 and in Figures 9-11. EDR data clearly shows out of family and above engineering allowable (3g) condition. It should also be noted that the EDR data may not represent the worst case due to the position of the gauge on the motor centerline.

EDR data clearly shows out of family and above engineering allowable (3g) condition. It should also be noted that the EDR data may not represent the worst case due to the position of the gauge on the motor centerline.

The remaining four segments that dropped (98A and 98B Forward and 99A and 99B Aft) did show significant departures from the historical data and were returned to Utah for further evaluation and disposition after a difficult and delicate transload of the segments onto undamaged cars.

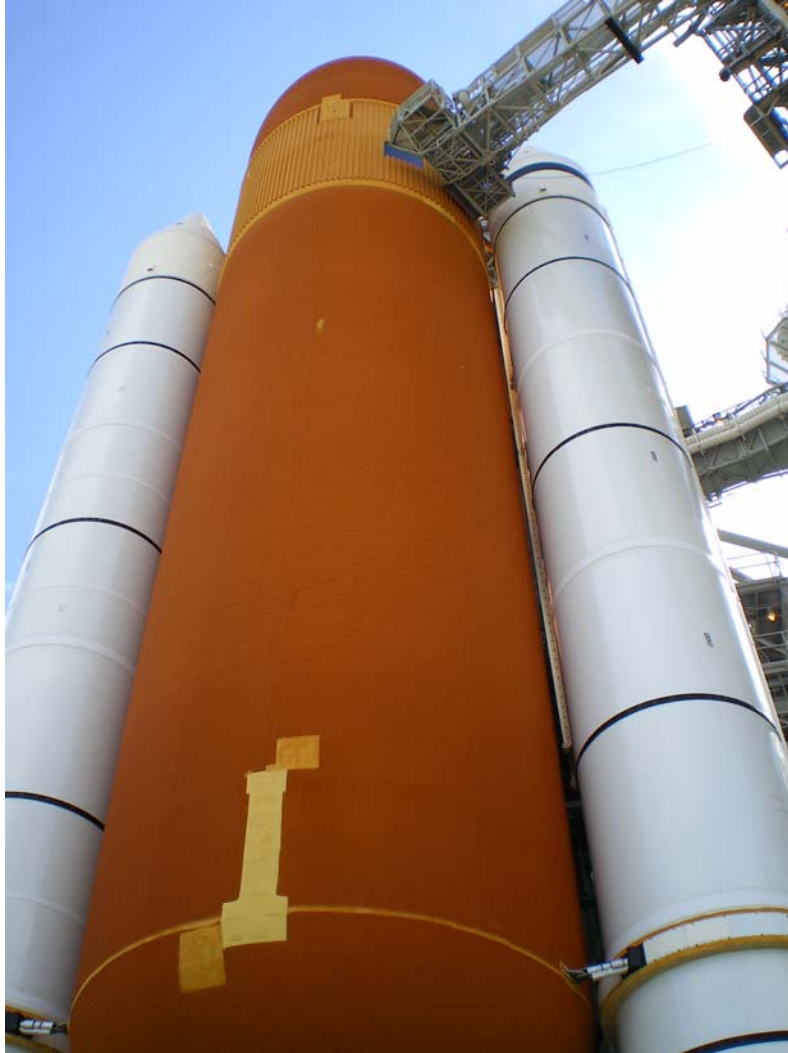
Figure 12. STS120 Stacked and Ready.

The Center Forward and Center Aft segments for RSRM Motor set 98 are shown stacked and ready to fly in Figure 12. Launch of this motor set on STS120 is shown in Figure 13.
