Dynamic Impact Tolerance of Shuttle RCC Leading Edge Panels Using LS-DYNA

This paper describes a research program conducted to enable accurate prediction of the impact tolerance of the shuttle Orbiter leading-edge wing panels using “physics-based” codes such as LS-DYNA, a nonlinear, explicit transient dynamic finite element code. The shuttle leading-edge panels are constructed of Reinforced-Carbon-Carbon (RCC) composite material, which is used because of its thermal properties to protect the shuttle during re-entry into the Earth’s atmosphere. Accurate predictions of impact damage from insulating foam and other debris strikes that occur during launch required materials characterization of expected debris, including strain-rate effects. First, analytical models of individual foam and RCC materials were validated. Next, analytical models of foam cylinders impacting 6-in. x 6-in. RCC flat plates were developed and validated. LS-DYNA pre-test models of the RCC flat plate specimens established the impact velocity of the test for three damage levels: no-detectable damage, non-destructive evaluation (NDE) detectable damage, or visible damage such as a through crack or hole. Finally, the

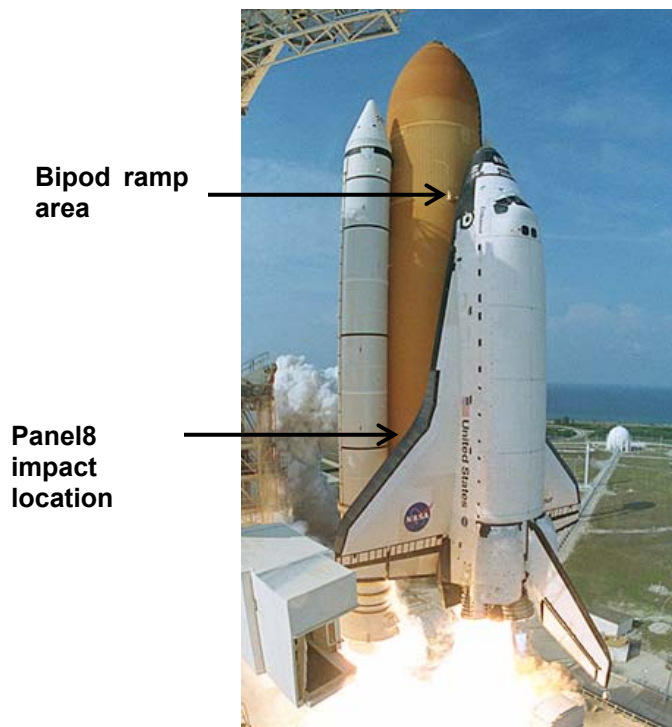
Figure 1. Picture of Columbia showing the bipod ramp area where the foam block was released and the panel 8 location on the left wing where the foam impacted.

block of External Tank (ET) insulating foam from the bipod ramp area that impacted and penetrated the lower portion of a left-wing leading edge RCC panel (see Figure 1). The location of the impact was determined to be the left-wing RCC Panel 8. Consequently, the CAIB sanctioned a foam impact test onto RCC panel 8 in July 2003 at Southwest Research Institute (SwRI) in San Antonio, Texas. In the test, a 1.67-lb. block of foam was shot from a large compressed-air gun and impacted panel 8 at a velocity of 777 ft/s at an angle of incidence of 25.1 degrees in an attempt to simulate the scenario observed approximately 82 seconds into Columbia's flight. The impact resulted in a large 16-in. x 16-in. hole in panel 8.

The foam that brought down Columbia was an abnormally large 1.67-pound wedge of hand-applied foam from the bipod ramp area where the external tank is attached to the Orbiter (see Figure 1). The normal foam debris environment consists of small pieces, each typically only a fraction of a pound. The foam wedge was estimated to impact the left wing of the Orbiter at a velocity of over 700 ft/s. Although the bipod ramp area has been redesigned to use heaters, thus eliminating the large piece of foam, smaller foam debris can still potentially cause serious damage if the impact is at a high velocity at a relatively large incidence angle. According to debris transport analysts, a small piece of foam shed from the external tank stops very quickly in the slipstream, allowing the foam to impact the Orbiter at velocities as high as 2500 ft/s.

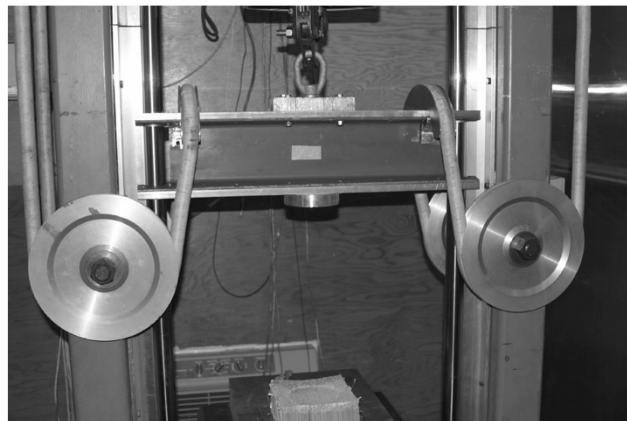
Figure 2. High-speed bungee-assisted drop tower.

These tests are required to develop the physics-based material models for LS-DYNA that include strain-rate data. Much of the high-speed crush testing of foam, ice, and ablators required to develop these LS-DYNA material models was generated using a high-speed bungee-assisted drop tower at NASA Langley, shown in Figure 2.

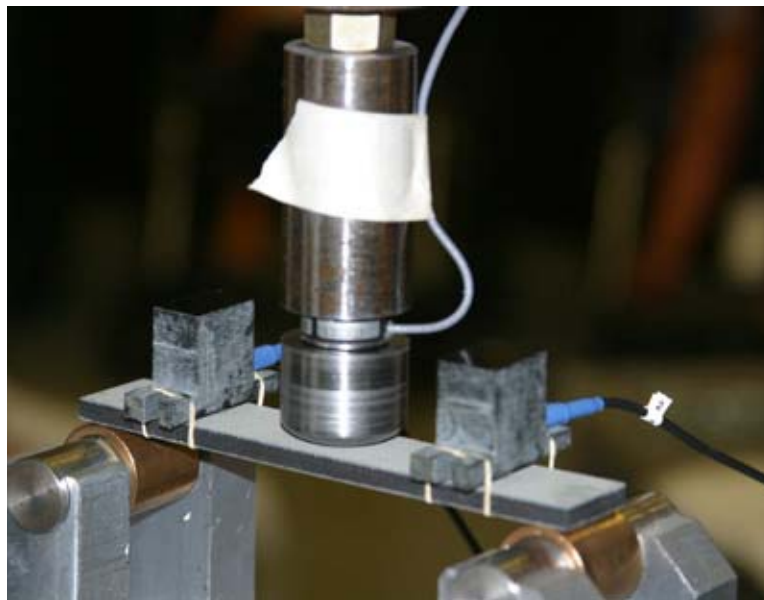
Figure 3. Level 1 three-point bend test of RCC coupon.

Southern Research Institute (SRI) cut twenty 1-in. x 5.8-in. flex coupons, a compression test coupon, a tension test coupon, and a scrap for testing coating crush strength from RCC test panel TC3-11. Static and low-rate dynamic 3-point bend tests of 19-ply RCC coupons 1.0-in. wide x 5.8-in long (5-in. gage length) were conducted with incremental loading and NDE after each load cycle to validate the LS-DYNA RCC threshold of damage predictions. The objectives of the tests were: 1) to study the damage initiation and propagation in the RCC samples under quasi-static 3-point bend loading, 2) to determine the NDE detectable damage threshold, 3) to correlate first-detectable NDE damage with LS-DYNA damage parameters, and 4) to determine if delamination can be initiated in RCC bend tests, and if so, can that delamination be correlated with LS-DYNA damage parameters. A picture of the test set-up is shown in Figure 3.

The model discretization is shown in Figure 4. The load was spread over 9 nodes at the center and simple-support boundary conditions were applied at the ends at the positions of the two rollers (see Figure 3).

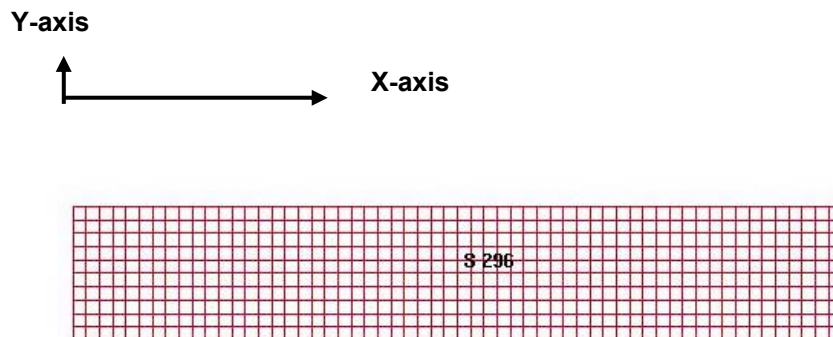
Figure 4. Simple 3-point specimen discretization.

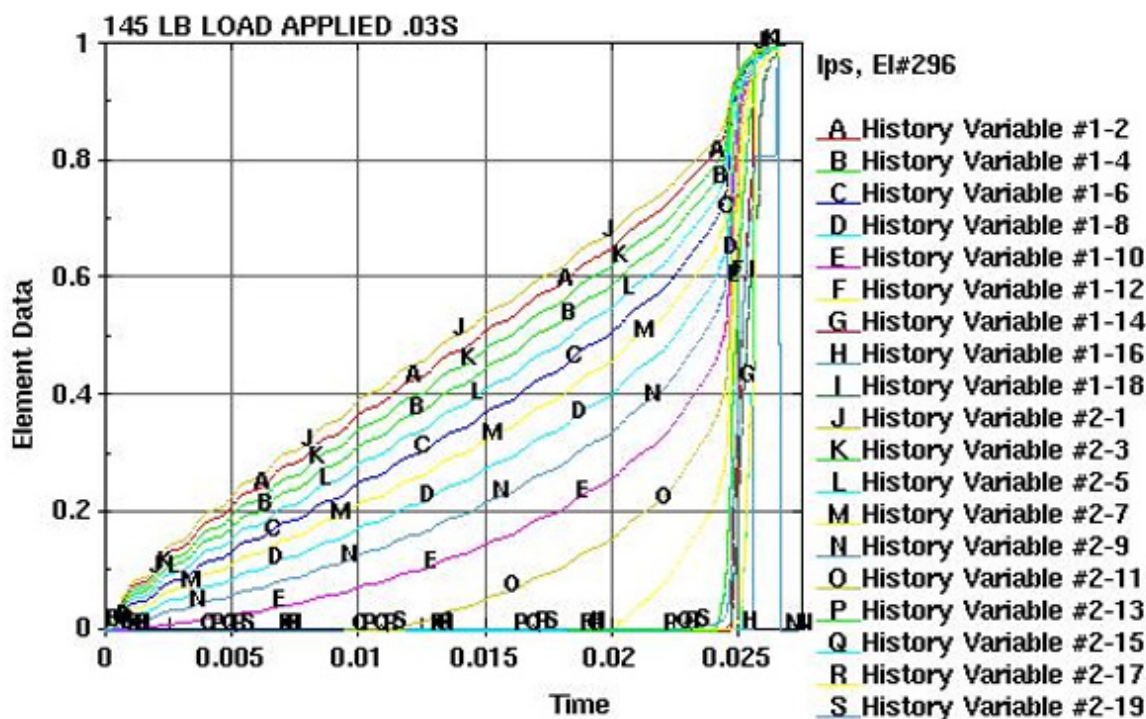
Figure 5. Damage parameter for a center element 296 versus time.

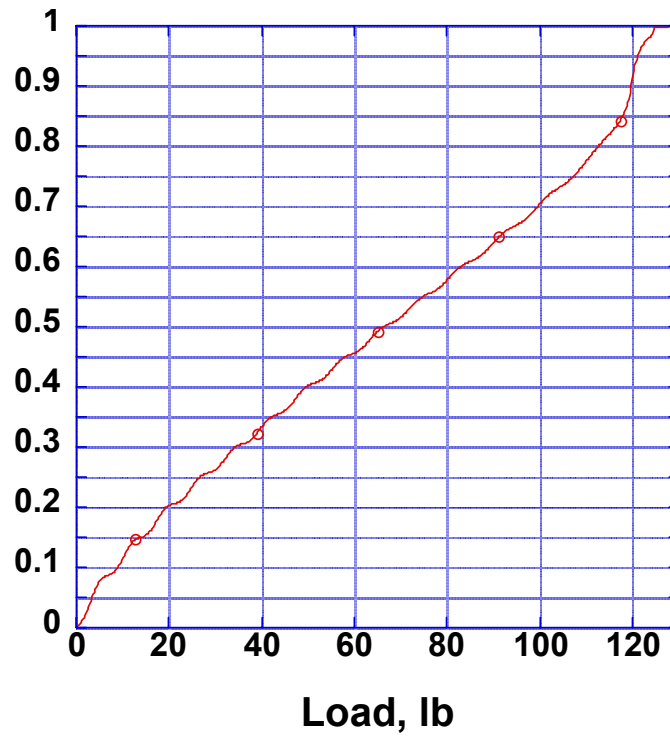
Figure 6. Maximum damage parameter versus load (bottom ply).

was well predicted as shown in Figure 6. First NDE damage was not detected until about 120 lbs, which corresponds to a damage parameter of 0.9 as shown in Figure 6. The initial failure for the bend tests was always a tension crack in the lower ply. Delamination did not occur, or if it did occur, it occurred very late in the loading sequence. For dynamic tests, where NDE damage that looks like internal delamination does occur early in the damage sequence, the maximum damage parameter for NDE-detectable damage ranged from around 0.9 to 0.98, with values 0.95 – 0.97 being typical.

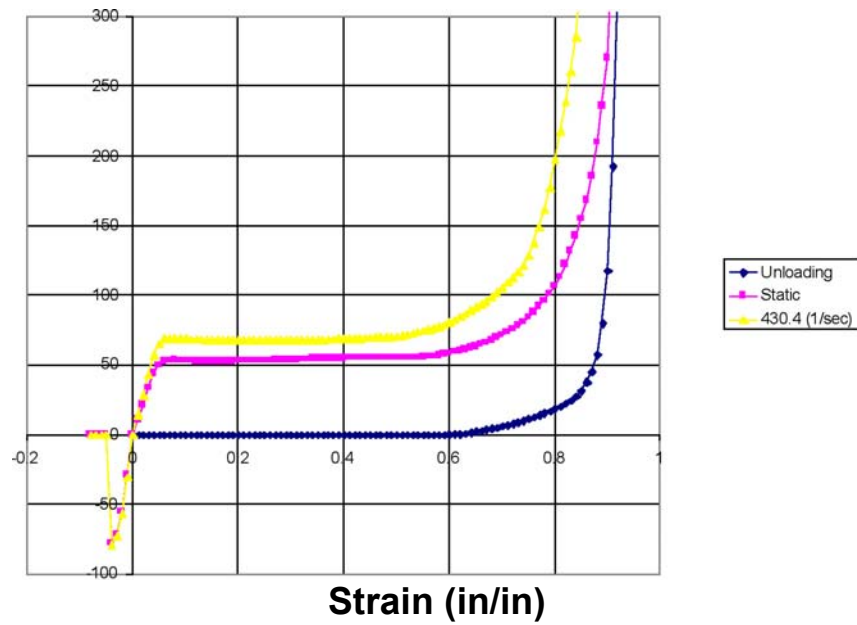
Figure 7. Foam model for BX-265 in the rise direction for room temperature. Note tension is negative.

The external tank foam material representation for the projectile used the Mat 83 MAT_FU_CHANG_FOAM model⁶. Strain rate effects were found to be important in the foam material at the velocities of interest. The external tank foam is a closed-cell polyurethane foam that is sprayed onto the tank in layers. The material strength is direction-dependent with the “rise-direction” having the greatest crush strength. High strain-rate data for the Fu-Chang model was generated in a specially configured and instrumented 14-ft. bungee-assisted drop tower at the Impact Dynamics Research Facility at NASA Langley that can achieve strain rates of over 400/s (see Figure 2). The high strain-rate data were directly input into the Fu-Chang model. Different foam models were created for different orientations and for different temperatures. A series of curves for the BX-265 room temperature foam model is shown in Figure 7.

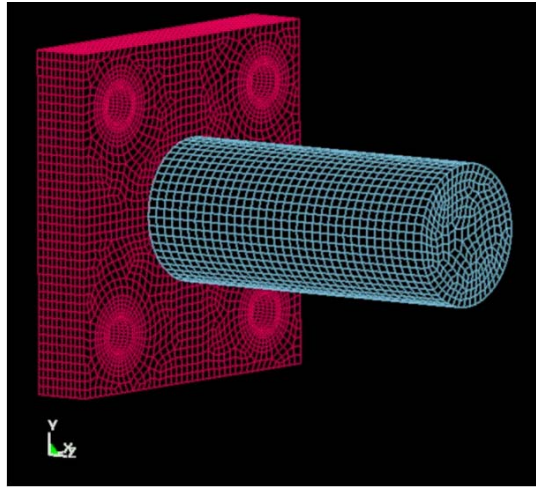
Figure 8. Typical LS-DYNA model of foam impacting an instrumented target.

A typical simulation of a test modeled in LS-DYNA is shown in Figure 8. Both the projectile and target were modeled using solid elements, and the stiffnesses of the load cells were represented as springs.

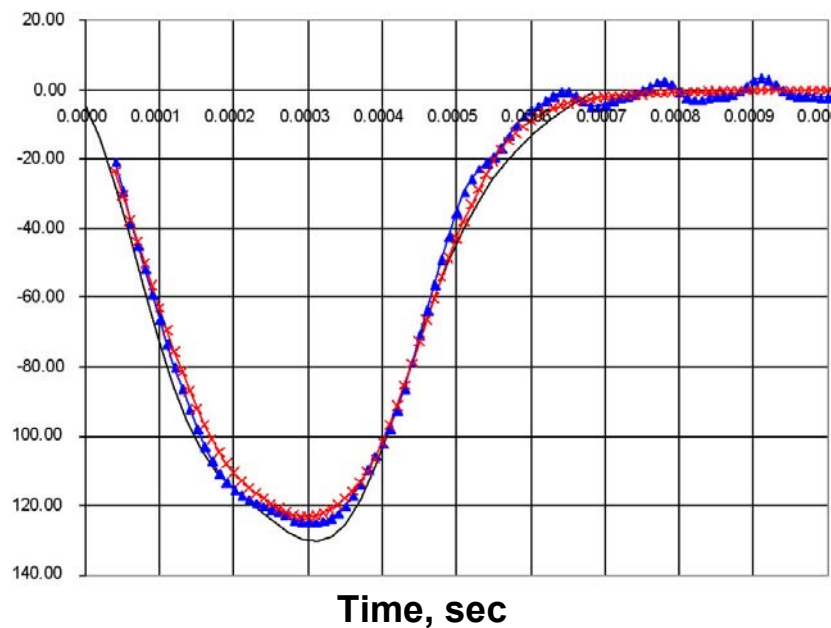
Figure 9. Comparison of test data (black line) with analysis (triangles and crosses) for a 23-degree impact at 693 ft/s.

Comparing the resulting forces of test and analysis, an example of which is shown in Figure 9, shows excellent agreement. The qualitative behavior of the foam analytical model also showed excellent agreement with high-speed video of the test.

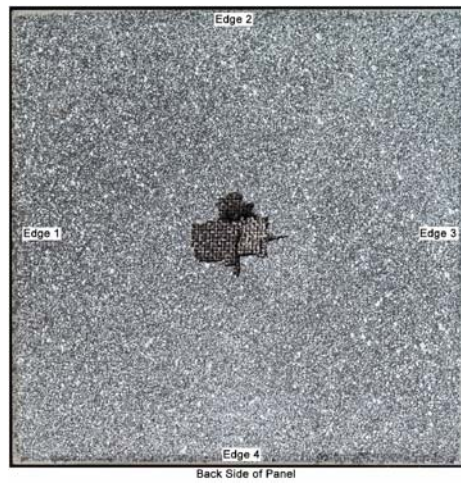
Figure 10. Post-test photograph of the backside of a 6x6-in. RCC flat panel. Coating loss is evident at the center.

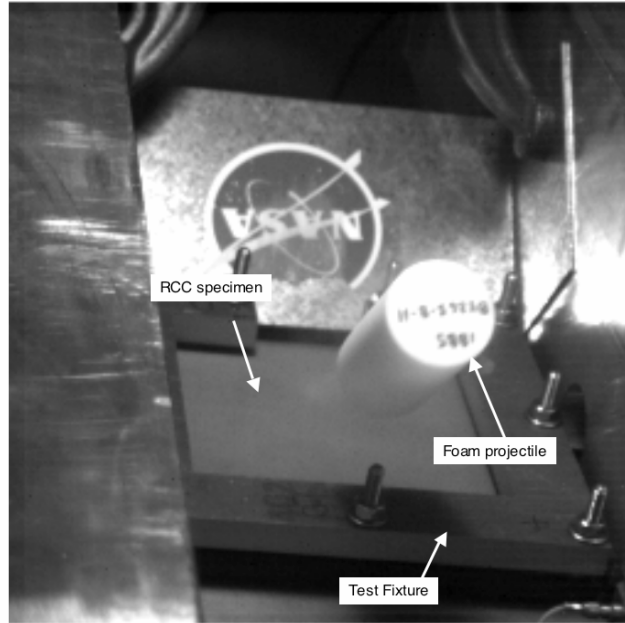
Figure 11. Photograph of 45-degree foam impact onto 6-in.square RCC plate.

The 45° test configuration including a foam projectile just prior to impact is shown in Figure 11. In each test, the RCC panel had dimensions 5.95 x 5.95-in. with a nominal thickness of 0.233-inches. The plate thicknesses have been observed to vary from 0.21 to 0.24 inches. The panels were constrained on the upper and lower surfaces with aluminum half-round rods located 0.16 inches from the four edges. The BX-265 foam projectiles were nominally 1.5 inches in diameter and 3.0 inches long with a mass of 3.0 grams. The following information was also acquired for each test: impact velocity, pre- and post-test photographs, pre- and post-test non-destructive evaluations, and dynamic displacements using the Aramis photogrammetry system.

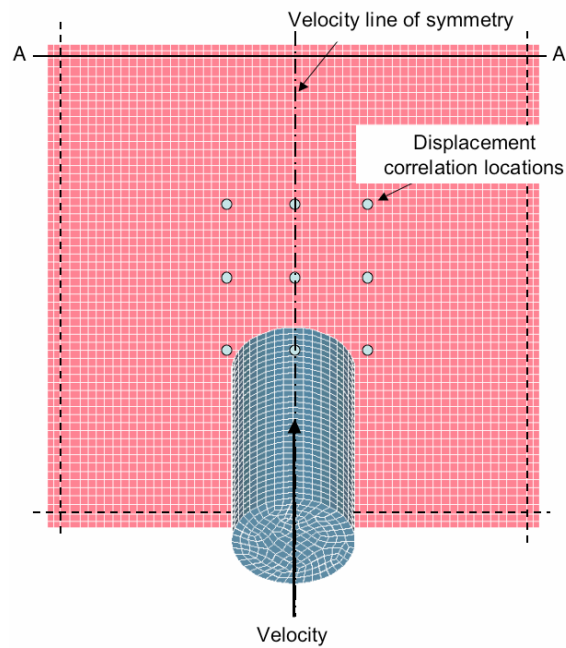
Figure 12. LS-DYNA model of foam cylinder impacting RCC panel at 45-degrees.

A typical model of an LS-DYNA simulation of the impact of a 1.25-in. diameter foam cylinder onto a 6x6-in. flat plate of 19-ply RCC material is shown in Figure 12. Various boundary conditions were simulated to bound the actual response. The flat plate was restrained at 0.1625-in. from the edges by round aluminum rods in a picture-frame configuration. Thus, the nominal dimensions of the model were 5.675-in. x 5.675-in. The units used in the LS-DYNA model for length, mass, and time were inch, pound/g, and seconds. The RCC plate was 6 x 6 in., with a shell element edge length of 0.1 in. Idealized boundary conditions were applied at the locations matching the test. Specifically, the out-of-plane displacements were constrained along three edges as represented by the dashed lines in Figure 12. The displacements, both out-of-plane and in-plane perpendicular to Line A-A, were constrained. No rotations were constrained at the boundaries. The RCC material properties and plate thickness were adjusted for

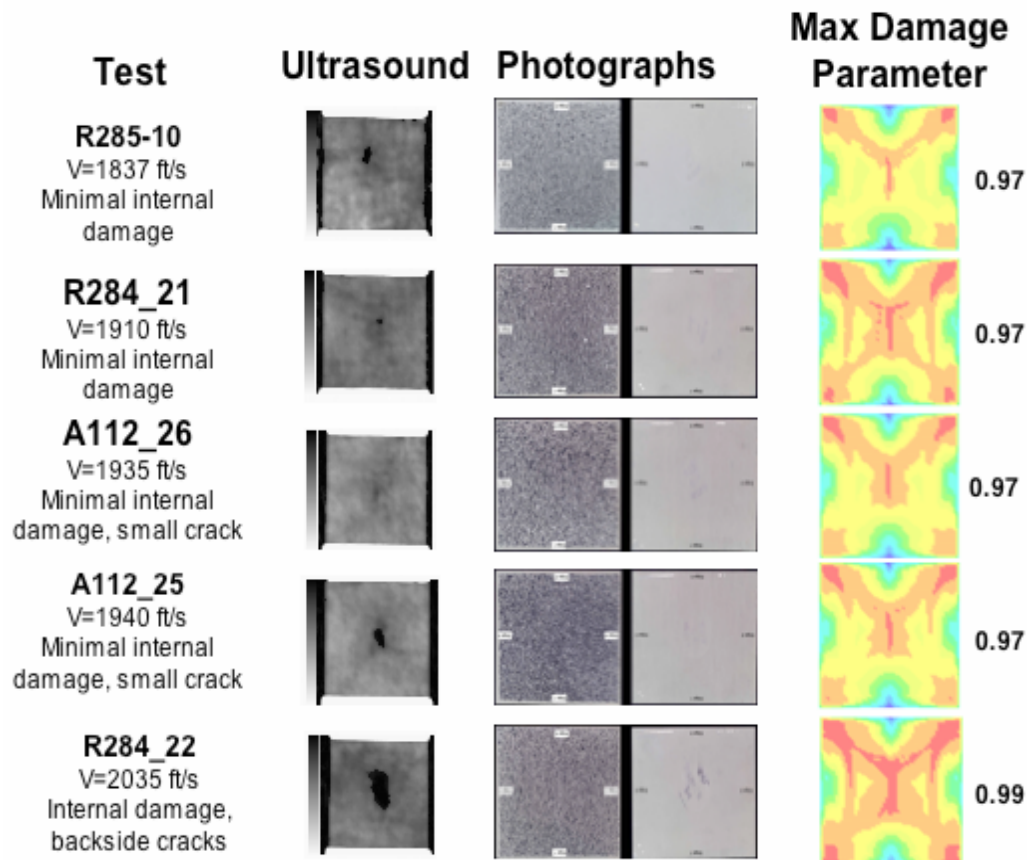
Figure 14. Comparison of measured and predicted damage for lower velocity impacts.

A qualitative comparison of measured and predicted damage is shown in Figures 14 and 15. The cases shown in these figures represent impact velocities above the NDE-detectable damage limit of RCC. Both test and analysis indicate a similar amount of NDE internal damage for impacts ranging from 1837 to 1940 ft/s (Figure 14). The maximum damage parameter of 0.97 correlated best with the threshold of NDE-detectable damage. For test R284-22, the maximum damage parameter was found to be 0.99 and backside cracks were seen in addition to the large black area of internal damage seen in the ultrasound image. At the higher velocities, both the test and analyses show significant damage to panels emanating from the center and progressing to the corners furthest from the impact site as can be seen in Figure 15. Note the damage parameter of 1.0 indicates that RCC shell elements have been deleted, which corresponds to a through crack in the test. Also, notice that the diagonal or V-shaped front-side surface damage shown in Figure 15 follows the trends of the damage parameter contour plots.

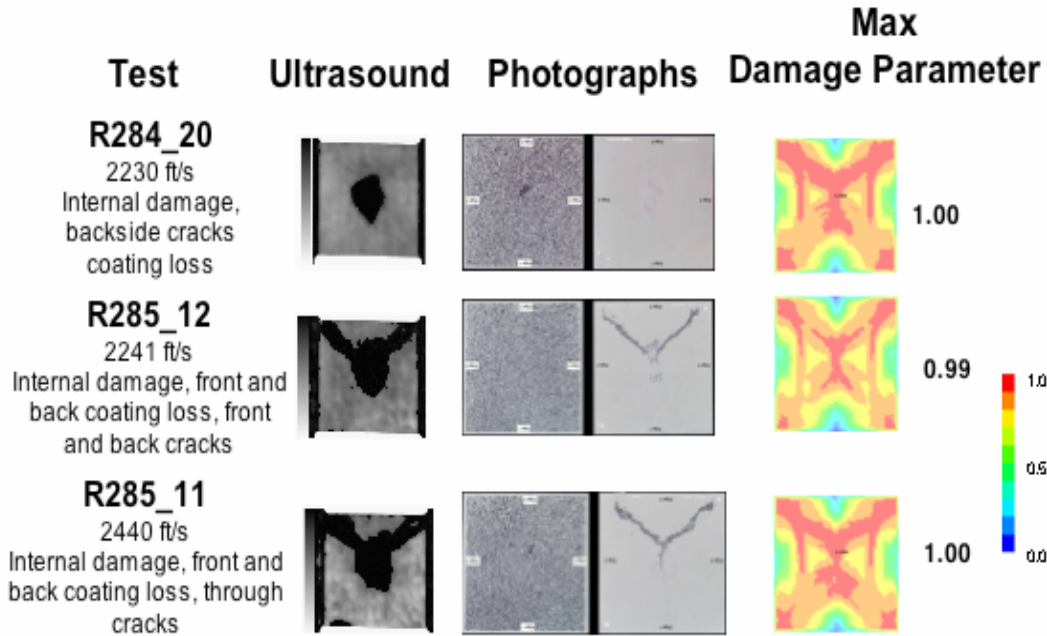
Figure 15. Comparison of measured and predicted damage for higher velocity impacts.

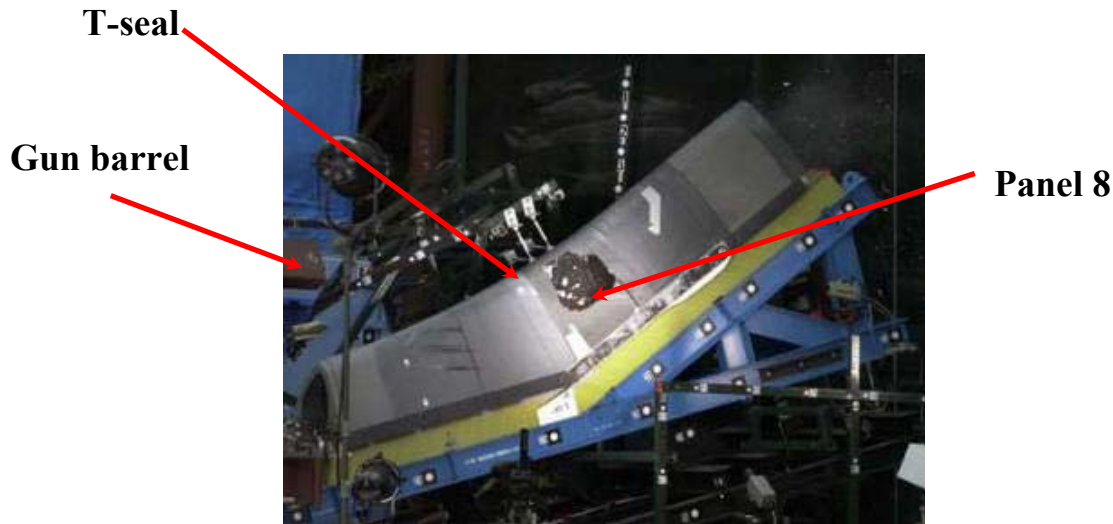
Figure 16. Post-test photo illustrating the test set-up at SwRI with panels 5 through 10 and associated T-seals on the test rig.

The setup of panels 5 through 10 with T-seals between panels is shown on the test-rig at SwRI in Figure 16. The gun barrel was rotated such that the front edge of the foam would align with the RCC panel to produce as much contact surface as possible.

The most obvious result from the test was the large 16-in x 16-in hole in panel 8 shown in Figure 16. In addition to high-speed photographic data, photogrammetric measurements were made of the panel behind the area of the foam impact. Also, strain gages, accelerometers, and load cell transducers were used on the test article to obtain time histories of the impact event.

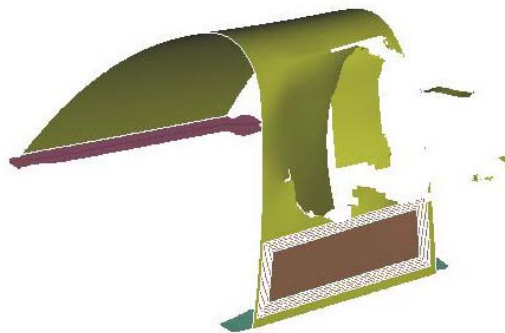
Figure 18. LS-DYNA model, with panel ribs and foam removed for clarity, at 5 ms after impact.

The damage that occurred to Panel 8 test was truly catastrophic. Consequently, the primary comparisons made of the test results with analysis are the damage pattern that occurred and photogrammetry data. The predicted damage to the panel is shown in Figures 18 and 19, and the damage that occurred in the test is shown in Figure 20.

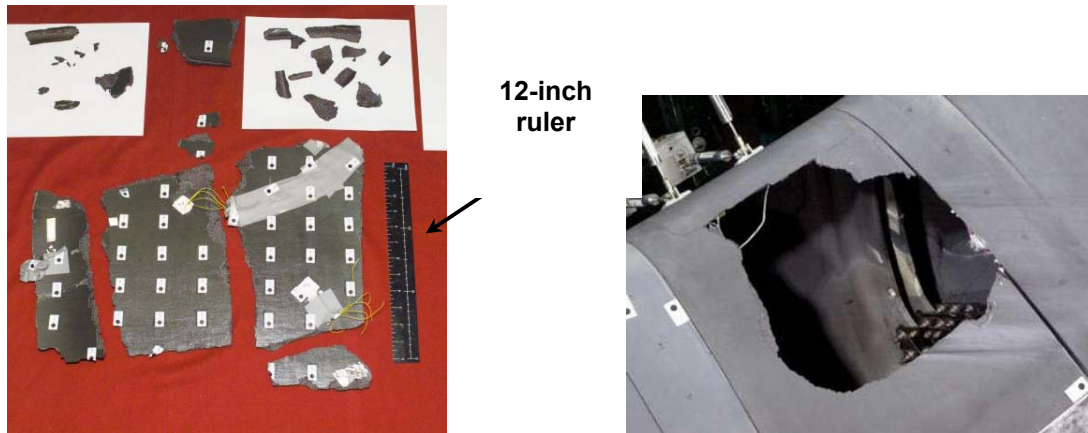
Figure 20. Panel debris showing photogrammetric targets on the back side (left) and the damage to panel 8 (right).

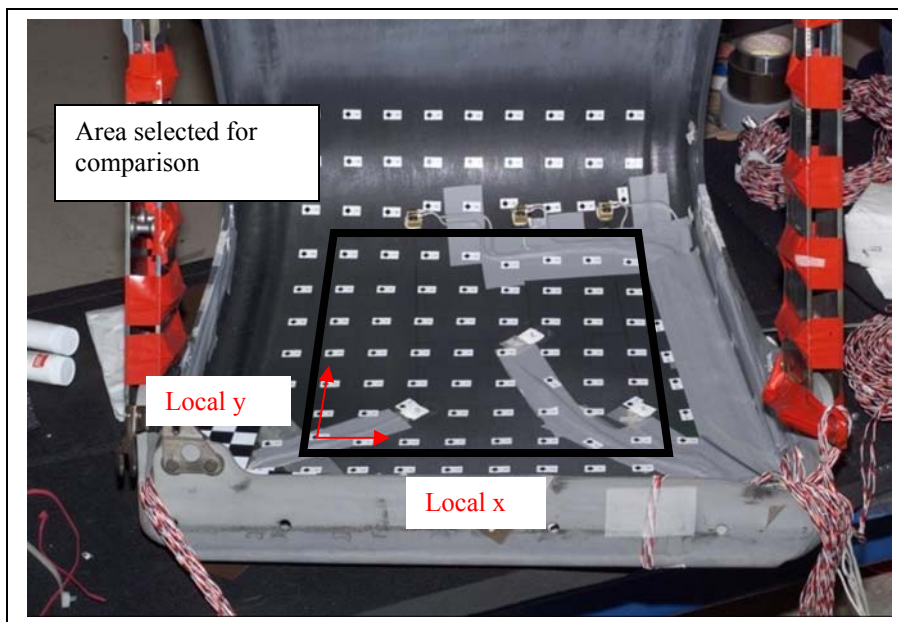
Figure 21. Location of photogrammetric targets on Panel 8 prior to impact. Box outlined in black indicates area of interest.

The three-dimensional motion of over 100 optical targets on the inside of panel 8 were tracked using photogrammetry (Figure 21). The motion was tracked semi-automatically using two Phantom 5 digital video cameras that captured 2,000 to 7,000 frames per second. The videos were analyzed by the Image Science and Analysis Group (ISAG) at the NASA Johnson Space Center (JSC). The ISAG examined the position and velocity of each point looking for discontinuities in its trajectory. Spatial continuity was then assessed by comparing the motion of each point with other points in the same row and column.

Since the local axis system shown in Figure 21 did not align with the model axes, the photogrammetric data were further processed to obtain the resultant displacement of each point versus time. Resultant displacement, a scalar quantity independent of the coordinate system, was used for the comparisons with the analysis because of the uncertainty in the coordinate transformation between the measured data and the finite-element model.

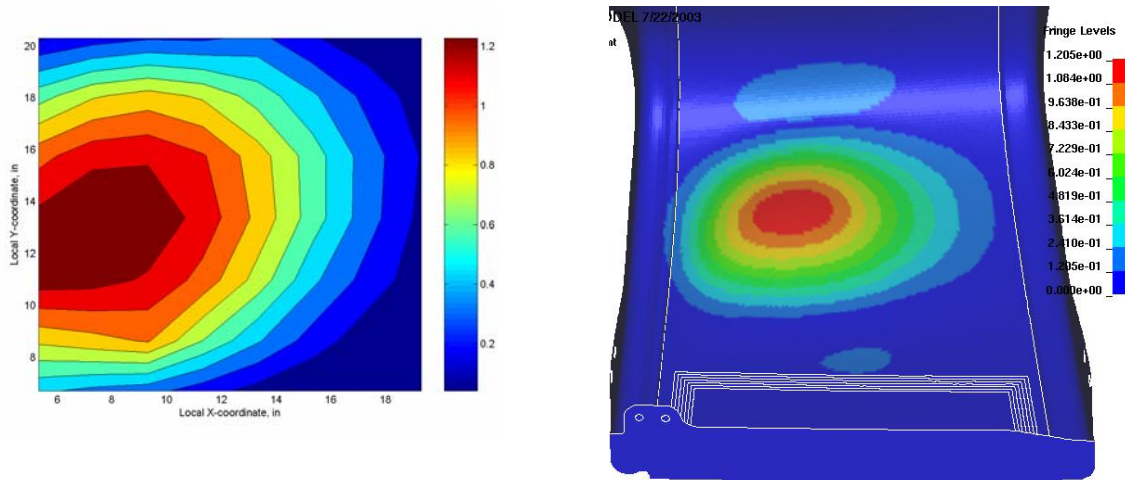
Figure 22. Comparison of measured (left) and predicted (right) deflections at 2 ms after foam impact. The maximum deflection contour for both plots is 1.2 inches.

is the last data point that existed for all of the selected points. A typical comparison of test with analysis is shown in Figure 22 at 2 ms after the foam impact.

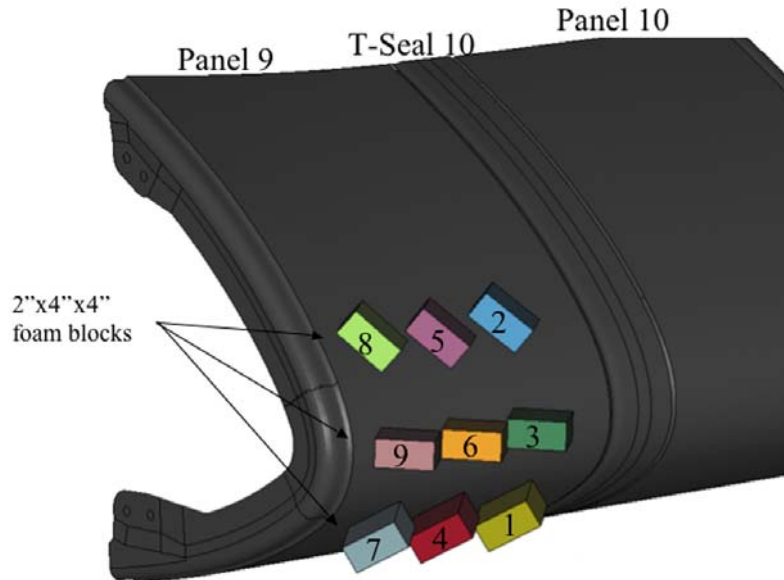
Figure 23. The location of the 9 foam impact tests onto panel 9.

For the upper and lower surface and apex, three impact velocities were defined using LS-DYNA predictions. The lowest impact velocity should produce no detectable damage, the middle impact velocity should have a 50% chance of producing damage such as delamination, and the highest impact velocity should produce severe damage such as a through crack. The projectile was a block of BX-265 foam with dimensions 2 in. x 4 in. x ~4 in. long weighing 0.044lbs. To account for foam density variations, the lengths of the blocks were adjusted so that the weight of each block was 0.044 lbs.
