# Effect of charging electron exposure on 1064nm transmission through bare sapphire optics and SiO<sub>2</sub> over HfO<sub>2</sub> AR-coated sapphire optics.

Experiments measuring the effect of electron exposure on 1064nm transmission for optical sapphire were conducted. Detailed before and after inspections did not identify any resulting Lichtenburg patterns. Pre- and post-exposure 1064nm transmission measurements are compared.

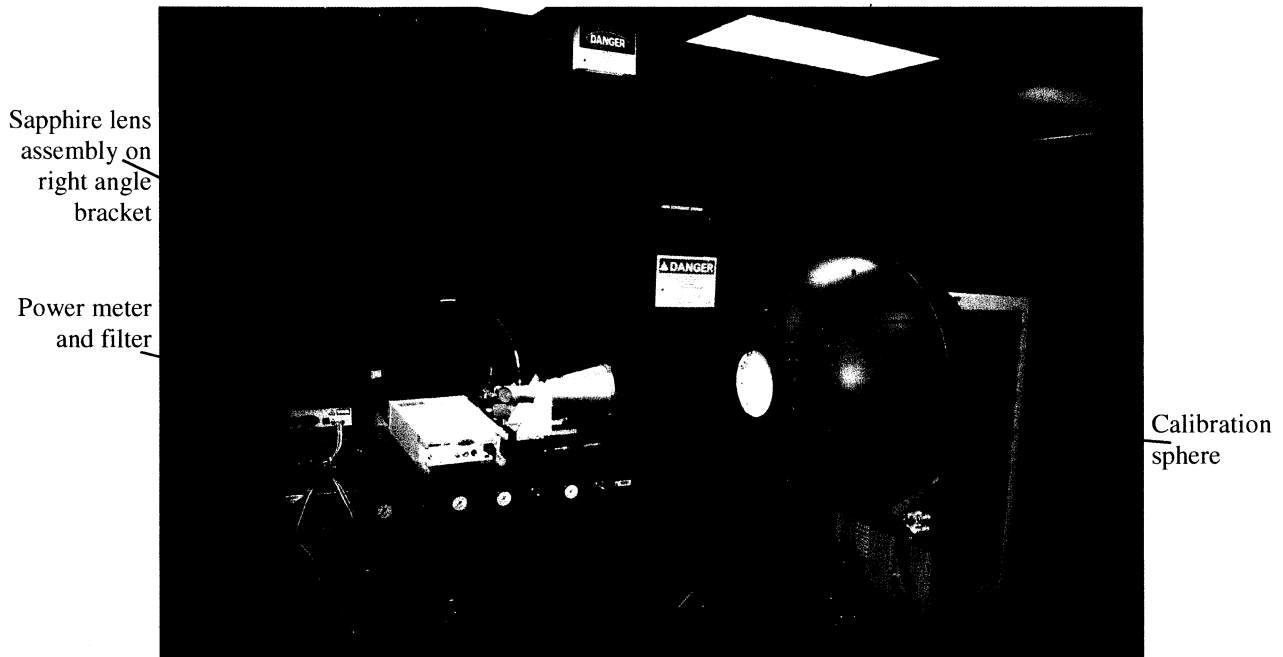
To measure pre- and post-exposure transmission, an integrating sphere, 1064 +/-5nm FWHM filter, power meter, and right-angle bracket were configured as in figure 1. Intensity measurements were recorded for each sample (including control sample).

Figure 1 – Setup for the Transmission Measurement

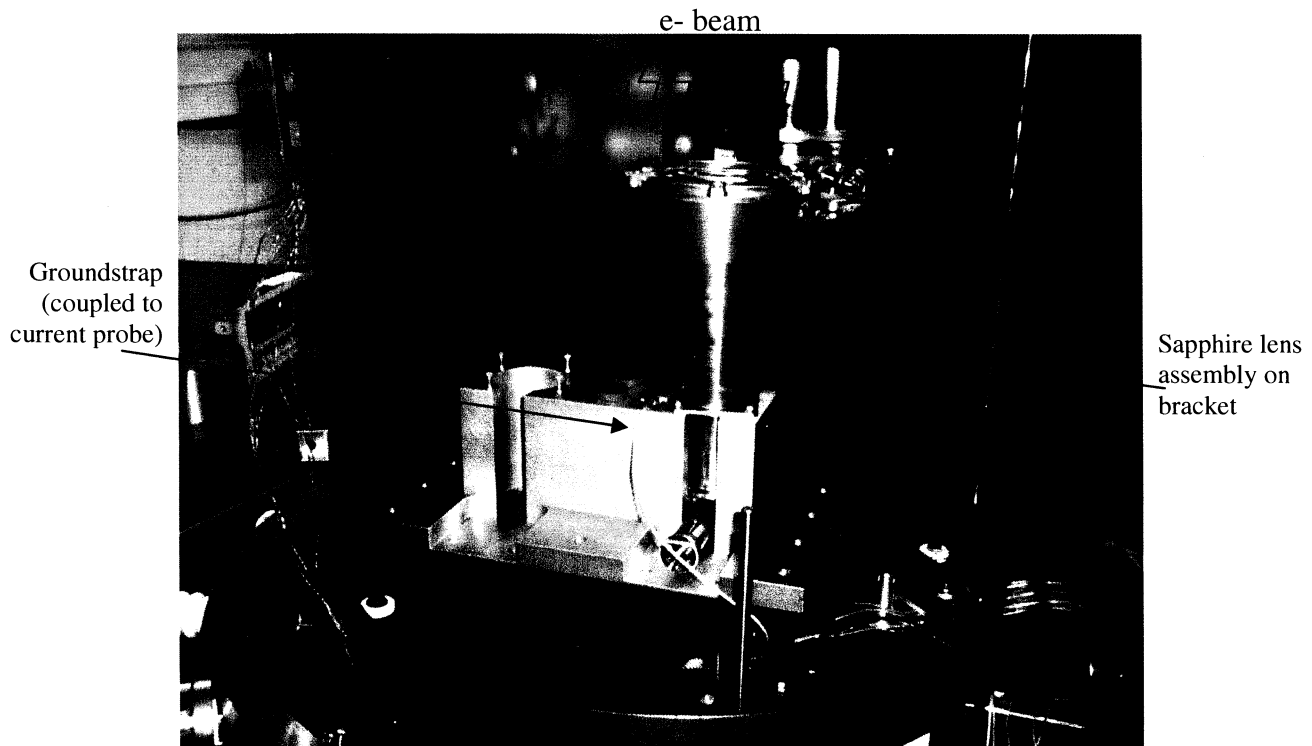
Figure 2 – Sample A prior to 10 keV exposure

After pre-exposure inspections and measurements, sample A was exposed to 10 keV electrons in the NASA Goddard Contamination and Coatings Branch Electrostatic Chamber and sample B was exposed to 1 MeV electrons at the NASA Goddard Radiation Effects Facility. Dosing for sample A was 1 nA/sq cm for 2 hours and dosing for sample B was  $8 \times 10^6$  e-/sq cm-sec for 5 hours. One inch diameter x 0.5" thick, bare-sapphire witness samples were placed in the chamber but blocked from the electron beam to bound possible effects of contamination. The witness sample was measured using an automatic transmission spectrometer.

A photograph of sample A inside the chamber is shown in figure 2 and a photograph of sample B inside the chamber is shown in figure 3.

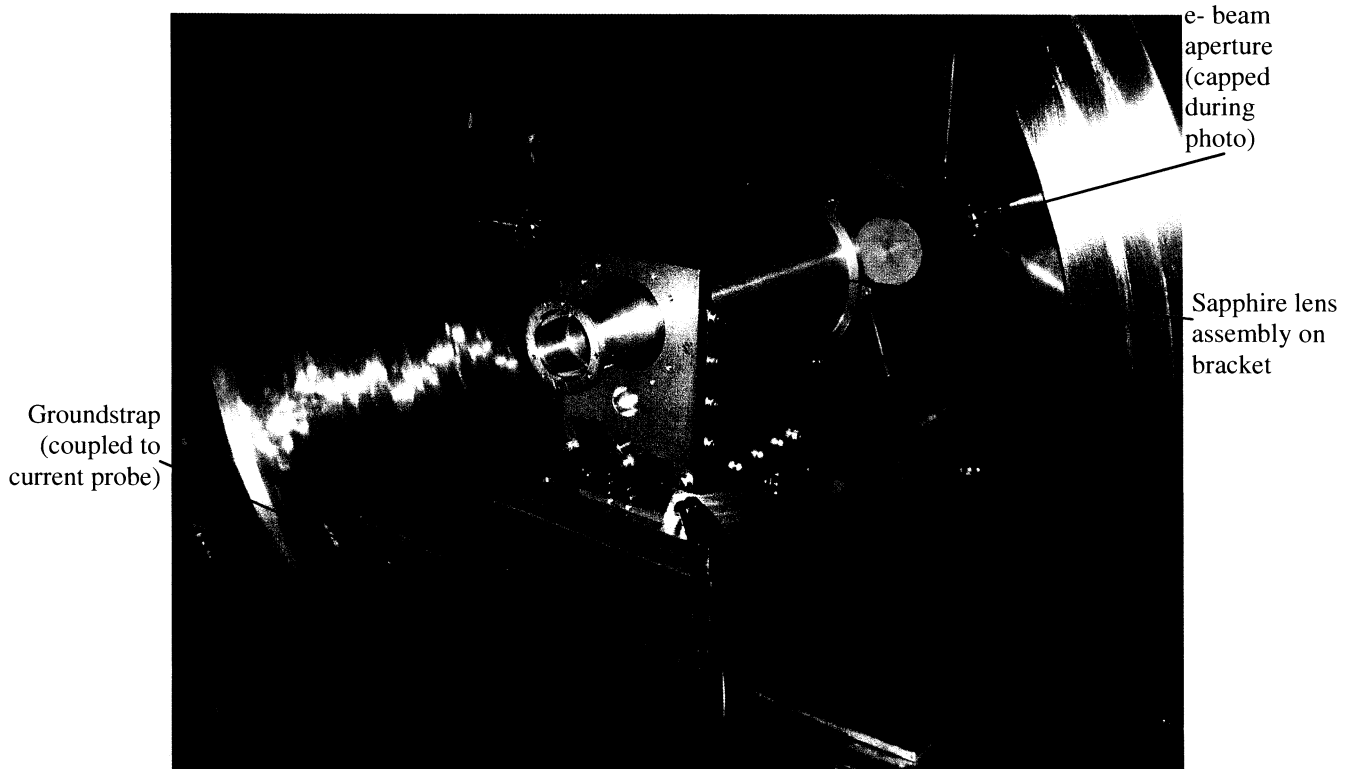
Figure 3 – Sample B prior to 1 MeV exposure

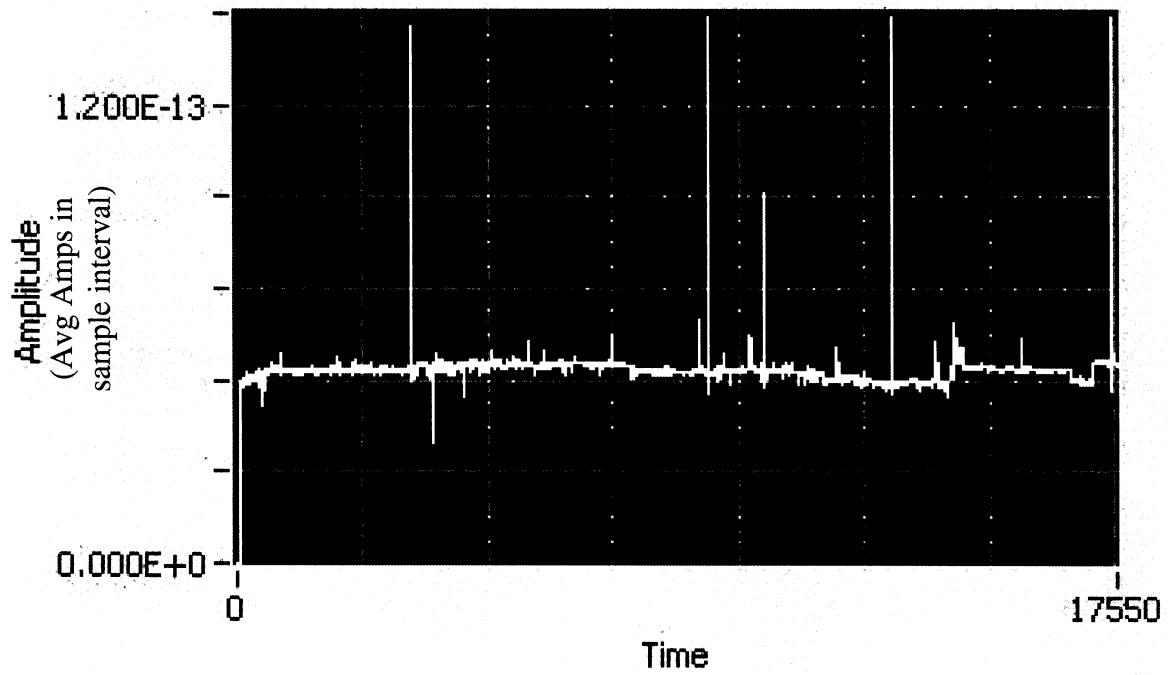
Approximately 4 major spikes in the current monitor were seen for during sample B exposure. A plot of current vs. time for that exposure is given in figure 4. No events  $>30A$  were seen during sample A exposure, therefore no graphics of scope triggers are presented.

Figure 4 – Current monitor for sample B

To monitor possible discharge events, a current monitor was placed between the metal housing and ground. For sample A, it was implemented via an off-the-shelf current probe, amplifier, and oscilloscope. Events were triggered at 30A on the oscilloscope. For sample B, it was connected to an integrator and logged approx every 200msec through LABView

Four major and 1 minor discharge events are believed to have occurred during 1 MeV exposure and no discharge events were seen during 10 keV exposure. Transmission loss and Lichtenburg patterns, if any, due to electron exposure are believed to be very slight.
