# Rotorcraft Downwash Flow Field Study to Understand the Aerodynamics of Helicopter Brownout

Presented at the American Helicopter Society Southwest Region Technical Specialists' Meeting, "Technologies for the Next Generation of Vertical Lift Aircraft," Dallas-Fort Worth, TX, October 15-17, 2008.

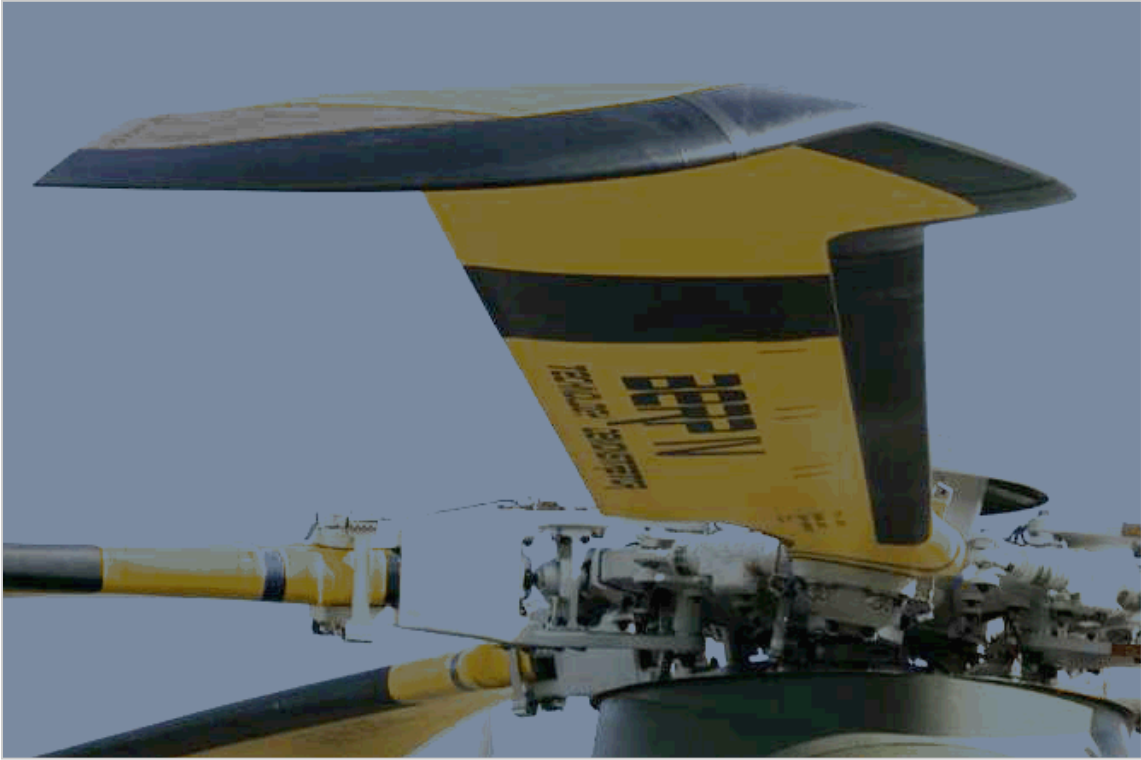
Figure 2. BERP IV blade tip design [5].

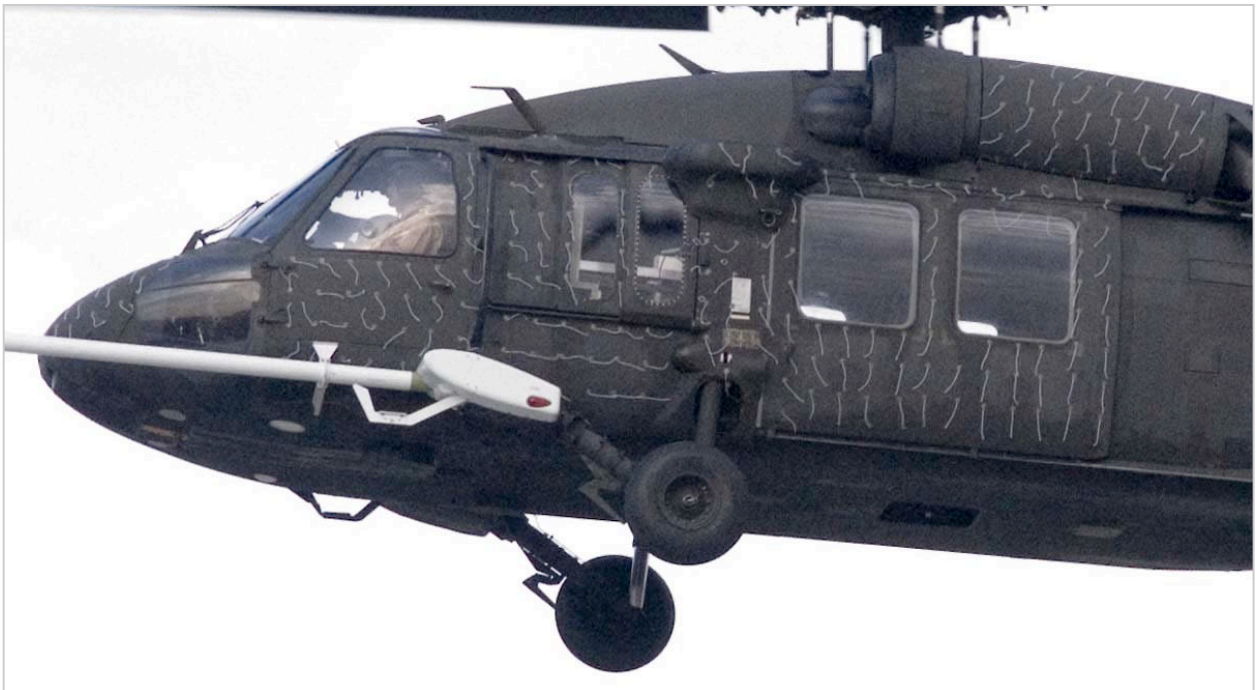
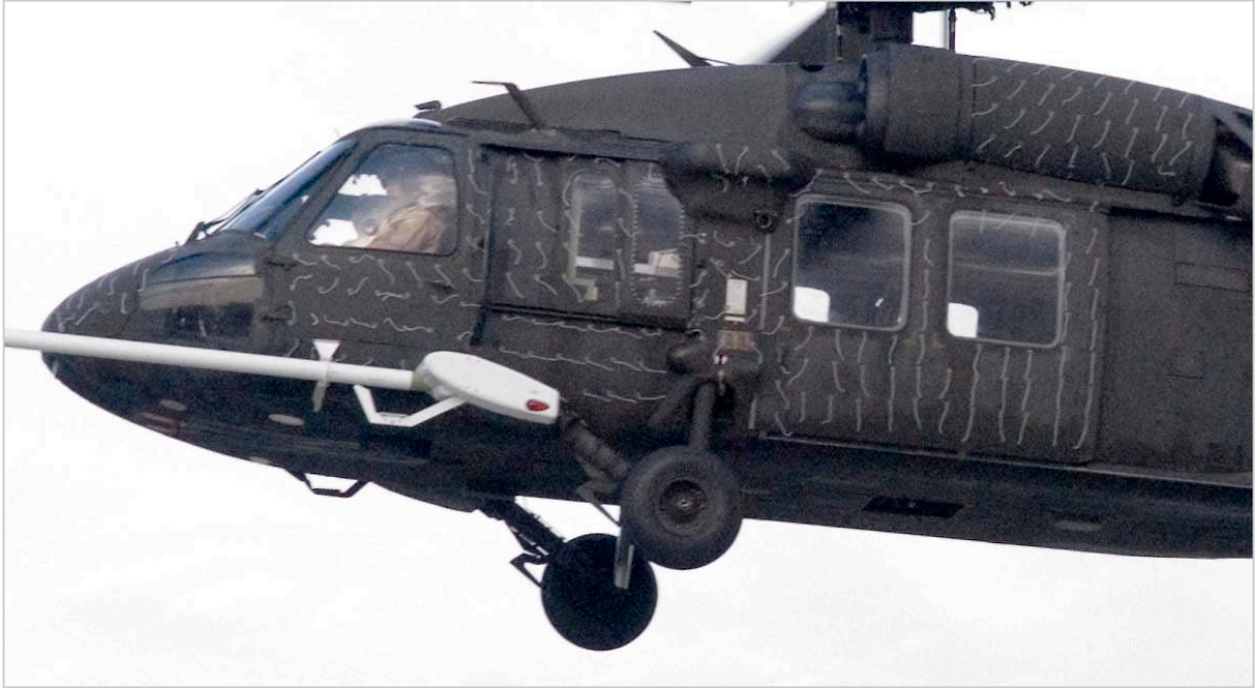
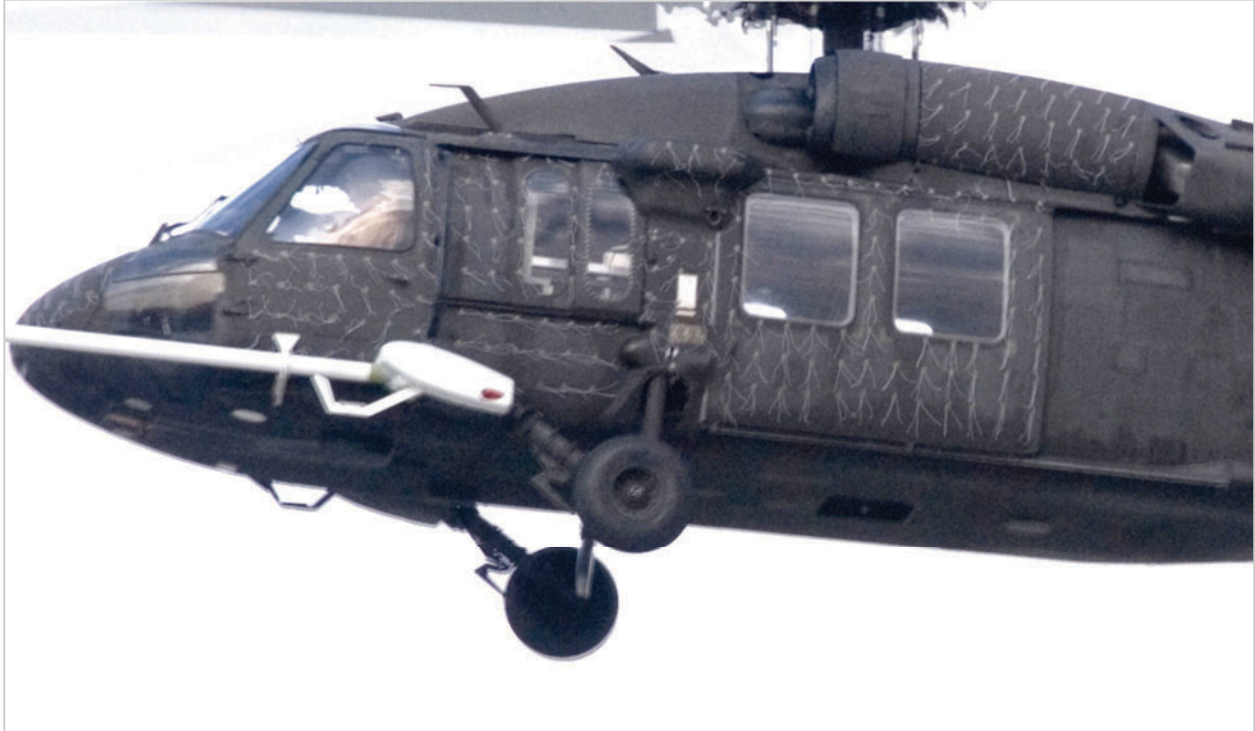
Figure 4. UH-60 airframe tufts in hover at 50-ft wheel height (OGE).

Figure 4(a). Single instantaneous airframe tuft pattern; Wheel height=50 ft.

Figure 4(b). Single instantaneous airframe tuft pattern; Wheel height=50 ft.

Figure 4(c). Single instantaneous airframe tuft pattern; Wheel height=50 ft.

Figure 4(d). Overlay of three instantaneous airframe tuft images; Wheel height=50 ft.

Figures 4(a) through 4(c) show single instantaneous photographs of airframe tufts on the UH-60L hovering out of ground effect (OGE) at 50-ft wheel height. Figure 4(d) represents an overlay of all 3 instantaneous images, providing information on average tuft direction and degree of flow steadiness (from degree of tuft coning) at this wheel height. The flow is clearly not steady. However, in general, tufts are seen to be pointing downwards on the side of the airframe (in the direction of the rotor downwash) indicating attached flow.

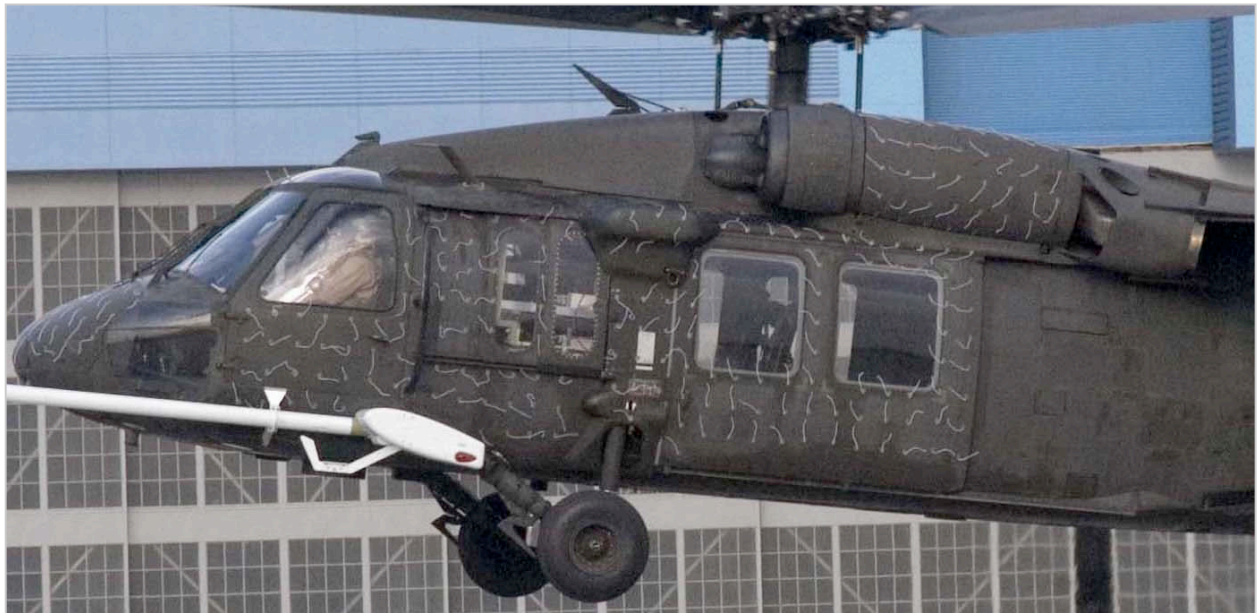
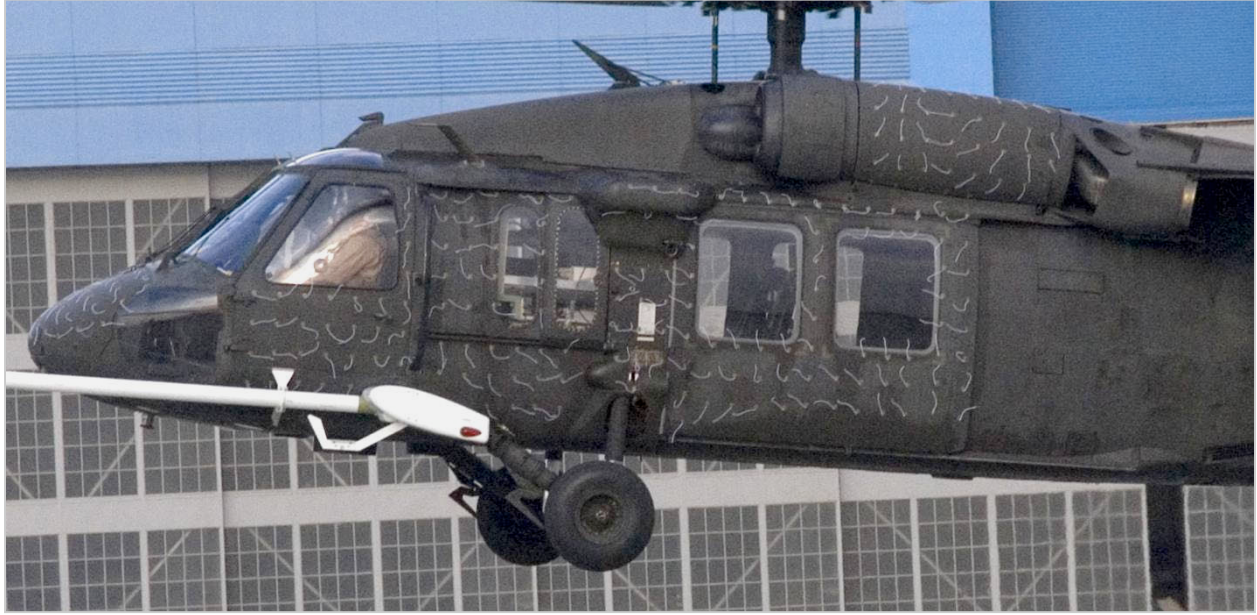
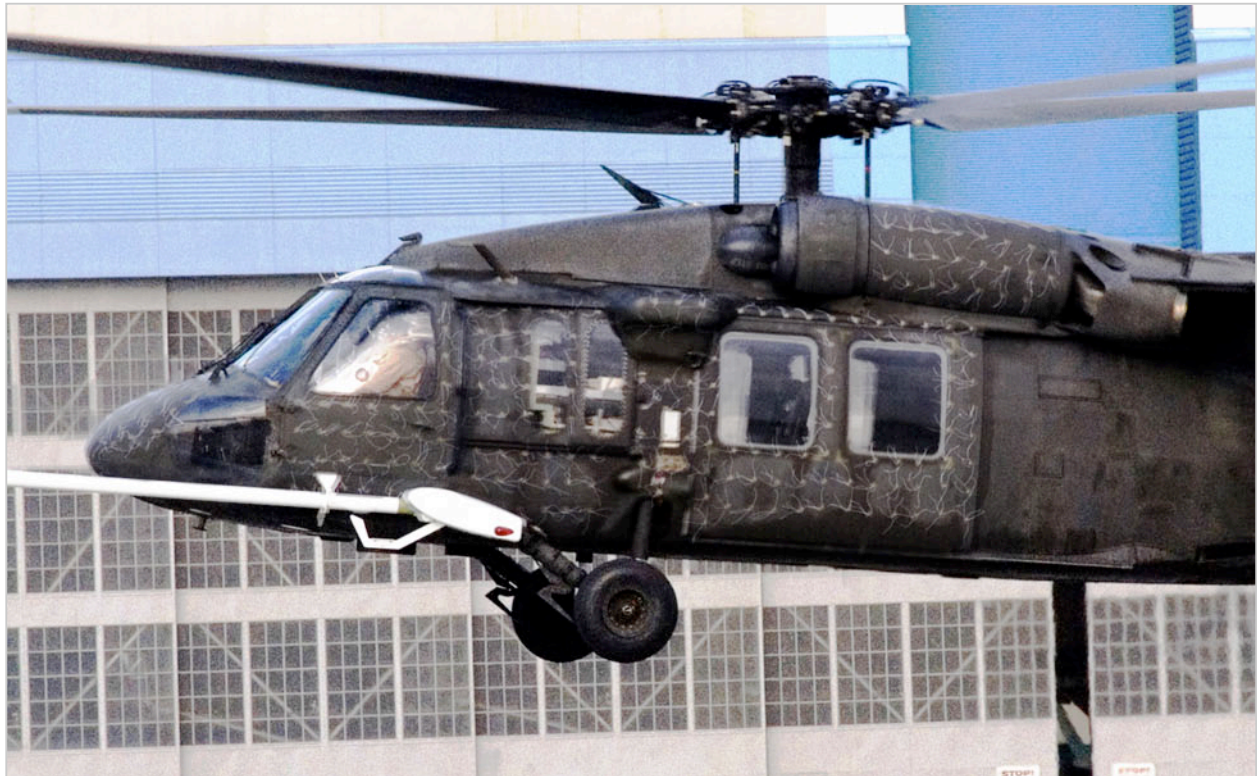
Figure 5. UH-60 airframe tufts in hover at 5-ft wheel height (IGE).

Figure 5(a). Single instantaneous airframe tuft pattern; Wheel height=5 ft.

Figure 5(b). Single instantaneous airframe tuft pattern; Wheel height=5 ft.

Figure 5(c). Single instantaneous airframe tuft pattern; Wheel height=5 ft.

Figure 5(d). Overlay of three instantaneous airframe images; Wheel height=5 ft.

Figures 5(a) through 5(c) show single instantaneous photographs of airframe tufts on the UH-60L hovering in ground effect (IGE) at 5-ft wheel height. Many tufts can be seen pointing upwards toward the rotor and away from the ground. Figure 5(d) represents an overlay of all 3 instantaneous images providing information on average tuft direction and degree of steadiness. In general, for the rotor in ground effect, the airframe tufts are very unsteady (the degree of unsteadiness increasing as the rotor approaches the ground). Many tufts show a large range of motion including complete reversal of flow direction. In general, tufts near the rotor hub tend to be pointing upwards.

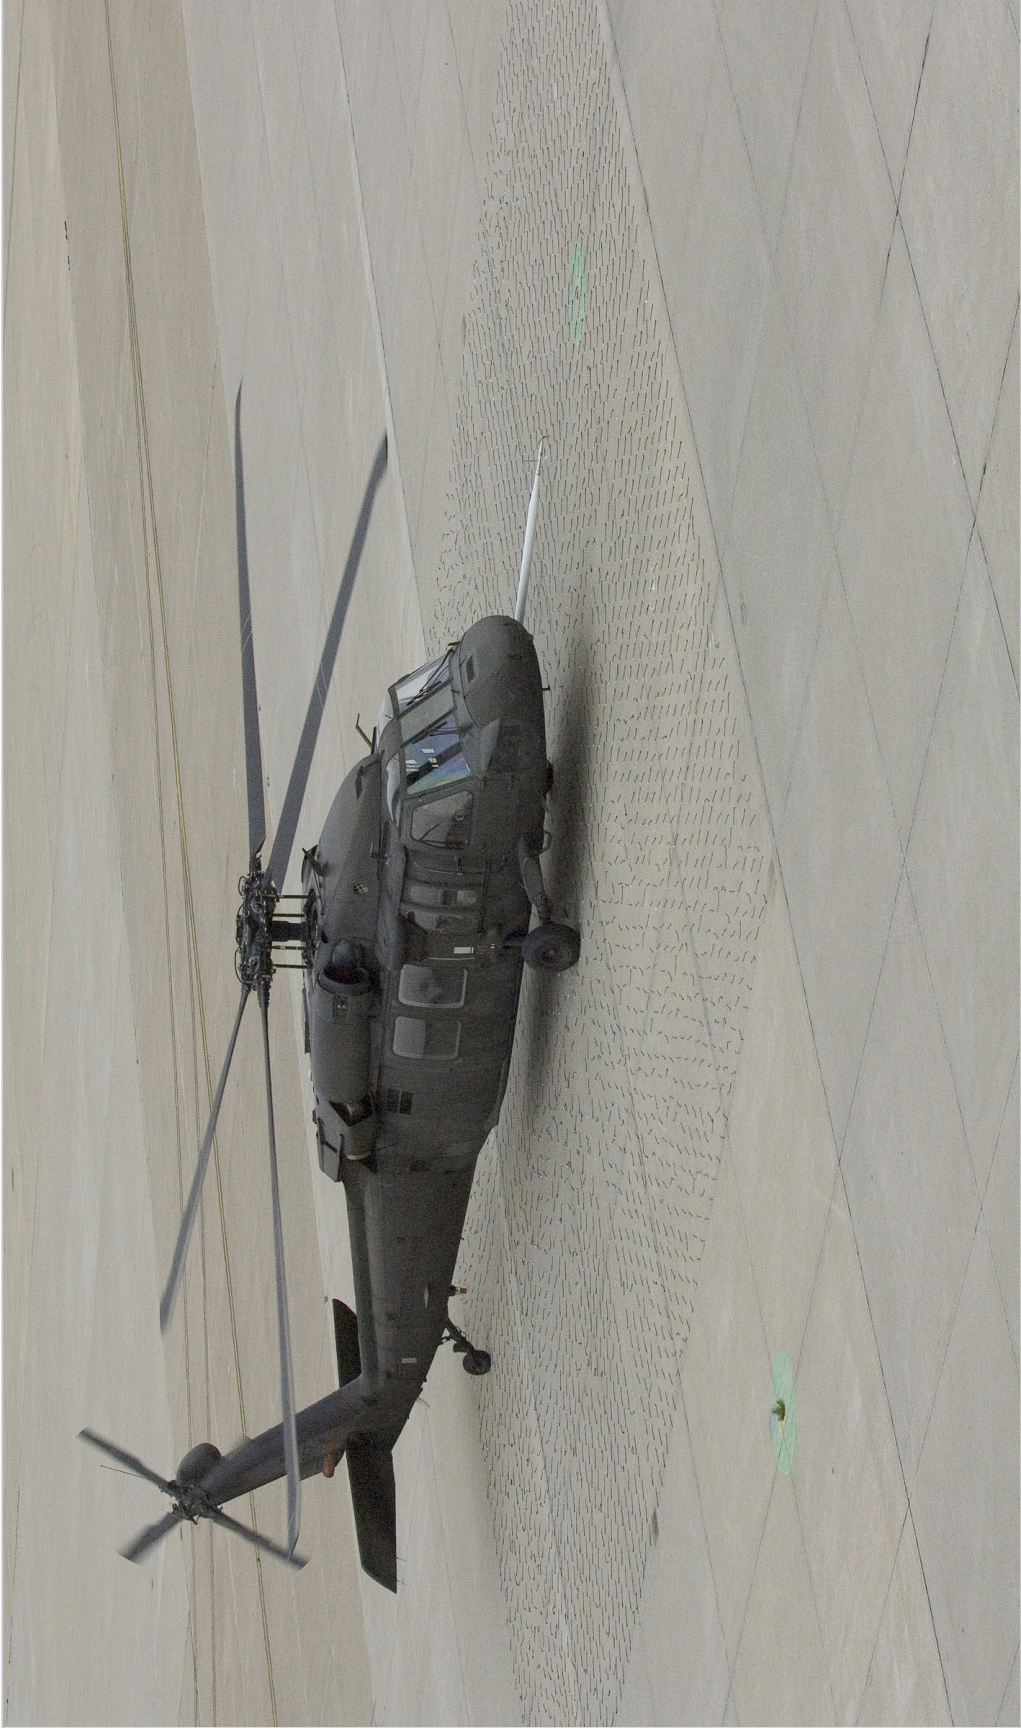
Figure 6. Original UH-60 instantaneous ground plane tuft image; Wheel height=0 ft.

unsteadiness due to pilot induced motions of the rotor. Ground plane tuft images were acquired with the UH-60L with wheels on the ground, rotor spinning at full rpm with collective at 75% of hover value. Figure 6 shows a single instantaneous photograph of the UH-60L with wheels on the ground, the image being taken from the roof of an adjacent building. All photographs of the ground plane tufts were acquired from this vantage point as described earlier. The original oblique view of the ground plane tufts shown in Figure 6 is difficult to interpret. Using Adobe Photoshop™, this image has been reoriented to show the ground plane tufts from a birds-eye view. Figure 7 shows Figure 6 after reorientation. This represents the view an observer would see from immediately above the center of the tuft grid. Because the image has been reoriented, the airframe shown in the upper right hand corner of Figure 7 appears warped. One feature in Figure 7 that should be readily recognized from Figure 6 is the white boom protruding from the front of the aircraft. The rotor disk and an outline of the airframe in plan view have been added for clarity. To remove the 180-degree directional ambiguity associated with any tuft, note that the silicone adhesive used to anchor the tuft to the ground is white. The instantaneous flow pattern under the rotor disk appears relatively disorganized. Figure 8 shows the result of averaging 25 such instantaneous images acquired every 3-seconds over a period of 1 minute and 15 seconds. Significant tuft coning is an indication of flow unsteadiness in Figure 8. Minimal tuft coning is an indication of steady flow. No tuft coning is an indication that the tuft has become entangled with an adjacent tuft or has become stuck to the ground.
