# Nondestructive Evaluation (NDE) for Characterizing Oxidation Damage in Cracked Reinforced Carbon-Carbon (RCC)

## **Abstract**

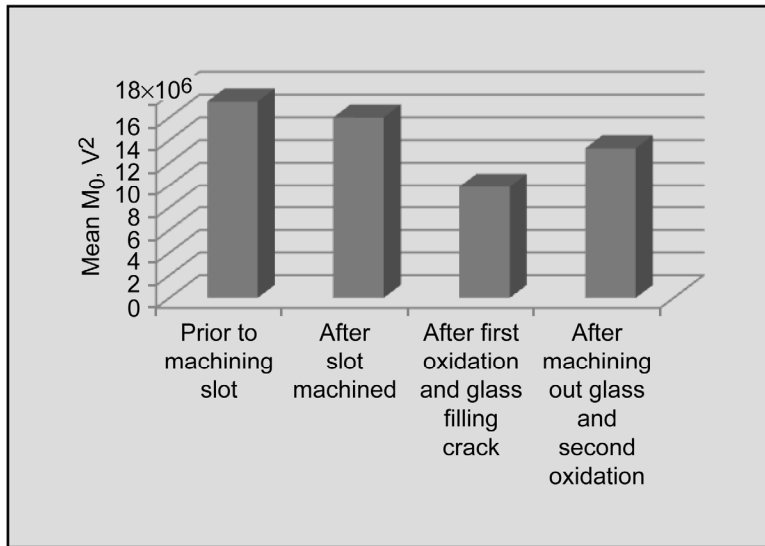
Figure 8.—Ultrasonic guided wave (mean total energy  $M_0$ ) results on sample RCC1 (Fig. 2). Measurement variability is about 2 percent based on repeated trials.

Figure 8 shows ultrasonic guided wave (mean total energy  $M_0$ ) results for RCC1 with the single machined slot. The guided wave technique is extremely sensitive to surface condition and the optical appearance of the surface appeared the same both before (baseline) and after oxidation. Controlled, identical force was present on the ultrasonic transducers for the ultrasonic measurements prior to and after oxidation. As compared to mean  $M_0$  of the time domain wave for the baseline condition (prior to machining slot), mean  $M_0$  had decreased after machining, after first oxidation, and after machining out glass in the slot and performing a second oxidation. However, the decrease was not monotonic for these steps. The general decrease in  $M_0$  after slotting and subsequent oxidation treatments is indicative of the slot structure scattering the ultrasound such that less ultrasonic energy reaches than receiving transducer as compared to the baseline (no slot) condition. Note that the repeatability of the measurement method was good. The five scans that were repeated after the final step show variability of mean  $M_0$  to be about 2 percent which is significantly less than the 8 percent decrease in  $M_0$  noted from baseline to after slot machined condition. This variability is dependent upon surface condition and measurement load remaining very similar.
