## CSM RCS Design Considerations & Failure Modes

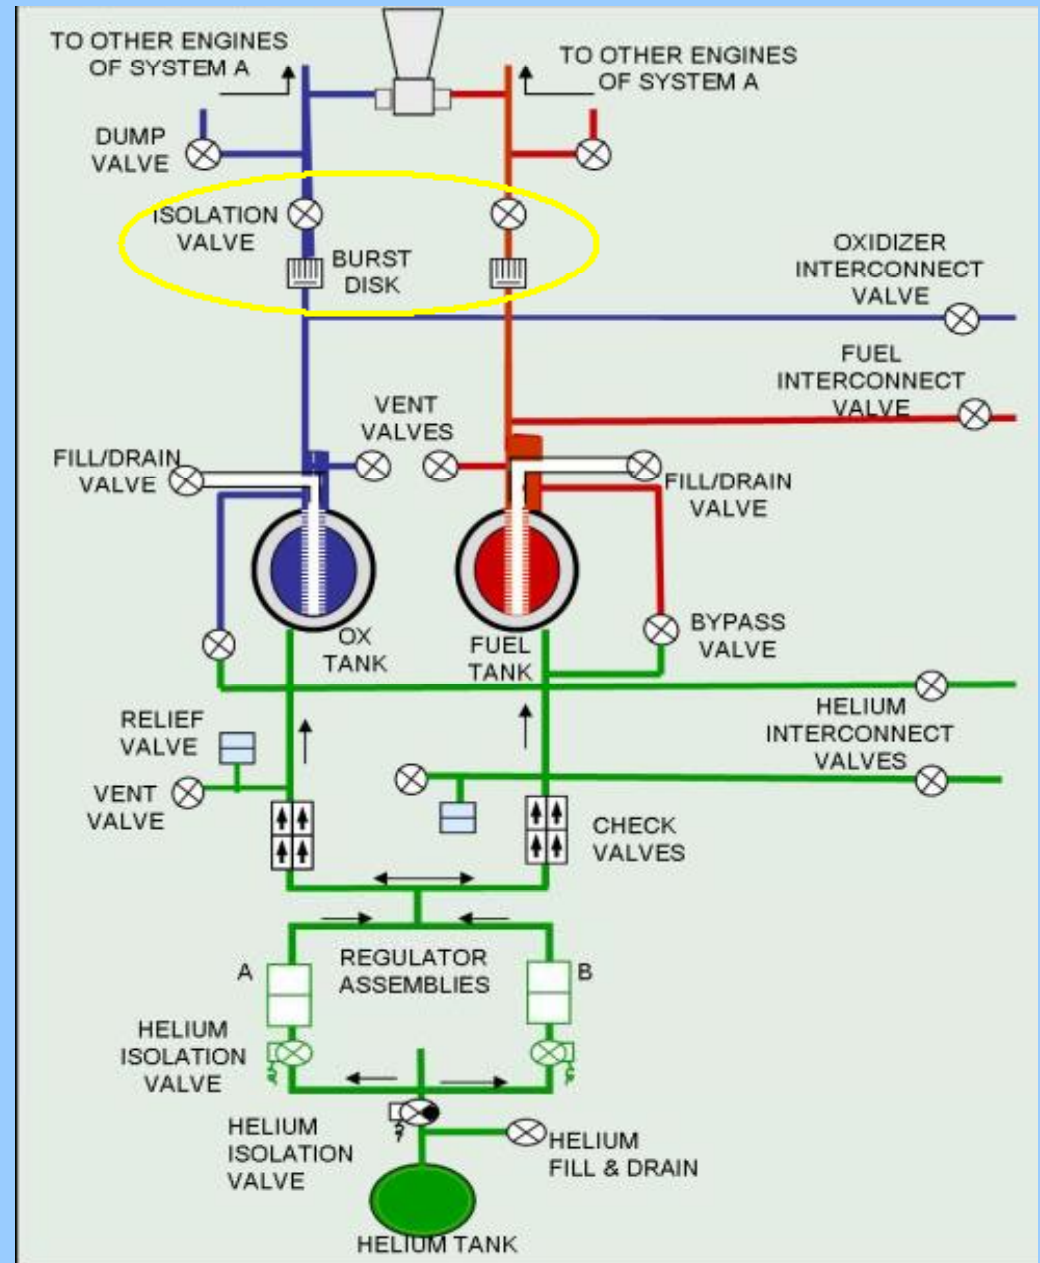
## CM Propellant Isolation Valves

- ❑ Apollo 7 - damaged bellows
- ❑ Apollo 10 - ruptured oxidizer burst diaphragm
- ❑ Apollo 12 - damaged bellows
- ❑ Apollo 13 - fuel valve coil miswiring

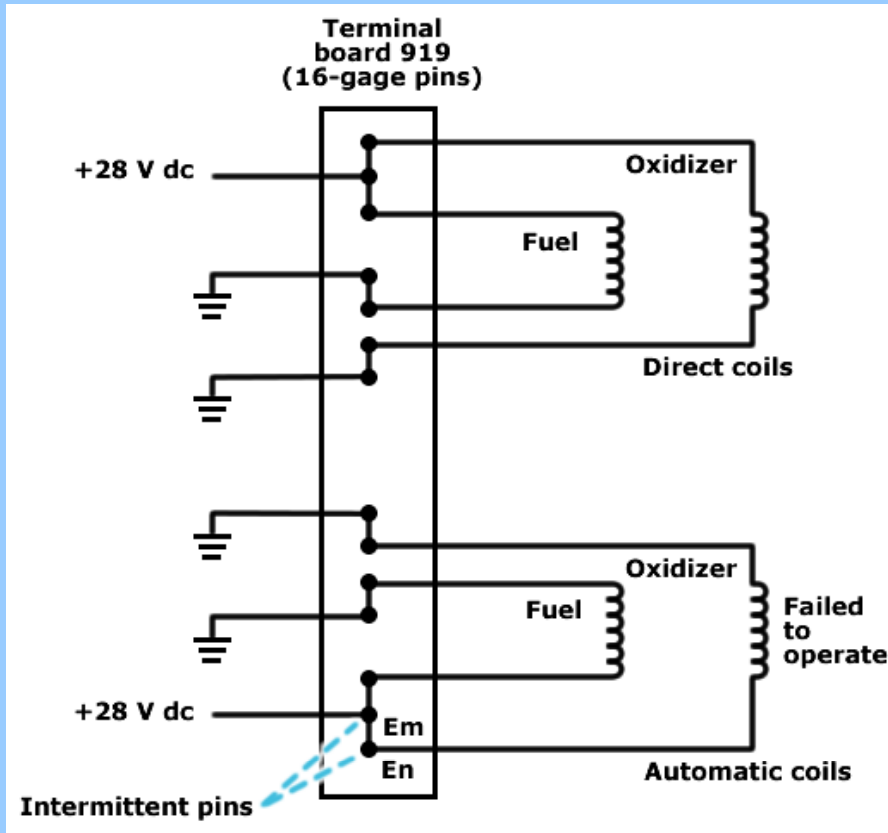
## CM Automatic Coil

Terminal board schematic for minus-yaw engine

- ❑ Anomaly: Faulty terminal board sending erratic firing signals through automatic coils
- ❑ Conclusion: Two loose pins causing intermittent continuity to coils
  - Found in all pre-November 1967 terminal boards
- ❑ Solution: No corrections made since terminal boards did not affect circuits that jeopardized crew

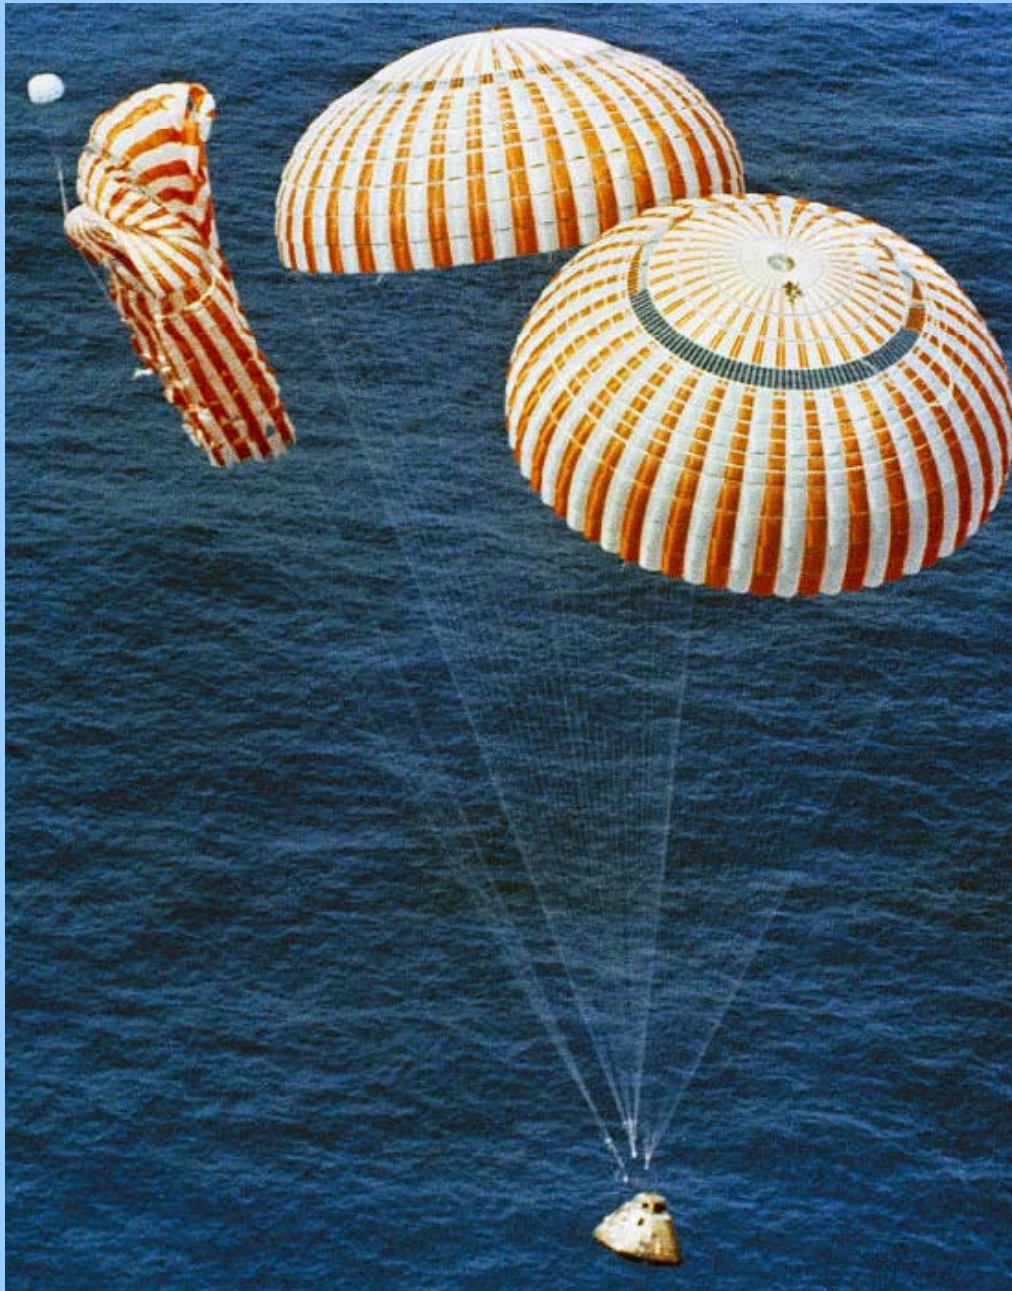
## CM Propellant Dump

- ❑ Apollo 15 - Deflated parachute due to CM RCS depletion firing
  - Correction:  
Procedures changed to allow propellant to remain onboard at landing
- ❑ Apollo 16 – Small burn holes caused by yaw engine firings
  - Tests determined maximum pressure and planned for on-the-water operation of the system if required
