## Space-Based Range

Global Positioning  
System (GPS)  
Metric Tracking

Space-Based Range (SBR), previously known as Space-Based Telemetry and Range Safety (STARS), is a multicenter NASA proof-of-concept project to determine if space-based communications using NASA's Tracking and Data Relay Satellite System (TDRSS) can support the Range Safety functions of acquiring tracking data and generating flight termination signals, while also providing broadband Range User data such as voice, video, and vehicle/payload data.

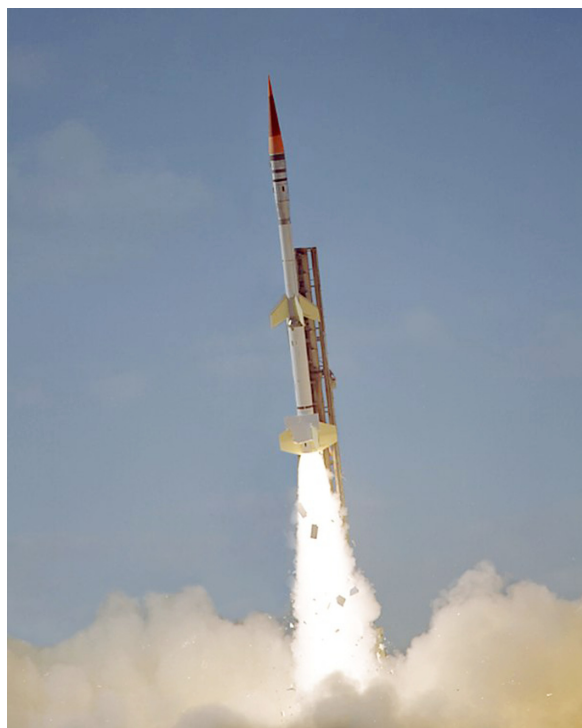
Figure 1. Sounding rocket launch.

There was a successful test of the Range Safety system at Wallops Flight Facility (WFF) on December 20, 2005, on a two-stage Terrier-Orion spin-stabilized sounding rocket. SBR transmitted GPS tracking data and maintained links with two TDRSS satellites simultaneously during the 10-min flight. The payload section deployed a parachute, landed in the Atlantic Ocean about 90 miles downrange from the launch site, and was successfully recovered.

Figures 1 through 3 show the phased-array antenna mounted on the F-15 and architecture of the sounding rocket. Figure 4 shows the Range User return link margins as functions of antenna elevation for 5-Mbps and 10-Mbps flights. Link margins greater than 9 dB could not be measured, so it can only be said that the link margins were greater than 9 dB for elevations above 30°.

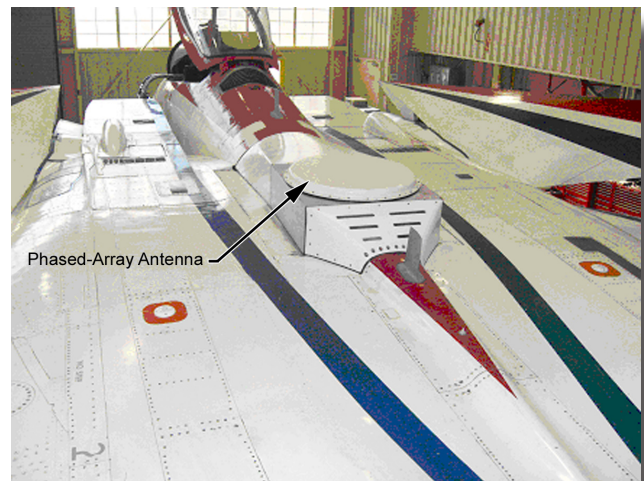
Figure 3. Phased-array antenna on the F15.

There were 11 flights on an F-15B at Dryden Flight Research Center (DFRC) between November 2006 and February 2007. The Range User system tested a 184-element TDRSS Ku-band (15 GHz) phased-array antenna with data rates of 5 Mbps and 10 Mbps. This data was a combination of black-and-white cockpit video, Range Safety tracking and transceiver data, and aircraft and antenna controller data streams. IP data formatting was used. The Range Safety system used the previously flown S-band transceiver to validate the forward and return links. Several “flyaway” maneuvers tested the transition from launch-head to satellite for the forward links.

During the F-15 test flights, custom algorithms used the vehicle position and attitude to steer the phased-array antenna toward TDRSS West (TDW) at 174° W longitude with a pointing error typically much less than 1°. The measured data and video latency for the Range User system was about 0.4 s. More than 99 percent of the Range User frames were locked for both 5 Mbps and 10 Mbps when the antenna azimuth performance was within nominal operating parameters and more than 98 percent when these parameters were intentionally exceeded. There was a reasonably smooth transition between the Range Safety launch-head and satellite

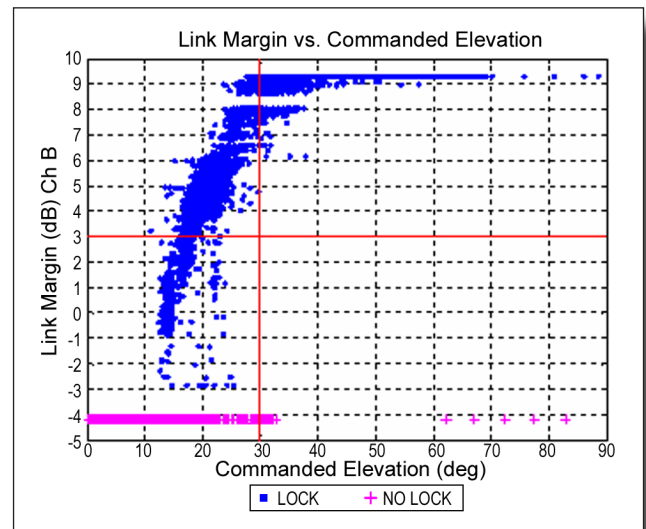
10-Mbps Flight

No-lock conditions caused when TDRS passed through the antenna zenith and signal reacquisition was delayed at the beginning of the test maneuver.

Figure 4. Link margin results for 5- and 10-Mbps flights. Note: No coverage was guaranteed by the manufacturer below  $30^\circ$  elevation.
