The International Space Station Solar Alpha Rotary Joint Anomaly Investigation

Abstract

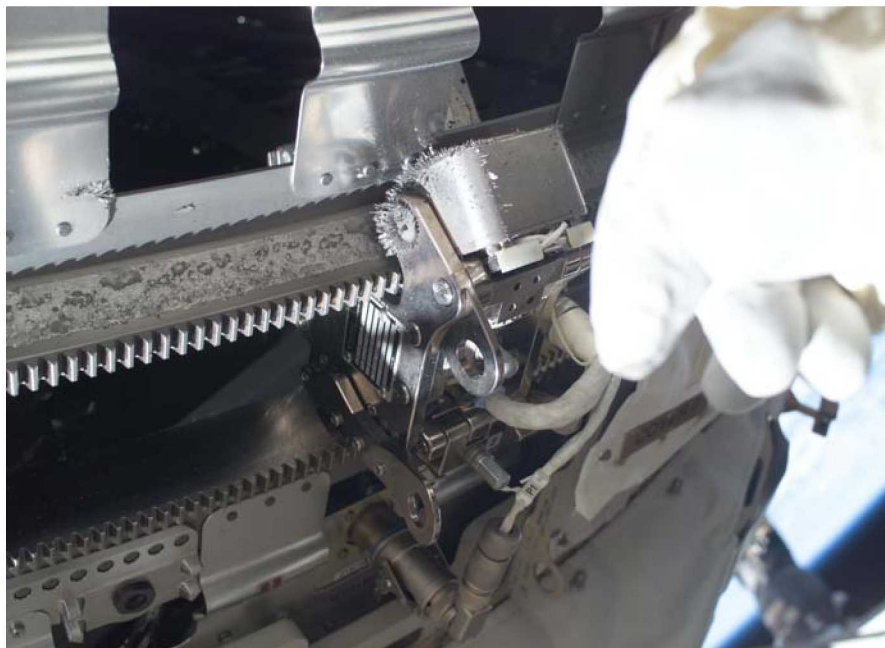
Figure 6. Astronaut Inspecting the Starboard SARJ During an Extra Vehicular Activity

Nothing off nominal was noted during the external survey. The crew had sufficient time to remove a MLI cover for additional inspection. Upon removing the cover the astronaut immediately noticed that there were fine metal shavings across the outboard bearing race surface. Additionally the astronaut noted that the TBA roller housing was acting as a magnet and collecting metal shavings. Samples of the debris collecting around the TBA housing were gathered and returned to ground for analysis (results discussed below). A characteristic picture of the condition of the mechanism can be seen in Figure 6 below. The outboard race ring, and specifically the outer canted surface, appeared discolored and mottled and there was debris on much of the surrounding hardware.

The root cause of the damaged bearing race was not immediately known. It was clear however that the mechanism was mechanically damaged and operating in a significantly degraded condition. There was concern that continued operation could exacerbate the problem. Also, the vibrations caused by rotating the joint had become severe enough that accelerated hardware fatigue was a concern. The anomaly investigation team recommended that operation of the Starboard SARJ be halted immediately until the root cause of the anomaly was known.
