Effect of charging electron exposure on 1064nm transmission through bare sapphire optics and SiO₂ over HfO₂ AR-coated sapphire optics.

Keywords: Space-based laser altimeter, sapphire optics, 1064nm optics, SiO₂ and HfO₂ AR coating, LOLA, MLA, radiation belt effects, space charging

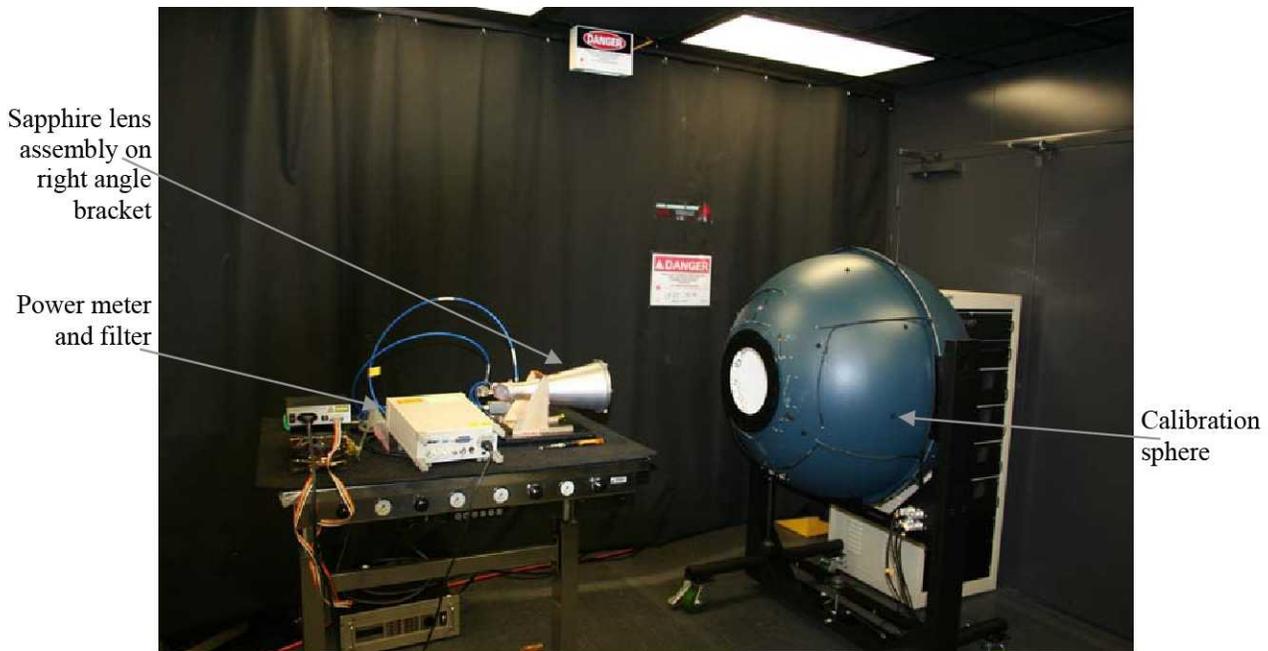
Figure 1 – Setup for the Transmission Measurement

To measure pre- and post-exposure transmission, an integrating sphere, 1064 +/-5nm FWHM filter, power meter, and right-angle bracket were configured as in figure 1. Intensity measurements were recorded for each sample (including control sample).

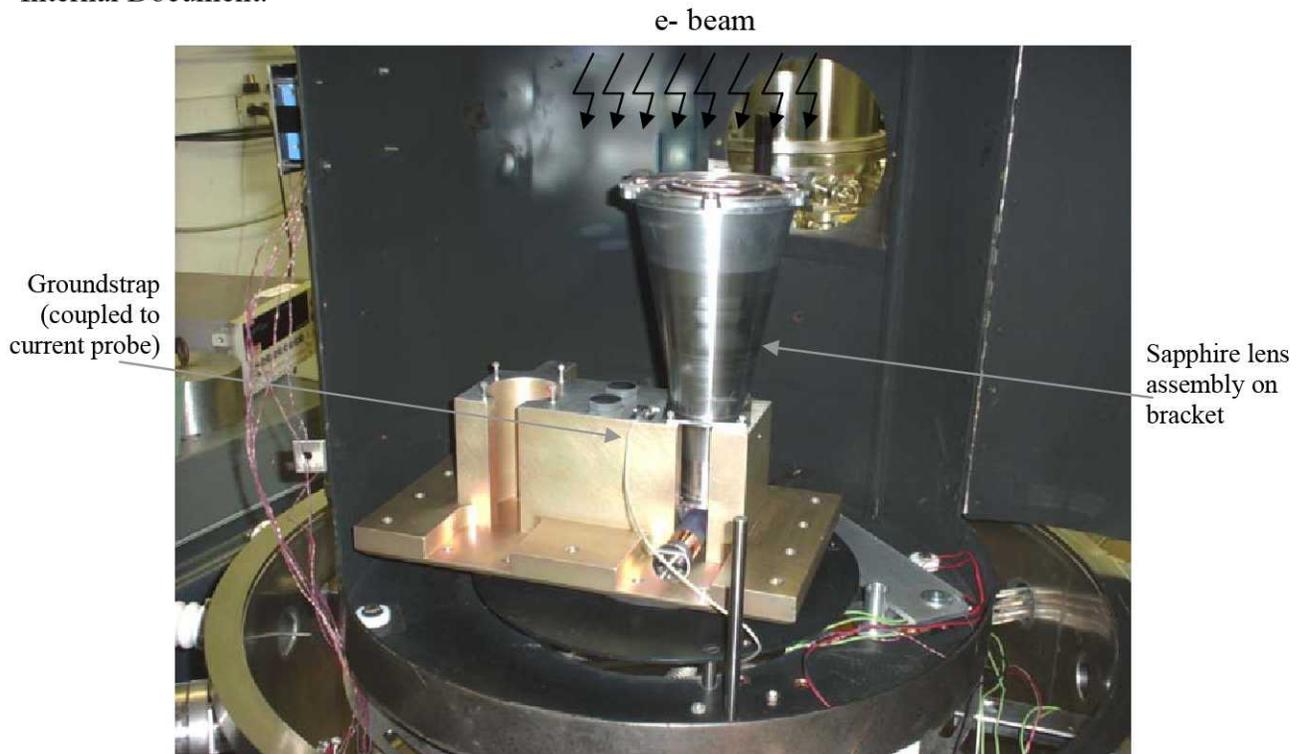
Figure 2 – Sample A prior to 10 keV exposure

After pre-exposure inspections and measurements, sample A was exposed to 10 keV electrons in the NASA Goddard Contamination and Coatings Branch Electrostatic Chamber and sample B was exposed to 1 MeV electrons at the NASA Goddard Radiation Effects Facility. Dosing for sample A was 1 nA/sq cm for 2 hours and dosing for sample B was 8×10^6 e-/sq cm-sec for 5 hours. One inch diameter x 0.5" thick, bare-sapphire witness samples were placed in the chamber but blocked from the electron beam to bound possible effects of contamination. The witness sample was measured using an automatic transmission spectrometer.

A photograph of sample A inside the chamber is shown in figure 2 and a photograph of sample B inside the chamber is shown in figure 3.

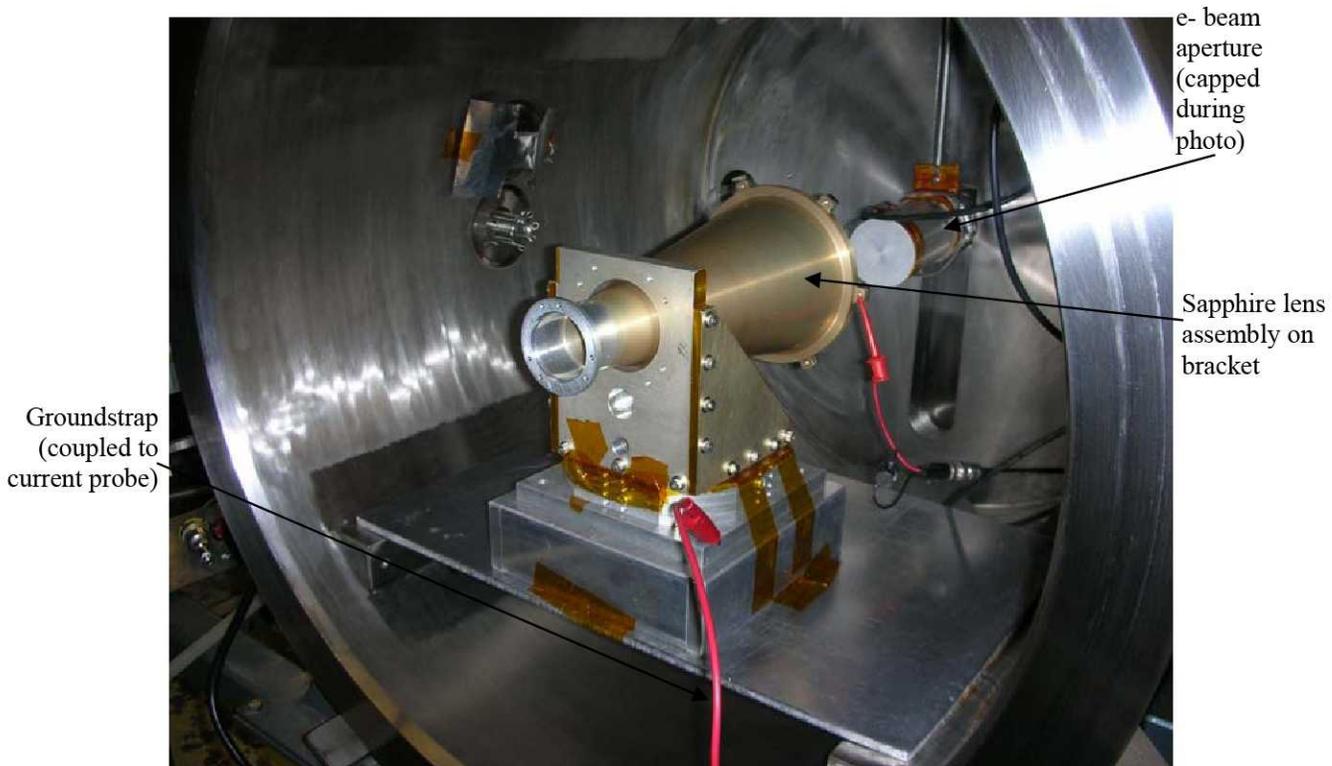
Figure 3 – Sample B prior to 1 MeV exposure

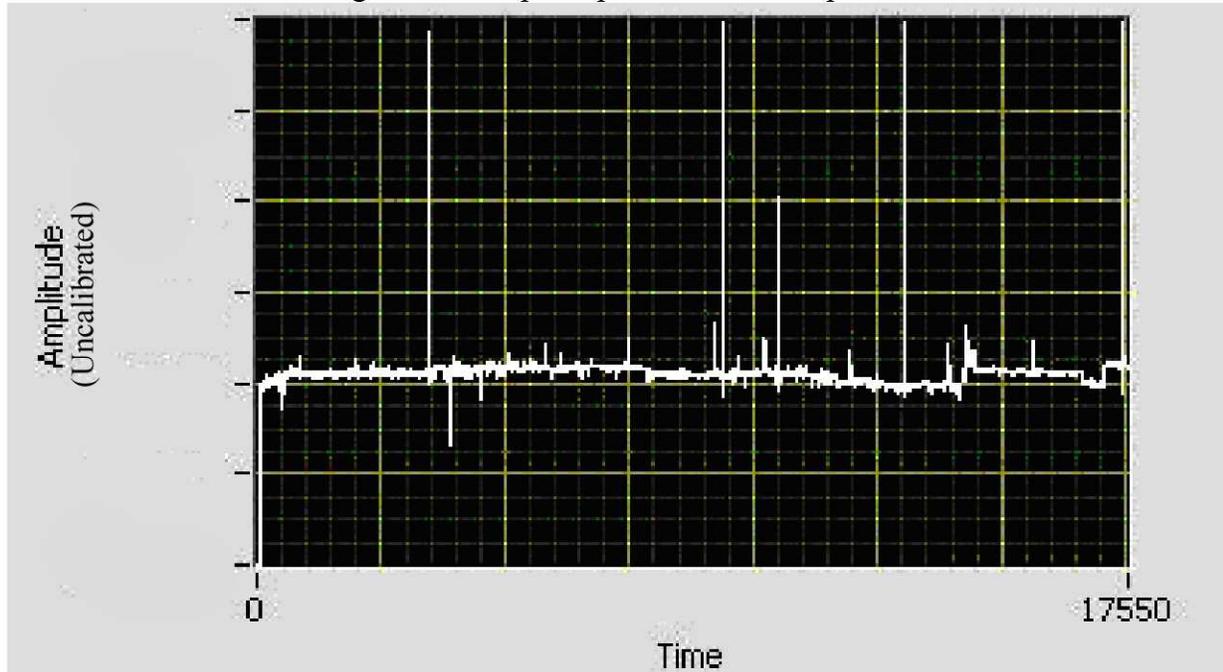
Figure 4 – Current monitor for sample B

To monitor possible discharge events, a current monitor was placed between the metal housing and ground. For sample A, it was implemented via an off-the-shelf current probe, amplifier, and oscilloscope. Events were triggered at 30A on the oscilloscope. For sample B, it was connected to an integrator and logged through LABView

Approximately 4 major spikes in the current monitor were seen for during sample B exposure. A plot of current vs. time (uncalibrated) for that exposure is given in figure 4. No events >30A were seen during sample A exposure, therefore no graphics of scope triggers are presented.

Four major and 1 minor discharge events are believed to have occurred during 1 MeV exposure and no discharge events were seen during 10 keV exposure. Transmission loss and Lichtenburg patterns, if any, due to electron exposure are believed to be very slight.
