NASA/TM-2010-216694
NESC-RP-07-035

Distributed Impact Detector System (DIDS) Health Monitoring System Evaluation

NASA Engineering and Safety Center Technical Assessment Report	Document #: NESC-RP- 07-035	Version: 1.0
Title: Distributed Impact Detector System (DIDS) Evaluation			Page #: 1 of 34

13. SUPPLEMENTARY NOTES					
14. ABSTRACT Damage due to impacts from micrometeoroids and orbital debris is one of the most significant on-orbit hazards for spacecraft. Impacts to thermal protection systems must be detected and the damage evaluated to determine if repairs are needed to allow safe re-entry. To address this issue for the International Space Station Program, Langley Research Center and Johnson Space Center technologists have been working to develop and implement advanced methods for detecting impacts and resultant leaks. LaRC funded a Small Business Innovative Research contract to Invocon, Inc. to develop special wireless sensor systems that are compact, light weight, and have long battery lifetimes to enable applications to long duration space structures. These sensor systems are known as distributed impact detection systems (DIDS). In an assessment, the NASA Engineering and

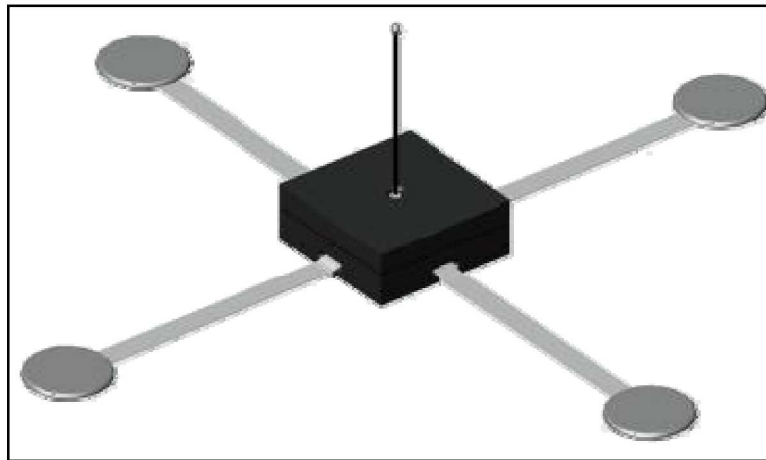
Figure 6.0-1. Conceptualization of a Wireless DIDS Module with Four Sensors

In 2005, LaRC selected an SBIR Phase II development proposal by Invocon, Inc. entitled “Distributed Impact Detection System” to develop a small, low power, multichannel, high-speed digitizing circuit that, in principle, could be used for continuous monitoring of spacecraft structures for accelerations or high-rate strains caused by impacts throughout all mission stages. The system would be able to provide general purpose circuits designed for integrated structural health monitoring. The goal was to allow for passive monitoring of a structure, including modal, frequency-based sensing, active damage detection, and structural monitoring. It was to have a modular architecture with a variety of triggering, power, and data interfaces and could support a variety of sensor options (Piezoelectric accelerometers, AE sensors, polyvinylidene fluoride (PVDF) piezoelectric patches, macro-fiber composite (MFC) patches, and microphones). Most importantly, it was to be decoupled from large amplifier modules, working wirelessly with a base station to simplify system installation, integration, and repair/replacement. Figure 6.0-1 represents a conceptualization of a DIDS module.

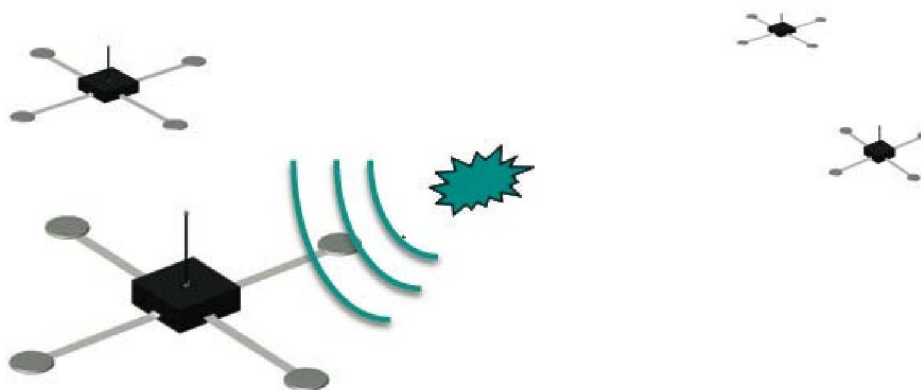
Figure 6.0-2. Schematic of the System Concept

The system concept was to deploy an array of modules throughout the spacecraft that could detect a significant impact event, see Figure 6.0-2 [refs. 1 and 2]. These units would be placed in a low-power, quiescent state where they would be “asleep” except for periodic radio telemetry checks and threshold sensing of an impact signal. The sensing of an impact event would wake a unit from the low-power mode and initiate data acquisition and storage on all four channels within a few microseconds.

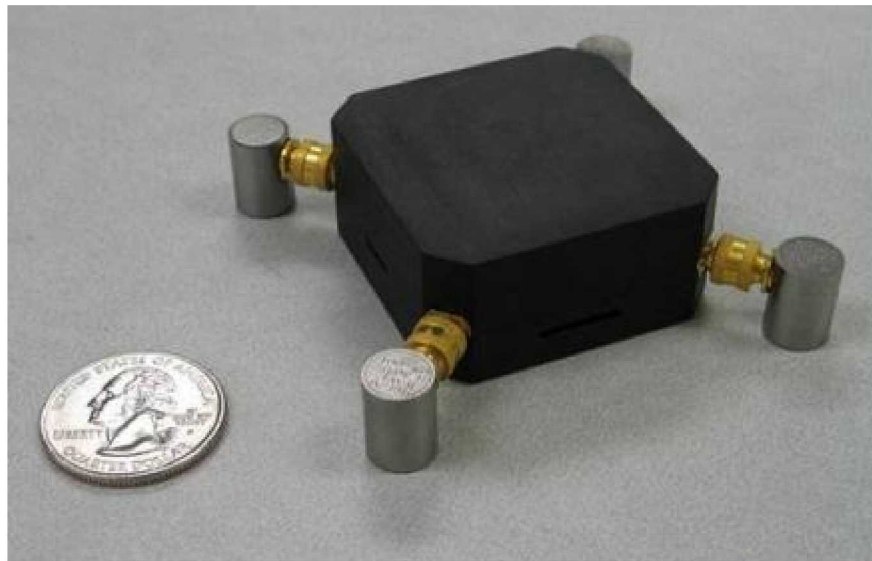
Figure 7.1-1. First Prototype DIDS Module Directly Connected to Four 0.375 inch AE Sensors

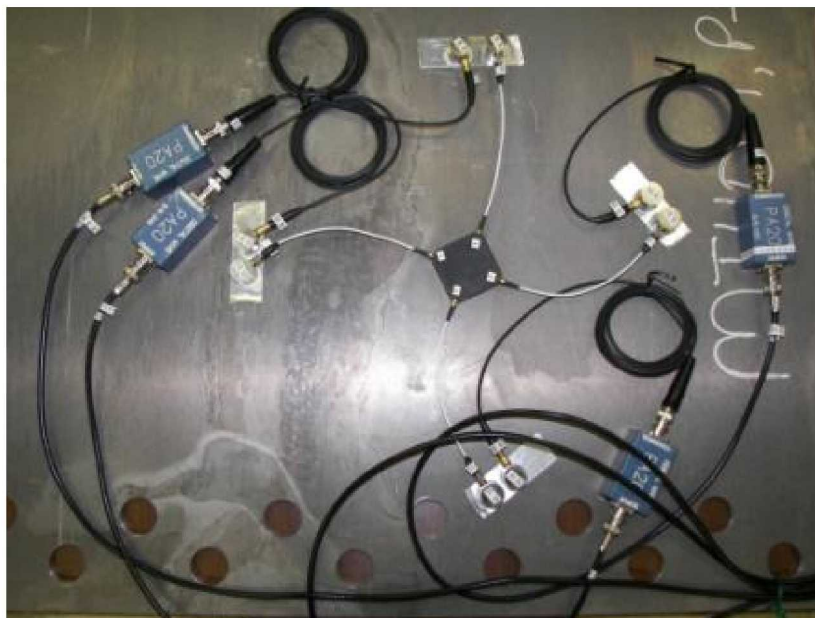
Figure 7.1-2. Close up of a DIDS Module Attached to an Aluminum Plate in Parallel to a Conventional AE System

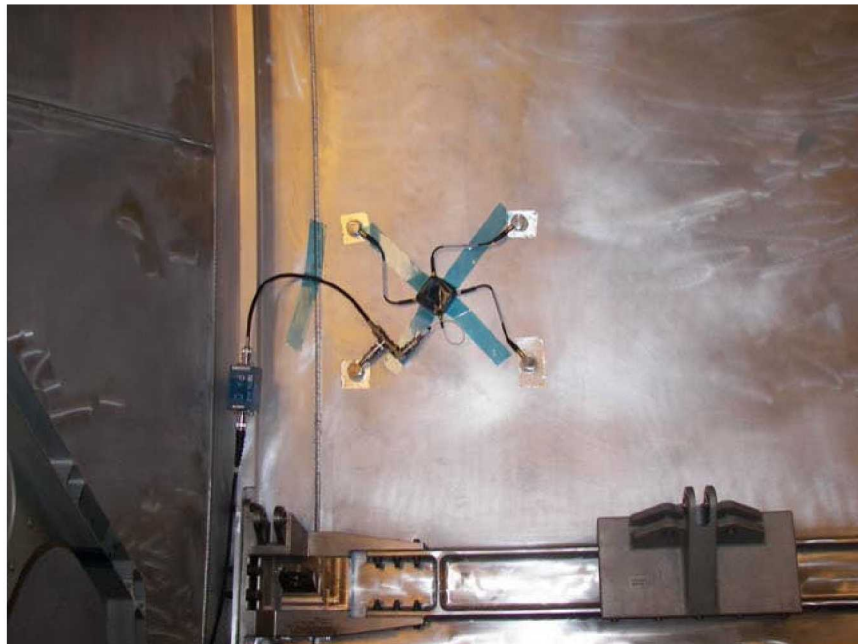
***Figure 7.2-1. DIDS Module with Four AE Sensors Attached to the Node 1 STA Module Wall
(The Third Sensor (Channel 3) was also connected to a Conventional AE System)***

Five DIDS units were attached to the STA walls as shown in Figures 7.2-1 and 7.2-2. From each DIDS, the channel 3 sensor signal was split for connection to a parallel AE data acquisition system for simultaneous recording. To simulate a leak due to a MMOD penetration in the module wall, a small hole was drilled in the forward cone wall, see Figure 7.2-3. A vacuum system was attached to the external module wall to simulate an atmosphere to space leak. The DIDS sensors under a forced trigger command then recorded the signals generated by the leak. The locations of the DIDS systems are shown in the schematic in Figure 7.2-4. They were distributed from the aft to forward end of the module to cover a range of detection distances. In addition to the actual leak source, a signal similar to a leak signature was injected at various points on the Node 1 STA wall by means of a piezoelectric transmitting transducer.

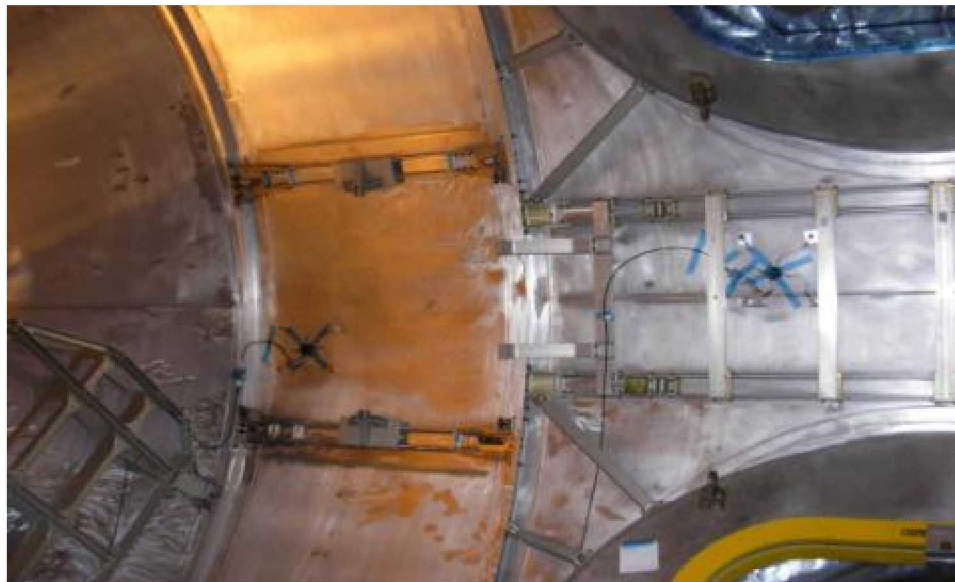
Figure 7.2-2. Photograph of Two DIDS Modules Attached to the Node 1 STA Module Wall

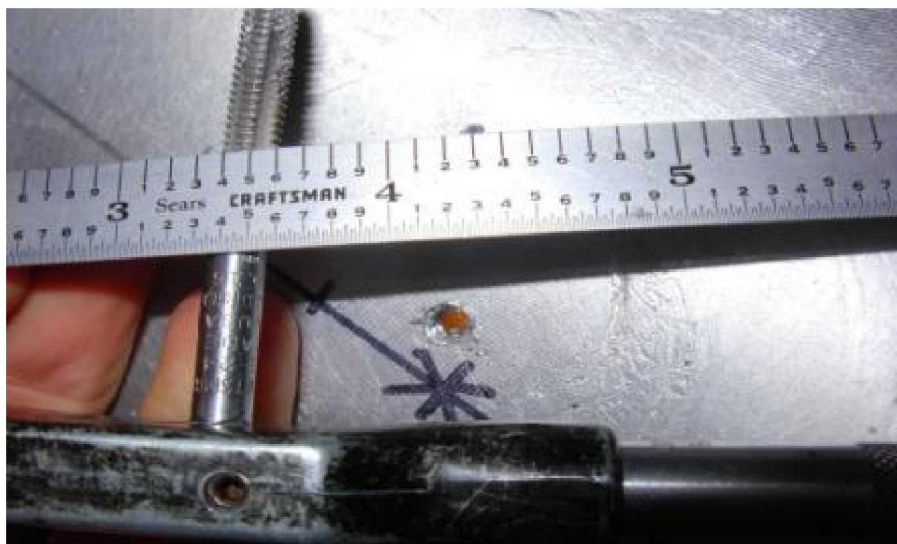
Figure 7.2-3. Example of a Hole that was drilled into the Module Wall for Purposes of Creating a Leak Signature (A tap was used to roughen the hole's edge)

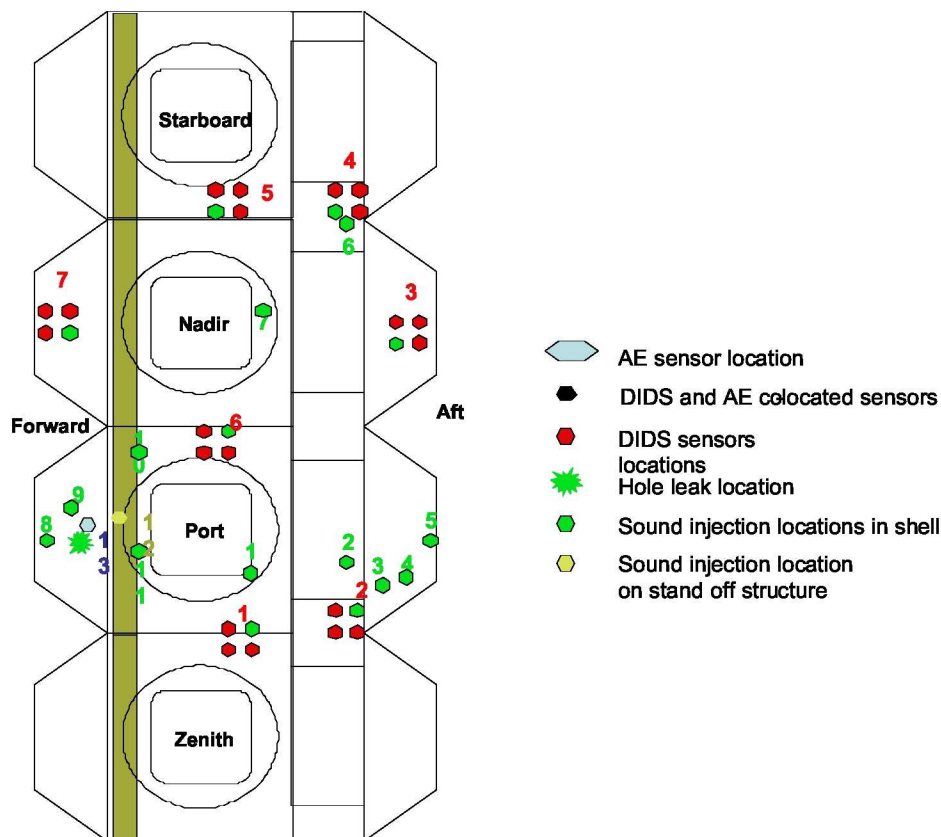
Figure 7.2-4. DIDS Module Locations (shown as red symbols) on a Schematic Layout of the Node 1 STA Wall

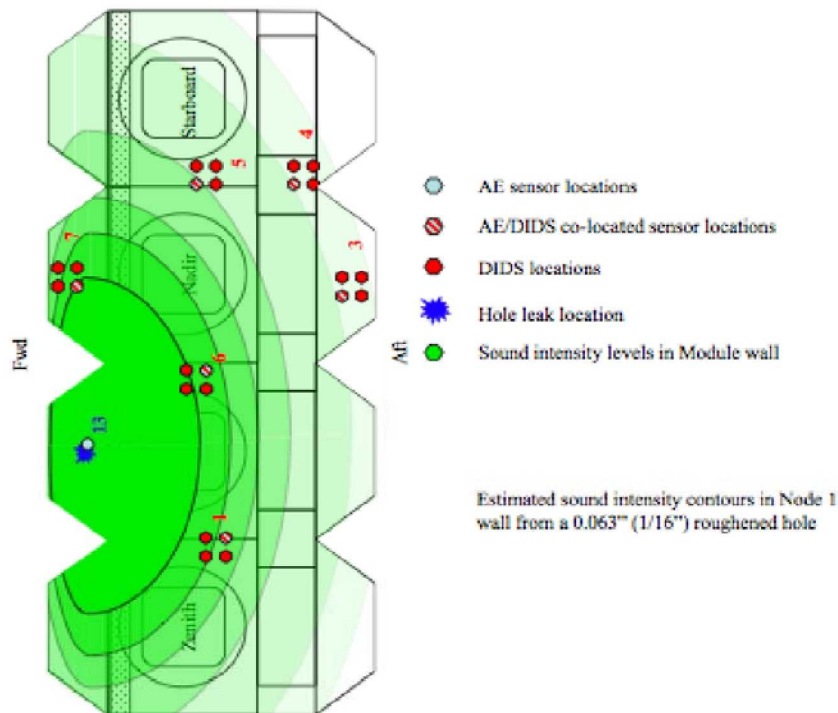
Figure 7.2-5. Estimates of the Sound Intensities as Shown on a Schematic Layout of the Node 1 STA. The noise signal was generated from air escaping through a 0.0625 hole drilled in the wall.

The resulting leak signals are schematically depicted as estimated iso-intensity curves seen in Figure 7.2-5. It can be seen that the sound intensity diminishes with distance from the source. Figure 7.2-6 shows a graph that depicts the sound intensity declining with distance from the source for four different hole sizes (0.0625, 0.089, 0.139, and 0.173 inches). Figure 7.2-7 shows a similar intensity character for the 0.0635 simulated MMOD leak. The difficulty that is evident in the data is that throughout these tests, channels would lock up on each module resulting in gain distortions as mentioned in Section 7.1.2.

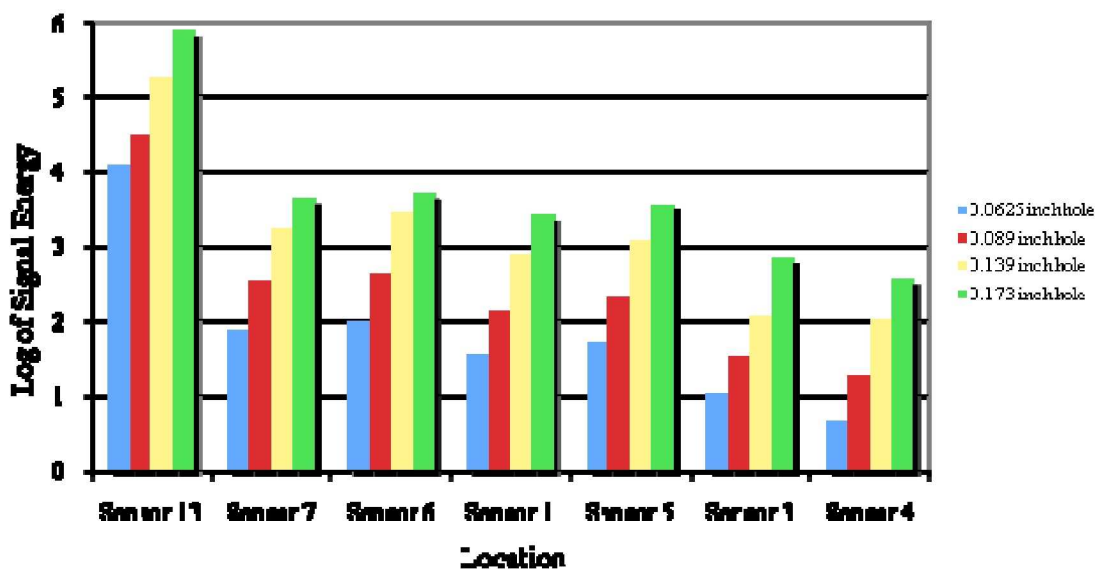
Figure 7.2-6. Measurements of the Sound Intensities from a Noise Signal Generated from Air Escaping through Holes Drilled in the Wall

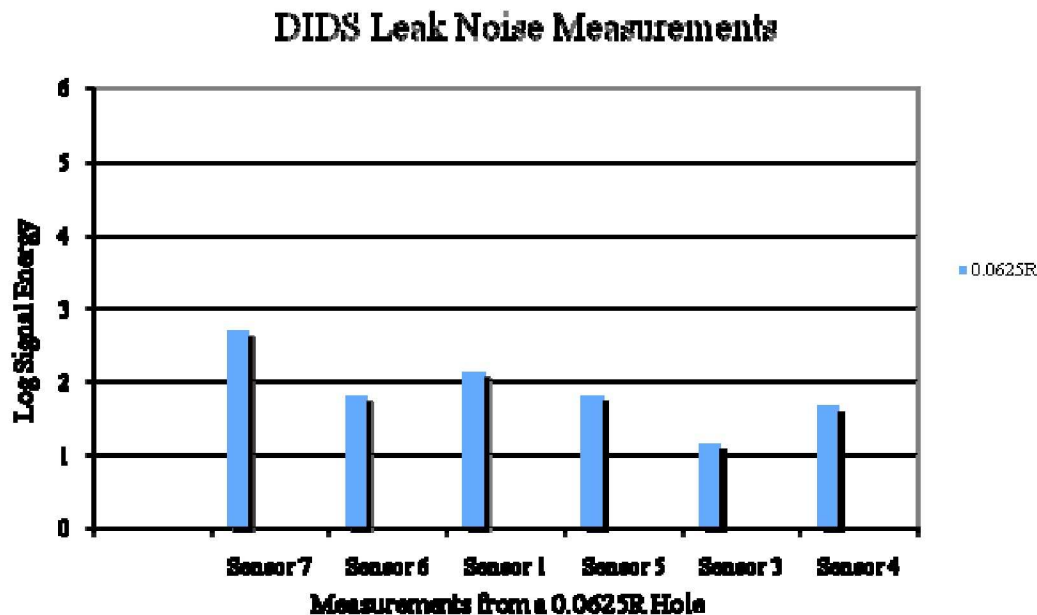
Figure 7.2-7. DIDS Measurements of the Sound Intensities from a Noise Signal Generated from Air Escaping Through a 0.0625 Inch Hole Drilled in the Wall

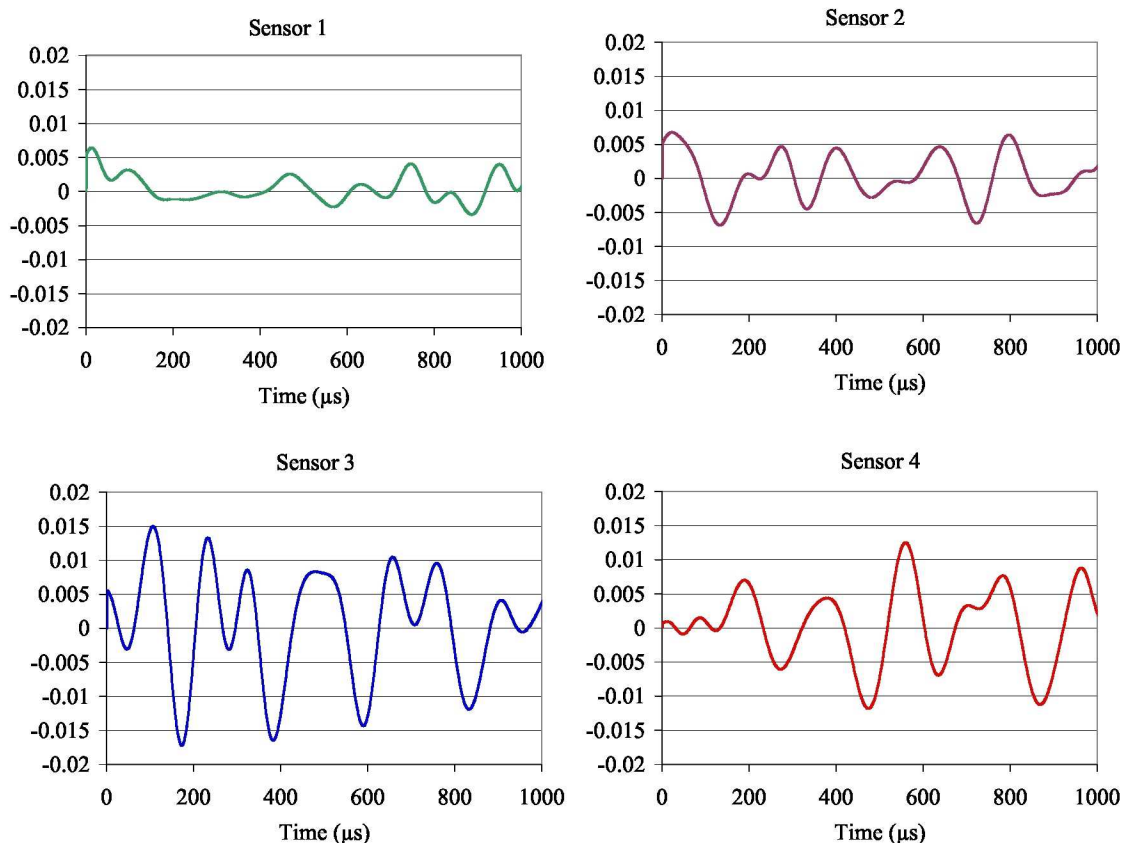
**Figure 7.3-1. Signals Recorded from an Impact on a Thick Large Composite Cylinder
(Vertical scale is in volts)**

Another characteristic of AE signals in composites is the lack of a relatively sharp event arrival onset, which allows the DIDS unit to trigger on one sensor and be able to record the signal arrival on the other three channels. In Figure 7.3-1, all the sensors are recording signals at the outset because the ultrasound wave has already arrived at all the sensors. This makes the identification of the signal first arrival time difficult. At these low frequencies, the signals have a slow, low level amplitude onset with time, which causes the signals to slowly build up in amplitude until it is strong enough to pass the triggering threshold. At that point, the signal’s first arrival will have passed all the sensors by the time the module is triggered.

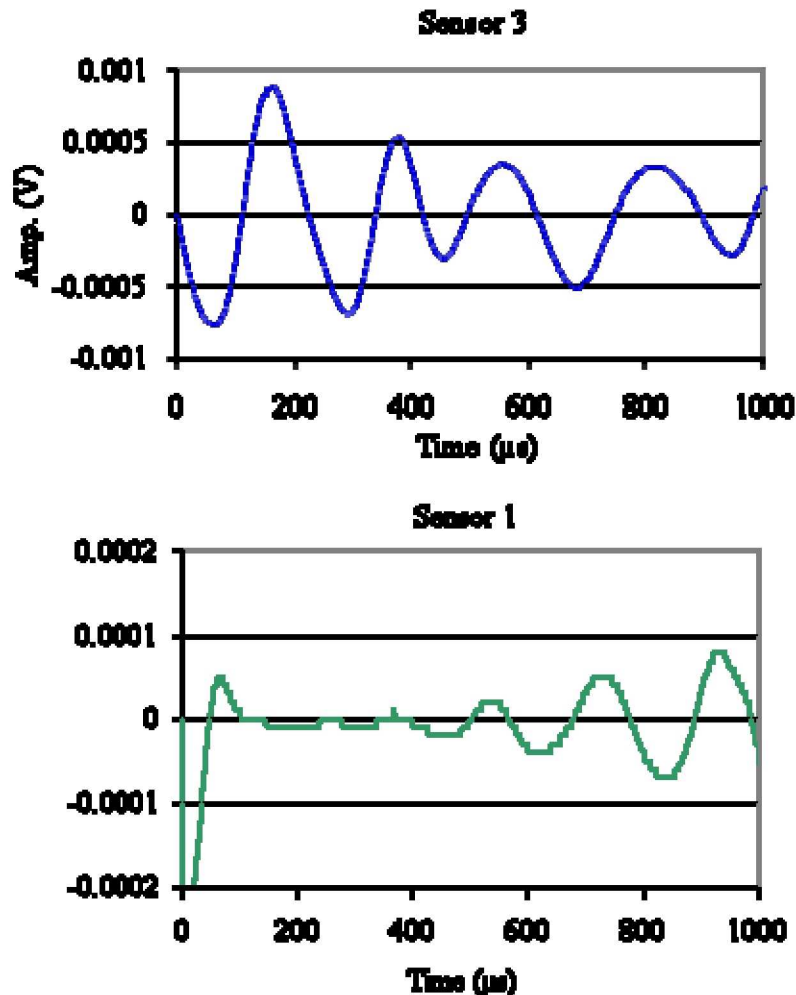
Figure 7.3-2. Signals from Sensors Spaced 60 to 70 inches Apart to Help Capture the First Arrival of the Ultrasound Wave at Sensor 1. (Vertical scale in both panels is in volts)

To counter this effect and to better record the signal's first arrival, the sensors should be placed further apart. This was done at ATK. The DIDS sensors were separated 60 to 70 inches apart on the solid rocket motor case. The results of a low level impact 15 feet away can be seen in Figure 7.3-2. In this test, the DIDS unit was triggered by sensor 3. Sensor 1 shows a signal arriving at about 250 μs later and at a reduced signal level. Note the vertical sensitivity is different because these were two different sensors with different sensitivities.

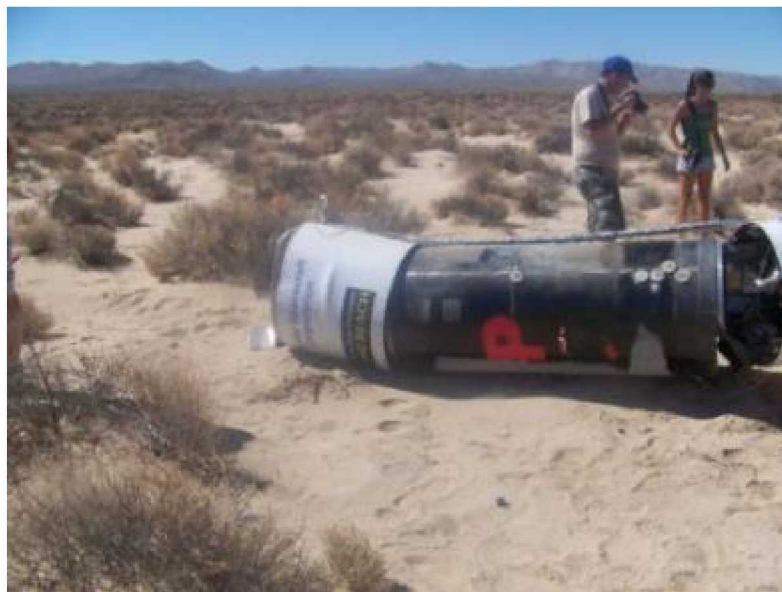
Figure 7.3-5. P-9 Rocket Crash Site Showing Vehicle Forward Section

Figure 7.3-5 shows the rocket forward end at the crash site. The black section is the linerless composite LOX tank. Figure 7.3-6 shows a closer view to the LOX tank with a longitudinal crack that ran the length of the tank. Figure 7.3-7 is an image of the crash area showing the

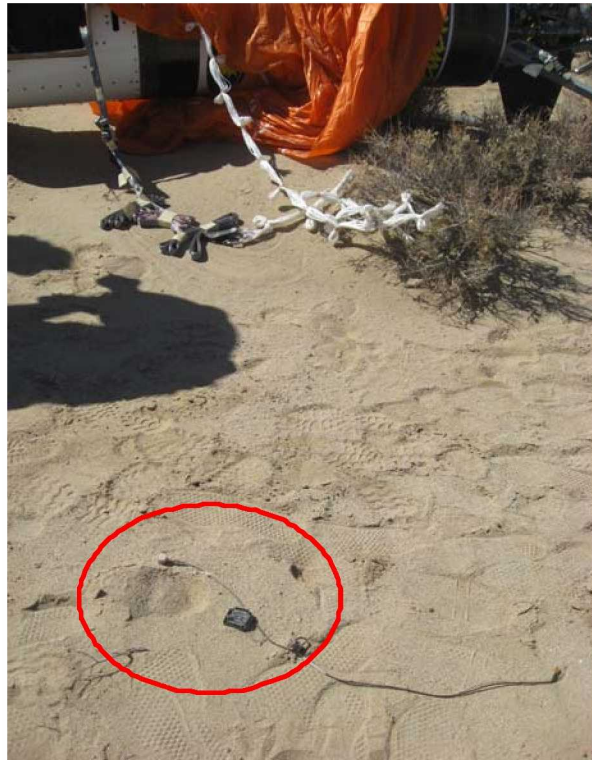
Figure 7.3-7. P-9 Crash Site with Ejected DIDS, Sensor and Cable

DIDS module and one of the sensors and cables lying near the vehicle body after it was ejected from the rocket.

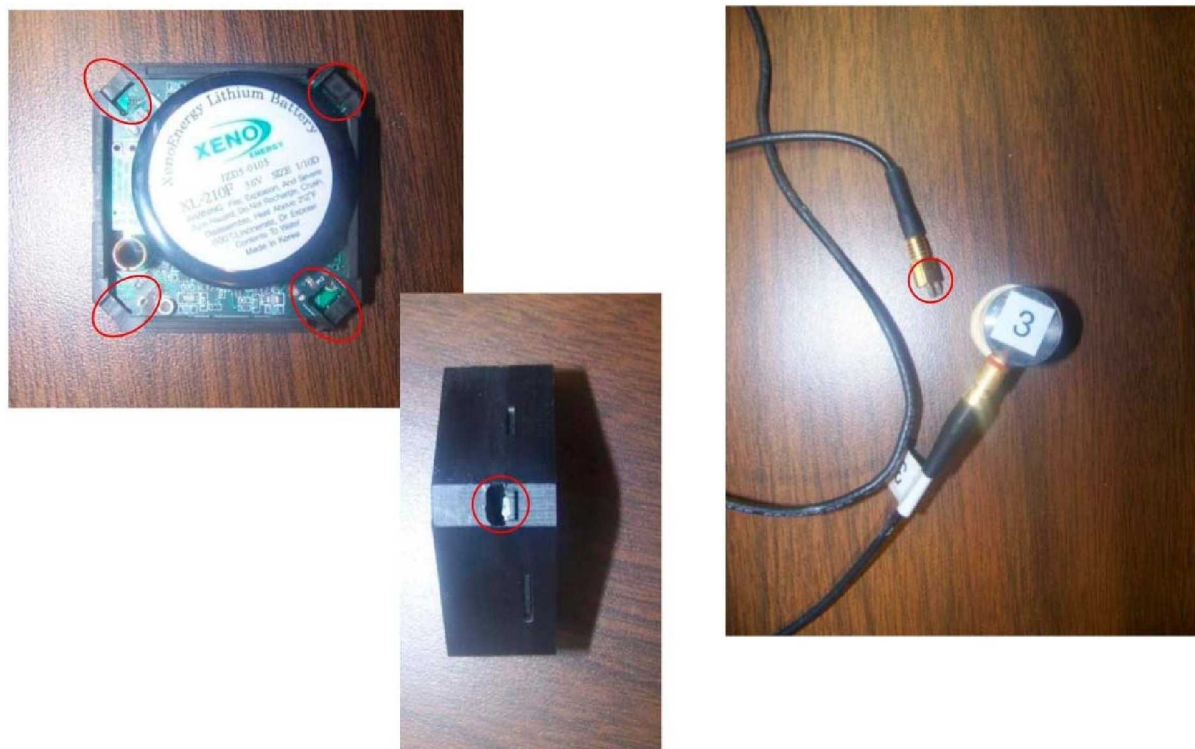
Figure 7.3-8. a) DIDS Body Showing a Missing Jack (circled in red). b) DIDS Showing Four Missing Jacks (circled in red). c) Cable with AE Sensor and DIDS Jack (circled in red).

The DIDS, battery, sensors, and cables were recovered, and the system was inspected. Figure 7.3-8 shows the damage that the DIDS sustained. The extent of the damage appeared to be that the jacks at the four corners of the module were displaced from the module's case by the sensors that came free prior to the final impact. After the battery was reinserted into DIDS, the module initialized and the complete data set was downloaded. The data set included all 275 recorded events corresponding to the flight preparation, loading and transportation to the Mojave Desert, propellant loading and, finally the launch and crash. No DIDS faults or failures occurred during this test and the system successfully collected data during the truncated flight.

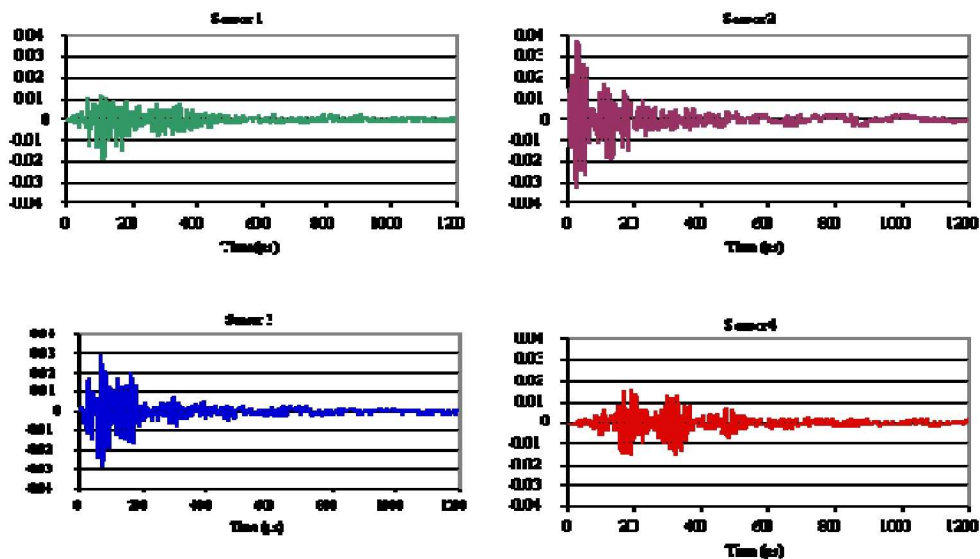
Figure 7.3-9. Data from the DIDS Sensors Measured during the LOX Fill. (Vertical scales in volts)

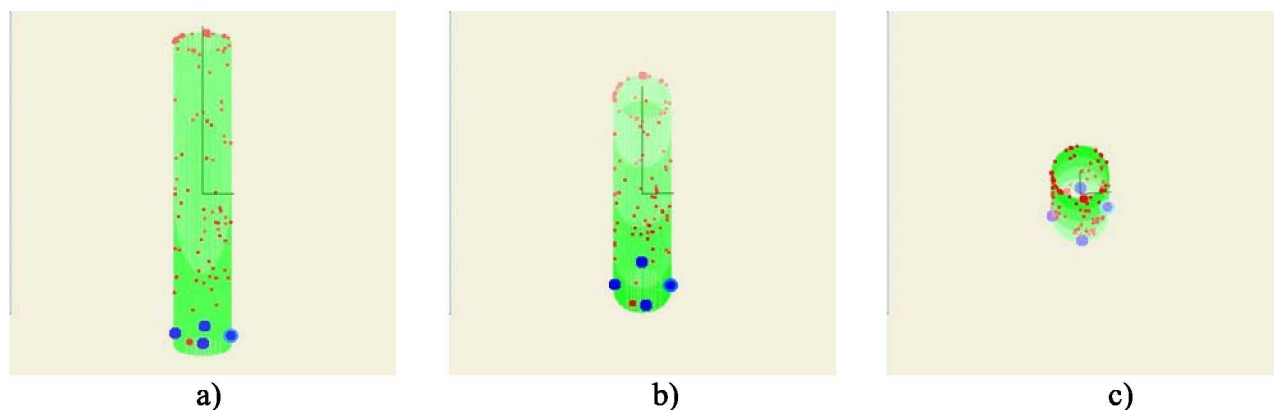
Figure 7.3-10. Estimated Event Locations Shown on a Cylindrical Shape used to Represent the LOX Tank. (The three views show the cylinder tilted at different angles)

Because the signal arrival times are discernable, it is possible to triangulate the signal's source location. This is shown in Figure 7.3-10, which is an example of a triangulation algorithm applied to a cylindrical shape. Three views of the cylinder are shown with different aspect ratios. The four blue dots are the sensor locations while the red dots are the estimated event locations. There are some distortions in the data in Figure 7.3-10 as the tank does not have opened ends and the composite material is anisotropic. This treatment of the tank as an open cylinder tended to push the event locations away from the transducers. The estimated locations were obtained for numerous events, and many were at the LOX fill port at the top of the cylinder, which should be expected.

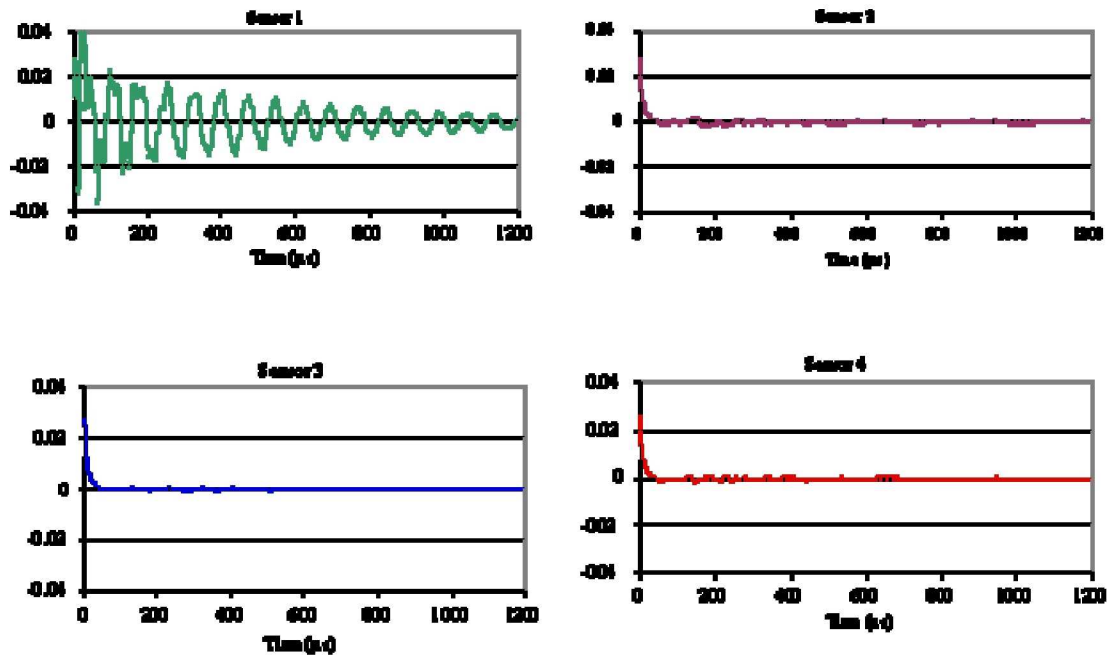
*Figure 7.3-11. DIDS Response when Sensor Detached During LOX Tank fill
(Vertical Scales in Volts)*

Another interesting event occurred during the LOX fill when the attachment for sensor 1 failed, see Figure 7.3-11. It was subsequently determined that the incorrect adhesive was used to attach the sensors. Sensors 2 and 3 failed during flight when the nose cone failed and only sensor 4 stayed attached until the rocket crashed, see Figure 7.3-12).

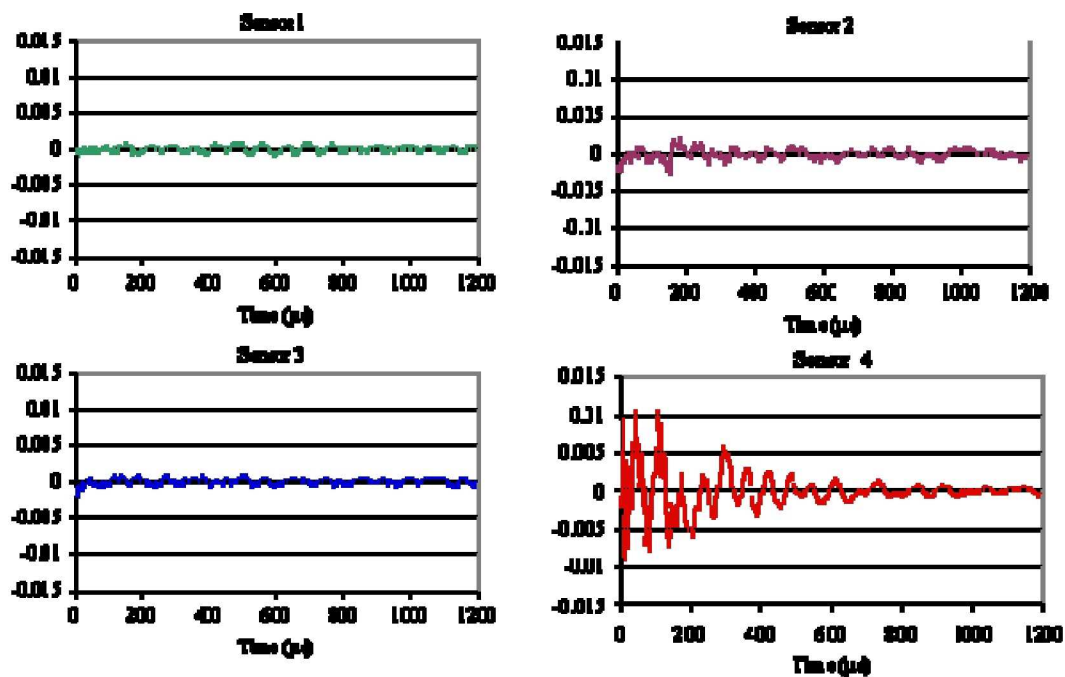
Figure 7.3-12. DIDS Response when Sensor 4 Separated at Rocket Impact

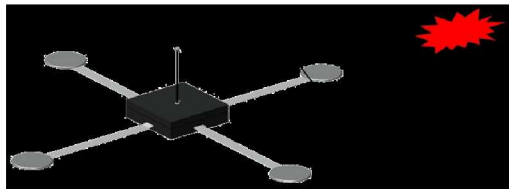
Figure 1. DIDS Operating Concept

Invocon completed the Distributed Impact Detection System (DIDS) as a Phase 2 SBIR contract from the NASA Langley Research Center. Impact detection and characterization on manned spacecraft has been an elusive goal due to the transitory nature of the detectable high-frequency signals. The approach for this effort is to use large numbers of wireless, self-powered, miniaturized, "stick on" piezoelectric sensory nodes. Each node will continuously monitor an accelerometer, acoustic emission sensor, or PZT element for an impact event, such as the foam impact that caused the Columbia tragedy or a micro-meteor impact. The figure below depicts the operating concept for DIDS.

When a programmable threshold is exceeded by an impact event, an extremely low-latency signal acquisition circuit will capture the event as a digital waveform for post-processing and impact characterization. The innovative signal conditioning circuit design is capable of operation in the micro-watt range on average while constantly maintaining the capability to process and acquire high-frequency acoustic signals in the hundred kilohertz range. DIDS employs multiple modes operating at different power levels in order to maintain extremely low average power consumption.
