Using Facility Condition Assessments to Identify Actions Related to Infrastructure

Kennedy F. Rubert
Jacobs Technology, Inc., Hampton, VA, 23681

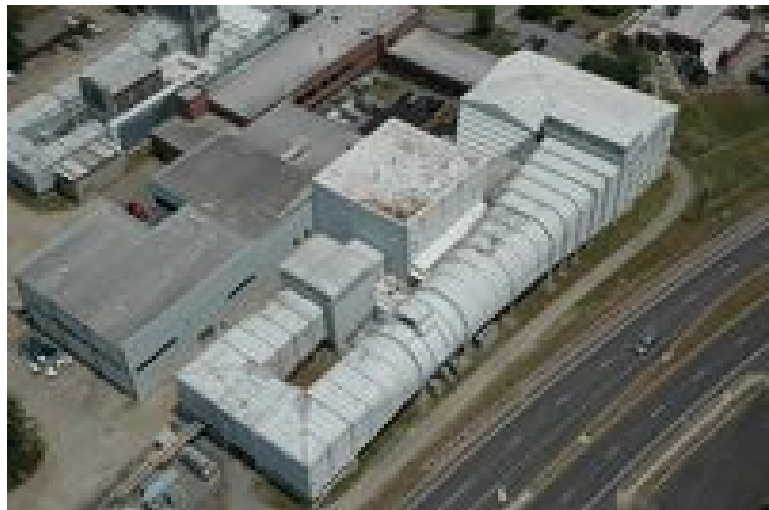
Figure 1. NASA Langley 14- by 22-Foot Subsonic Tunnel

During the winter of 2010, this team performed a combined FCA/RCM on LaRC’s 14- by 22-Foot Subsonic Tunnel (Figure 1). This is an atmospheric, closed return tunnel with a test section 14.5 ft. high x 21.75 ft. wide x 50 ft. long. In addition to the tunnel, drive equipment, and control room, there are associated offices and shop areas. The gross square footage area is a little less than 100,000. This survey required 803 labor hours for FCA and 678 for the RCM.

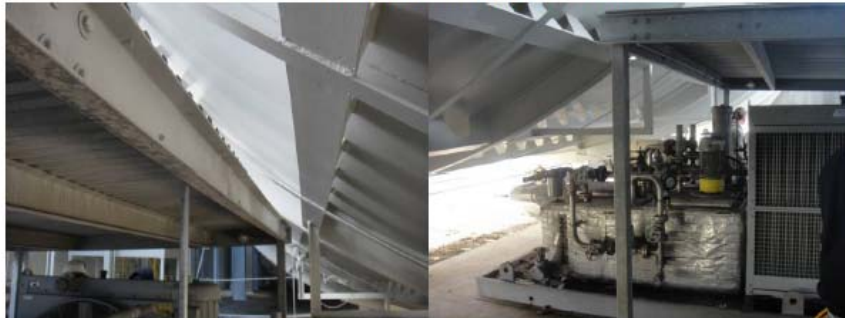
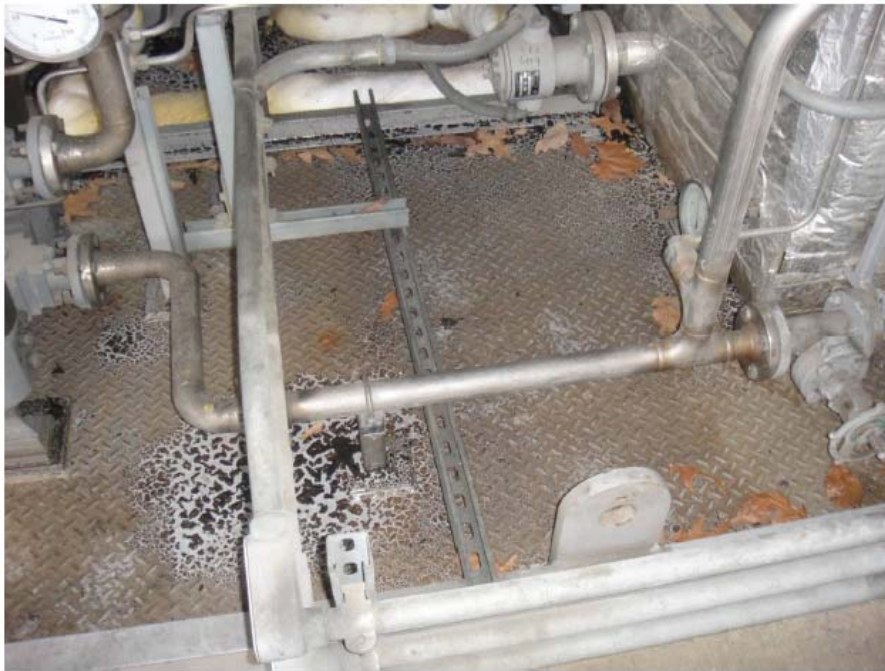
The current shed does not prevent rain water from entering the oil catch pan during rain events. Water runs down the side of the tunnel as well as off of the shed roof into the pan.

Oil catch pan

a. Design and build new pump system shed.

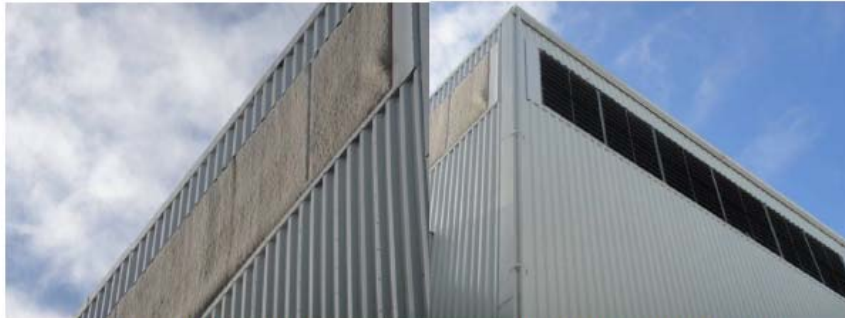
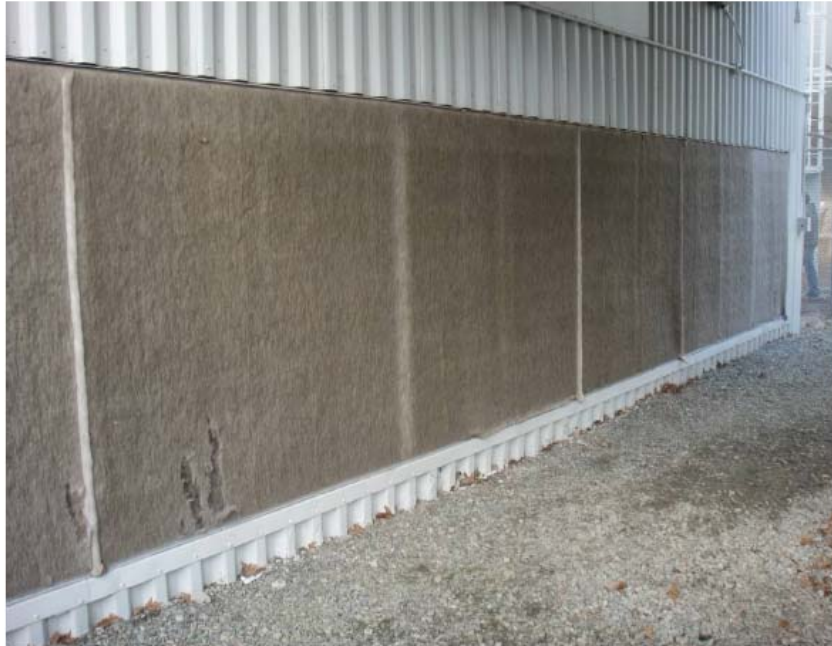
Existing filter material

Intake with missing filter material

Lower intake at ground level

- b. Design and install a frame to secure filter material to the air intake tower
