# An Experimental Investigation of Silicone-to-Metal Bond Strength in Composite Space Docking System Seals

Prepared for the  
45th Joint Propulsion Conference and Exhibit  
cosponsored by AIAA, ASME, SAE, and ASEE  
Denver, Colorado, August 2–5, 2009

<b>1. REPORT DATE (DD-MM-YYYY)</b> 01-10-2010		<b>2. REPORT TYPE</b> Final Contractor Report		<b>3. DATES COVERED (From - To)</b>	
<b>4. TITLE AND SUBTITLE</b> An Experimental Investigation of Silicone-to-Metal Bond Strength in Composite Space Docking System Seals			<b>5a. CONTRACT NUMBER</b> NNX08AU01H; NNC08CA35C		
			<b>5b. GRANT NUMBER</b>		
			<b>5c. PROGRAM ELEMENT NUMBER</b>		
<b>6. AUTHOR(S)</b> Conrad, Mason, C.; Daniels, Christopher, C.; Bastrzyk, Marta, B.			<b>5d. PROJECT NUMBER</b>		
			<b>5e. TASK NUMBER</b>		
			<b>5f. WORK UNIT NUMBER</b> WBS 644423.06.31.04.01.03.22		
<b>7. PERFORMING ORGANIZATION NAME(S) AND ADDRESS(ES)</b> Case Western Reserve University			<b>8. PERFORMING ORGANIZATION REPORT NUMBER</b> E-17465		
<b>9. SPONSORING/MONITORING AGENCY NAME(S) AND ADDRESS(ES)</b> National Aeronautics and Space Administration Washington, DC 20546-0001			<b>10. SPONSORING/MONITOR'S ACRONYM(S)</b> NASA

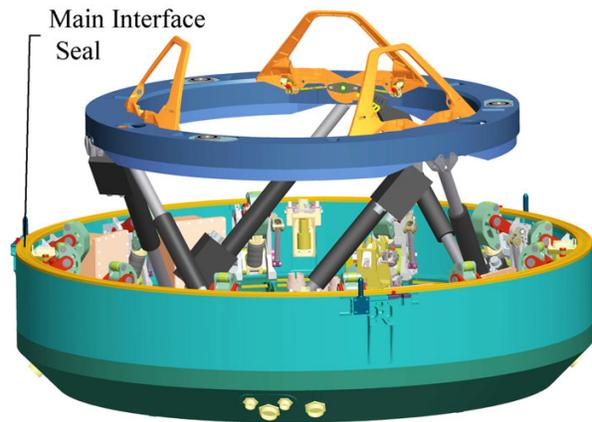
Figure 1. Illustration of the active LIDS

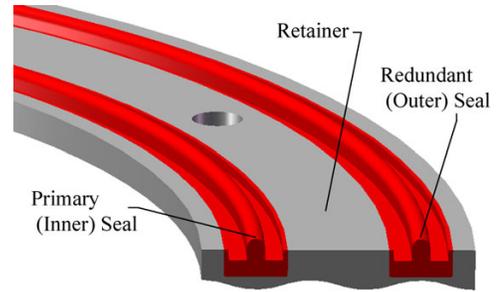
**Figure 2.** Illustration of the upper portion of a test specimen cross section showing two elastomer seals in grooves in an electroless nickel plated aluminum retainer.

The test specimens were custom designed seal assemblies manufactured by the Composite Sealing Systems Division at Parker Hannifin Corporation. The test specimens considered herein were manufactured according to a candidate Gask-O-Seal<sup>TM</sup> design with multiple elastomer seals molded into an aluminum retainer, as shown in Figure 2. The upper portion of the seal assembly consists of a primary (inner) seal and a redundant (outer) seal, providing single fault tolerance.

The seals were made of S0383-70 silicone elastomer compound. The 6061-T651 aluminum retainer of the seal assembly had an outside diameter of 12.0 inches. The expected outside diameter of the full-scale LIDS interface seal is currently 58 inches.

In the nominal fabrication process for the seal assembly, the metal retainer is machined and electroless nickel plated, after which a priming agent is applied to the groove surfaces prior to silicone vacuum-molding. Once the silicone cures in place in the grooves, it is permanently bonded to the retainer. Unintentional localized disbond occurs where the silicone separates from the metal, as seen in Figures 3 and 4.

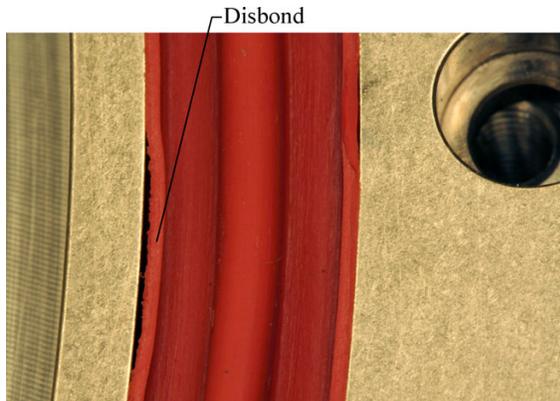
**Figure 3.** Photograph of unintentional localized disbond at an arbitrary location.

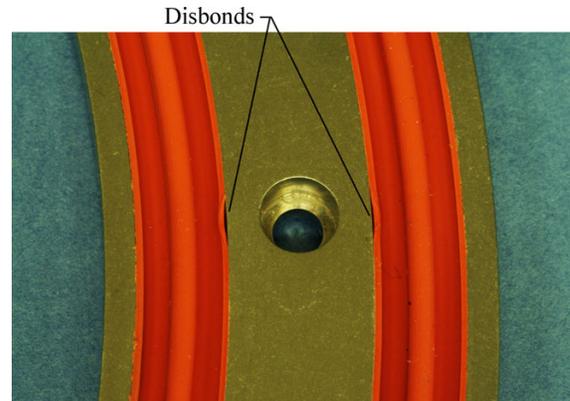
**Figure 4.** Photograph of unintentional disbond occurring at bolt hole locations due to molding process.

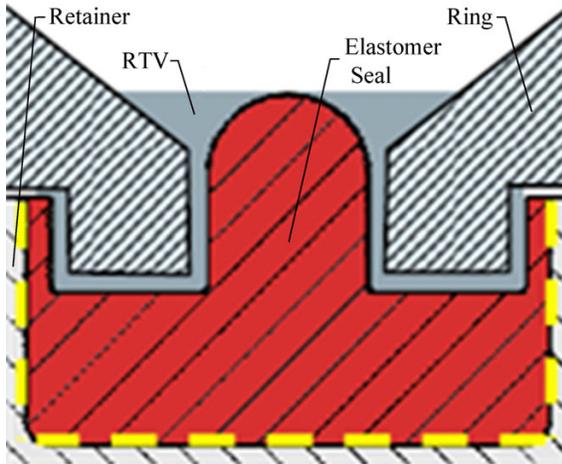
**Figure 5. Section view of the test fixture used to maximize adhesive bonding area by matching the seal profile. The seal-to-retainer bond being tested is shown in dashed yellow lines.**

Custom steel rings were designed to allow “gripping” of the seals without actually pinching or squeezing the S0383-70 material. Different ring sizes were made so that only one seal, inner or outer, would be tested at a time. These rings were bonded to the top surface of the seal using a room temperature vulcanizing (RTV) silicone adhesive. The rings were designed to match the seal surface profile in order to maximize the area available for bonding with the RTV, as shown in Figure 5. The RTV was applied to the elastomer surface and the rings were placed onto the seals. The rings and the seal assembly were then fastened to identical 1.0 inch thick stainless steel platens and the RTV was cured for a period of approximately five days. A schematic of the resulting test fixture assembly is shown in Figure 6.

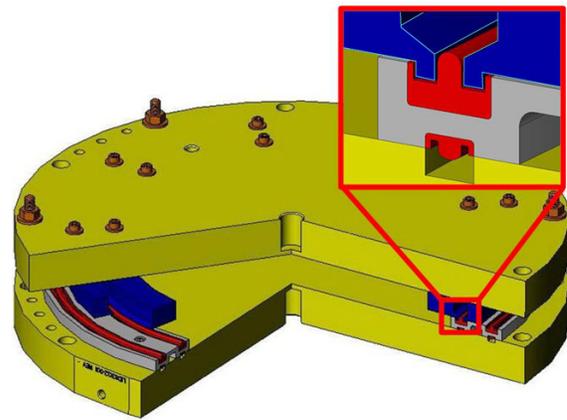
**Figure 6. Illustration of the test fixture showing the seal specimen, rings (blue), and platens (yellow) with an inset view of the RTV interface.**

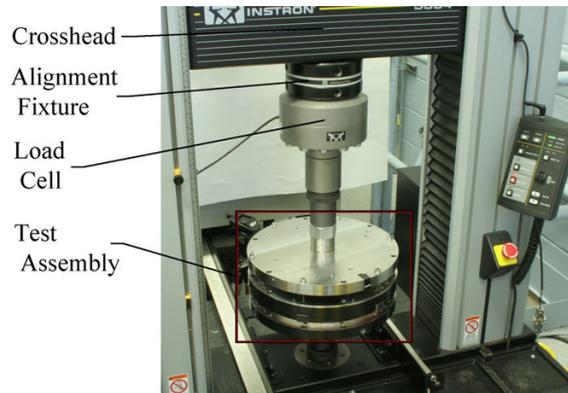
Figure 7. Photograph of the test specimen assembly mounted in the load frame.

The bond strength tensile tests were performed using an Instron 5584 electromechanical load frame. The frame was equipped with an alignment fixture for both angular and concentricity adjustments of the upper actuator rod with respect to the lower actuator rod. Load during separation was measured using a 33700 lbf capacity Instron 2525 – 171 load cell with an accuracy of 0.30% of the full range. A position encoder within the load frame was used to measure displacement of the crosshead to an accuracy of 0.001 inch. Sources for measurement uncertainty include linearity, repeatability, and hysteresis, as well as the off-axis nature of loading the circumference of the seal. The speed at which the platens were separated was a function of time simulating the expected LIDS undocking rate. The test fixture assembly was mounted in the load frame as shown in Figure 7.

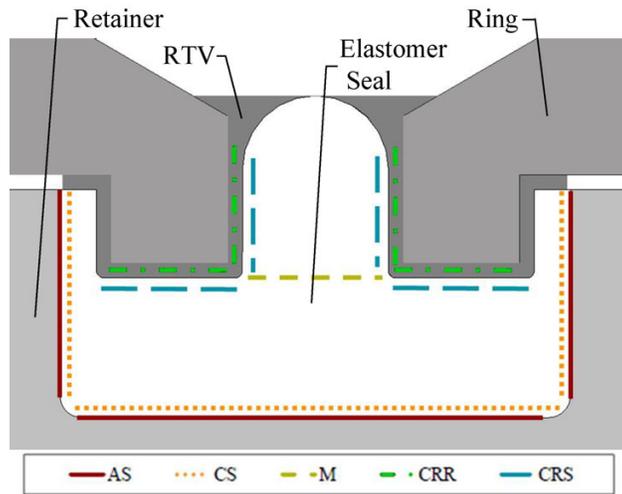
Figure 8. Schematic showing the location of the five failure modes observed.

1. Adhesive failure at the molded seal-to-retainer bond (AS),
2. Cohesive failure in the S0383-70 at the molded seal-to-retainer bond (CS),
3. Material failure in the S0383-70 away from the surfaces (M),
4. Cohesive failure in the RTV adhesive at the top surface of the seal (CRR),
5. Cohesive failure in the S0383-70 at the top surface of the seal (CRS).

The adopted nomenclature is also shown in Figure 8 along with a schematic of a seal molded into a retainer at the bottom and attached to two rings at the top using RTV. All of the defined failure modes represented either adhesive or cohesive failure in a general sense. However, the area of failure had different implications for the LIDS main interface seal and thus they were differentiated for clarity. Careful selection of the RTV adhesive successfully eliminated two other possible failure modes: adhesive failure at the top surface of the seal and adhesive failure at the RTV-to-retainer bond. The relative strengths of the materials precluded any cohesive failure within the metal components.

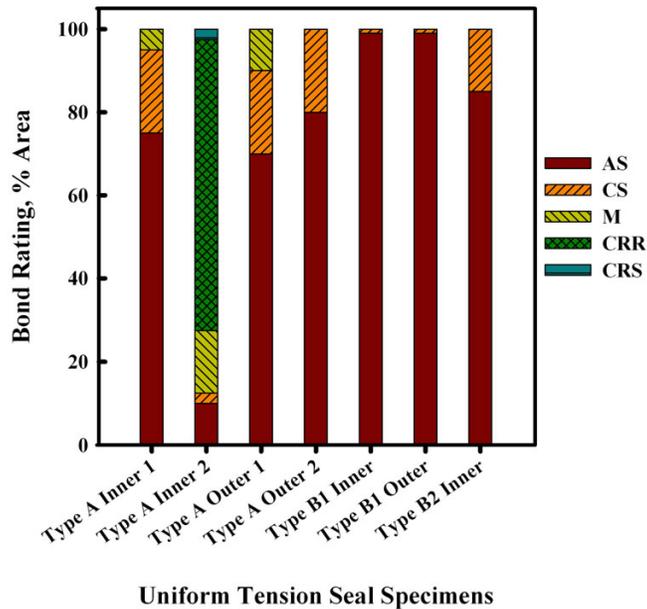
Figure 9. Bar chart summarizing the bond ratings of uniform tension case test specimens.

Bonds are commonly given bond ratings which represent the percentage of bond area exhibiting each failure mode. A summary of bond ratings using the failure modes defined above is shown in Figure 9 for the uniform tension case specimens. The most dominant failure mode observed was adhesive failure of the seal-to-retainer bond (AS), notably on specimens which exhibited greater than 99% adhesive failure (Type B1 specimens). A representative area of the groove surface exhibiting adhesive failure (AS) is shown in Figure 10, where the retainer surface was clear of any seal residue. In addition to adhesive failure, all of the other failure modes were observed. During the Type A Inner 2 seal test, a majority of the RTV failed (CRR) and the specimen exhibited all five of the failure modes to some extent. This result highlighted the variability that is possible of the seal-to-retainer bond, even within a single seal specimen.

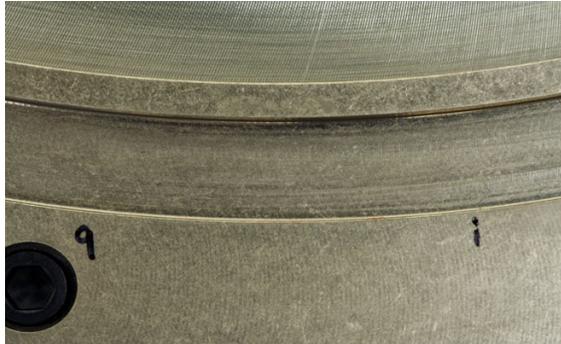
Figure 10. Photograph of a representative area showing exclusively adhesive failure i.e. the seal material is completely removed.

spots with size on the order of  $100\mu\text{m}$  (Figure 12). This led to the observation that cohesive failure may be more prevalent than is visible with the naked eye. Specimens that failed in the adhesive (AS) were also examined under magnification to confirm the visual assessment as shown in Figure 10.

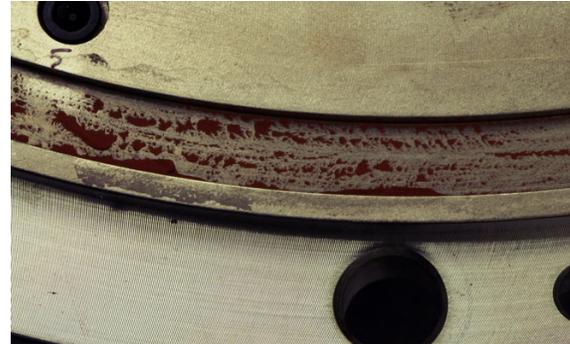
Figure 11. Photograph of a fracture surface showing significant cohesive failure, along with adhesive failure.

A representative image of significant cohesive failure (CS) in the bottom of the groove of a Type A specimen is shown in Figure 11. For this particular section of the seal, it was not immediately clear whether cohesive or adhesive failure was the dominant failure mode. The groove bottom was covered in S0383-70 residue in patterns along the circumference, possibly indicating that priming agent was brushed in this direction, leading to distributed spots of superior bond formation and resulting in cohesive failure. This observation suggests the sensitivity of bond quality to fabrication processes. To explore this failure in more detail, the surface was examined with an optical microscope. Under 63X magnification, areas which appeared to the naked eye as sparse spots of residue, were actually interspersed with fields of much smaller residue

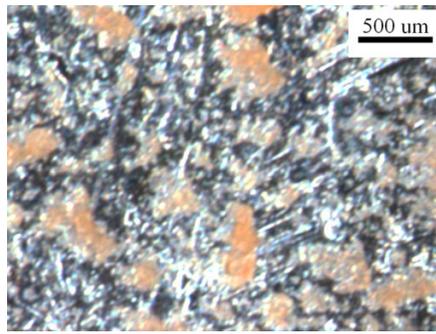
Figure 12. Optical micrograph of fracture surface under 63X magnification showing small spots of cohesive failure invisible to the naked eye.

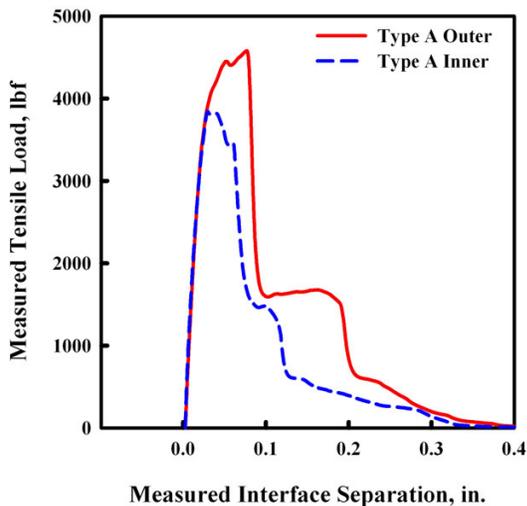
Figure 13. Graph of measured results for uniform tension case exhibiting significant cohesive failure.

Representative load-displacement results of an inner and outer seal of a Type A specimen are shown in Figure 13. These particular test results produced the highest measured failure loads of the uniform tension test series, with the peak load of 4576 lbf for the outer seal and 3842 lbf for the inner seal. As seen in Figure 13, the load-displacement curves of the inner and outer seal tests agree closely until the point of failure in the inner seal test. In the first stage of the separation (approximately 0.030 inch) a linear relationship between load and deflection was observed. At the initiation of failure, a flattening of the curve is noted as small areas began to fail and could no longer carry the load. The first steep drop in load represents the initial bond failure in part of the seal and this peak load was the parameter of interest. A chart summarizing the peak measured load divided by the seal circumference for all specimens in the uniform tension case is shown in

Figure 14. The second steep drop indicates that most of the remaining bonded area had failed. The slightly downward slope in the final region indicates that the last remaining bonded section of the elastomer was stretching and/or tearing away from the retainer. The failure surface image shown in Figure 11 corresponds to the outer seal data shown in Figure 13.

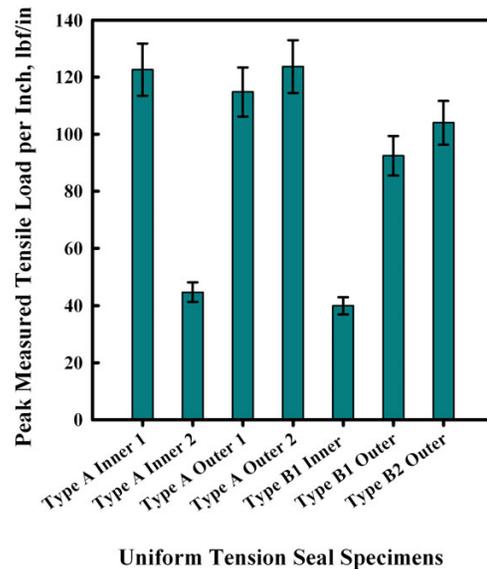
Figure 14. Bar chart representing failure load per circumferential inch of a single seal. The error bars indicate load measurement uncertainty.

Based on the peak measured tensile load values shown in Figure 14, there was no clear correlation between intentional flaw length and failure load. The two significantly lower values of Figure 14 can be explained by failure mode observations. The second Type A inner seal exhibited mostly RTV failure (CRR), and thus the seal-to-retainer bond had at least that level of strength. In the Type B1 Inner seal test a portion of the circumference initially failed at the RTV-to-seal interface (CRR and CRS), as shown in Figure 15, while most of the seal failed adhesively at the seal-to-retainer bond (AS). The subsequent separation removed the rest of the seal circumference in adhesive failure (AS). This partial RTV failure is characterized by a lower peak load measured, followed by a long and slow decline in the measured load as the remaining length of the seal peeled out. Aside from these lower values, there was no clear relationship between the failure load and the failure modes exhibited. The Type A seal specimens exhibited slightly higher load measurements and more cohesive failure (CS and M). However, the load to failure was not significantly different for seals with intentional flaws, though they exhibited more adhesive (AS) failure. It was originally anticipated that the intentional disbond location would be the initiation point of rapid peel-out of the seal.

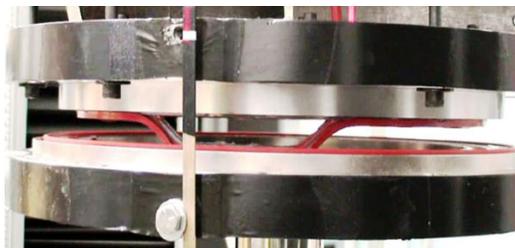
Figure 15. Video frame of the initial partial RTV failure in a uniform tension case test leading to an altered load-displacement curve. The remaining bonded section was peeled out adhesively.

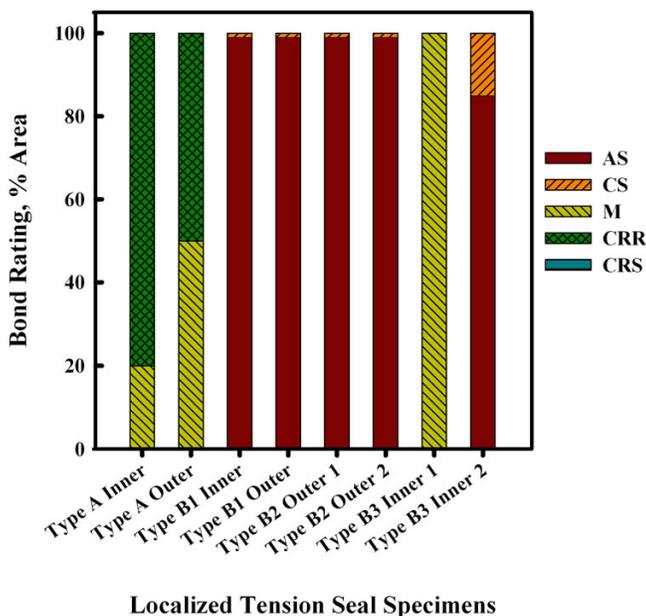
Figure 16. Bar chart summarizing the bond rating of localized tension case test specimens.

A summary of the bond ratings for the localized tension case is presented in Figure 16. Five of the eight seals tested in this case produced predominantly adhesive failure (AS). The seals in this category detached

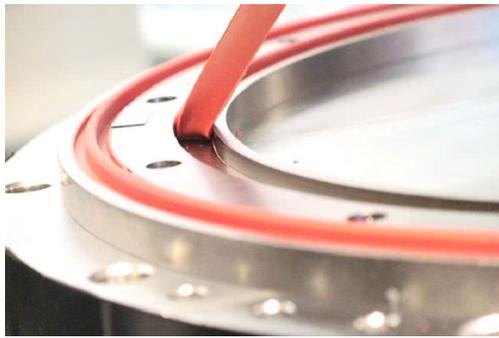
Figure 17. Video frame of an inner seal pull-out and peel from the retainer groove.

from the retainer by way of slow, steady peel-out (Figure 17) along the entire circumference, resulting in the complete removal of the seal in one piece as shown in Figure 18. The bottom of the grooves in these tests exhibited the same conditions as the adhesive failure mode exhibited by tests of the uniform tension case. Inspection of the groove side walls on several tests revealed small spots of apparent cohesive failure (CS) as well. The remaining three tests failed significantly within the S0383-70 material (M) rather than at

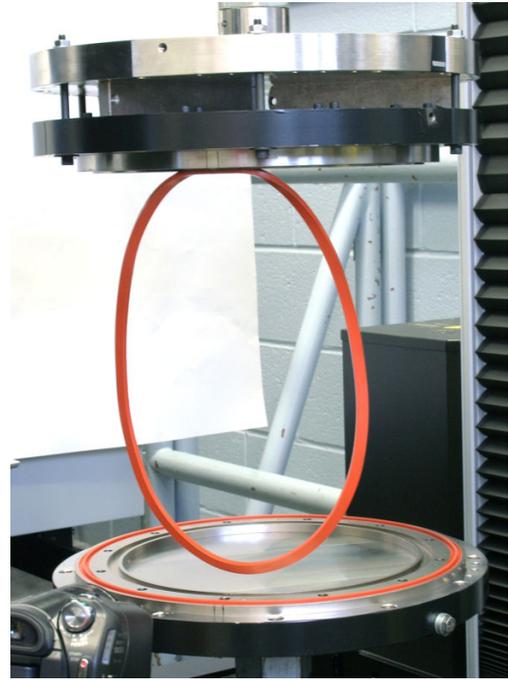
Figure 18. Photograph of the complete removal of the seal in one piece due to localized tension.

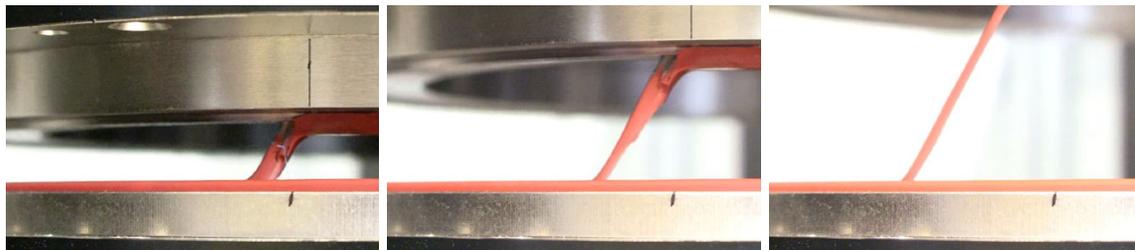
Figure 19. Video frame sequence showing the progressive material failure along the top of an inner seal. The reference mark on the lower platen shows the edge of the 1.0 inch disbond.

Material failure in the localized tension case progressed along the top of the seal for a distance before release. A sequence of photographs detailing the material failure process is outlined in Figure 19. The failure shown in Figure 19 is analogous to the propagation of peel around the circumference, except that the failure occurred within the S0383-70 elastomer.

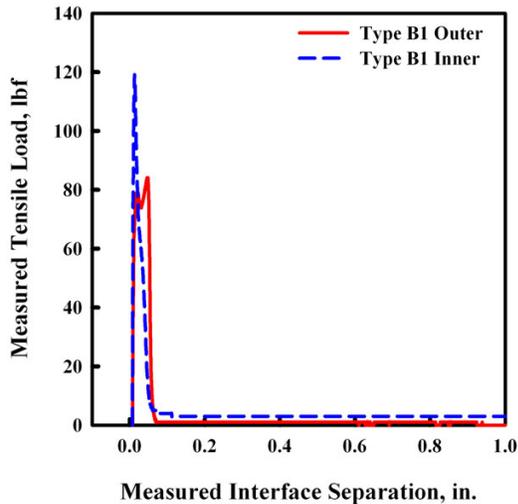
Figure 20. Graph of measured results for a localized tension case specimen exhibiting adhesive failure.

Representative load-displacement curves for Type B1 localized tension case specimens which failed adhesively (AS) are shown in Figure 20. Peel out of the seal began at a displacement of about 0.06 inches and continued at negligible peel loads until the entire seal circumference was extracted from the retainer groove. Complete extraction required nearly 15 inches of total displacement, but only the first inch is shown in Figure 20 for visual clarity. These results suggested that once peel had initiated, the seal was likely to be completely extracted from the groove.

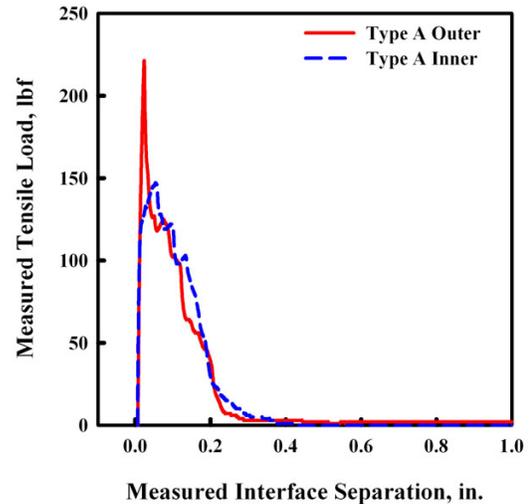
Figure 21. Graph of measured results for a localized tension case specimen exhibiting material failure.

Results from two localized tension cases which demonstrated failure in the seal material (M) are plotted in Figure 21. The “sawtooth” pattern evident in both the inner and outer seal curves indicates start-stop failure. In other words, the failure progressed for a distance, then stalled until enough stress built up again to recommence the failure propagation. Figure 22 shows a summary of the peak loads measured in the localized tension case. An image of the surface of material failure is shown in Figure 23.

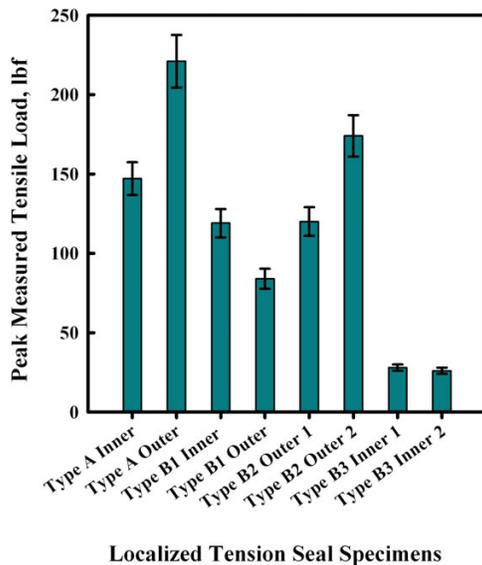
Figure 22. Bar chart representing failure loads measured during localized tension tests using 1.0 inch of RTV adhesive. The error bars indicate load measurement uncertainty.

The Type A, B1, and B2 specimens resulted in peak measured load between approximately 75 and 225 lbf, but there is not a clear correlation between disbond length and peak measured load. However, the Type B3 specimens are both less than 30 lbf due to the fact that only the 1.0 inch disbond was pulled with RTV adhesive. Therefore, the seal-to-retainer bond was stressed in peel almost immediately, leading to material failure or peel progression.

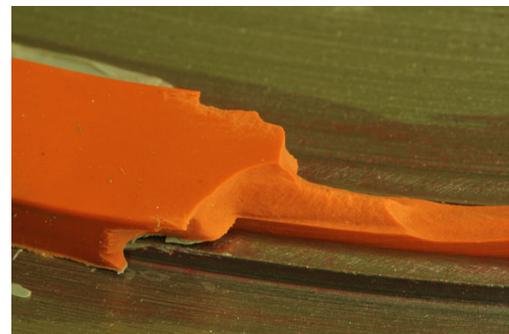
Figure 23. Photograph of material failure of a test specimen with a 1.0 inch intentional flaw.
