# NASA-DoD LEAD-FREE ELECTRONICS PROJECT: OVERVIEW

NASA Technology Evaluation for Environmental Risk Mitigation (TEERM) Principal Center

## ABSTRACT

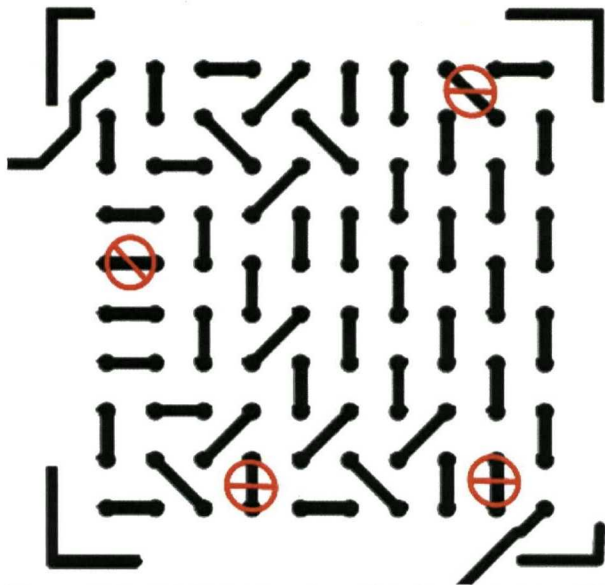
Figure 2 Test Vehicle Drawing, Chip Scale Package (CSP)

When reviewing the CSP data, please note that the CSP components on all test vehicles only have continuity in the outside solder balls. The wrong component configuration was used during test vehicle drafting. Traces interconnecting internal rows of balls to the outside row of balls do not exist on the test vehicles, Figure 2

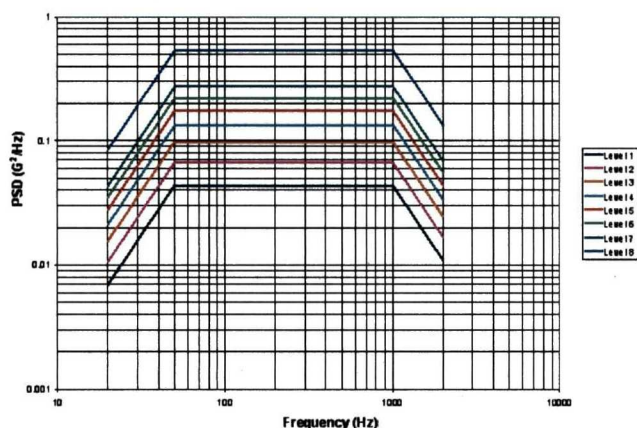
Figure 4 Vibration Spectrum

The stakeholders agreed that a stress step test representing increasingly severe vibration environments was appropriate for this test, see Figure 4. A step stress test is required since a test conducted at a constant 8.0  $g_{rms}$  level (Step 1) would take thousands of hours to fail the same number of components as a step stress test. This is because some locations on a circuit assembly experience very low stresses and severe vibration is required in order to fail components at these locations. The shape of the PSD (Power Spectral Density) curve for each step stress level was designed so that all of the major resonances of the test vehicles would be excited by the random vibration input. The PSD curves presented in MIL-STD-810F were used as guides for the creation of this step stress test but were not directly duplicated.

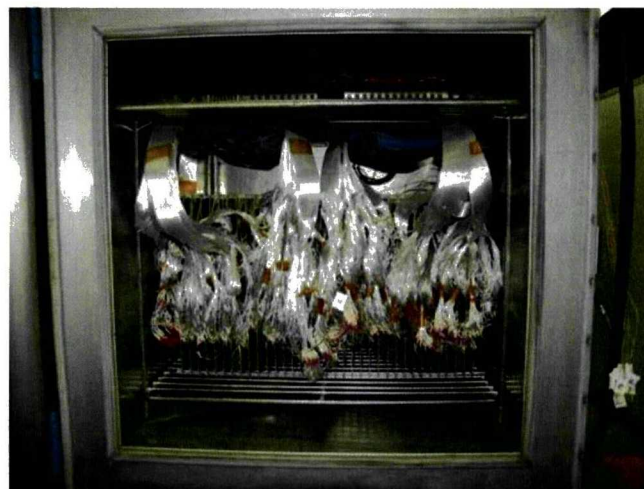
Figure 5 Test Vehicles in the Thermal Cycle Chamber

After examining the available data on dwell time effect, the lead-free solder project participants agreed that the high-temperature dwell time would be 30 minutes. Solder alloy creep during the high temperature dwell of the thermal cycle is largely responsible for damage within the solder

joints. In order to maximize the effects of solder alloy creep, a 30-minute high temperature dwell will be used for this project.

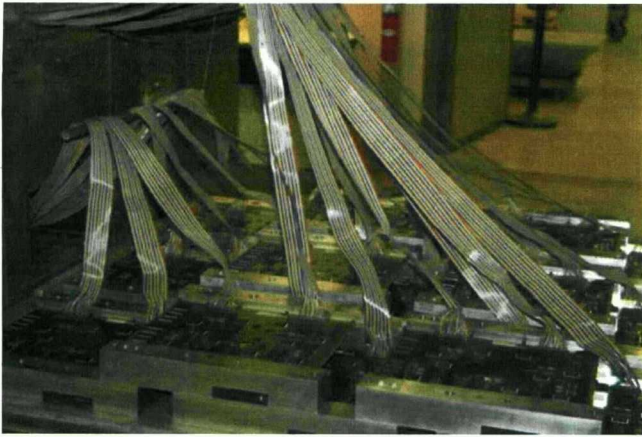
Figure 6 Test Vehicles in the HALT/HASS Chamber

This test utilized a temperature range of -55 to 125°C with 20°C/minute ramps. The dwell times at each temperature extreme are the times required to stabilize the test sample plus a 15-minute soak. 10  $g_{rms}$  pseudo-random vibration was applied for the duration of the thermal cycle. Testing continued until sufficient data was generated to obtain statistically significant Weibull plots indicating relative solder joint endurance (cycles to failure) rates. If significant failure rates were not evidenced after 50 cycles, the vibration levels were increased in increments of 5  $g_{rms}$  and cycling continued for an additional 50 cycles. This process was repeated until all parts failed or 55  $g_{rms}$  was reached. Figure 6 illustrates the test vehicles loaded into the HALT/HASS Chamber.

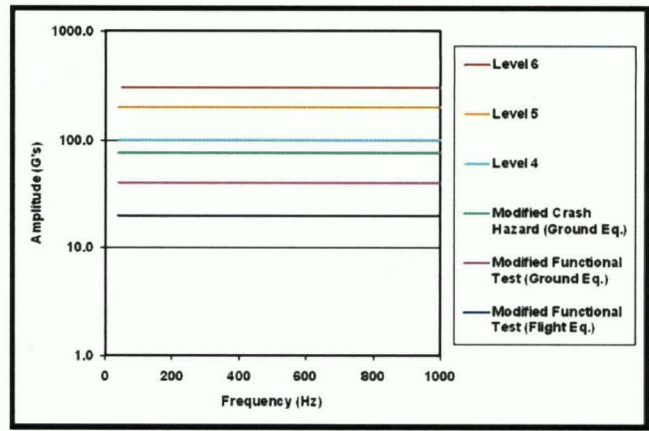
Figure 7 Mechanical Shock SRS Test Levels

Testing followed MIL-STD-810F, Method 516.5 with the following modifications: (1) 100 shocks were applied per test level (rather than 3) and all of the shocks were applied in the Z-axis, and (2) the shock transients applied at the levels specified in MIL-STD-810F, Method 516.5 for the Functional Test for Flight Equipment, the Functional Test for Ground Equipment, and the Crash Hazard Test for Ground Equipment followed modified parameters detailed in the Joint Test Protocol. An additional step stress test will then be conducted (see Figure 7) with the shocks being applied in the Z-axis only. For Level 6 (300 G's), 400 shocks will be applied instead of 100. Testing continued until a majority (approximately 63 percent) of components was failed.

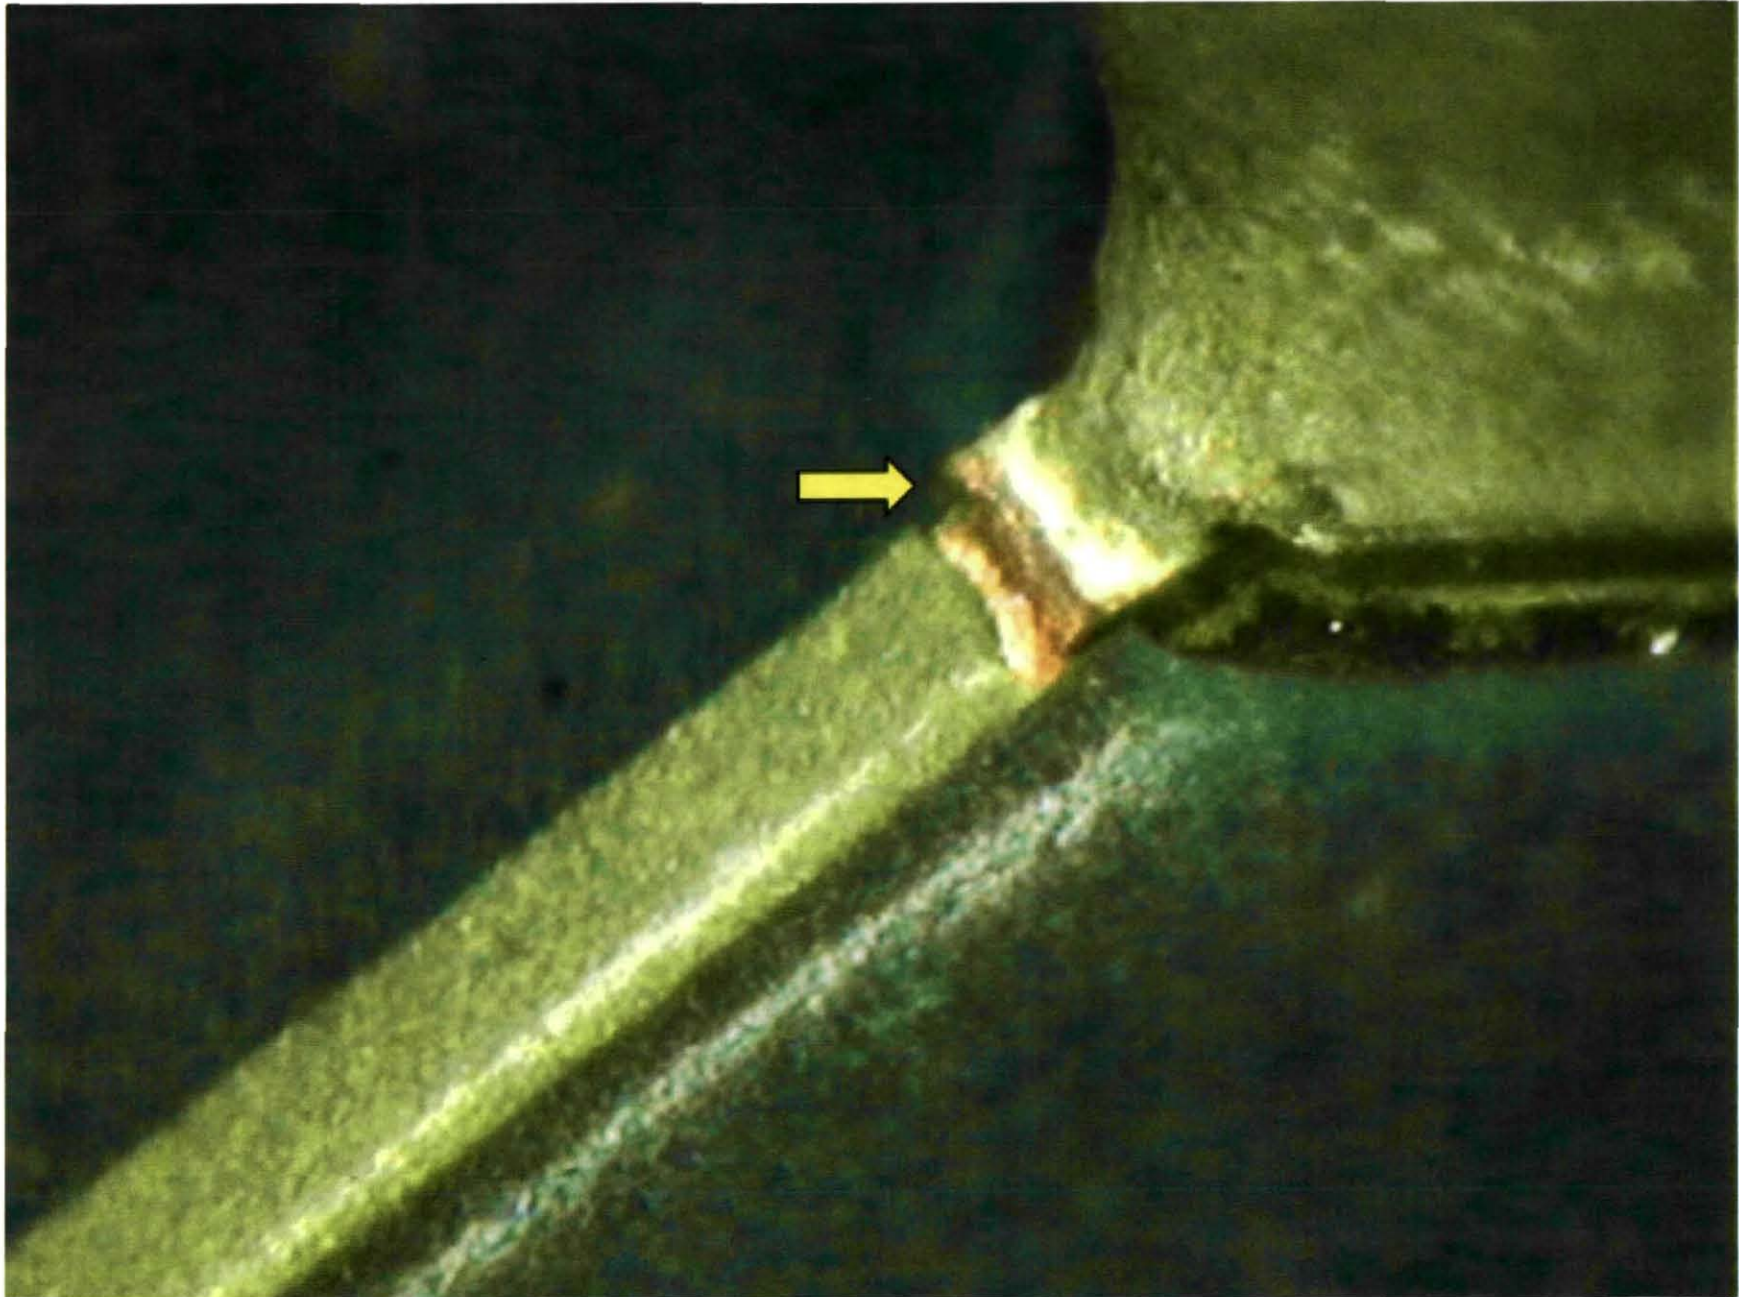
PDIP U38 Trace Crack (SN100C)
