Space Shuttle Star Tracker Challenges

Linda M. Herrera
Shuttle Guidance, Navigation &
Flight Controls Engineer
Boeing Space Exploration
May 13, 2010

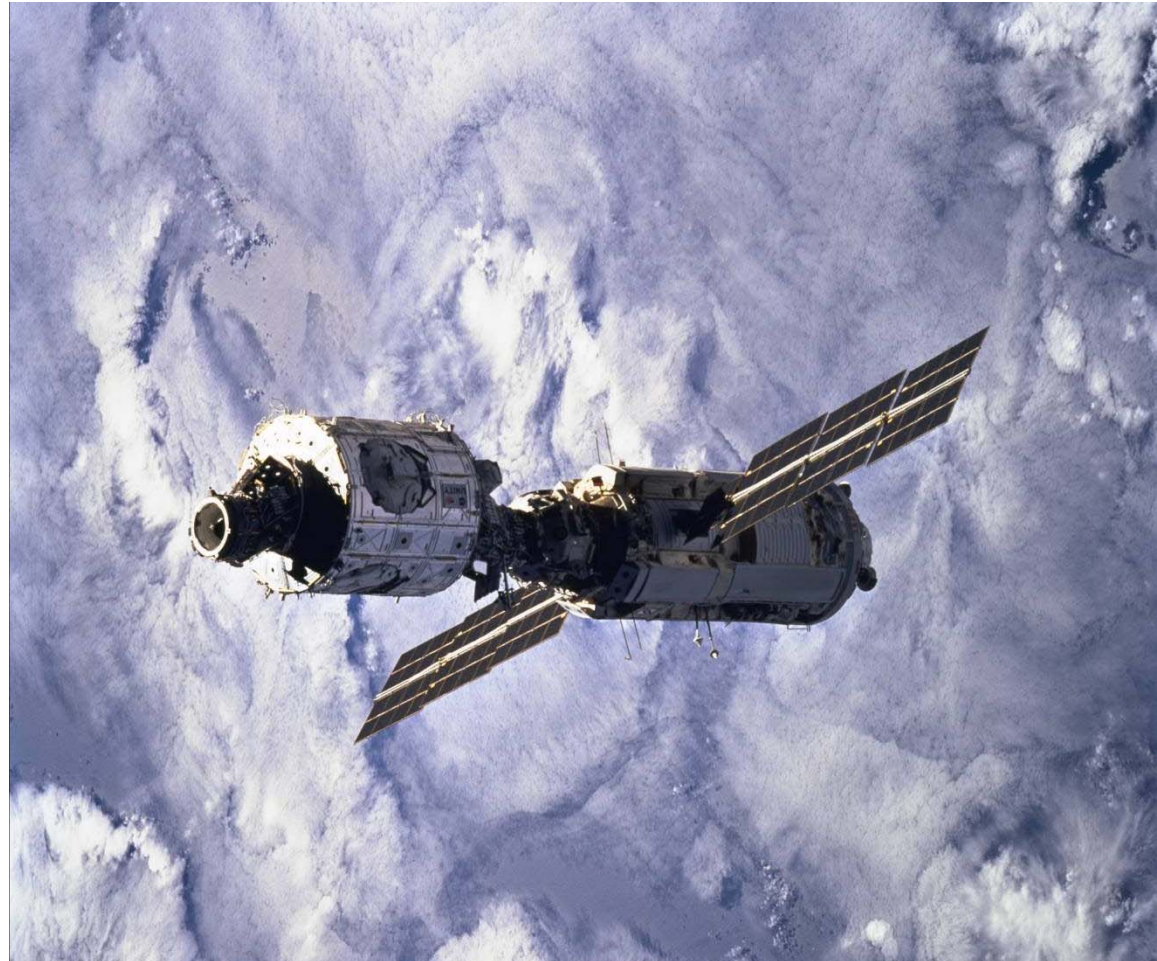
ISS 2A: NODE 1 (Unity) and Zarya
STS-088 --- Dec 1998

First hint of brightness
problems began during
STS-88 post-undocking
operations December, 1998.

The –Y solid state star
tracker set a '**target
suppress**' flag.

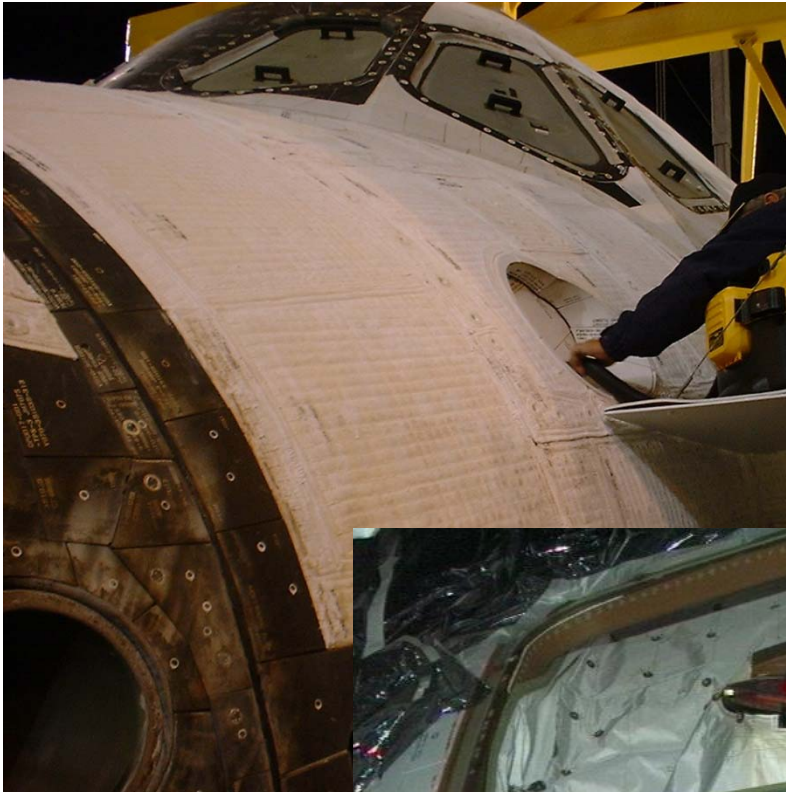
**Star Tracker
Doors and
Carrier Panels
Removed**

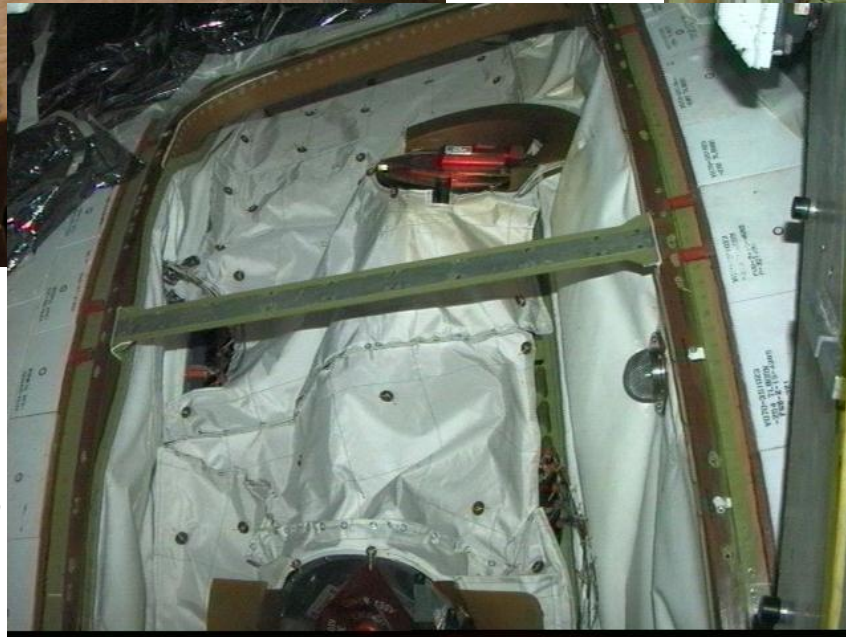
Thermal Blankets Removed

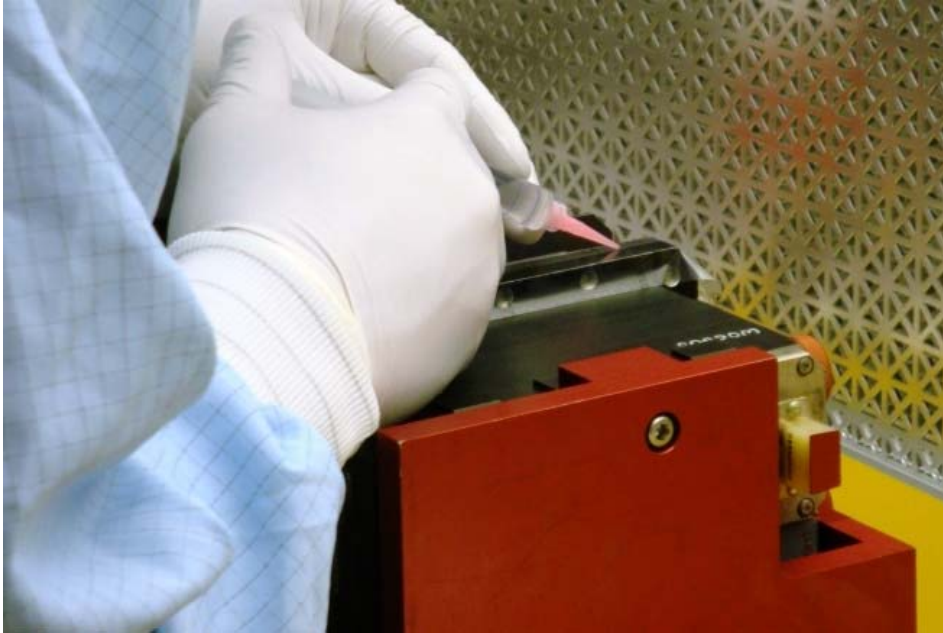
Each side (face) required a minimum four hour cure time prior to moving star tracker.

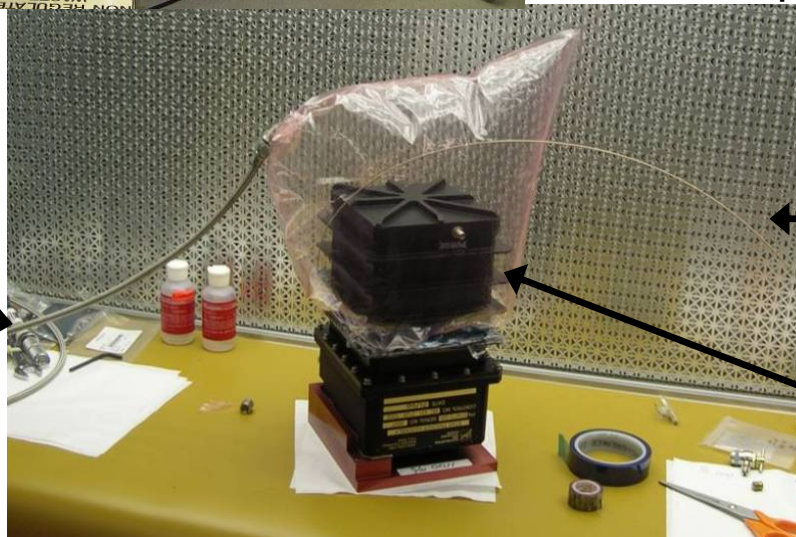
Leak detection probe
(11 foot; 0.0025 inch PEEK capillary)

Bag sealed to Star Tracker
