Adding a Second Ku-Band Antenna to the International Space Station

Authors: Chuck G. Dusold, Corey Thacker, and Sundeep Kwatra

Abstract - The International Space Station, as originally developed, used the Ku-Band Tracking and Data Relay Satellite System communications link to transmit non-critical data to the ground. Since becoming operational, the use for the link evolved to include additional services that, although also not critical, were deemed to be necessary for the crew. The external Ku-Band Antennas were designed for transport to the ISS in the shuttle cargo bay and thus are not suitable for manifesting on any current cargo vehicle. The original intent was to stow two spare antennas on orbit in a protective container until such time as they were needed to replace a failing unit which is a long and complicated process due to the complexity of the removal and replacement procedure. The Boeing Company proposed manifesting one of those spare antennas in an operable configuration eliminating the need for an Extravehicular Activity (EVA) to correct the first failure and as such minimizing the time to hours rather than weeks required to restore the Ku-Band communications link af

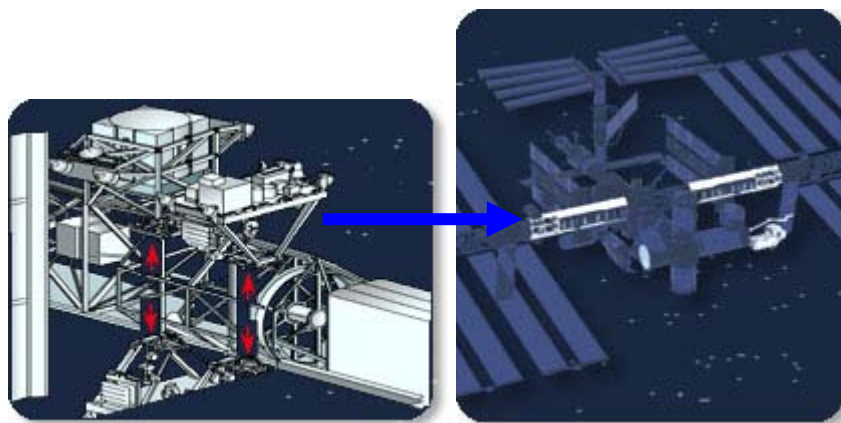
There are four dedicated sites on the starboard side (S3) and four on the port side (P3) of the ISS truss where external payloads can be attached. Two attach points are located on the nadir, or Earth-facing, side of the truss, and two are located on the opposite, or zenith, side. For each attach point there is a system of three guide vanes and a capture latch to secure the payload, as well as an umbilical assembly to mate utilities and connections. The external payload locations are shown in Figure 1.

Figure 1. ISS External Payload Locations.

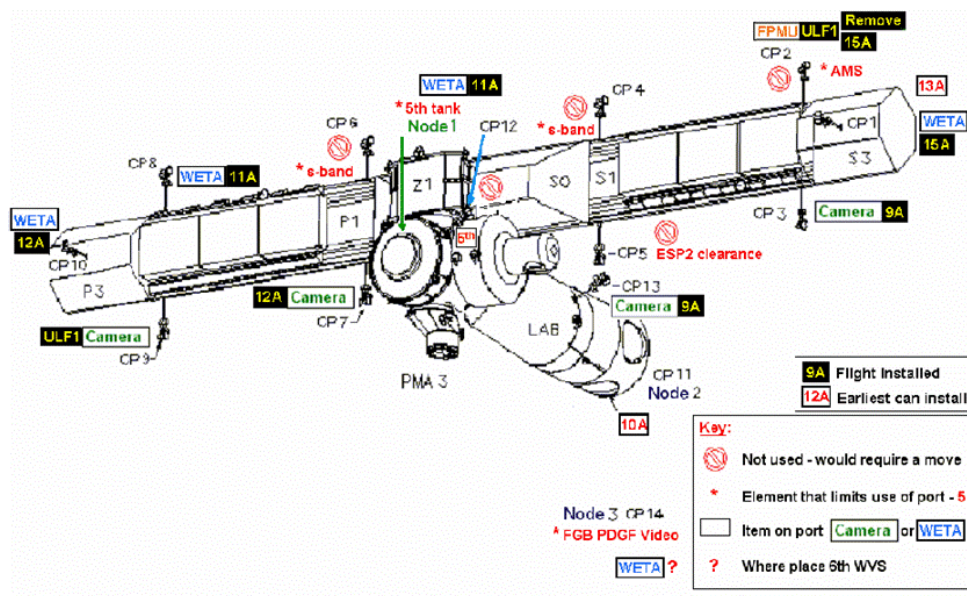
The external camera ports are shown in Figure 2. The only two locations at the time that were unplanned for use were CP4 and CP6, which are in close proximity to the S-Band system. Using these ports would result in reduced TDRS visibility from the S-Band antennas and were therefore considered to be undesirable candidates. Mounting ORUs within the structure of the truss was considered, but the truss is covered by a shroud for thermal conditioning. Thus, attachment to these points presented complications that made their use undesirable.

Figure 2. External TV Camera Ports.

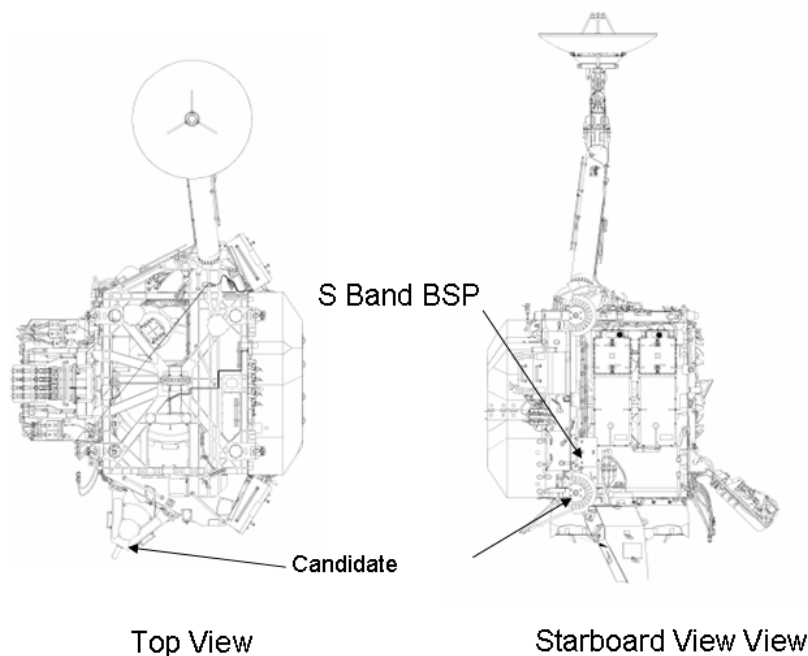
When the P6 element was relocated, the utility connections to the P6 mounting points were disconnected and although the structural attach points remain, any further use for active avionics is essentially curtailed. The attach points for the S-Band RF Group mounting during launch (launched with Z1), were covered up with the heat pipes from the Direct Current-to-Direct Current Converter Unit (DDCU) after it was installed making that location unusable as an attach point. However, there was a trunnion pin in the immediate vicinity of the S-Band BSP and this option was investigated (See Figure 3).

Figure 3. Candidate trunnion pin location on Z1 for antenna attach.

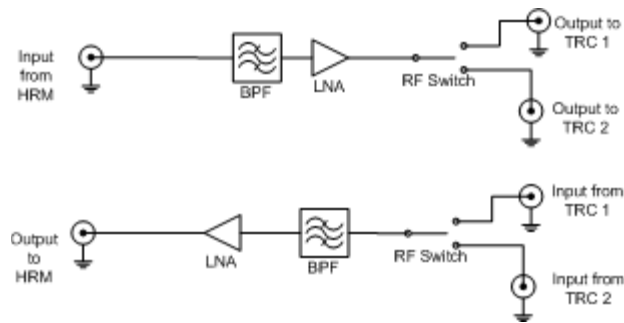
An RF switch on the Ku-Band communications paths could be used to select a destination RF Group. The internal ORUs could continue to perform the baseband processing and create the modulated intermediate frequency signal. This, however, would still leave a single failure point within the switch. It might also be necessary to add additional band pass filtering and a subsequent low noise amplifier (LNA) to restore signal levels (Figure 4). Using a switch like the one shown in Figure 4, the IF signals could be routed to and from the active Antenna Group. Because the solution selected uses a modem internal to the ISS, placing the switch internally allows for Intravehicular Activity (IVA) maintenance; however, it also uses two of the remaining available termini and requires more external cable installation.

Figure 4. IF switch box schematic

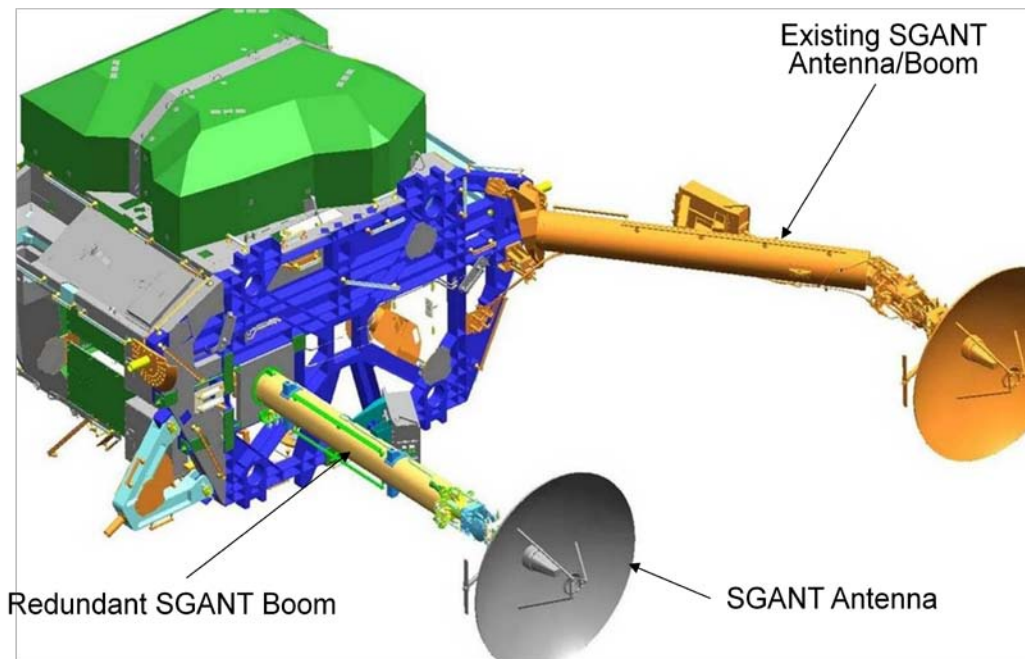
After completing a trade study evaluating each potential option for all cost, schedule, and implementation impacts, it was determined that the addition of a second Ku-Band Antenna Group located on the Z1 truss assembly was the most viable solution. Should the prime Ku-Band string fail, the redundant string would provide a readily available backup requiring only an internal IF cable swap by the crew and ground-based operational configuration changes. Like the existing Ku-Band string, the redundant Ku-Band integrated assembly was flown within the Shuttle payload bay (STS-132) and it included the Space-to-Ground Antenna (SGANT), the SGANT Boom Assembly, RF waveguide, and the Space-to-Ground Transmitter-Receiver Controller (SGTRC). Figure 6 is a CAD model of the two Ku-Band strings installed on the Z1 truss segment. The redundant Ku-Band Antenna Group is offset from the center of the Z1 truss and unlike the prime Ku-Band string which is angled off the port side of the truss¹, the redundant antenna boom is vertical in the negative Z direction and orthogonal to the Z1 top horizontal surface.

Figure 6. Two Ku-Band Antenna Groups installed on the Z1 truss.

The physical mounting location of the redundant SGANT Boom shown in Figure 6 was chosen for three reasons. First, the location was the mounting location used for the existing SGANT when the Z1 truss was launched and installed. Thus, there were vacant mounting bolts available with enough rigidity to support the redundant hardware. Second, the distance from the existing Ku-Band string reduced any potential structural blockages or RF interference between the antennas. Finally, there was availability of the power and data connections. An additional unintended benefit is the location's physical closeness to the existing Antenna Group, providing similar thermal models and similar relation to the ISS state vector which simplified antenna pointing.

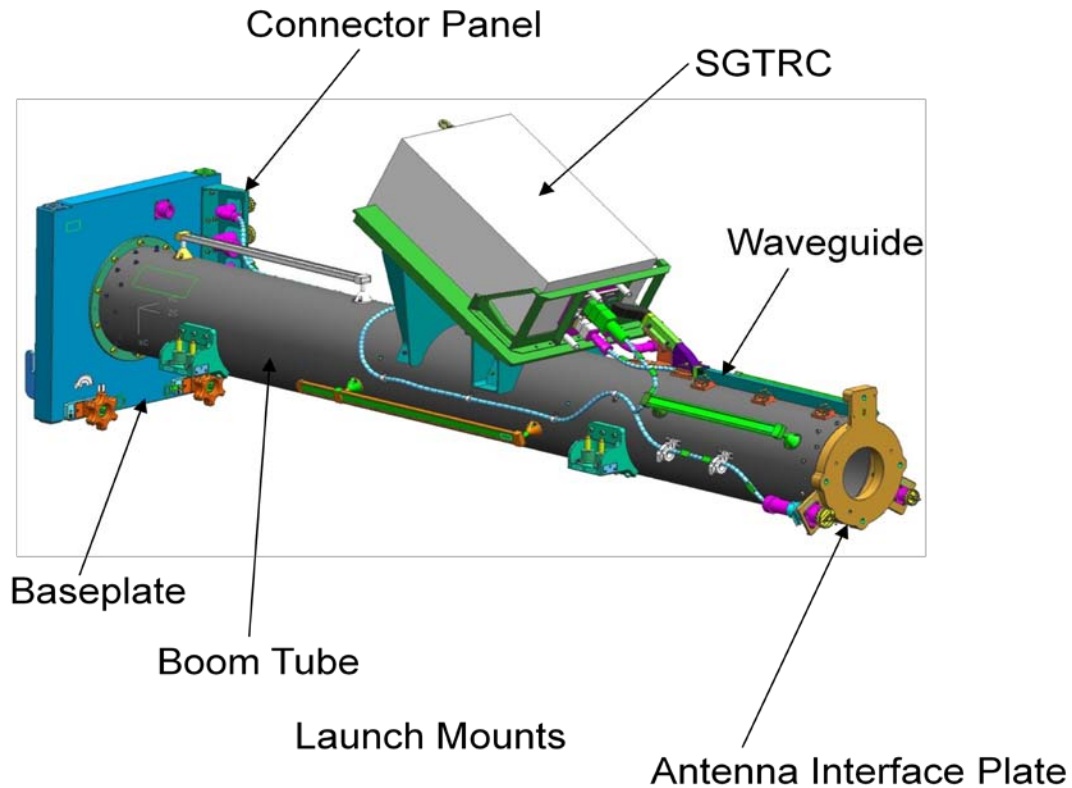
With a spare flight SGANT and SGTRC available on the ground, Boeing and NASA engineers centered the majority of work on the development and fabrication of the Redundant Boom itself (though, the spare SGANT *did* need to be refurbished by the antenna's manufacturer to bring it back into flight readiness which was a project completed in parallel to the Redundant Boom development). The key components of the Redundant Boom include the baseplate, boom tube, cable connector panel, RF waveguide from the SGTRC to SGANT, antenna interface plate, EVA handrails used for on-orbit installation, and the SGTRC mounting plate. Figure 7 shows a CAD model of the Redundant Boom.

Crucial to the initial design was the minimization of structure blockage between antennas and the ability for the boom to be installed and launched on the Space Shuttle program's Integrated Cargo Carrier-Vertical Light Deployable (ICC-VLD). The boom length needed to be minimized to reduce mass and volume, while retaining a minimum length to provide a clear field of view for the Redundant SGANT. Thus, the length of the boom was designed to be approximately 107 inches from the Z1 interface to the SGANT antenna interface. An analysis was completed to show the impact to Ku-Band coverage compared to the existing Antenna Group would be less than 5%, and this length allowed the boom to fit on the available carrier. Another important design consideration was the placement of the EVA handrails. The handrails had to be conveniently and strategically placed so that the crew could successfully maneuver the boom for installation while at the same time not interfere with antenna operation. Multiple EVA simulations within NASA's Neutral Buoyancy Lab (NBL) were run by the STS-132 crew to determine the optimal locations for installation, while keeping the handrails away from potential impingement from the back of the slewing antenna.

Figure 7. Redundant Boom.

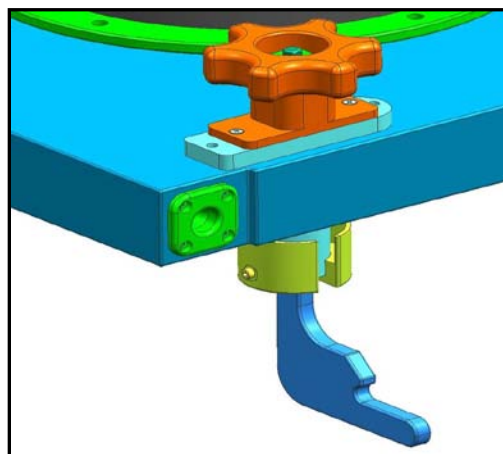
The antenna boom, shown in detail in Figure 8, was designed to mount via a baseplate in the location previously used to stow the existing Ku-Band antenna during launch on 3A. Located within the mounting position are two fixed pins and two adjustable screw rod pins; therefore, the baseplate incorporates four bushings which are designed to receive the available pins. The boom baseplate also includes two “soft dock” clamps which provide soft capture prior to driving in the screw rod pins and, in the event of a screw rod pin failure, can provide the backup clamping of the boom assembly. This also allows for the boom to be in a stable ‘soft dock’ configuration and provides sufficient stability during the EVA to allow the crew to get in place to drive the hard capture. Figure 8 shows a CAD model of the soft dock clamp. Finally, the baseplate provides a structural attachment for the tube mount and the cable connector panel through which the power, data, and IF cables are routed.

Figure 8. Soft Dock Clamp.

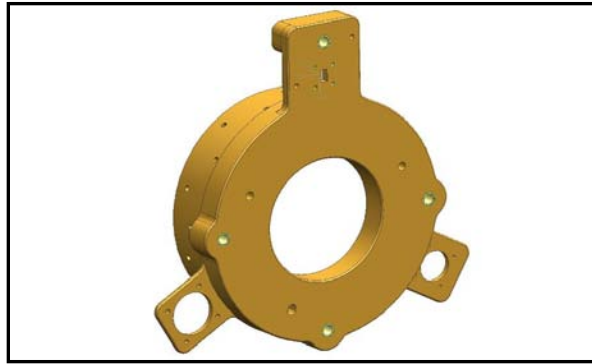
The Antenna Interface Plate is a one piece design and incorporates all of the mounting features for the SGANT into one solid part which includes the waveguide interface, the SGANT power connector interface, the data cable connector interface, and SGANT guide pin interface. The guide pin interface receives the guide pins located on the bottom surface of the SGANT assembly and its purpose is to ensure proper alignment of the antenna onto the boom and reduce the amount of gapping between the boom and antenna waveguides. Due to the Ku frequency requirements, this interface has very tight tolerances (0.005 inches). Additionally, the Antenna Interface Plate is match drilled to the boom tube to ensure an exact fit. Figure 9 is a CAD model of the Antenna Interface Plate.

Figure 9. Antenna Interface Plate.

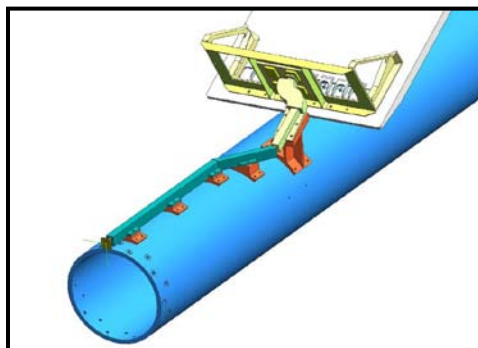
Critical to the performance of the Second Ku-Band Antenna Group is the design and manufacture of the RF waveguide. Increased RF losses caused by insertion losses or Voltage Standing Wave Ratio (VSWR) issues due to an ill-tuned waveguide or a waveguide misalignment can make received/transmitted RF signals unrecoverable. Thus, care was taken to ensure that the waveguide was properly tuned to receive and transmit carrier frequencies. A waveguide shield was also provided to give proper waveguide alignment/mounting and offer protection from on-orbit foreign object debris (FOD). As mentioned above, the Antenna Interface Plate, in conjunction with the SGANT guide pins, ensures a minimal gapping between the boom and antenna waveguides which results in miniscule insertion losses. Figure 10 is CAD model of the boom waveguide.

Figure 10. RF Waveguide.

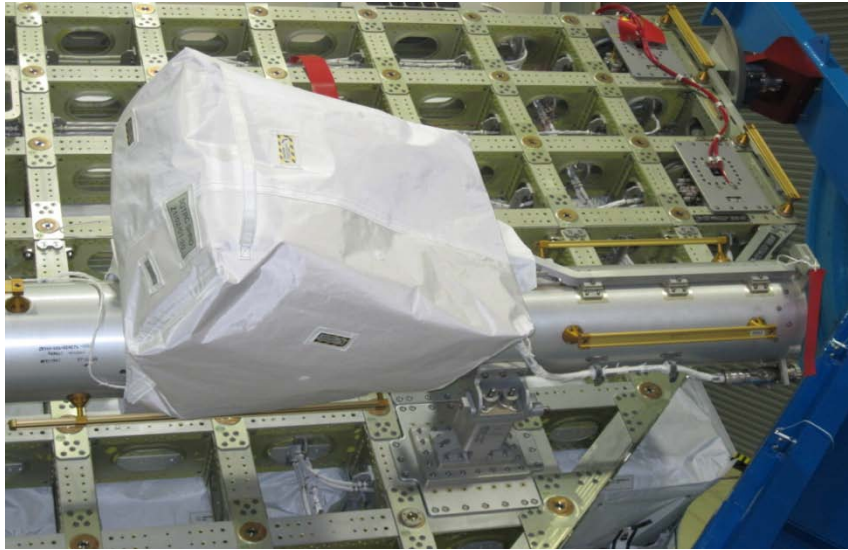
Following the thermal and vibration testing, the SGTRC flight unit was installed onto the SGTRC plate and a fit check was performed. Since the launch configuration of the Redundant Boom assembly included the SGTRC plus a multilayer insulation (MLI) cover, the SGTRC EVA bolts were tightened to their specified torque requirement for both launch and on-orbit installation. Figure 11 is a picture of the flight SGTRC plus MLI cover installed onto the Redundant Boom. Next, a fit check was performed at the HPSC to ensure no gapping existed between the SGANT interface plate and a dummy, flight-equivalent Antenna Group Interface Tube (AGIT), which is the bottom component of the SGANT that is bolted to the boom. Any gaps or misalignments in the waveguide would increase the insertion losses seen on both the forward and return links; thus, it was important to ensure a precise fit. First, a visual inspection was performed to verify a “good” fit between the two components and was followed by physically measuring the gap. The resulting measurements confirmed the gap and alignment at the waveguide interface was within the designed tolerance, thus introducing minimal insertion losses.

Figure 11. SGTRC (with thermal blanket) installed on the Redundant Boom.

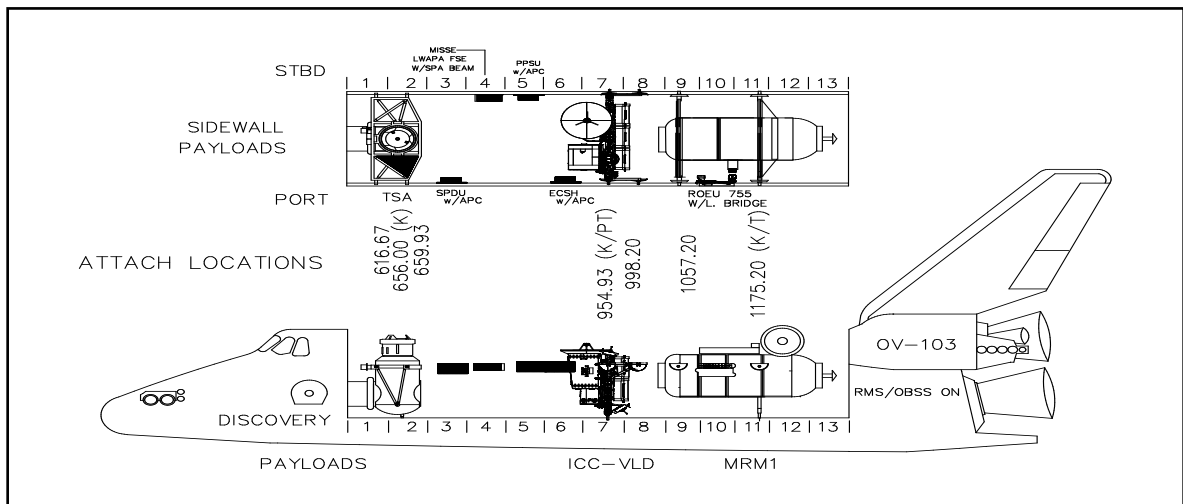
The Redundant Boom, spare SGTRC, and spare SGANT were launched on STS-132 (ULF-4) on 14 May 2010. The Space Shuttle Atlantis docked with the ISS on 16 May 2010, and its primary payloads included the Russian Rassvet Mini-Research Module and the ICC-VLD. In addition to the Boom Assembly and SGANT, the ICC-VLD also carried six battery ORUs to replace aging batteries located within the P6 truss segment. The ICC-VLD sits vertically within the Shuttle payload bay and is approximately eight feet long, thirteen feet wide, and ten inches thick. Constructed of aluminum, the total weight of the carrier plus ORUs is approximately 8330 pounds and is berthed near the center of the payload bay for both launch and re-entry. Figure 12 is an illustration of the shuttle payload bay with the ICC-VLD berthed.

Figure 12. ICC-VLD integrated into the Shuttle Payload bay.

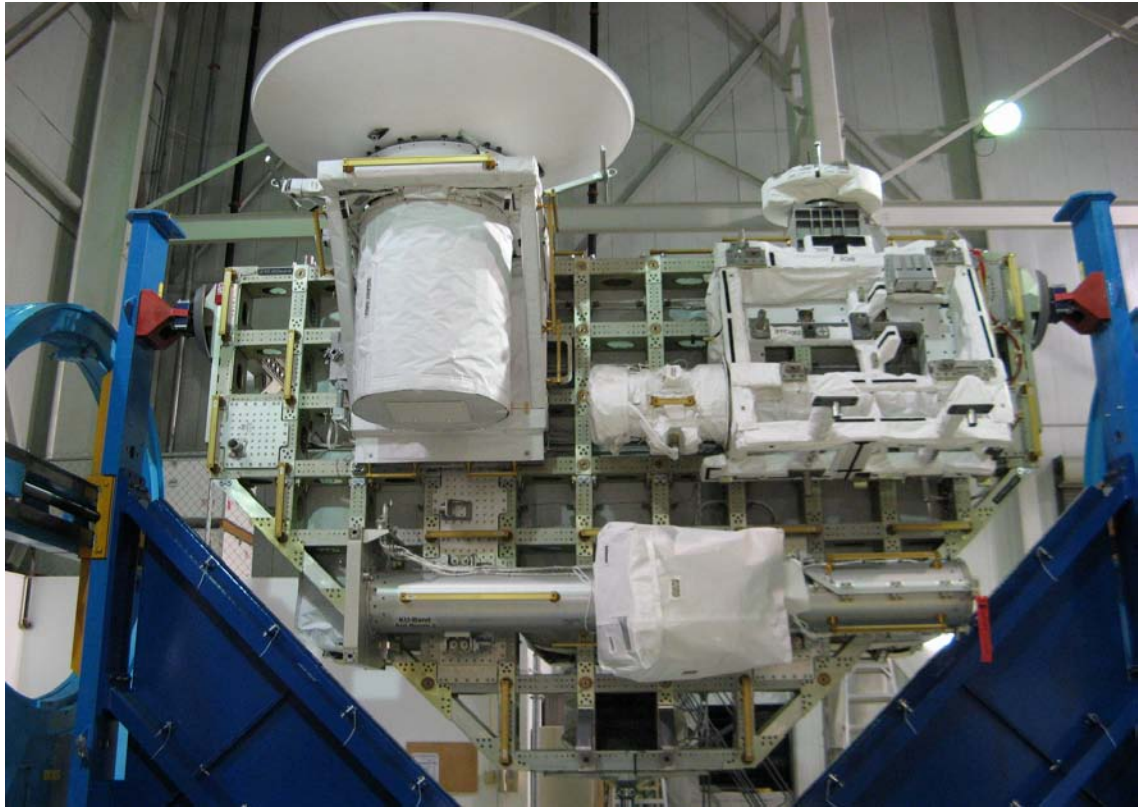
method should a failure occur in one of the primary EVA bolts. Following the ICC-VLD/Redundant Boom integration, the SGANT/FSE was installed on the upper left section as seen in Figure 13, while the batteries previously mentioned were installed on the back side of the carrier. Not mentioned was the installation of the Enhanced ORU Temporary Platform (EOTP), which was located immediately adjacent to the SGANT/FSE.

Figure 13. SGANT and Boom w/SGTRC installed on ICC-VLD.

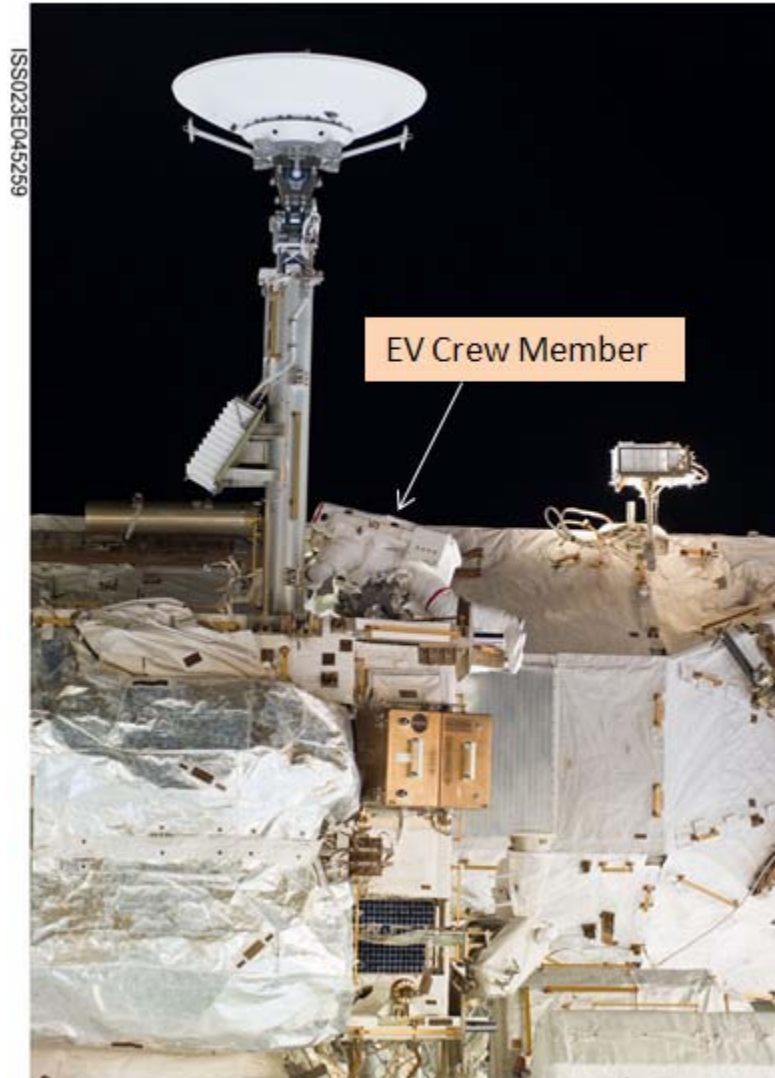
In preparation for EVA 1, the Shuttle astronaut Piers Sellers and ISS Expedition 23/24 astronaut Tracy Caldwell Dyson utilized the Space Station Remote Manipulator System (SSRMS) to relocate the ICC-VLD from the Shuttle payload bay to the ISS Mobile Transporter (MT). While the crew slept, the MT was translated to Worksite (WS) 4 where the EVA crew would off load the P6 truss batteries. After the EV crew, consisting of Garrett Reisman and Stephen Bowen, unloaded the batteries, the MT was moved to WS8 where the Boom/SGTRC would be offloaded for its installation onto the Z1 Truss. With the help of the SSRMS, both EV crew members easily installed the Redundant Boom and connected the power, data, and RF cabling according to plan. Figure 14 shows the EV crew installing the Redundant Boom's cables.

Figure 14. Redundant Boom cable installation.

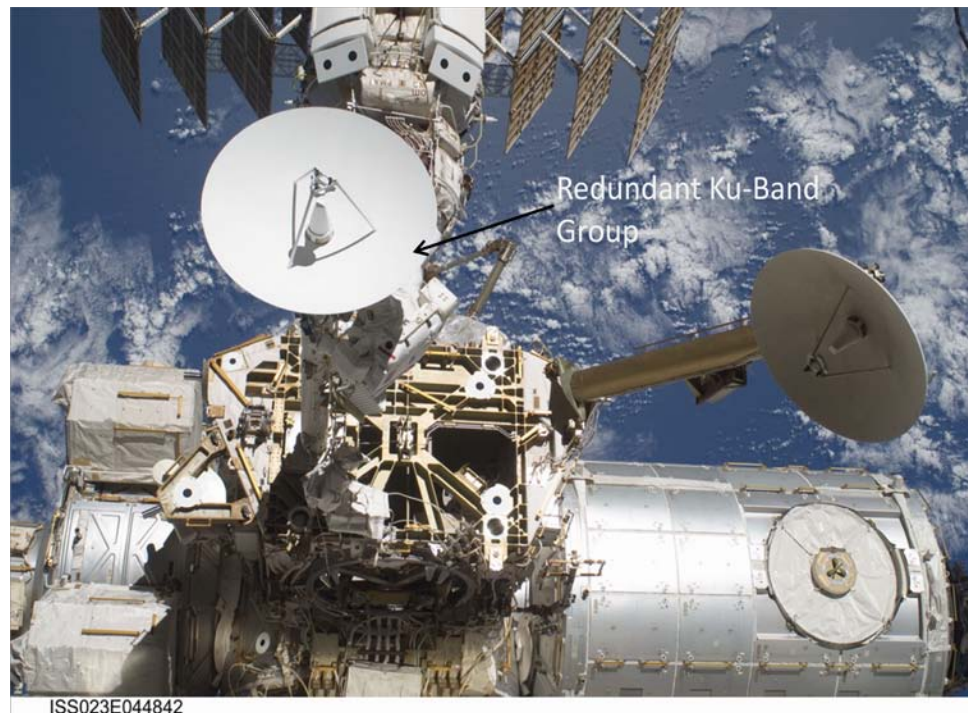
Official activation and checkout of the new antenna group was not planned to occur until after STS-132 undocking. The installation of an internal IF cable necessary to receive and transmit the IF frequency to/from SGTRC2 was needed for the full checkout and activation. Without the IF cable, the Boeing C&T team pushed to perform a forward link test to both verify the antenna pointing and tracking of the TDRS and measure the forward link insertion losses through the waveguide. The test was performed using TDRS 171 and the measured power level received by SGTRC-2 was approximately 1 dB greater than that seen with SGTRC-1 with the same TDRS satellite. This is due to the RF characteristics of the SGANT-2, the SGTRC-2, and the Redundant Boom waveguide and was expected per a link margin analysis previously completed. Initially, C&T engineers were concerned that the static bias of the antenna boom away from the ISS state vector would affect antenna pointing. This affect was immediately seen when the original string was activated and thus, a static bias matrix was developed to compensate for pointing errors. Since the Redundant Antenna Group resides near the actual ISS state vector, C&T hypothesized that the pointing error due to the offset would be so small that the development of a static bias matrix would be superfluous at best. This hypothesis was proven correct by the performance of SGANT-2 when the identity static bias matrix (no bias required) was applied. Figure 15 shows the installed redundant string on-orbit.

Figure 15. Installed redundant Ku-Band Antenna Group.

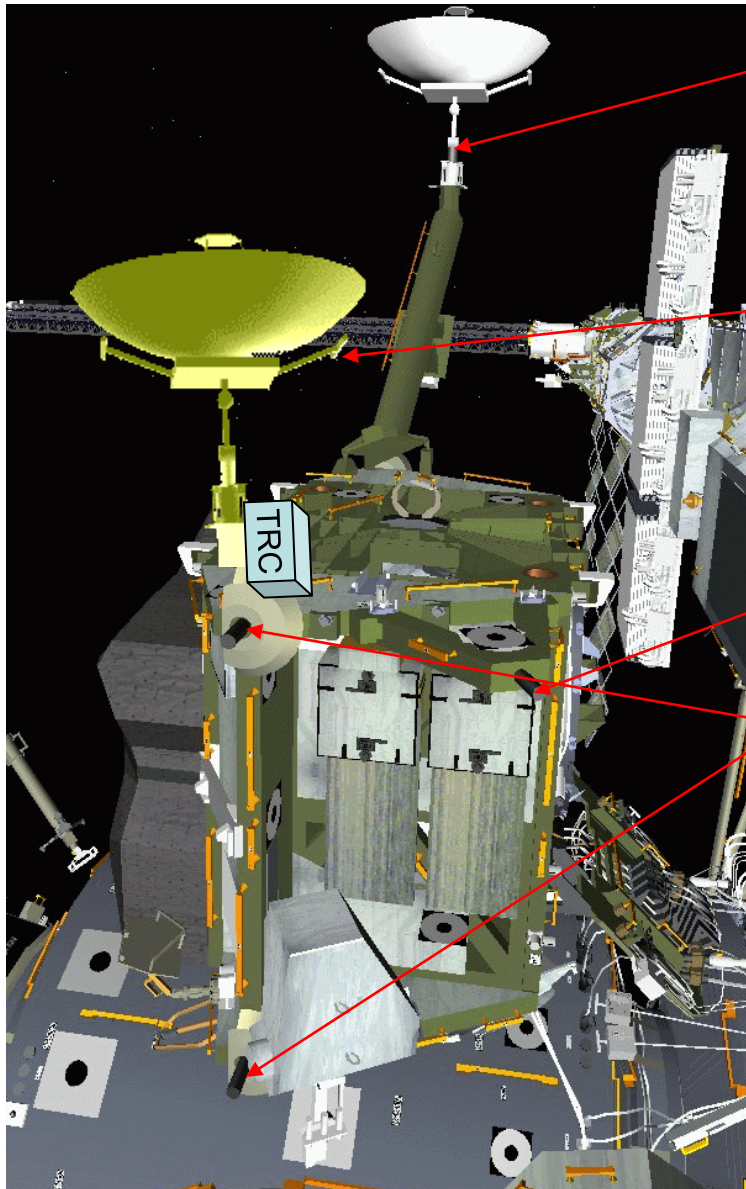
New Operational SGANT Location

Existing SGANT
and Z1 Boom

Proposed new
SGANT
and Z1 Boom

Z1 Keel trunnion.
No UTAS installed

Z1 Longerons
Trunnion with
1j00635 passive
UTAS already
installed

- A new Ku-Band mast provides the structural attachment for the Antenna, Waveguide and TRC
- The mast section will be attached to the Z1 zenith starboard trunnion pin with a UTAS. (More trunnions may be required to react load)
- The SGANT will be launched in its FRAM based FSE. The new mast, waveguide, TRC, UTAS, and cables will be brought up internally and/or in the starboard TSA.
- Power feeds will be run from the existing S-Band operating and heater power used for the P6 S-Band location
- The existing 1553 connection for the S-Band P6 ORUs will be used for the TRC
- A new coax pair (forward and return) will need to be run from the Z1 truss to the Lab Aft J7 connector

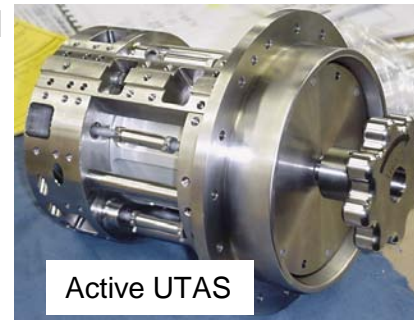
Active UTAS

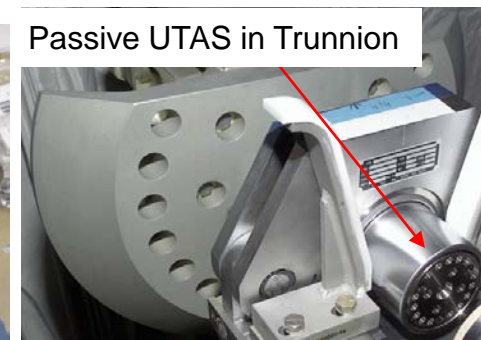
Passive UTAS in Trunnion

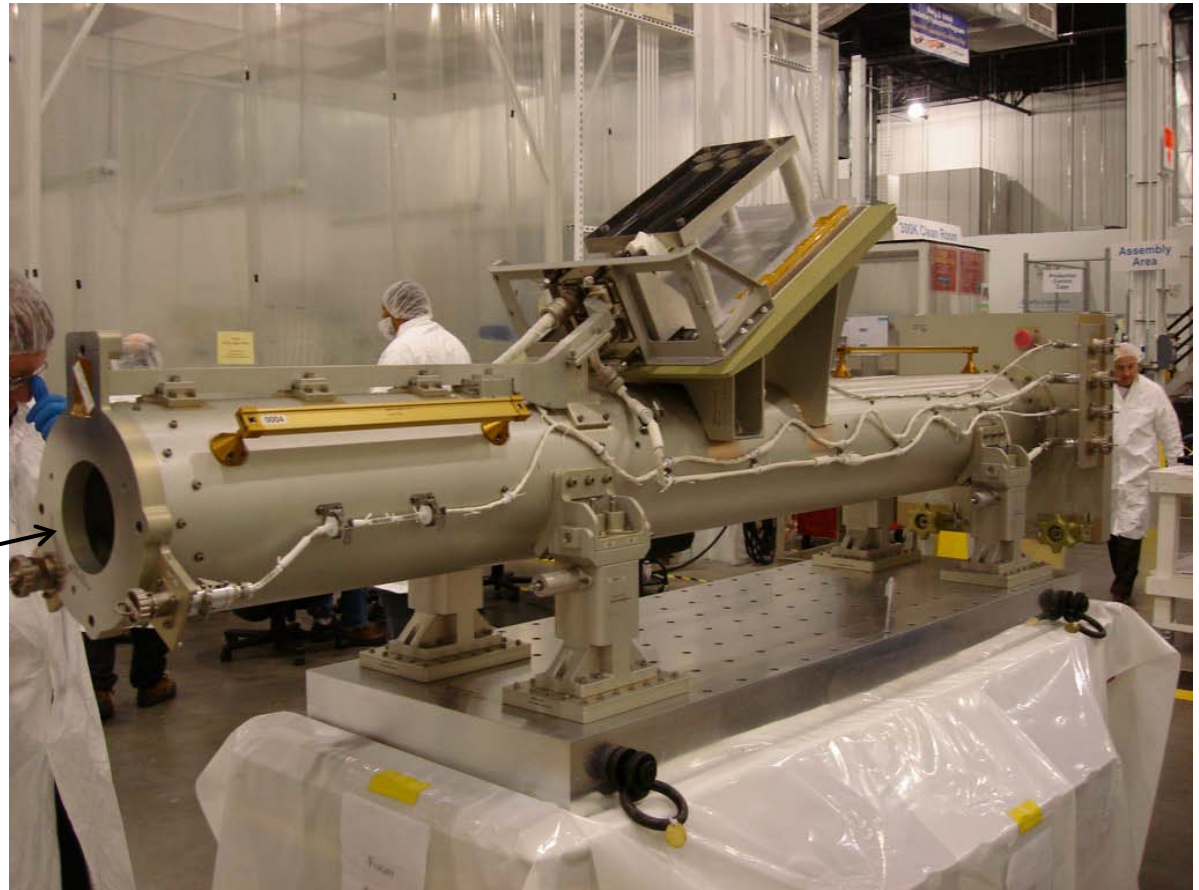
AGIT Interface

Boom interface testing at Boeing Houston August 2009

- Testing completed August 2009
- Used SGTRC Mass Sim and AGIT cast (same design as SGANT AGIT) to simulate interfaces

- VSWR and Insertion Loss testing was completed with JSC ESTL support to confirm the waveguide interfaces

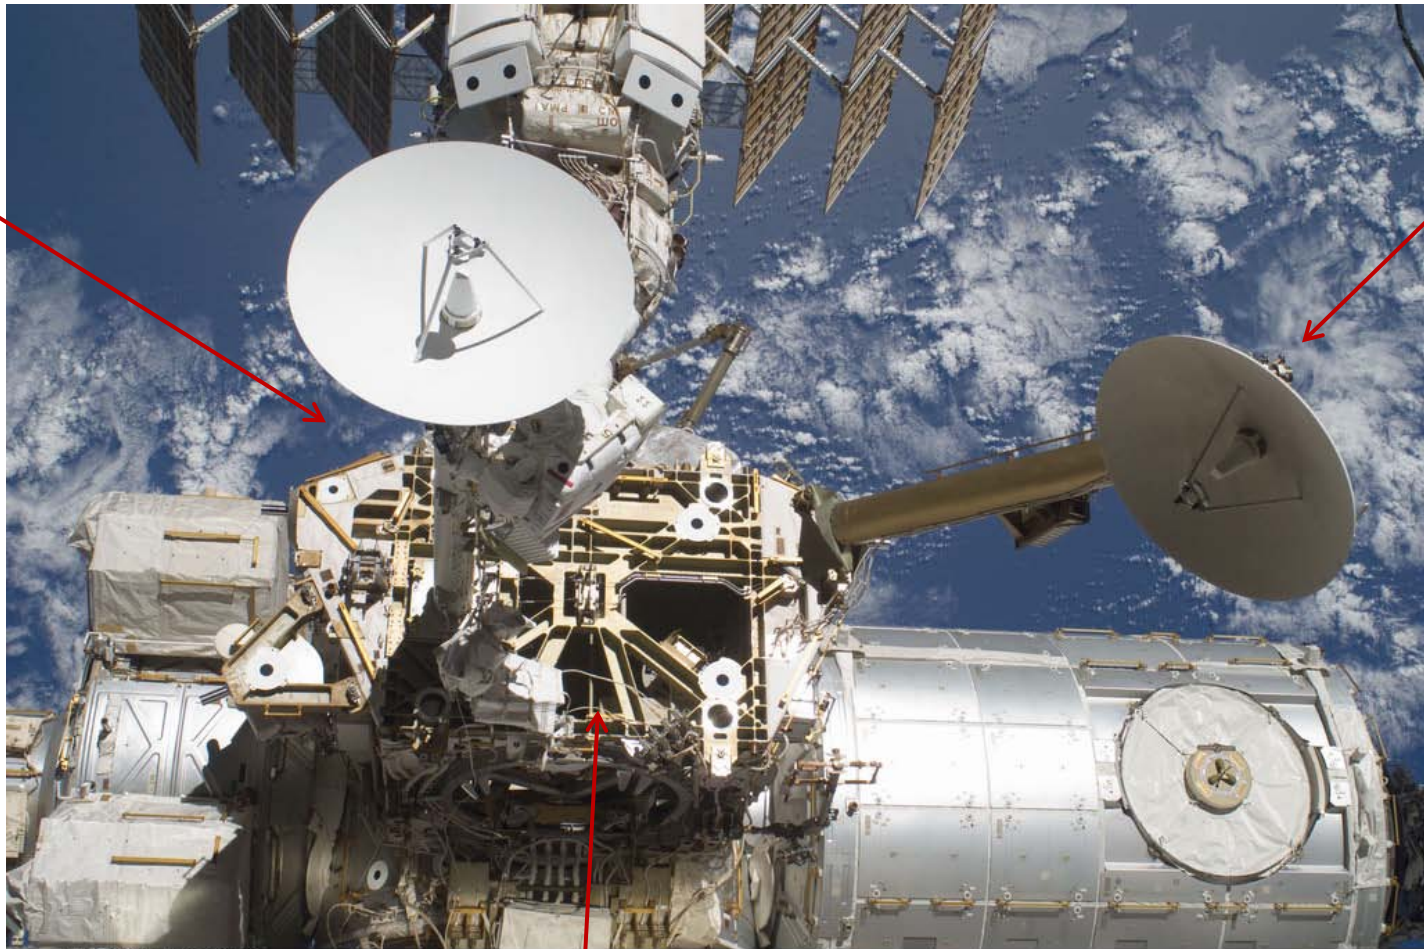
Ku-Band External Hardware as of ULF-4

Redundant
Boom

Prime
Boom

Z1 Truss
