Desert Research and Technology Studies Exposure of Lotus Coated Electrodynamic Shield samples

The Lotus dust mitigation coating and the electrodynamic shield (EDS) are two new technologies currently being developed by NASA as countermeasures for addressing dust accumulation for long-duration human space exploration. These combined technologies were chosen by the Habitation Demonstration Unit (HDU) program for desert dust exposure at the Desert Research and Technologies Studies (D-RaTS) test site in Arizona. Characterization of these samples was performed prior to, during and post D-RaTS exposure.

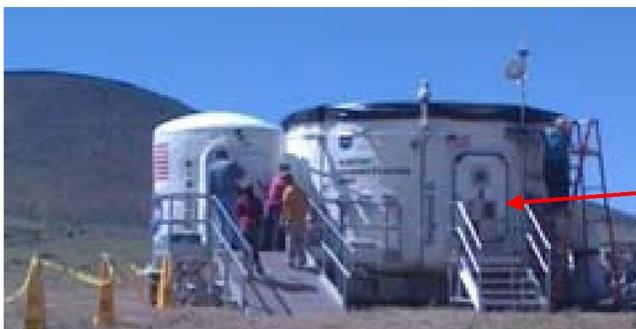
Figure 1: PEM door with mounted EDS panels at D-RaTS site

**PEM Door with mounted
EDS panels**

The D-RaTS demonstration involved placing four 8x10-inch panels on door 4 of the PEM. The panels were exposed to the uncontrolled elements in at the D-RaTS site for 14 days. Through a connected power supply, KSC activated the EDS panels daily during operations. GSFC Coatings Engineers traveled twice to D-RaTS at the beginning and end of exposure. During these visits GSFC performed microscopic imaging and reflection measurements on the four panels during the 1st, 10th, and 11th days of the 14 day exposure. At the conclusion of the D-Rats exposure, the PEM was transported back to Johnson Space Center (JSC). Once at JSC the panels were removed from the PEM door and hand delivered back to GSFC for post exposure testing.

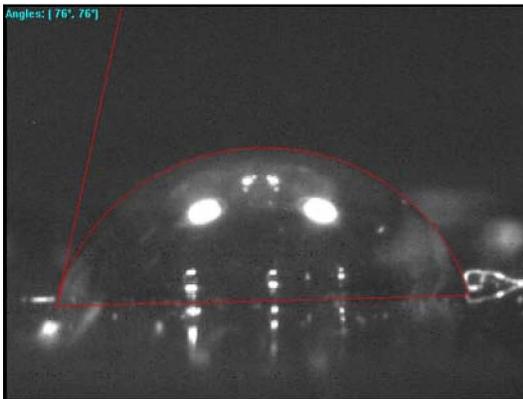
The post-exposure measurements showed a degradation of the super-hydrophobic properties of 2010_03_08A. In Table 2 this measurement is marked with **. A large range of measured contact angles was observed over the surface of this EDS panel. A visible inspection of 2010_03_08A showed a haze on a large portion of the surface. In these hazy areas hydrophilic properties with contact angles less than 90° were observed. In some cases contact angles were too small to be measured. Hydrophobic properties were demonstrated in the non-hazy areas. Contact angles of 135° were observed however this is under the super-hydrophobic threshold of 150° that was observed in the pre-exposure measurements. The post-exposure contact angle measurements performed on Controls 3 and 4 also showed decreased contact angles. Controls 1 and 2 did not show a significant change from pre to post exposure.

Figure 12: Control 1 - Pre-Exposure Contact Angle

Figure 11: Control 1 - Post-Exposure Contact Angle

Figure 10: Control 2 - Pre-Exposure Contact Angle

Figure 9: Control 2 - Post-Exposure Contact Angle

Figure 8: Control 3 - Pre-Exposure Contact Angle

Figure 7: Control 3 - Post-Exposure Contact Angle

Figure 14: Control 4 - Pre-Exposure Contact Angle

Figure 13: Control 4 - Post-Exposure Contact Angle

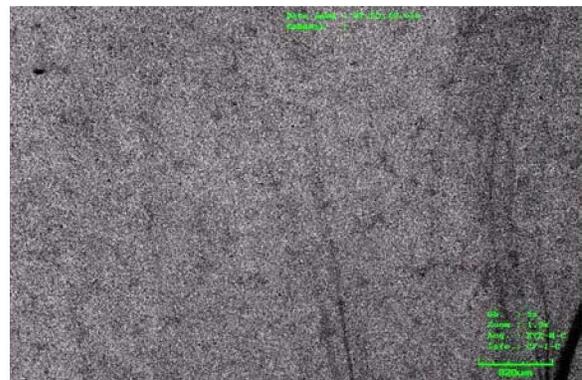
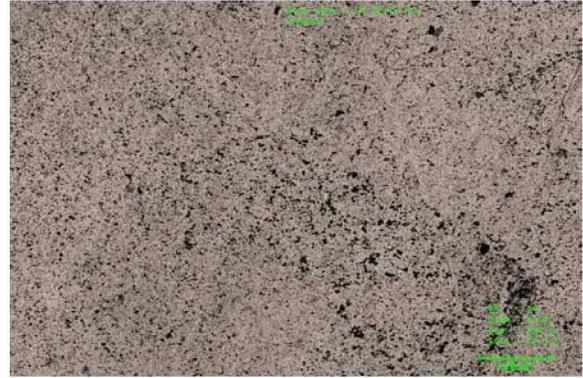
Figures 21 – 28 depict the pre and post exposure 2D and 3D confocal images of Control 2 and 4 at 5X magnification. Figures 21 – 24 show that Control 2 displays no visible irregularities from pre to post exposure. No haze and very little dust was present on the surface. Figures 25 and 26 are images of a representative Lotus coated Kapton™ sample. Figures 27 and 28 are 2D and 3D images of Control 4 post exposure. Dust residue can be seen in these Figures. This is also evident in the decreased contact angle for Control 4 measured post exposure.

Figure 22: 5X 3D Capture of Control 2 – Pre-Exposure

Figure 21: 5X 2D Capture of Control 2 - Pre-Exposure

Figure 24: 5X 3D Capture of Control 2 - Post-Exposure

Figure 23: 5X 2D Capture of Control 2 - Post-Exposure

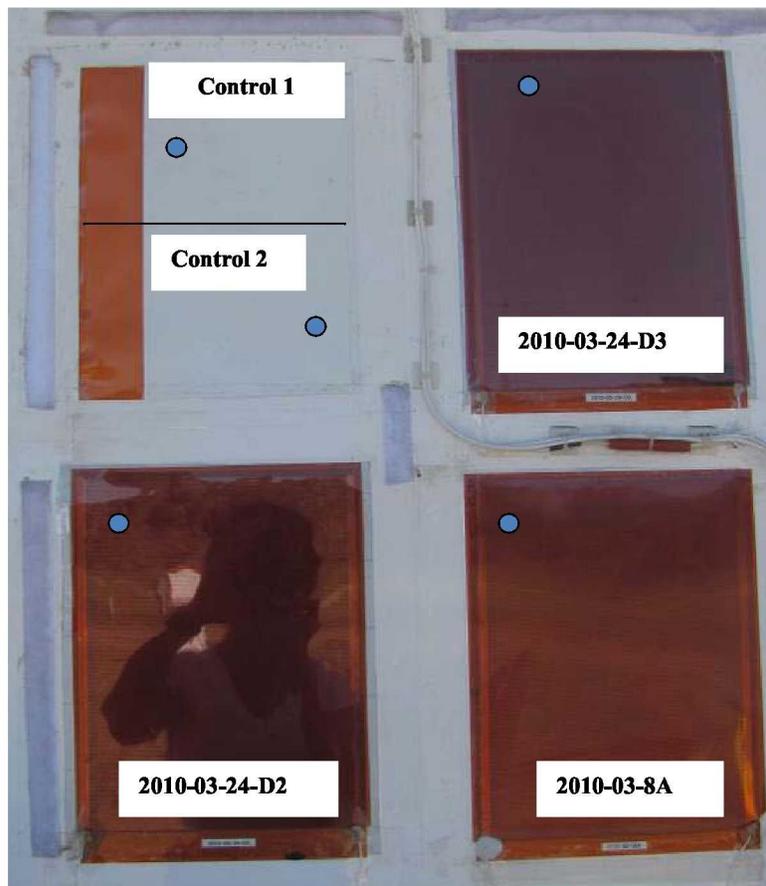
Figure 29: Measurement Locations (Depicted with blue dots)

During the first trip to D-RaTS all of the EDS panels were replaced. Following this replacement, solar absorptance measurements were performed on September 1, 2010 on each of the three EDS panels 2010_03_24-D3, 2010_03_24_D2, 2010_03_8A, and Controls 1 - 4. The measurements performed on the EDS panels will be considered the pre-exposure measurements. The measurements performed on March 22, 2010 will be considered the pre-exposure measurements for Controls 1 - 4 since this was the only panel not replaced. The measurements are all contained in Table 3. In Figure 29 the measurement locations are illustrated with blue dots.

During the second trip solar absorptance measurements were repeated several times in the same locations as indicated in Figure 29. Daily KSC performed dust tests followed by activation of the EDS panels during the D-RaTS exposure. JSC-1 lunar simulant was applied manually to the EDS panels by flicking a brush full of JSC-1 toward the panels before activation³. A visual inspection of JSC-1 accumulation was conducted and documented in photographs and microscope images.

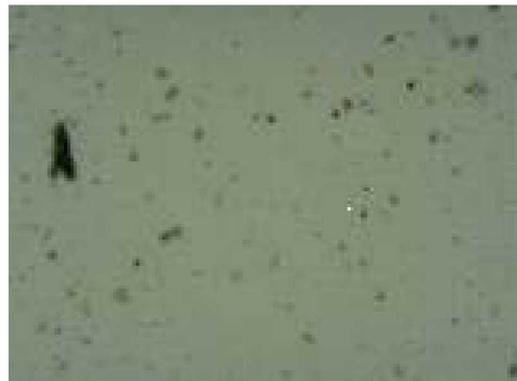
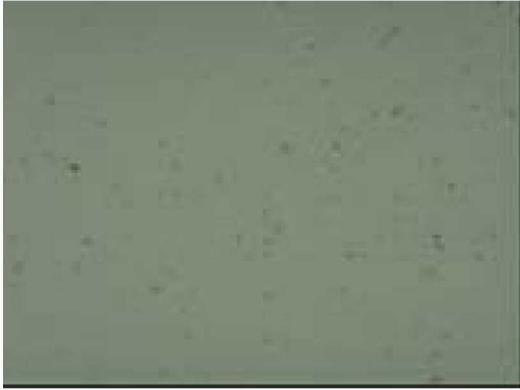
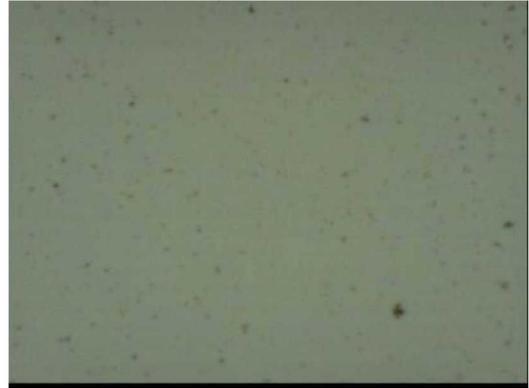
The Dino-Lite images that were taken on Controls 1 - 4 were helpful to show the difference between the Lotus coated and uncoated areas. The microscopic image Controls 1 and 3 show a larger quantity of particles at larger sizes than those seen on Controls 2 and 4. Figures 32 and 33 compare the microscopic images taken of Control 1 during trip #1 and #2. It is easily seen from these images how contaminated the surface became after less than two weeks of exposure at D-Rats. Figures 34 and 35 compare the microscopic images of Control 2 taken during trip #1 and #2. Through this observation it shows the significant dust mitigating properties of the Lotus coating.

Figure 33: Control 1 - Trip #2 (9/11/2010)

Figure 32: Control 1 - Trip #1 (9/1/2010)

Figure 35: Control 2 - Trip #1 (9/1/2010)

Figure 34: Control 2 - Trip #2 (9/11/2010)

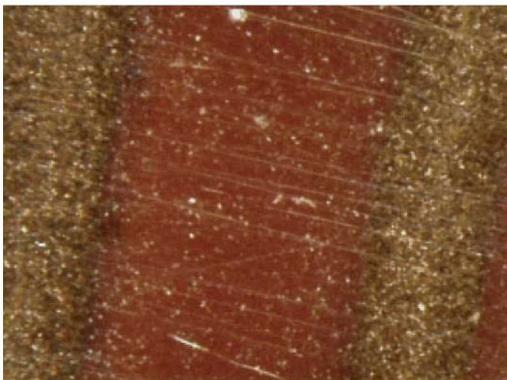
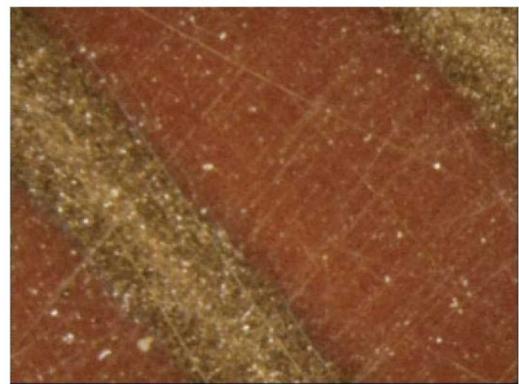
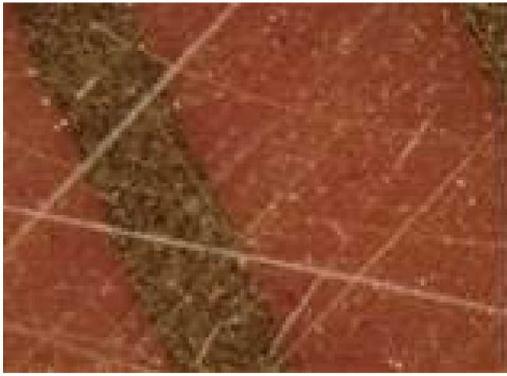
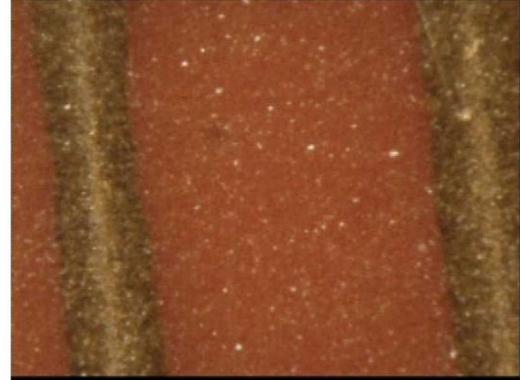
The same dust mitigating phenomena is seen on all of the EDS panels. Figures 36 – 41 compare the panels during trip #1 and #2. There was little to no dust accumulation on the surface of the all of the EDS panels over the two week exposure at D-RaTS. It should be noted that 2010_03_08A was not wiped at any point of D-RaTS while 2010_03_24_D2 and 2010_03_24_D3 were.

Figure 36: 2010-24-D2 - Trip #1 (9/1/2010)

Figure 37: 2010-03-24-D2 - Trip #2 (9/11/2010)

Figure 39: 2010_03_24_D3 - Trip #1 (9/1/2010)

Figure 38: 2010_03_24_D3 - Trip #2 (9/11/2010)

Figure 41: 2010-03-8A - Trip #1 (9/1/2010)

Figure 40: 2010-03-08A - Trip #2 (9/11/2010)
