**ATK Launch Systems
Crane Safety & Handling Symposium**

**Orbiter Payload Bay Bucket Hoist
Mishap... An Accident
We Should Never Forget**

Bradford P. Lytle, P.E.

November 5, 2009

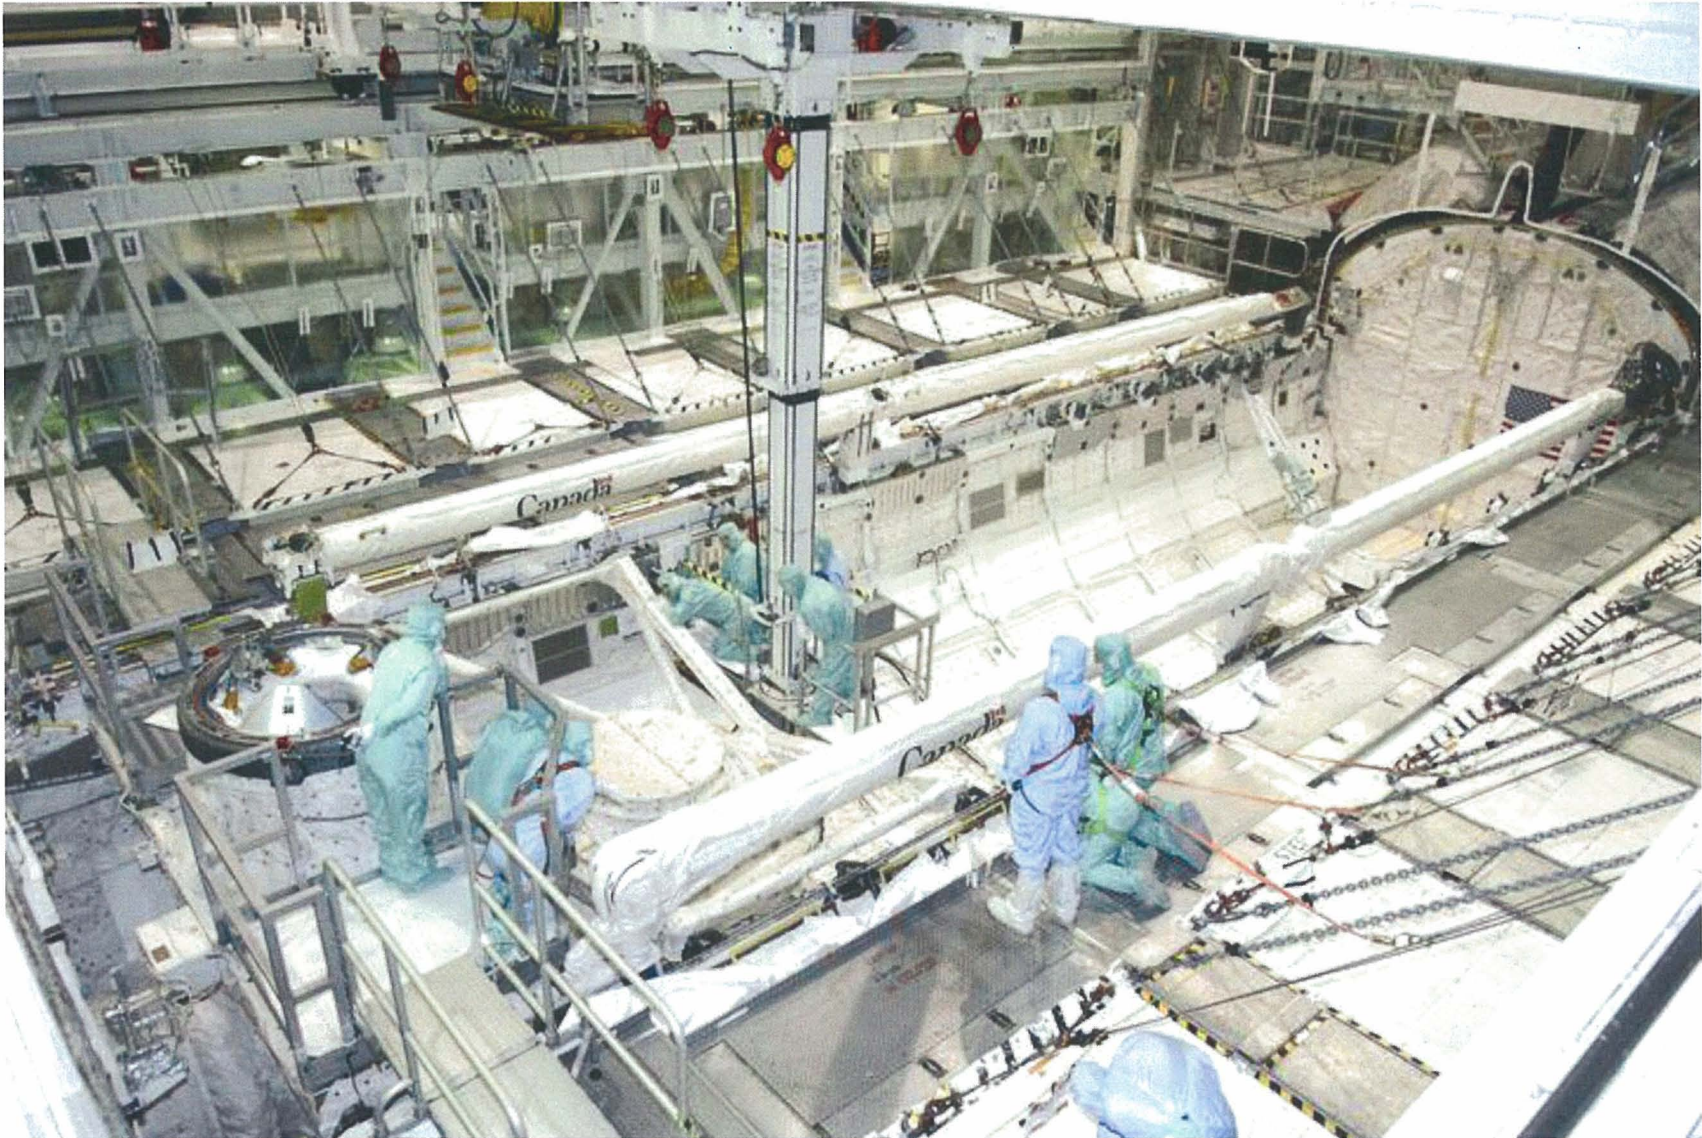
Figure 9-B-1. Sketch of OPF Access Platforms on bridge crane, upper view

ORBITER PROCESSING FACILITY ACCESS PLATFORMS

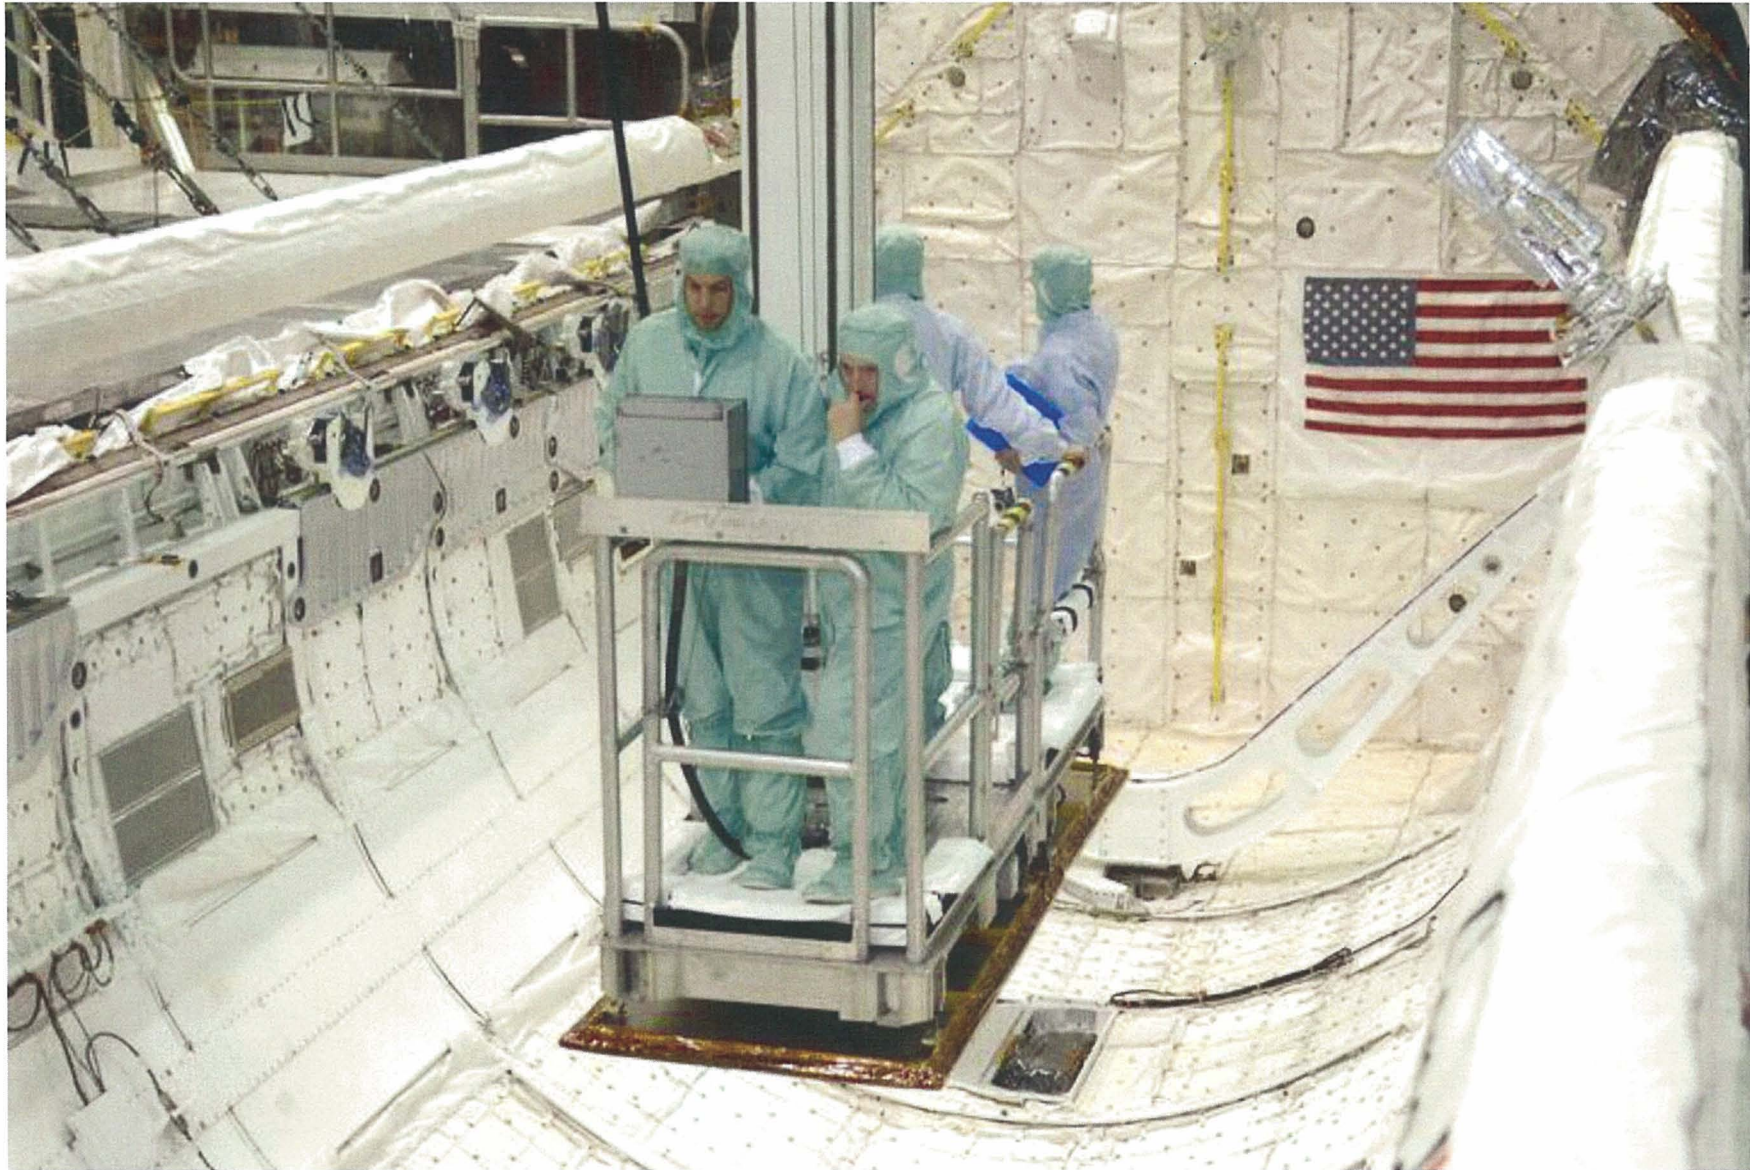
OPF Payload Bucket Hoist

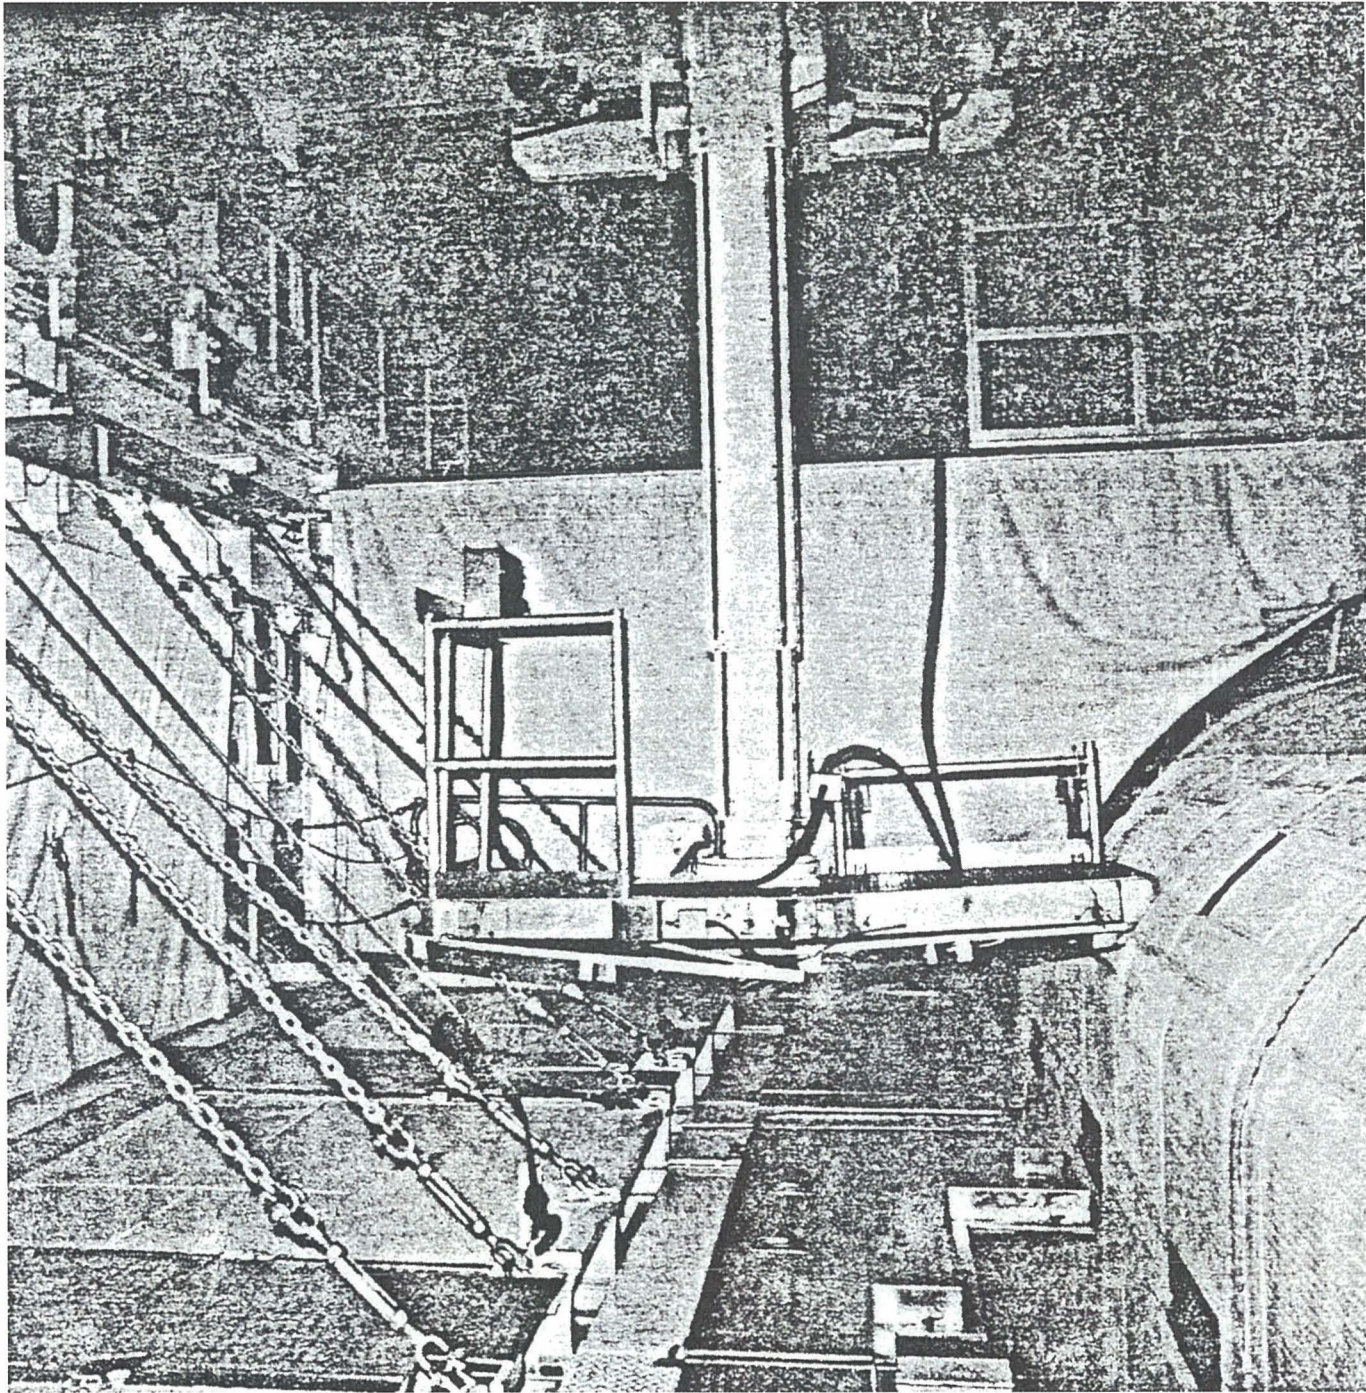
OPF Payload Bucket Hoist

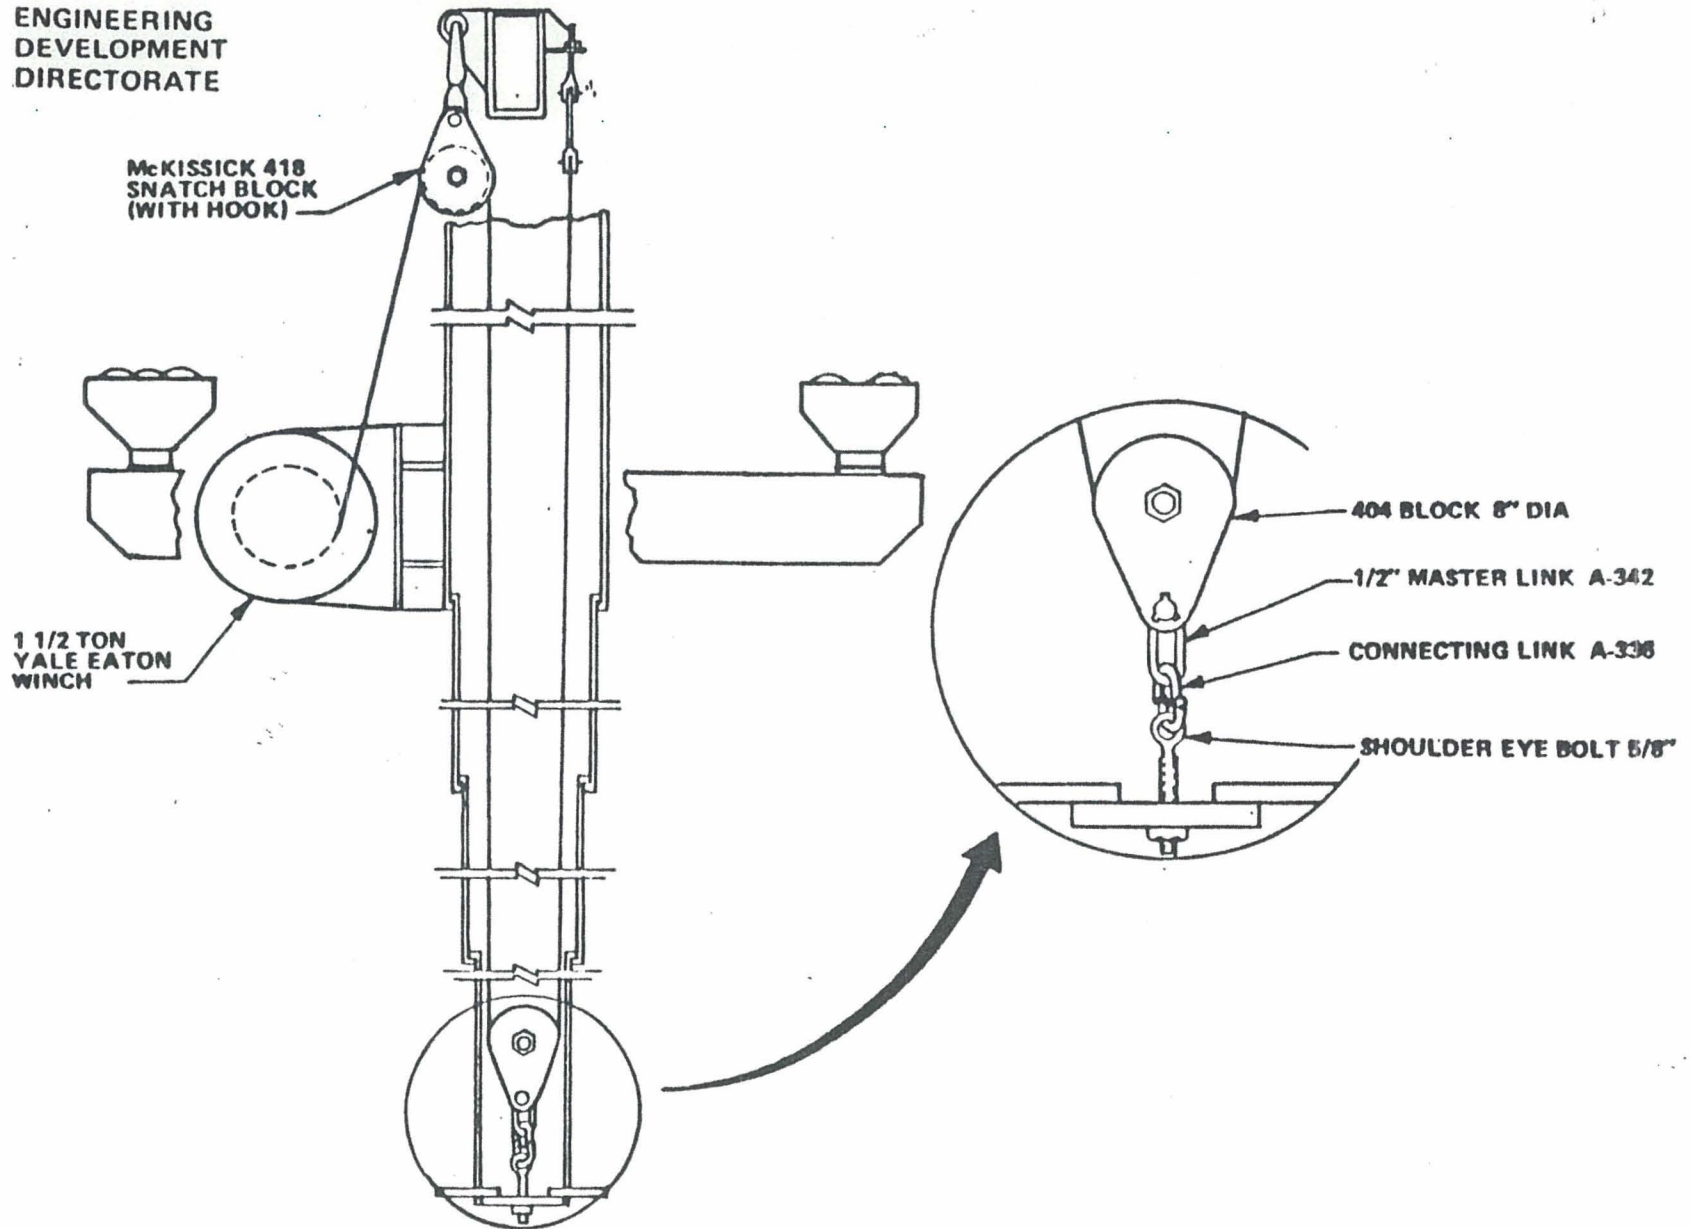
Figure 9-B-2. Side view of Access Platform hoist, cable system, and telescoping tubes

- While placing the platform in the full up position to stow the bucket hoist the operators were using the upper limit switch as a control stop (only one control type upper limit switch).
- The location of the limit switch set point and the mechanical configuration of telescoping tube assemblies was so close that there was little room for drift between the limit switch actuation point / hoist stop point and mechanical contact between the telescoping tube assemblies and hard structure. All 8 Payload Bucket Hoists were adjusted the same way.

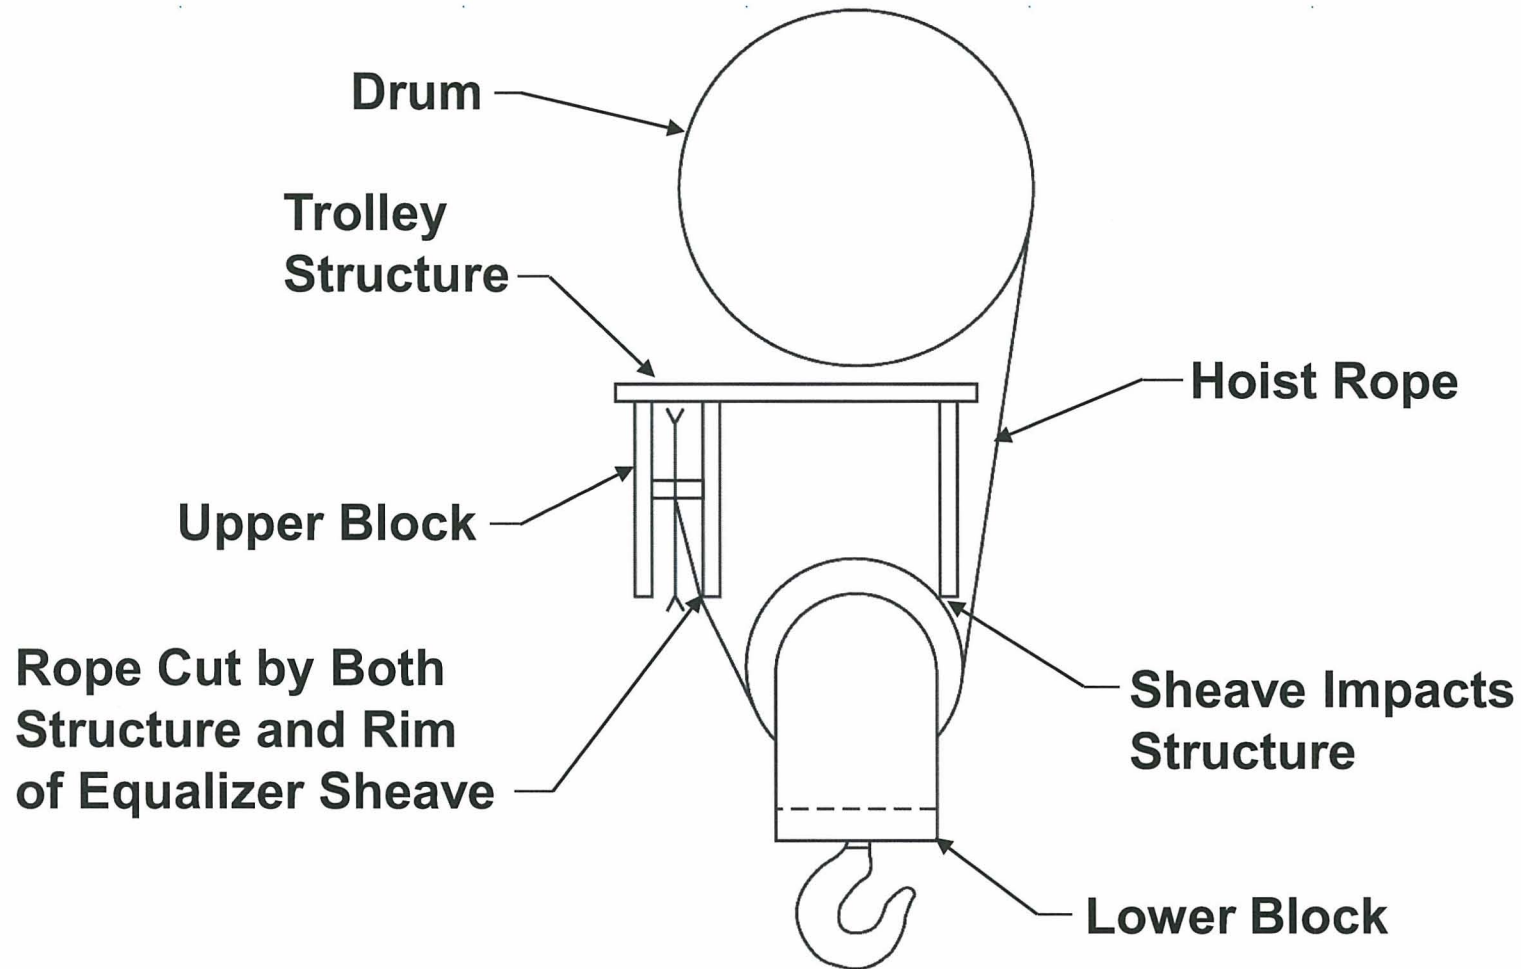
- Two-Blocking
 - Two-blocking is the result of hoisting beyond the intended safe upper limit of hook travel to the point of solid contact between the load block and the upper block or hoist/trolley structure. The usual result is immediate failure of the wire rope, due to the ropes being cut by the grooves of the drum or sheaves.

Two-Blocking

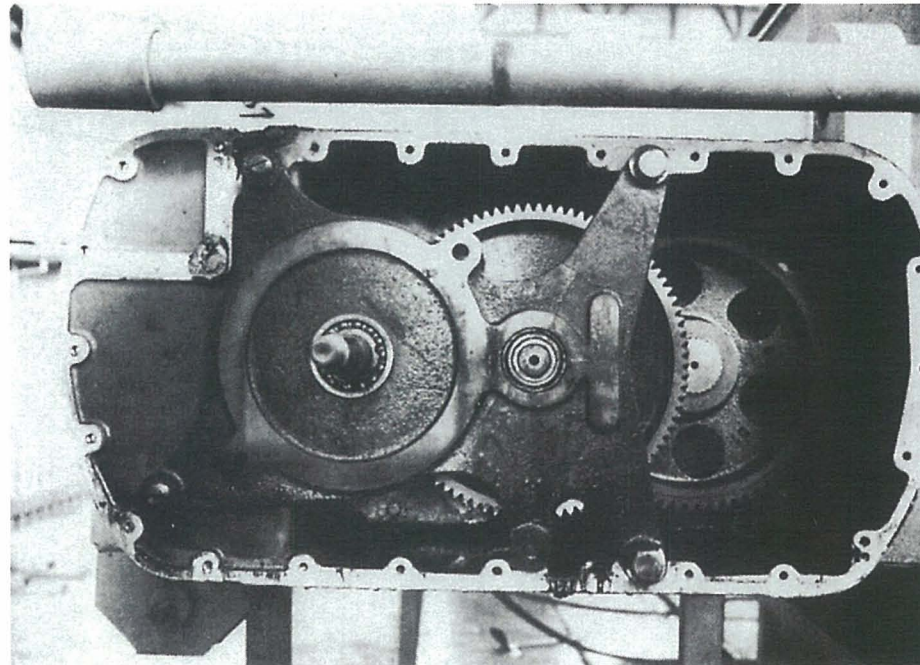
Gear Box Depicting the Spider Plate and Relative Position of the Spider in the Gear Box

- Two Blocking (continued)
 - The electric motor can produce high torque in a fraction of a second.
 - A DC motor can produce 180% of rated motor torque.
 - An AC motor can produce 275% of rated motor torque.
 - we are assuming the hoist motor is not oversized.
 - During the two block event two things happen at the instant the upper and lower block impact.
 - First the motor torque increases abruptly, secondly the rotational inertia of the hoist motor adds to the motor torque.
 - If the wire rope does not fail something else will. Perhaps damage will be hidden (in a coupling or gear reducer).
 - Commercial hoist machinery is not designed to withstand the loads created during two blocking.

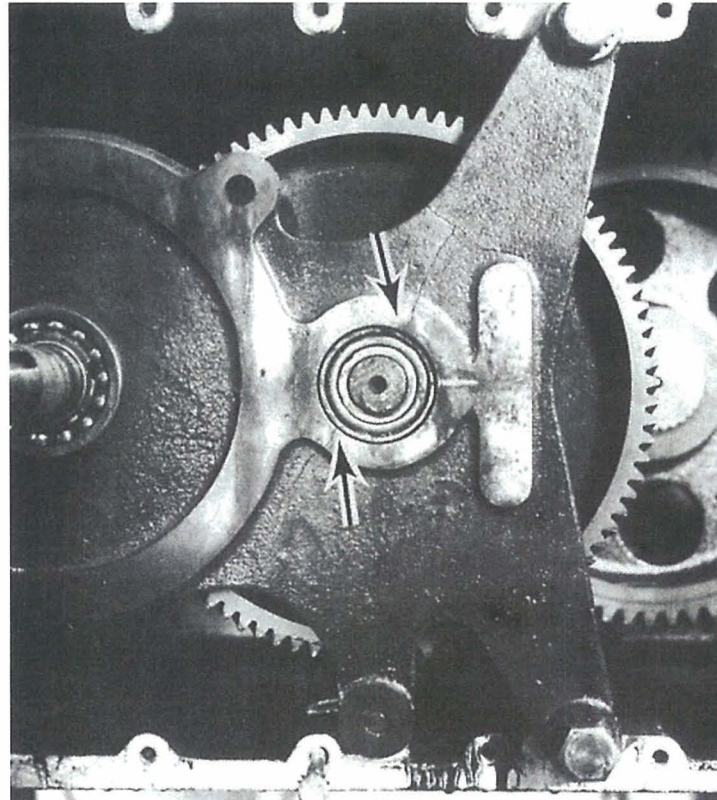
Cracks Around the Shaft and Bearing

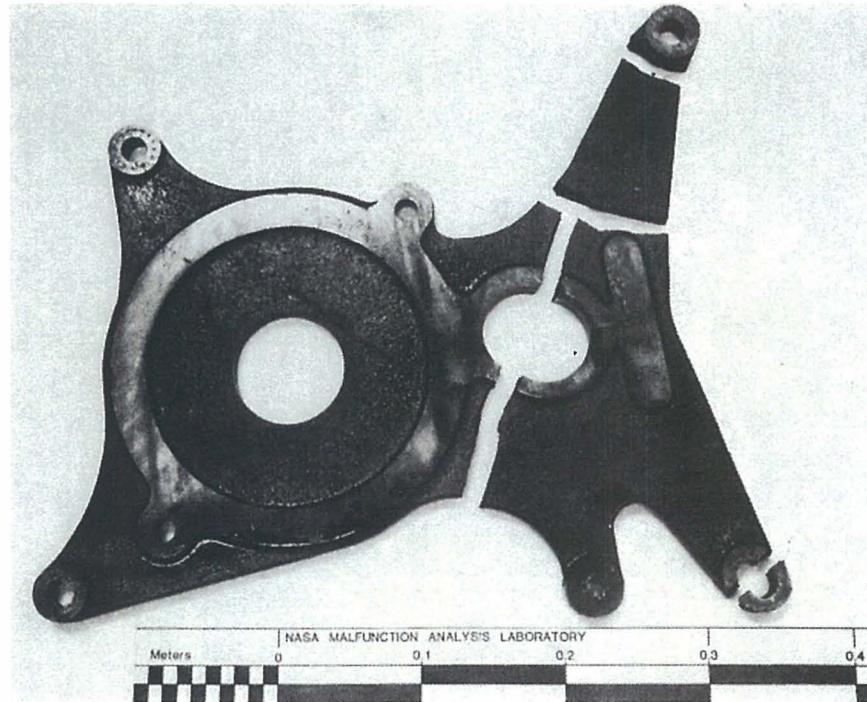
Spider Plate Removed From the Gear Box

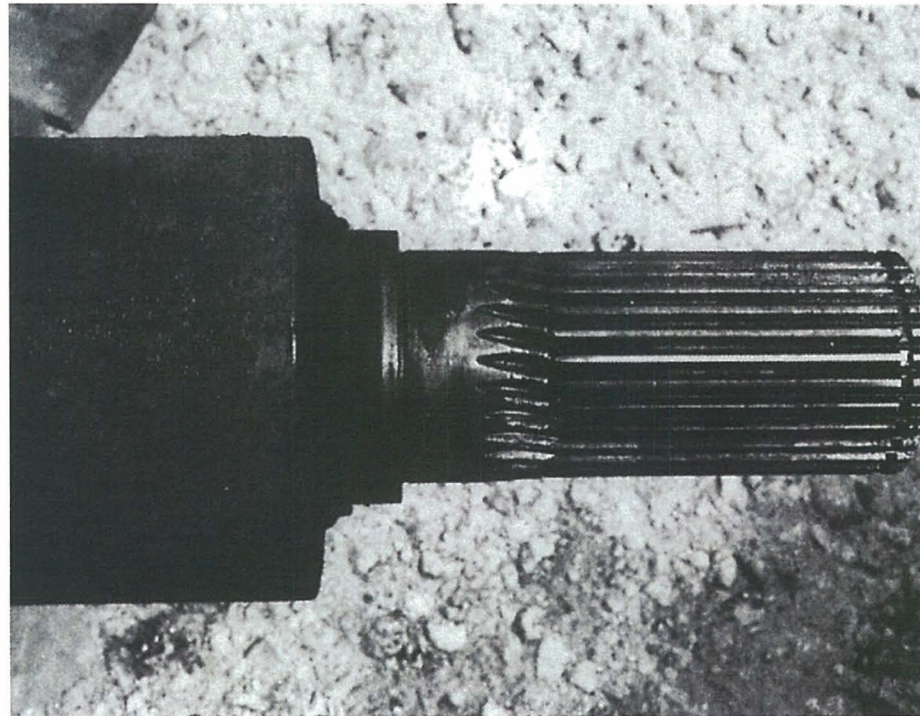
**Drum Shaft Spline Depicting the Deformation Found
After the Spider Failure**

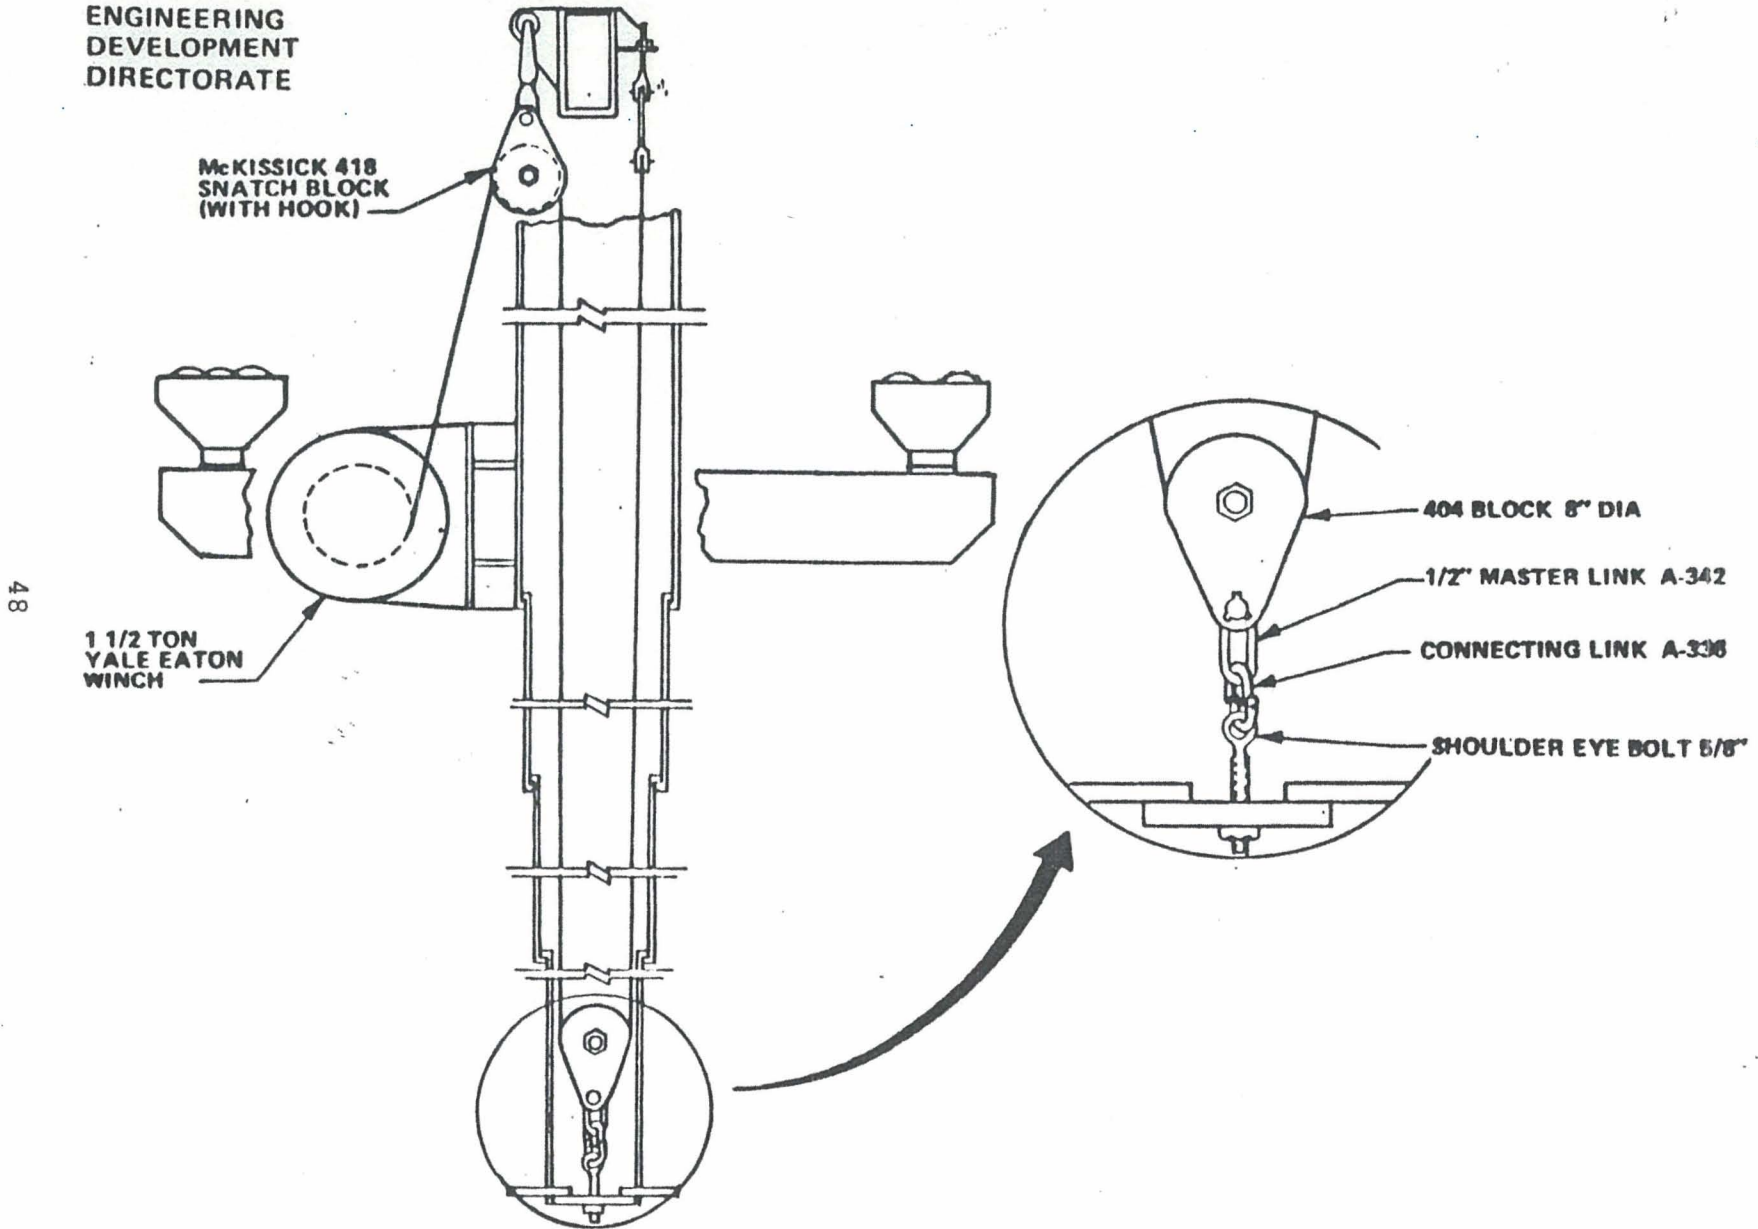
Figure 9-B-2. Side view of Access Platform hoist, cable system, and telescoping tubes

- The operators were “just barely” two blocking the hoist every time they stowed the bucket.
 - Before the accident... inspection of the 10 inch telescoping tubes revealed evidence of metal to metal contact on the supporting structure. Apparently no action was taken by the inspectors.
 - Before the accident... The actuator arm on the hoist limit switch broke. The Bucket Hoist was Locked Out / Tagged Out until repairs could be made.
 - The operators were confused about the type of Lock Out / Tag Out imposed on the equipment and they operated the unit anyway.

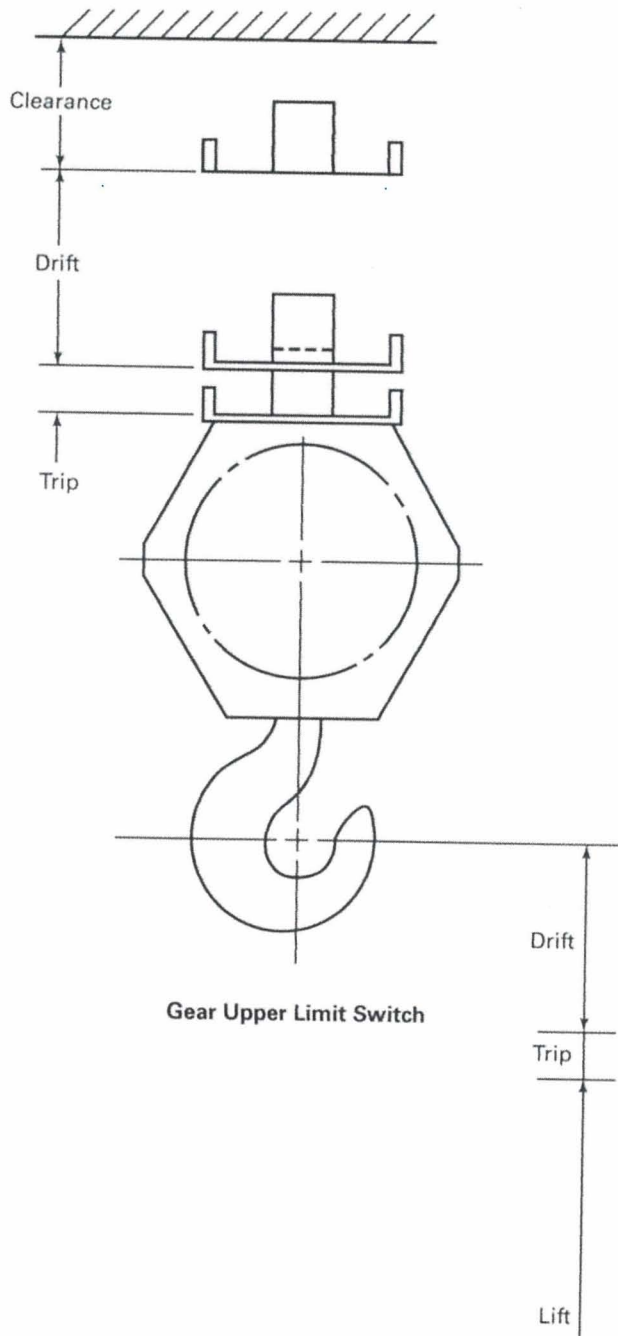
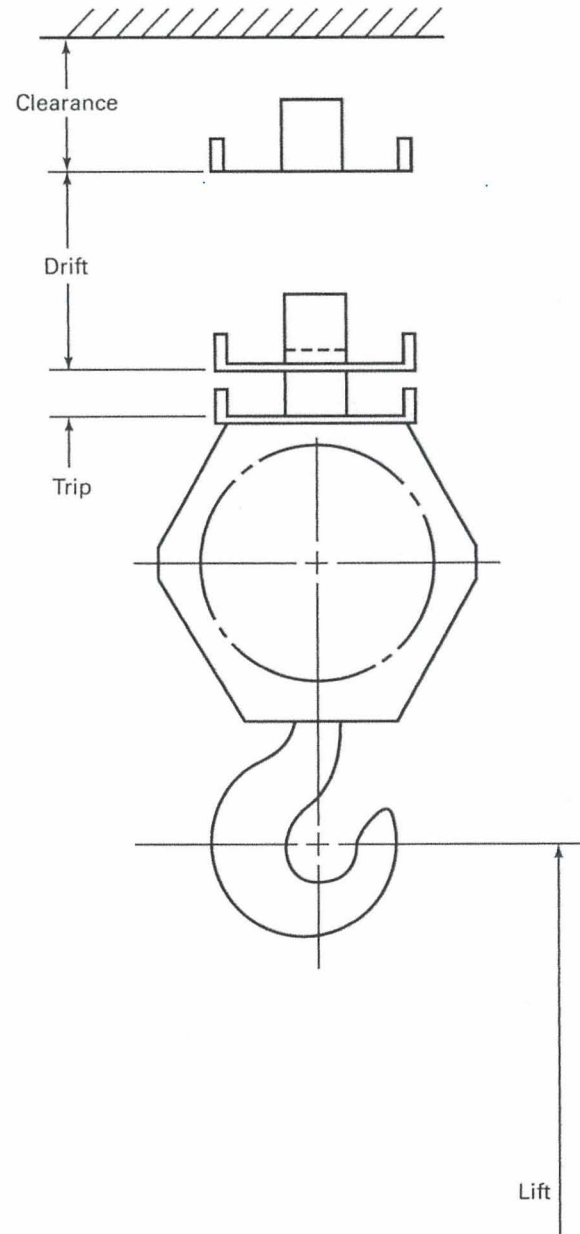
- Note in the figure... Each limit switch needs adequate space between their set points
 - They must have a distance to trip the switch
 - They must have adequate distance to allow for drift
 - And finally they must have adequate clearance between the each switch.
- Adequate space is necessary between the two switches and between the final switch and two blocking.

- The two switches complement each other. They provide an additional layer of protection... in the event one switch fails.
- The switches are of different types and they perform a different function. If the geared limit switch fails you know something is wrong.
 - If you approach the control limit switch and the crane shuts down you know the control switch has failed.
 - Also the control switch should be tested at the start of each operation to assure it's functioning properly.
