Monitoring Delamination of Thermal Barrier Coatings During Interrupted High-Heat-Flux Laser Testing Using Luminescence Imaging

Jeffrey I. Eldridge
Dongming Zhu
NASA Glenn Research Center

35th International Conference on Advanced Ceramics & Composites
Daytona Beach, FL
January 26, 2011

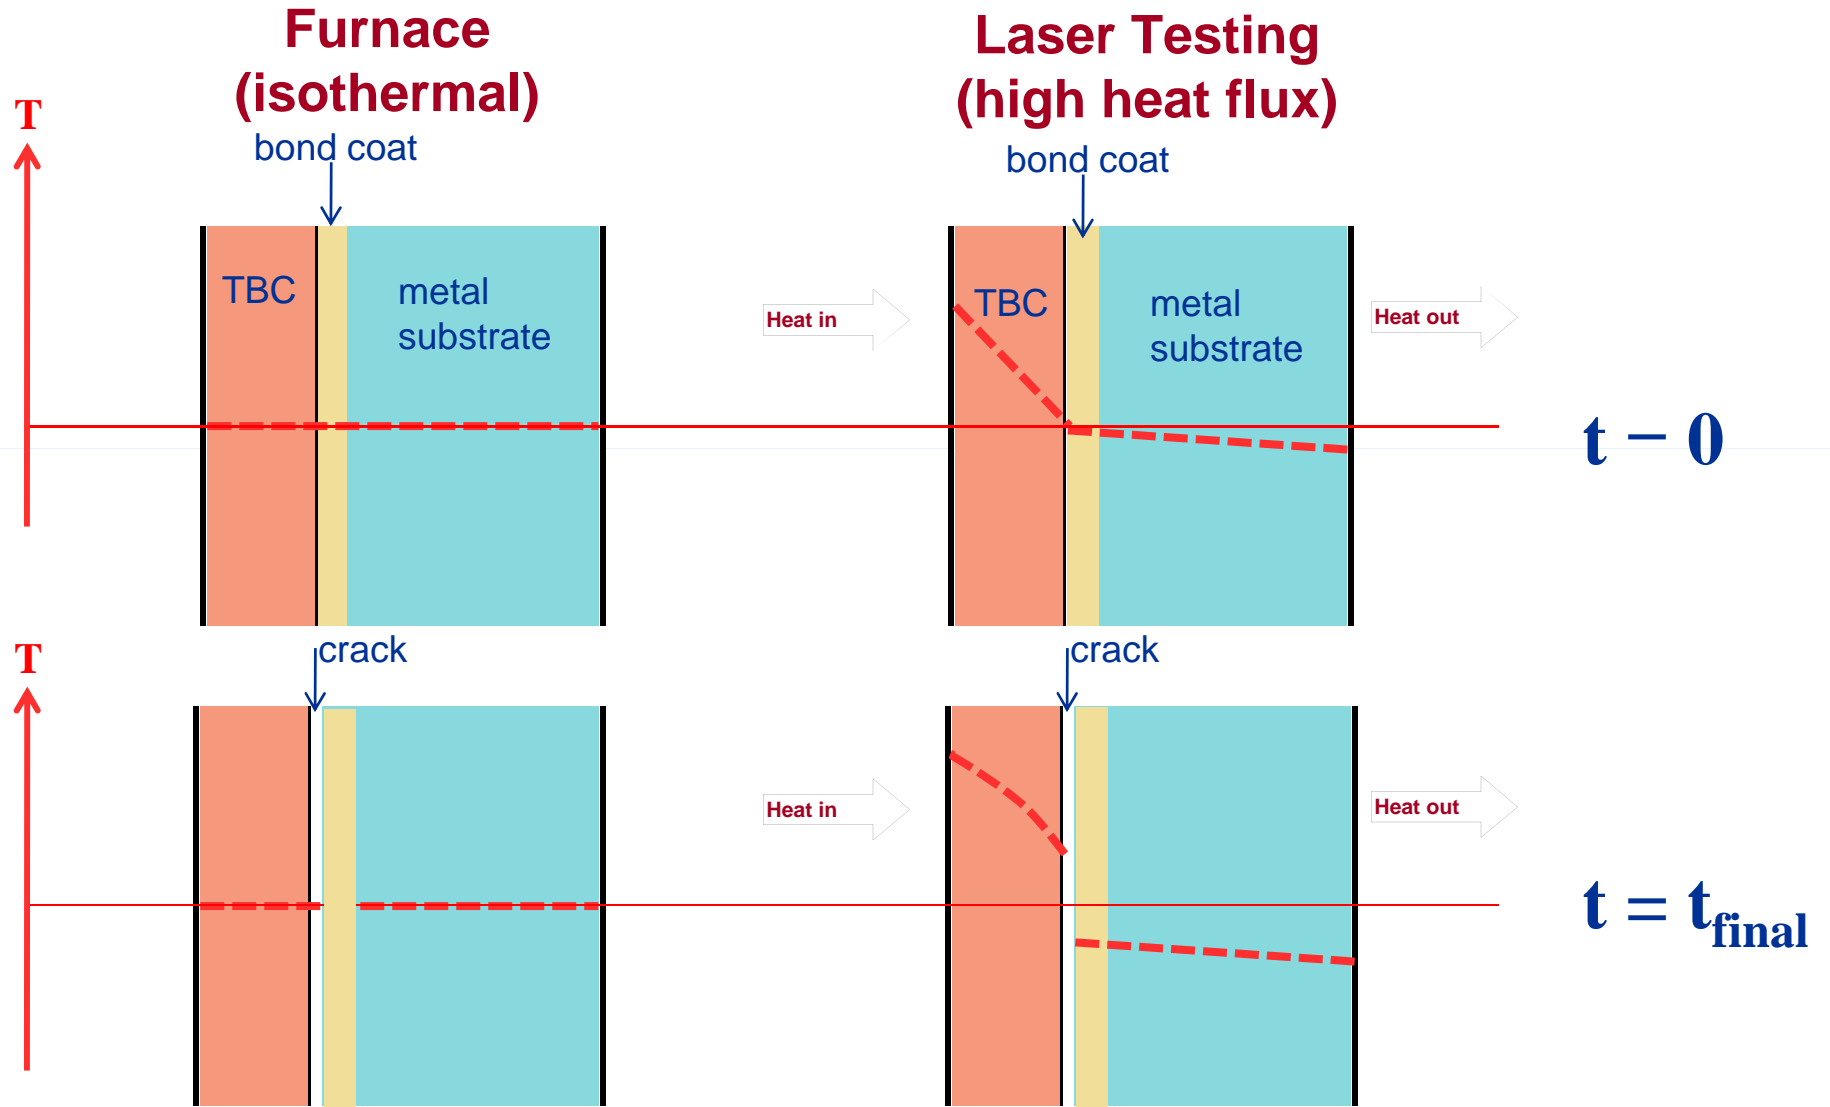
TBC Temperature Profile Progression Furnace vs. High-Heat-Flux Laser Heating

Aging does not affect thermal profile.

Aging produces evolving thermal profile.

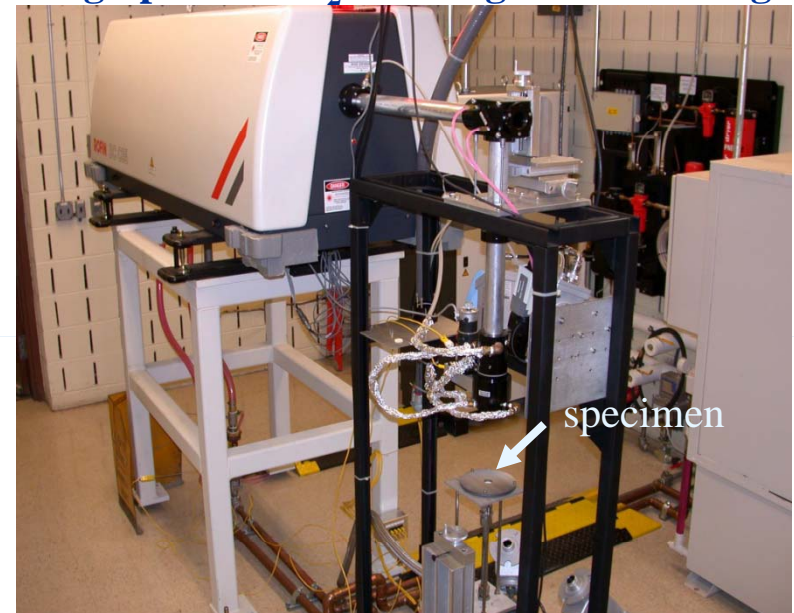
High Heat-Flux Laser Testing

• High power CO₂ laser high-heat-flux rig

$$q_{thru} = q_{delivered} - q_{reflected} - q_{radiated}$$

$$k_{TBC}(t) = q_{thru} \cdot l_{TBC} / \Delta T_{TBC}(t)$$

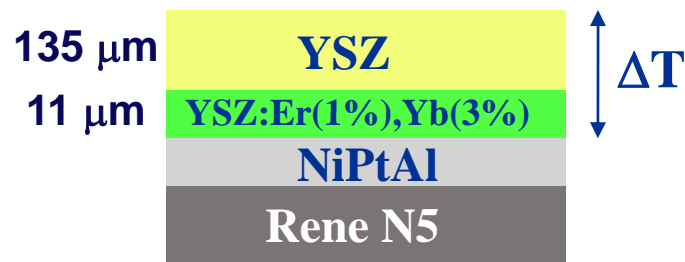
High-Heat-Flux Laser Testing Conditions

- $q = 0 \text{ W/cm}^2$
- $T_{\text{surface}} \approx 1163^\circ\text{C}$
- $T_{\text{interface}} \approx 1163^\circ\text{C}$
- $\Delta T \approx 0^\circ\text{C}$

- $q = 95 \text{ W/cm}^2$
- $T_{\text{surface}} \approx 1290^\circ\text{C}$
- $T_{\text{interface}} \approx 1140^\circ\text{C}$
- $\Delta T \approx 150^\circ\text{C}$

- $q = 125 \text{ W/cm}^2$
- $T_{\text{surface}} \approx 1345^\circ\text{C}$
- $T_{\text{interface}} \approx 1175^\circ\text{C}$
- $\Delta T \approx 170^\circ\text{C}$

1 cycle = 60 min laser on + 3 min laser off

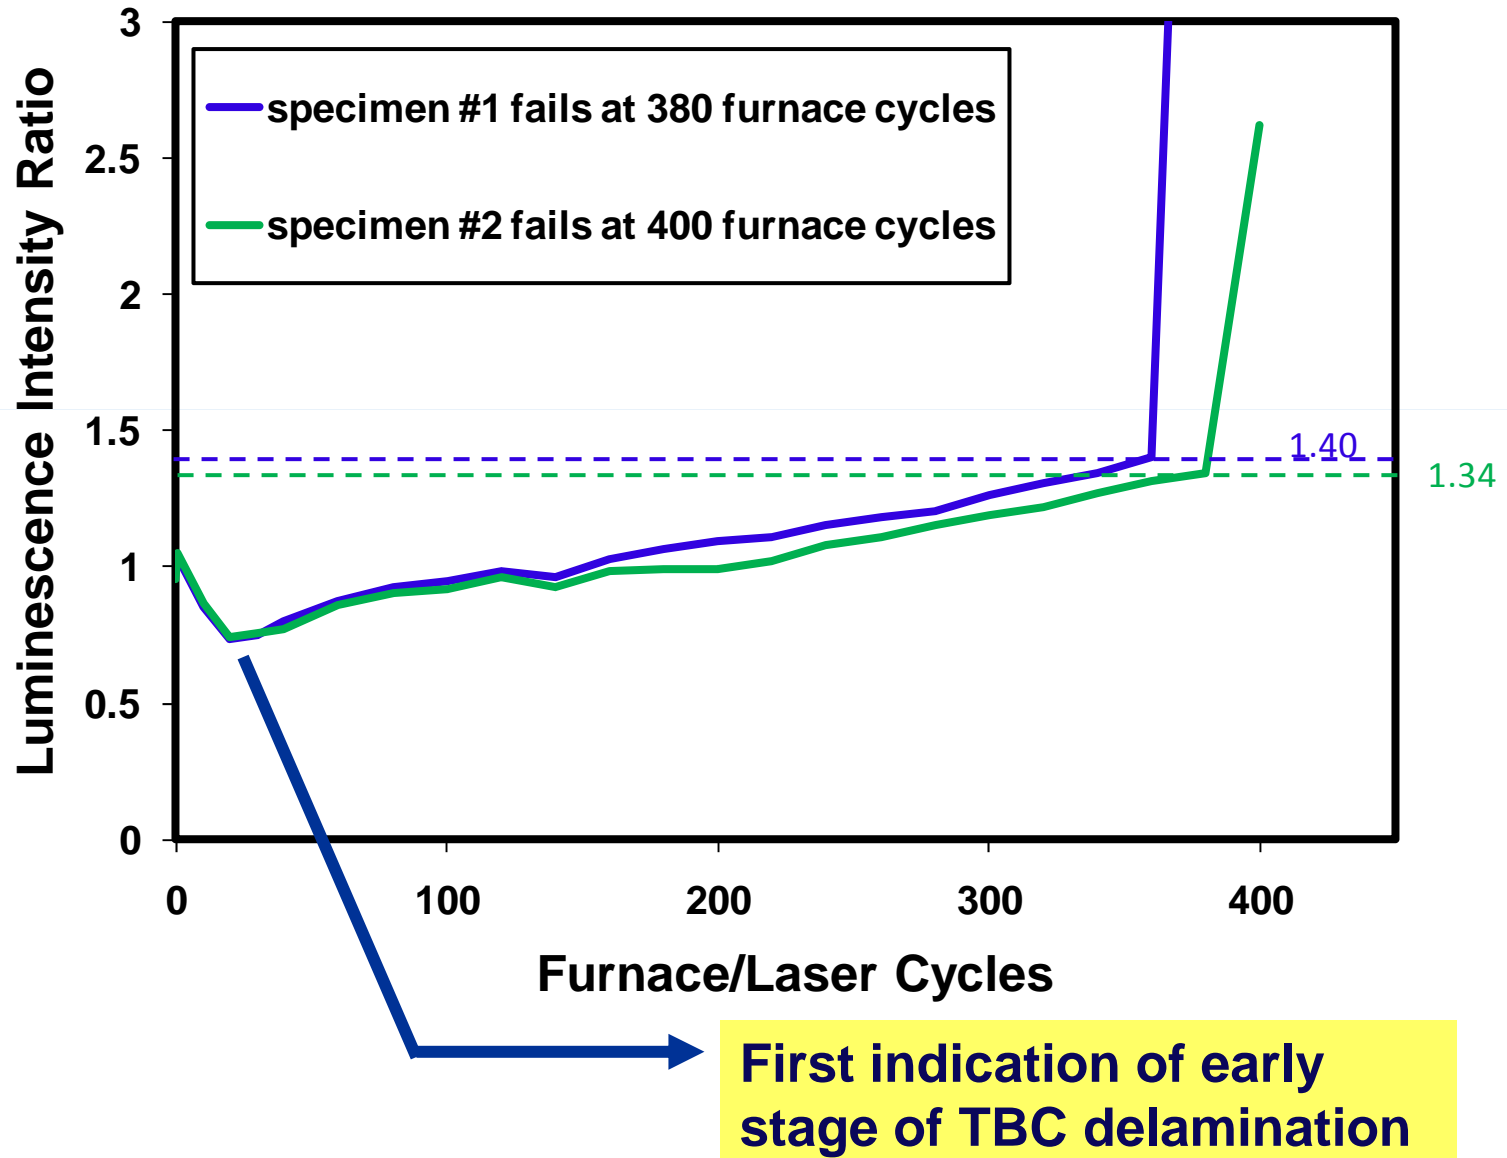
Comparison of Upconversion Luminescence Intensity During Interrupted Furnace vs. Laser Cycling

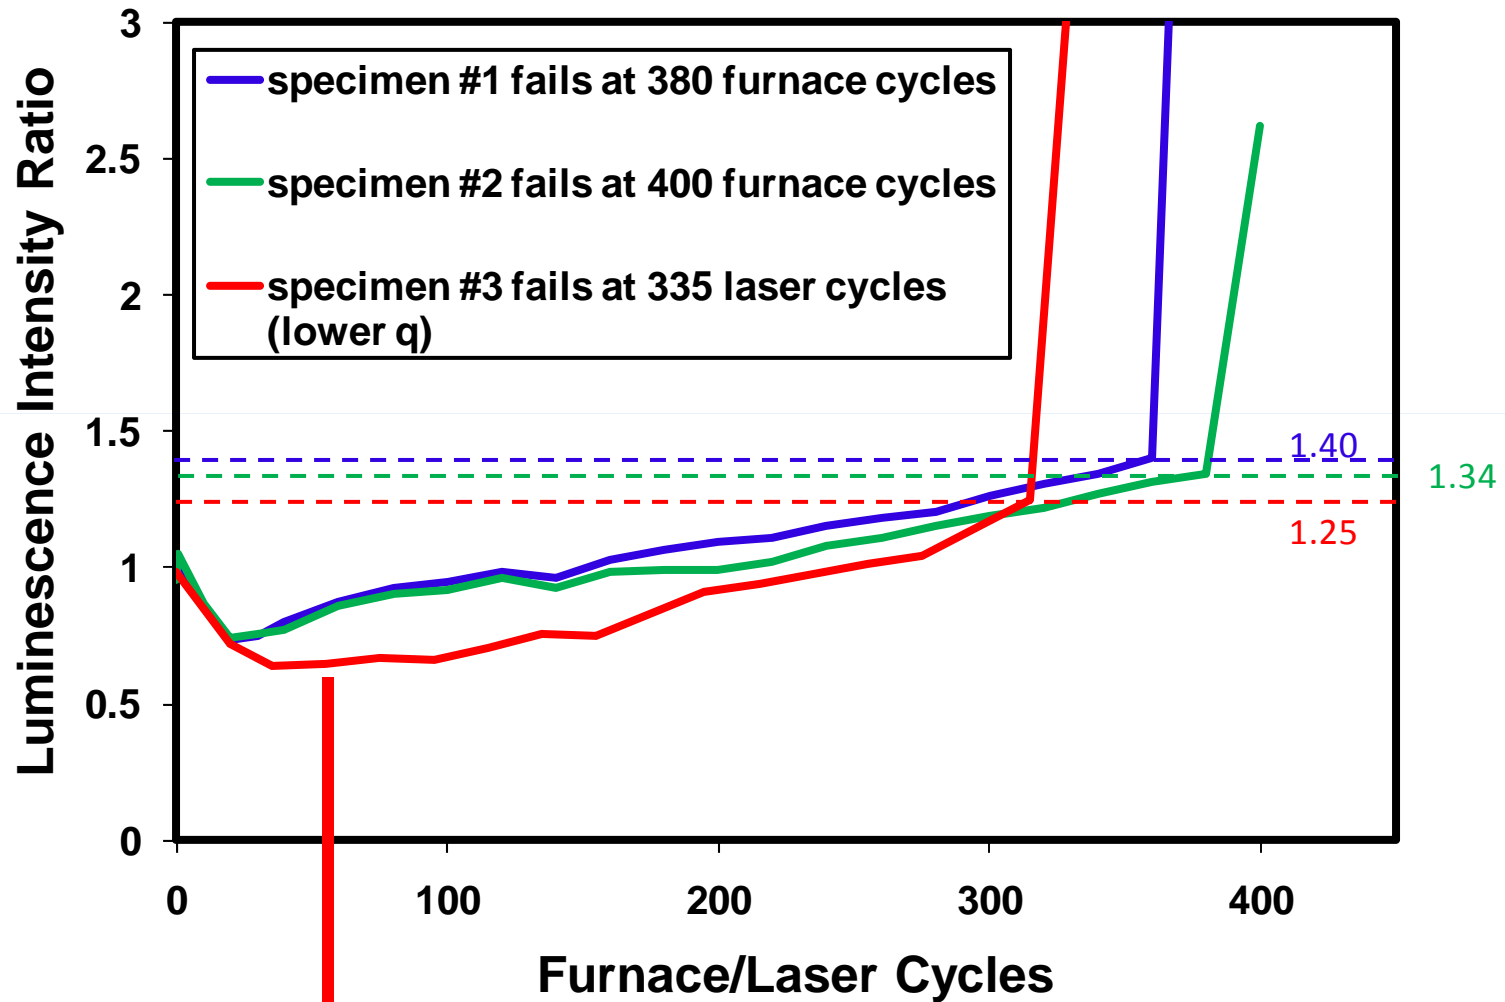
Comparison of Upconversion Luminescence Intensity During Interrupted Furnace vs. Laser Cycling

Laser cycling exhibits an initial incubation stage followed by accelerated delamination progression.

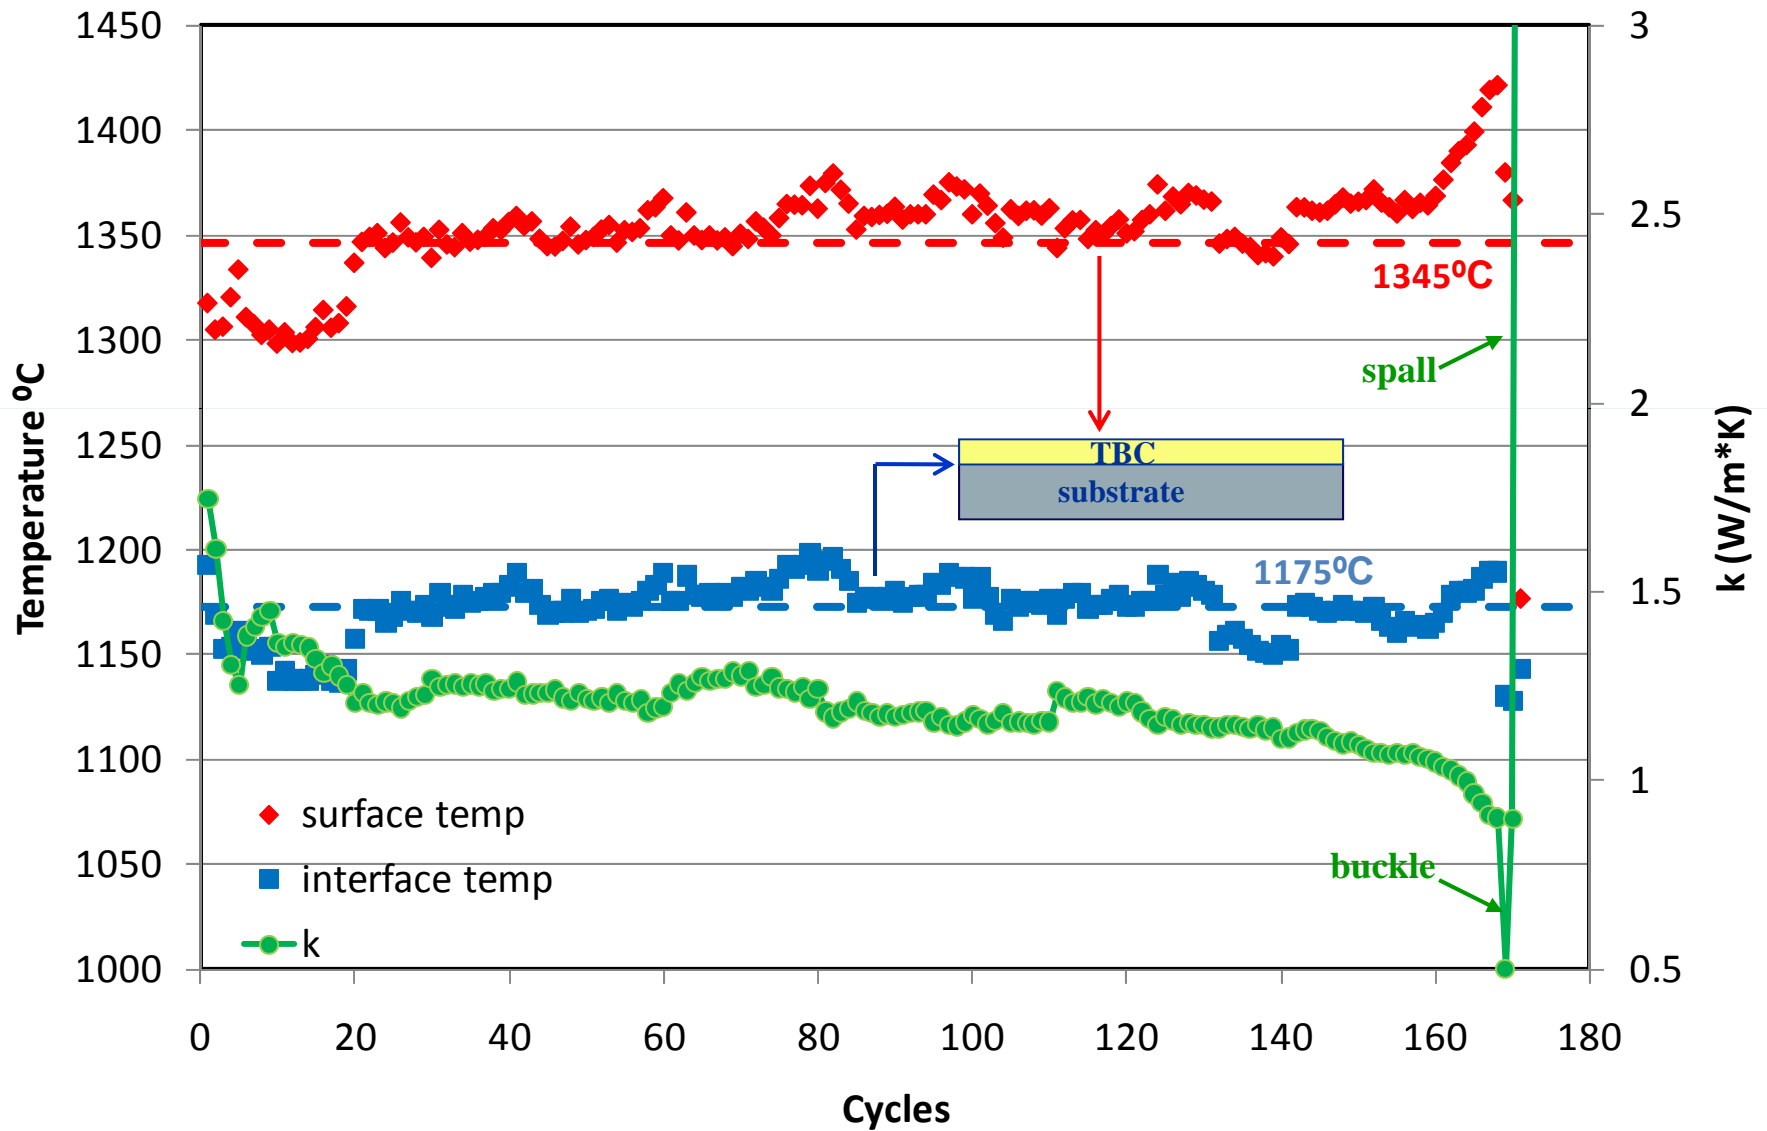
Temperature Sequence During High-Heat Flux Laser Testing

$$q_{\text{thru}} = 125 \text{ W/cm}^2$$

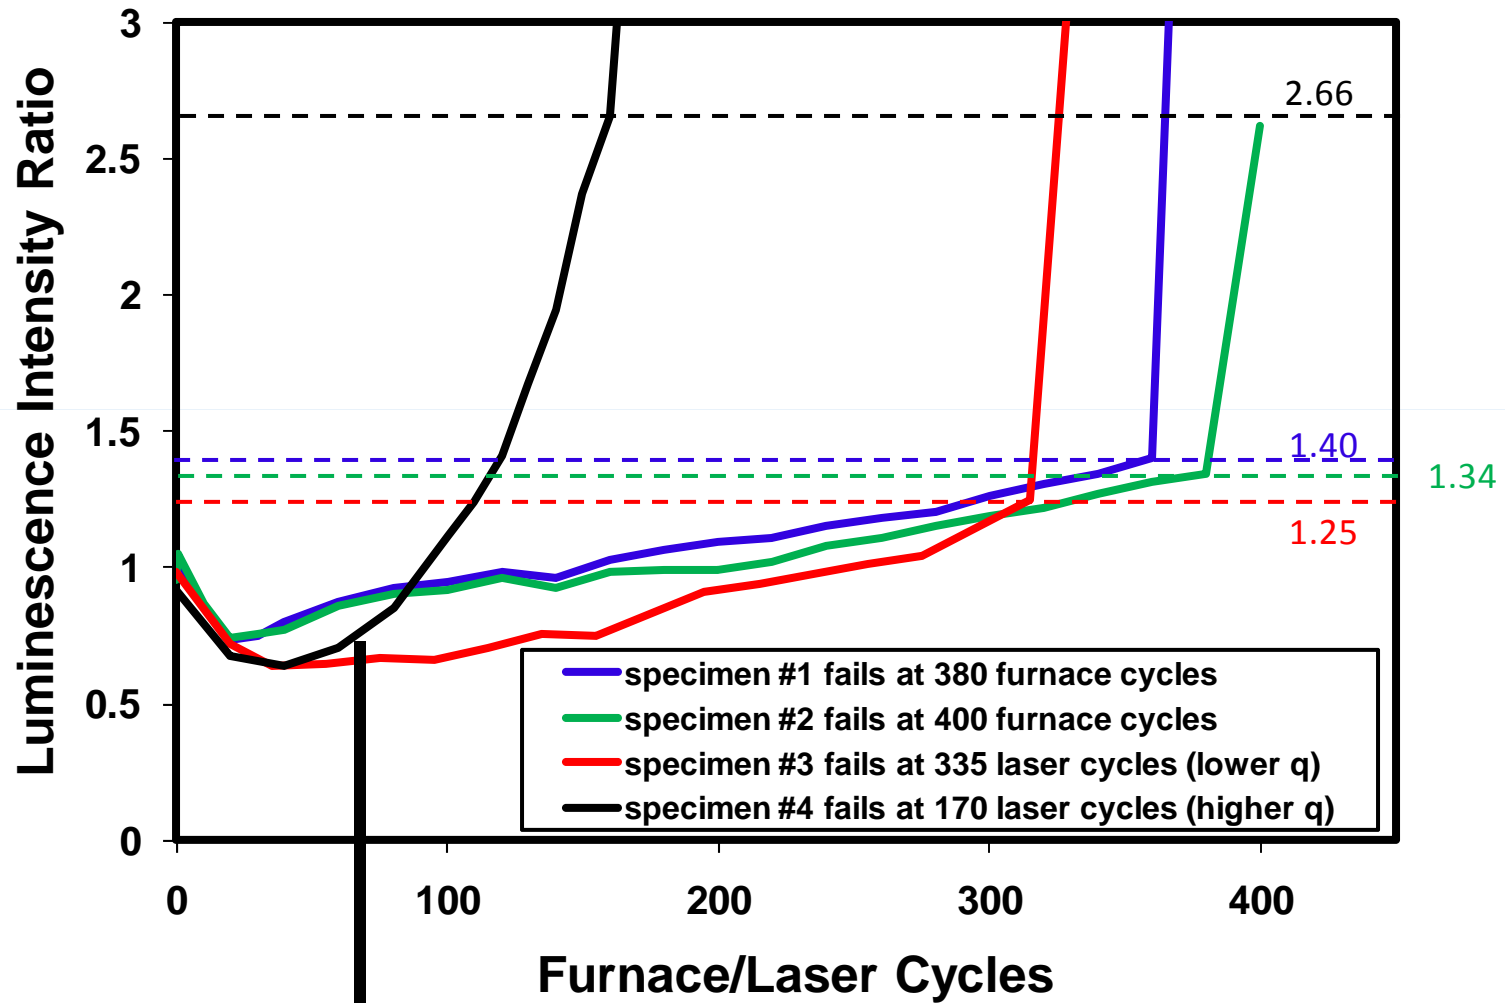
Comparison of Upconversion Luminescence Intensity During Interrupted Furnace vs. Laser Cycling

Out-of-family, accommodates greater damage before TBC failure.
