# New Wire Constructions for Active Damage Detection

**Materials Science Division  
Engineering Directorate  
Kennedy Space Center, Florida**

4/21/2011

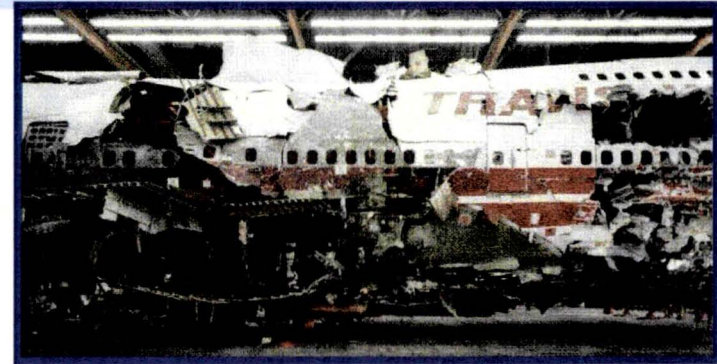
TWA 800 (July 1996)

Frayed Kapton® wire in center tank area led to midair explosion of 747 (230 killed)

3 other 747s were found with same fraying issue and grounded\*

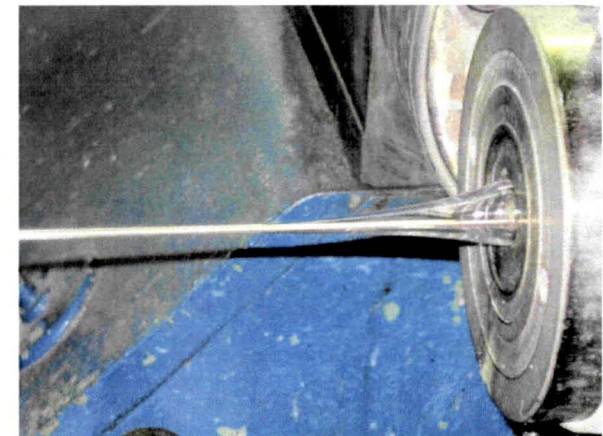
Extruded FEP on Cu foil

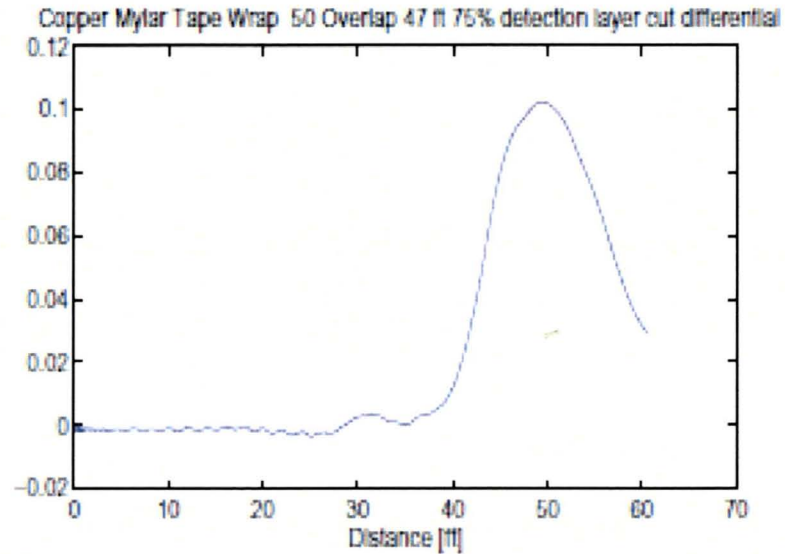
Wire Construction	Results
<p><b>Copper/Mylar®</b> Core: RG316 Hookup Wire Conductive Layer: Copper/Mylar® Tape Outer Insulation: Extruded FEP Conductive Layer Overlap: ~50% Resistance of Detection Layer: 0.11 <math>\Omega</math>/Ft</p>	<p>Two different lengths of this construction were evaluated: 37 feet and 8 feet. 75% damage to the detection layer was observable at both lengths. Damage less than 75% was not observable for the lengths evaluated.</p>

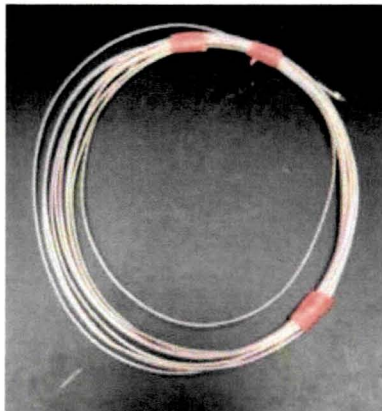
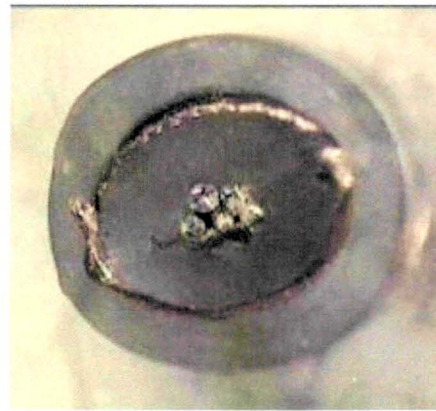
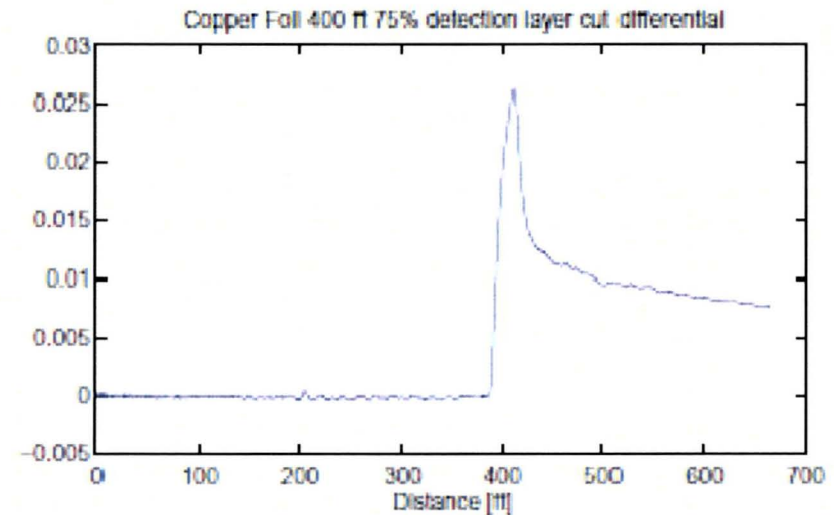
Wire Construction	Results
<b>Copper Foil</b> Core: RG316 Hookup Wire Conductive Layer: Copper Foil Outer Insulation: Extruded FEP Conductive Layer Overlap: ~25% Resistance of Detection Layer: 0.04 $\Omega$ /Ft	Four different lengths of this construction were evaluated: 400 feet, 190 feet, 100 feet, and 20 feet. 100% damage to the detection layer was observable at 190 feet, 100 feet, and 20 feet. 75% damage to the detection layer was observable at 400 feet. Damage less than 75% was not observable for the lengths evaluated.

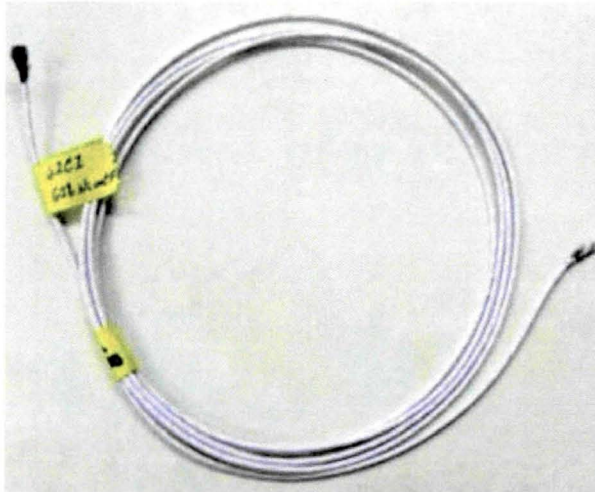
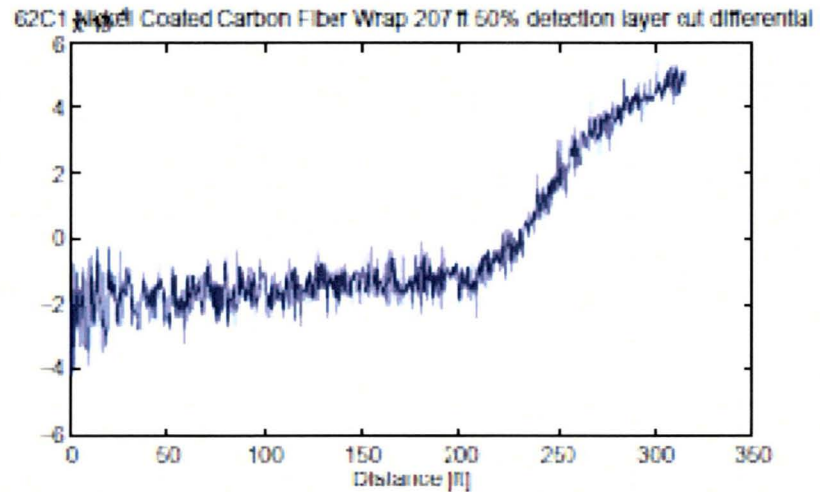
Wire Construction	Results
<b>62% Nickel-Coated Carbon Fiber</b> Core: RG316 Hookup Wire Conductive Layer: 62% Nickel-Coated Carbon Fiber Outer Insulation: PTFE Tape, Sintered Conductive Layer Overlap: ~0% Resistance of Detection Layer: 0.30 $\Omega$ /Ft	Two different lengths of this construction were evaluated: 197 feet and 8 feet. 50% damage to the detection layer was observable for both lengths evaluated. Damage less than 50% was not observable for the lengths evaluated.

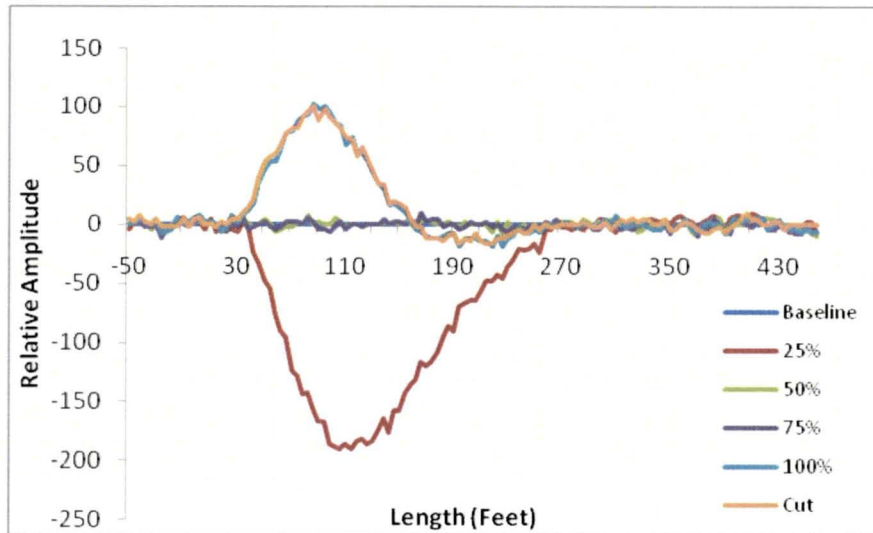
Off-line mode

Differential data for in-line TDR testing of new wire construction.
