# Lessons Learned from the Design, Certification, and Operation of the Space Shuttle Integrated Main Propulsion System (IMPS)

**The Space Shuttle Integrated Main Propulsion System (IMPS) consists of the External Tank (ET), Orbiter Main Propulsion System (MPS), and Space Shuttle Main Engines (SSMEs). The IMPS is tasked with the storage, conditioning, distribution, and combustion of cryogenic liquid hydrogen (LH2) and liquid oxygen (LO2) propellants to provide first and second stage thrust for achieving orbital velocity. The design, certification, and operation of the associated IMPS hardware have produced many lessons learned over the course of the Space Shuttle Program (SSP). A subset of these items will be discussed in this paper for consideration when designing, building, and operating future spacecraft propulsion systems. This paper will focus on lessons learned related to Orbiter MPS and is the first of a planned series to address the subject matter.**

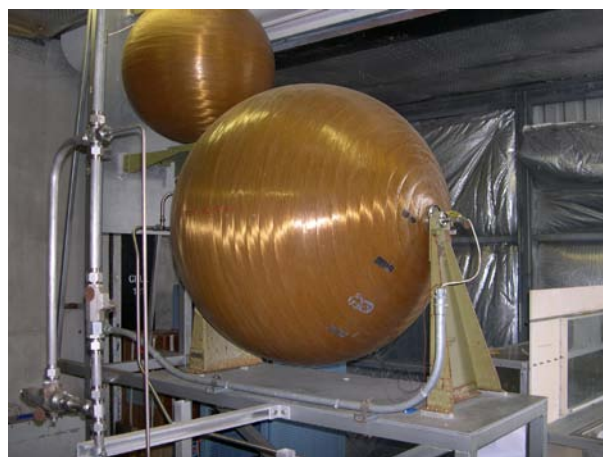
**Discussion/Observation(s):** The Orbiter MPS GHe system contains ten spherical high pressure (4500 psi) Composite Overwrapped Pressure Vessels (COPVs), including seven small units (26 inch diameter, 4.7 ft<sup>3</sup> internal volume) and three large units (40 inch diameter, 17.3 ft<sup>3</sup> internal volume). These COPVs are shown schematically in Figure 4. The large units have a titanium liner and Kevlar/epoxy overwrap. The small units have either a titanium liner and Kevlar/epoxy overwrap (same as the large units) or a stainless steel liner and graphite/epoxy overwrap. A simplified diagram and a photo of the large and small GHe COPVs installed in a test stand at JSC are shown in Figure 13.

**Figure 13: Orbiter MPS GHe System COPVs**

Following a flight readiness test on the vehicle, excessive GHe leakage that saturated a hand-held mass spectrometer was found to be emanating from the body of one of the small COPVs, specifically the pneumatic GHe tank, TK4. Although the indicated leak rate was still within the allowable range, the affected COPV was removed for failure analysis. Similar GHe leakage issues were subsequently experienced on other COPVs so this was not an isolated occurrence.

**Problem Resolution(s):** The failure analysis revealed numerous small cracks in the girth weld of the titanium liner, all of which were associated with weld porosity. Leak testing, radiographic inspection, and fractographic analysis confirmed that the observed leakage was associated with several of these cracks which had initiated around the weld pores during proof-sizing and grown through the liner thickness due to pressure cycling in service. Note that the affected COPV had passed a multiple radiographic and ultrasonic inspections, GHe leak tests, and a proof pressure test prior to delivery, and all weld pores were within acceptable limits for size and location/distribution given the liner material and wall thickness involved. Pressure cycle testing was also performed on the discrepant tank to determine the nature of how pores can lead to through-cracks from repeated high pressure cycles over time.
