**Structural Verification of the First Orbital Wonder of the World – The Structural Testing and Analysis
of the International Space Station (ISS)**

John J. Zipay / Deputy Branch Chief, Structures Branch

NASA-Lyndon B. Johnson Space Center, Houston, TX.;

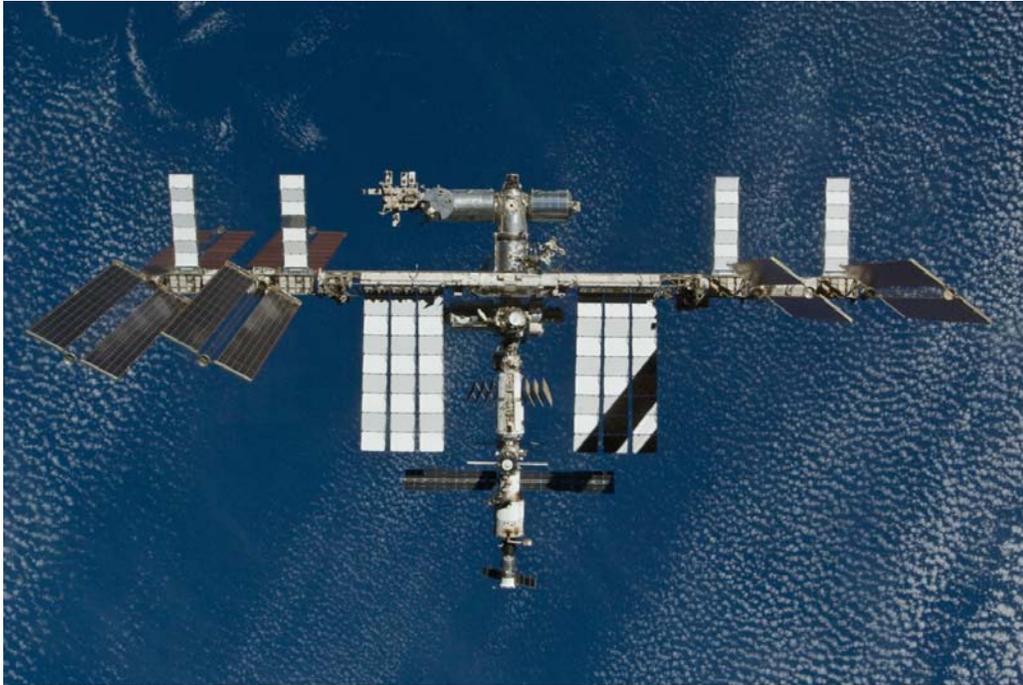
Figure 1 – The International Space Station (ISS) as seen during the fly-around of the Space Shuttle Atlantis (OV-104) during the STS-132 mission in May, 2010.

The ISS (Figure 1) is composed of pre-integrated truss segments and pressurized elements supplied by NASA, the Russian Federal Space Agency (RSA), the European Space Agency (ESA) and the Japanese Aerospace Exploration Agency (JAXA). Each of these elements was delivered to orbit by a launch vehicle and connected to one another either robotically or autonomously. The primary structure of each element was assembled and verified by teams of responsible structural engineers within and among their respective agencies and agency contractors. This paper is primarily focused on the structural

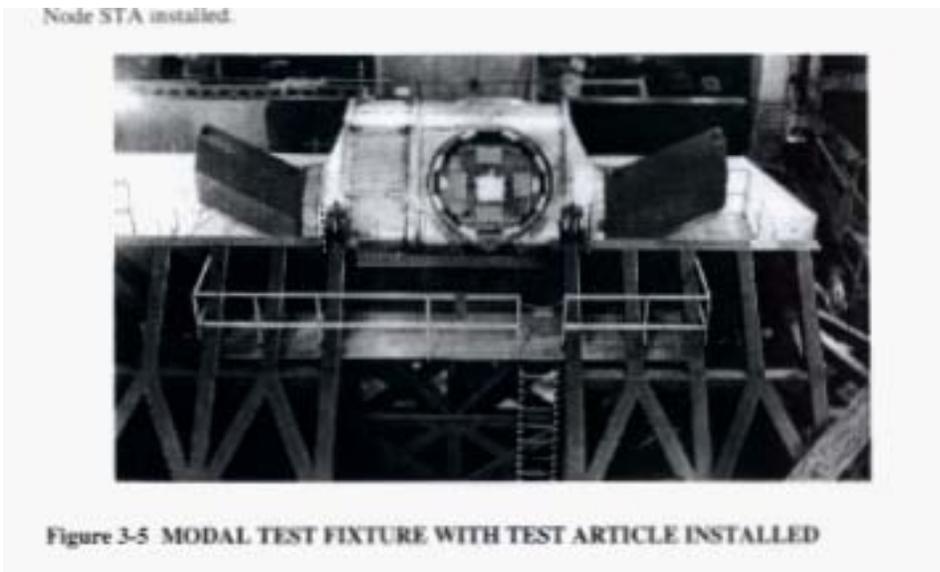
Figure 47 – Node STA with PMA mass simulators on each end installed in the Modal Test Bed.

The Node 1 STA was then lifted from its static test fixture and moved to the adjacent Space Shuttle Payload Modal Test Bed in Building 4619 (Figures 47 [15] and 48 [16]). During this operation, the facility crane stalled, leaving the Node STA hanging twenty feet in the air over the modal test fixture. The crane was fixed the next morning and it was determined that this prolonged hang load did not cause any damage to the test article. For the modal test, a 3200 lb mass/c.g. simulator was attached to both the forward and aft axial ports of the Node STA to represent the PMAs which would be attached to the Node 1 for launch in the Orbiter. A full modal test campaign including sine sweep and driving-point impedance testing on one axial and one radial port was undertaken in order to provide a verified Craig-Bampton-reduced model to both the Shuttle Program for verification coupled loads analysis of the ride to orbit and to the ISS Program for incorporation into the integrated ISS dynamic model used for on-orbit loads development. Pre-test predictions for the launch configuration (Figure 49) [17] and the configuration of the Node berthed to the Orbiter Docking System (Figure 50) [18] were performed and correlated with the modal test results. An excellent detailed discussion of the modal testing of the ISS

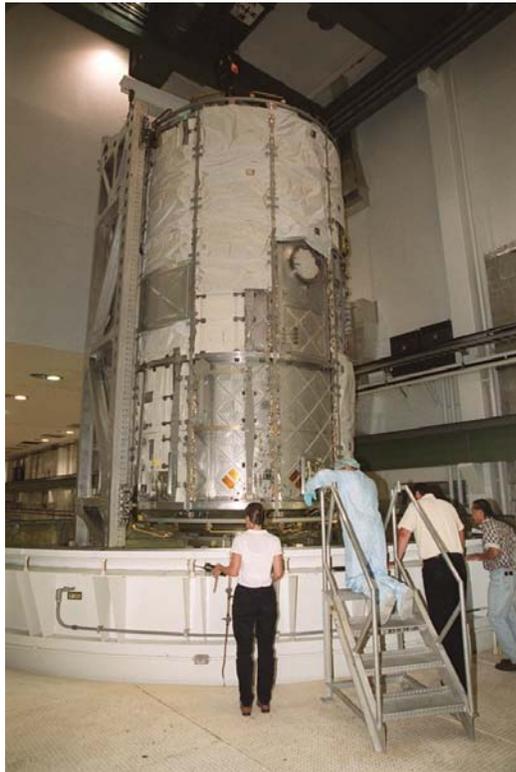
Figure 63 – U.S. "Destiny" Laboratory being lowered into KSC vacuum chamber for element leak testing (Isogrid skin panels and nadir window installation are visible).

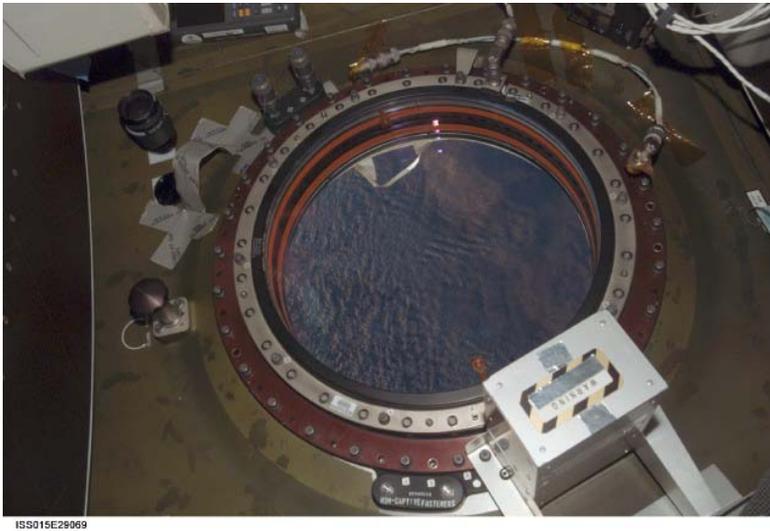
Figure 78 - "Destiny" Laboratory 20" diameter nadir-facing windows with flex hose cover installed.

Since glass is subject to static fatigue, a fleet leader window of identical construction as the Lab 20" window was built and has been under 15.2 psid pressure at the NASA-Lyndon B. Johnson Space Center's Structures Test Lab since the year 2000 (Figure 86 and 87). It is periodically inspected for flaws and leak tested. The fleet leader window has remained in excellent condition while the U.S. Lab window is periodically inspected on-orbit for flaws. As described above, the debris pane which covers the exterior of the Lab window and the scratch pane which covers the interior of the Lab window are present on-orbit to prevent incidental damage to the redundant pressure panes from micro-meteoroids and orbital debris as well as crew-induced damage. The only maintenance activity that has had to be performed on the Lab window on-orbit to-date involved replacing a leaking flex hose that is used to keep the cavity between the two panes at vacuum. The flex hose was inadvertently damaged and was replaced on-orbit. A protective cover was installed over the flex hose to prevent any recurrence of this problem.

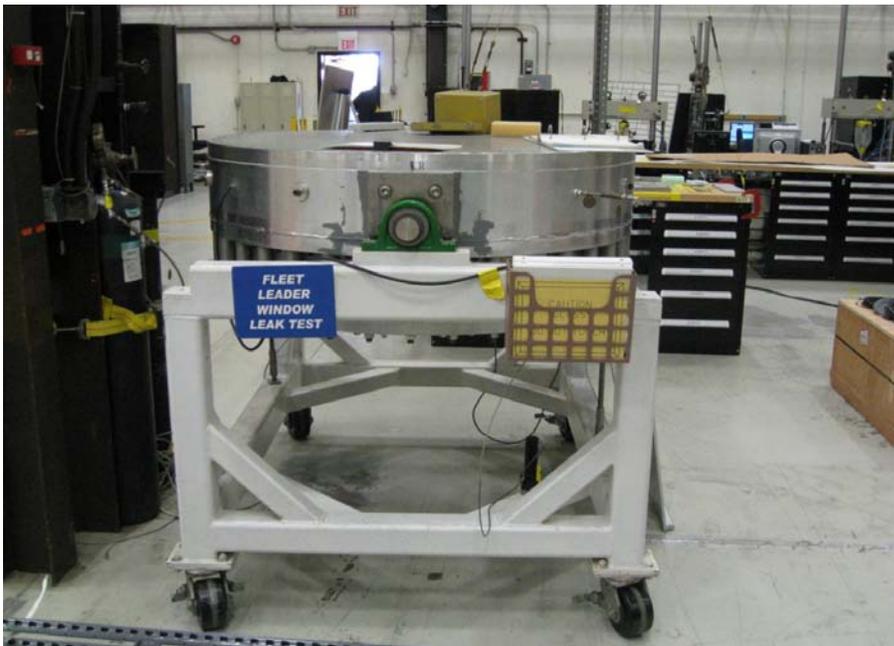
Figure 86 – Fleet leader window test article currently residing in the Building 13 Structures Test Lab at NASA-JSC.

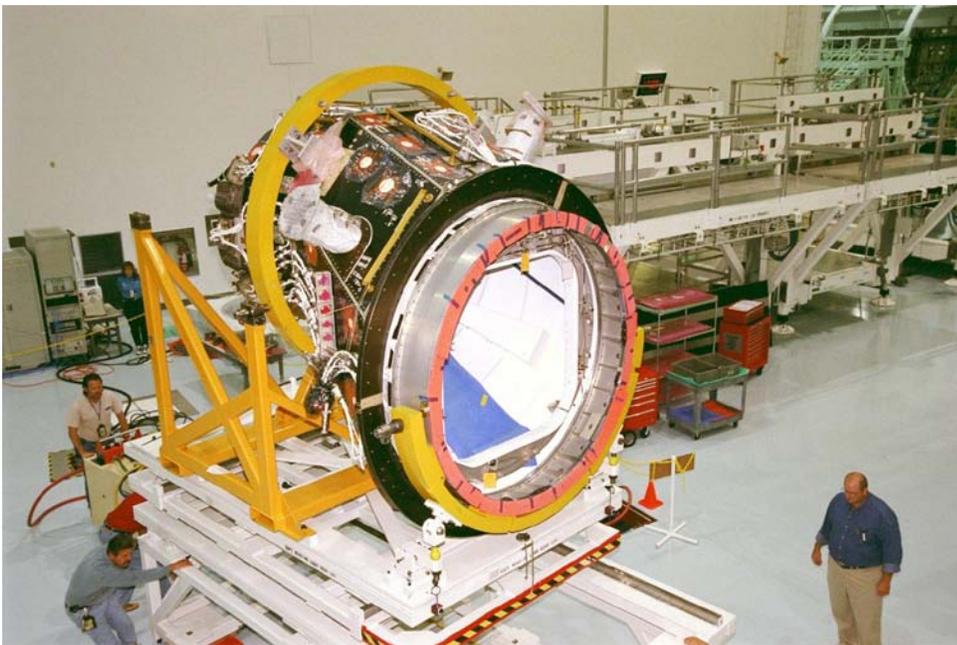
Figure 115 – Pressurized Mating Adapter undergoing final assembly at Boeing – Huntington Beach.

The Pressurized Mating Adapter was a transition structure originally designed to provide the interface between the Space Shuttle Orbiter and the Space Station Freedom. Its unique shape was developed to preclude contact between the Node or Lab endcone and the Orbiter Forward Fuselage during docking with the Shuttle External Airlock. It was constructed from four Aluminum 2219 forgings, machined to the required thickness and circumferentially welded using VPPA welding by The Boeing Company, Huntington Beach, California (Figure 115).

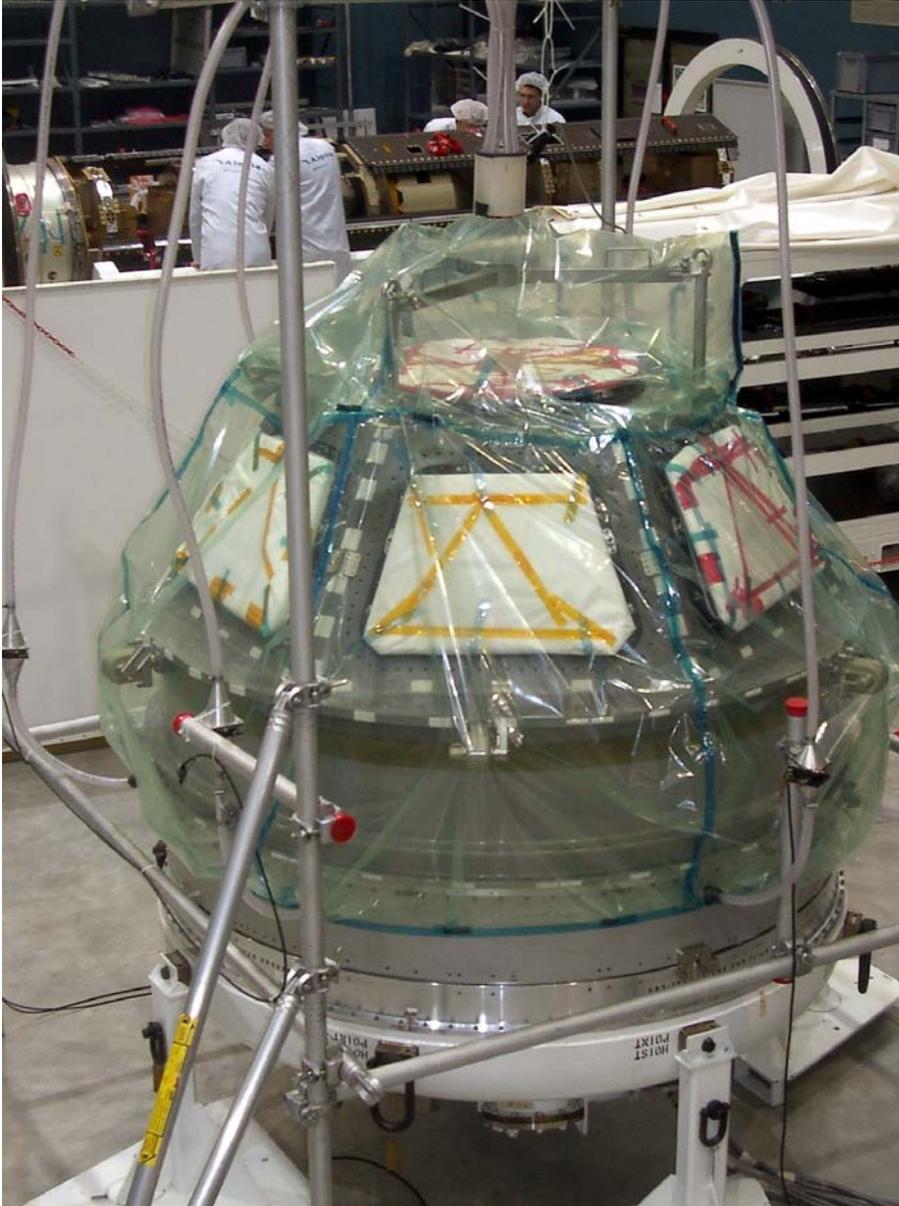
Figure 127 – Cupola flight article element level leak test.

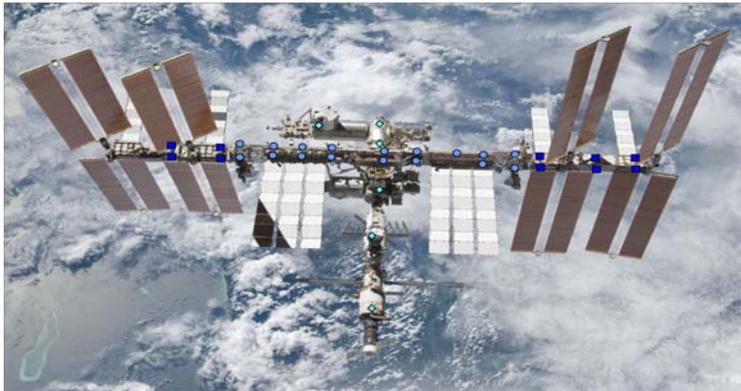
Figure 164 – On-orbit structural health monitoring instrumentation locations on ISS as of May, 2011.
