DIAGNOSIS OF A POORLY PERFORMING LIQUID HYDROGEN BULK STORAGE SPHERE

A. Krenn

*Fluids Division, Cryogenics Branch, NE-F7
NASA Kennedy Space Center, Florida 32899 U.S.A*

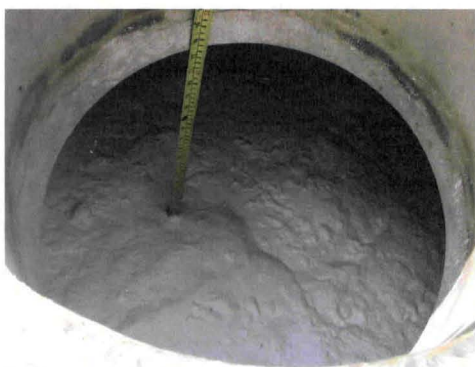
The 12 inch annular relief device was opened up, and the condition of the perlite was observed and photographed. It was approximately 17.5 inches below the top of the outer sphere and had a downward slope in the direction of the vent piping (see figure 3). Samples of the perlite were then taken. A sample was also taken from the bottom of the sphere by cutting off the 2 inch drain port cap. Perlite flowed freely into a collection container, then a fiberglass plug was installed, and the cap was welded back into place. Both samples were white and fluffy, and subsequent analysis identified no contaminants. A compaction test of the samples validated that the existing perlite compacted density is in the original specification range of 8 – 9.5 lb/cu.ft.

FIGURE 3. First Look Inside Annulus

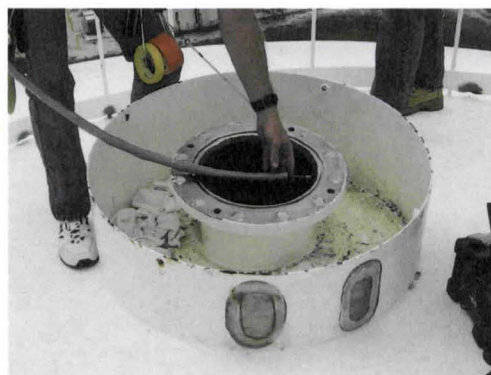
After perlite samples were gathered from the top of the sphere via the 12 inch annular relief opening, a boroscope was inserted in order to ascertain the cause of the high heat leak (see figure 4). Several difficulties were encountered during the boroscoping process. When the lens contacted perlite, a “white out” occurred, and the boroscope had to be removed and cleaned before visibility could be restored. The curvature of the sphere, and the fluffiness of the perlite made white outs a frequent challenge. To combat this challenge, the boroscope was run through a curved tube and a Teflon “ski” was used to keep the boroscope head above the perlite. In addition to perlite, there are pipes, supports, pump-down spirature, and other structures inside the annular region. All of these structures served as interferences to the boroscope and limited its travel. After several attempts on multiple days, using various lighting techniques, the boroscope recorded conclusive evidence of the cause of the sphere’s high heat leak. As suspected, there was a huge void in the insulation. It was difficult to detect at first because perlite was mounded up on the top of the sphere, but once the boroscope was able to successfully travel some distance, the void was apparent. Due to the difficulties boroscoping, the exact volume of the void was undeterminable, but was estimated to be between 7,000 – 14,000 cubic feet (12-24%).

FIGURE 4. Boroscope Being Inserted Into the Annular Relief Opening

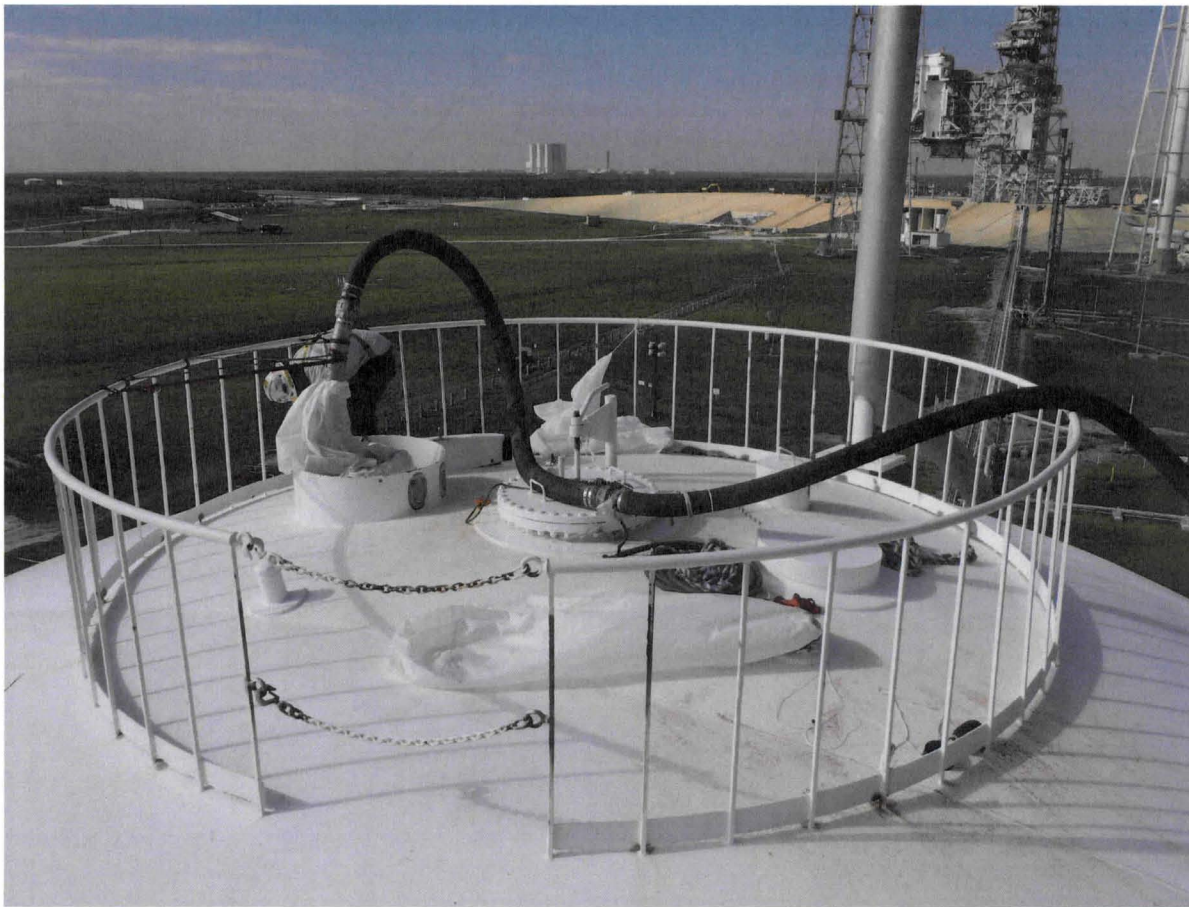
FIGURE 7. Perlite Top-off Fill and Vent Ports

The perlite contractor's typical fill verification method is to provide a person at the fill location to notify the ground crew when perlite begins to fill the filter sock (which is kept around the fill location to prevent perlite from escaping). Due to the history of the LC-39B sphere, there was a strong desire for a more affirmative method of verification. In the 1960s, the perlite was installed with a minimum temperature of 200 degrees F. This was to ensure no moisture absorption, and was relatively easy to maintain due to the perlite being cracked on-site. Initially, the plan was to use thermography, which had helped identify the problem to begin with, to verify the lower extent of the void was reached. However, blowing perlite in from trucks resulted in near ambient temperature perlite going into the sphere and rendered any use of thermography ineffective. A combination of limited boroscope viewing coupled with still photography taken from a tethered camera inserted into both the fill and vent openings was used to establish that the annular region was as full as possible.
