X-43A Final Flight Observations

***Laurie Grindle
NASA Dryden Flight Research Center***

Mach 10-Final Flight

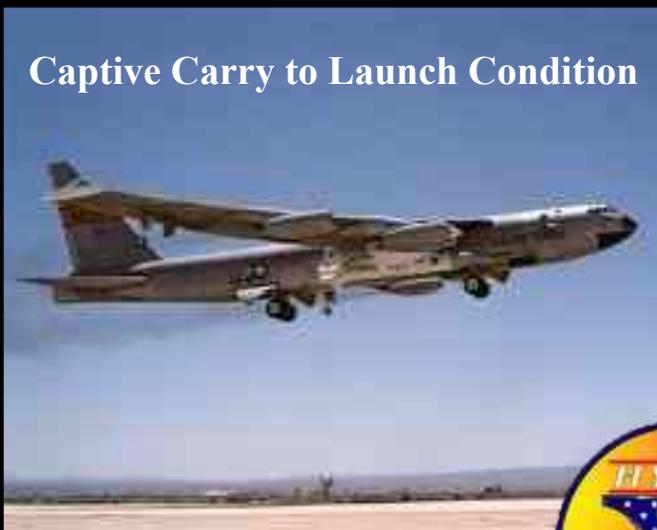
<p>Captive Carry to Launch Condition</p>

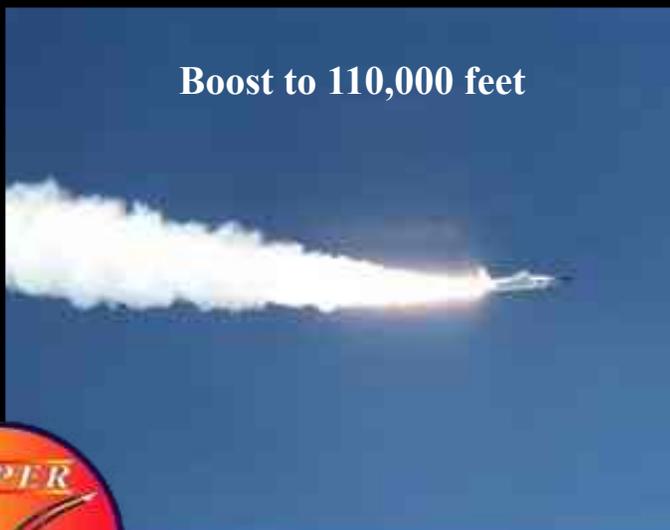
<p>Boost to 110,000 feet</p>

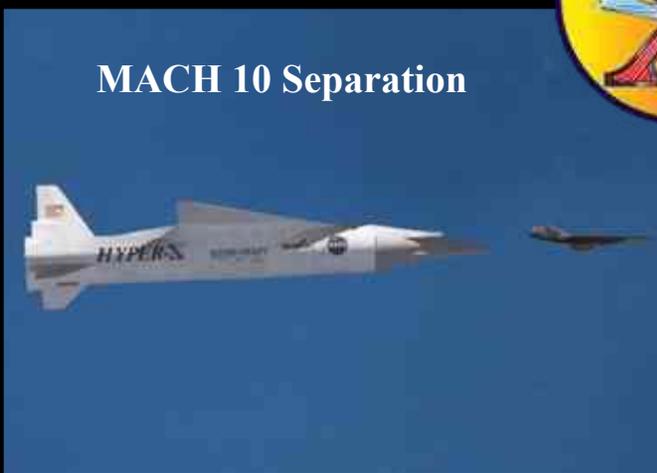
<p>MACH 10 Separation</p>

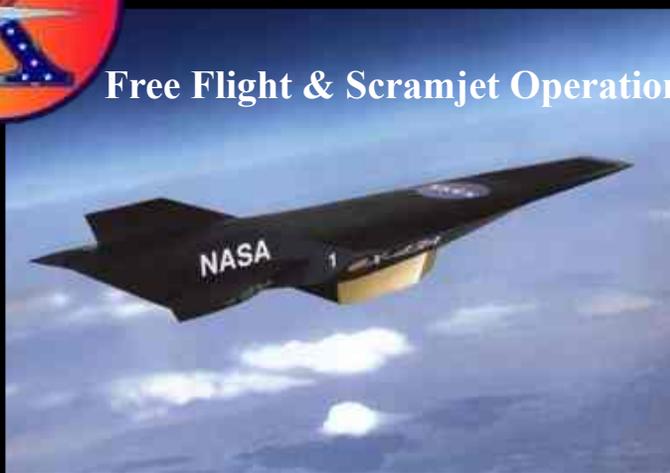
<p>Free Flight & Scramjet Operation</p>

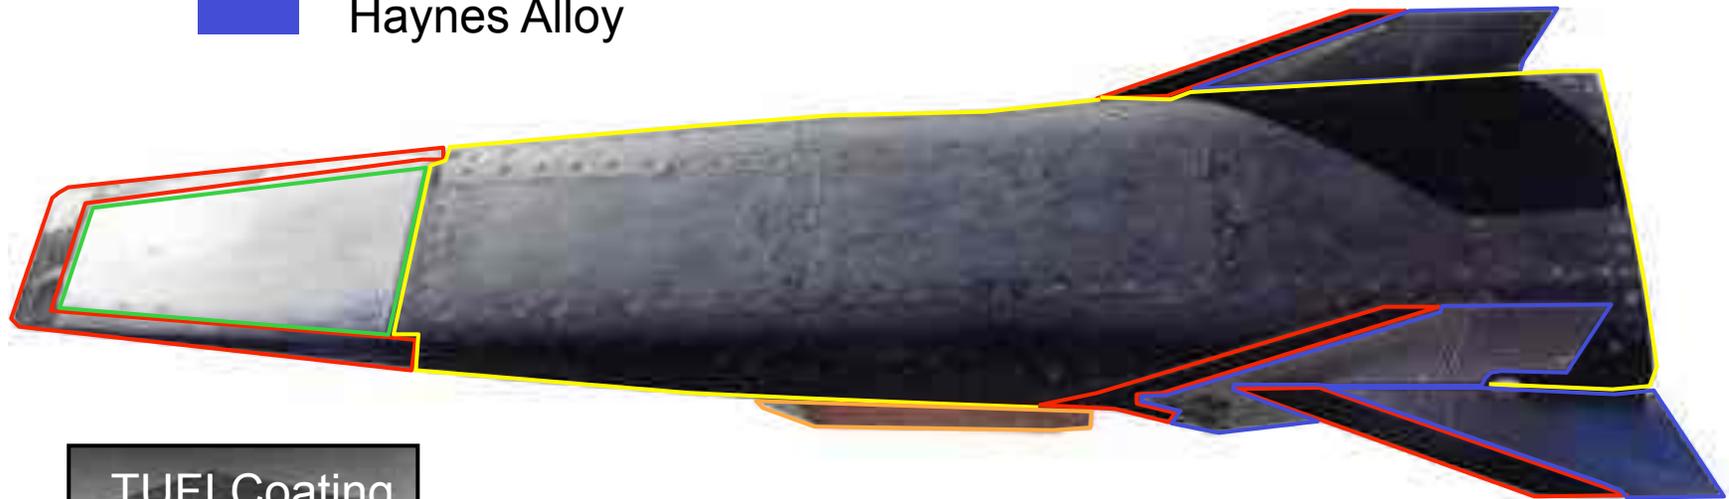
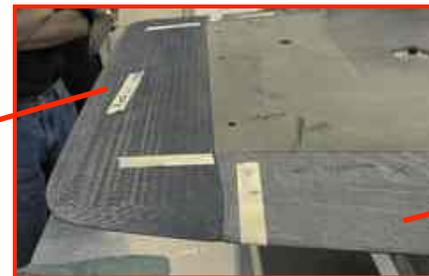
X-43A Material Layout

- Tungsten
- TUFU/AETB
- Haynes Alloy
- Carbon-Carbon
- Copper Alloy

TUFU =Toughened Uni-piece Fibrous Insulation
AETB=Alumina Enhanced Thermal Barrier

Nose
Leading
Edge

Side
Chine

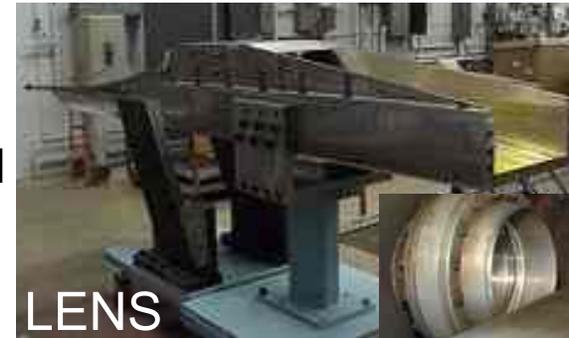
- Limited M10 Propulsion Ground Test Data
 - High energy requirement to simulate the mission flight conditions meant fewer ground test options were available. Shock tunnel testing was the only option.
 - Short test times only allowed single performance points per run, so no fueling or cowl position transitions possible.
 - Propulsion database uncertainties increased.

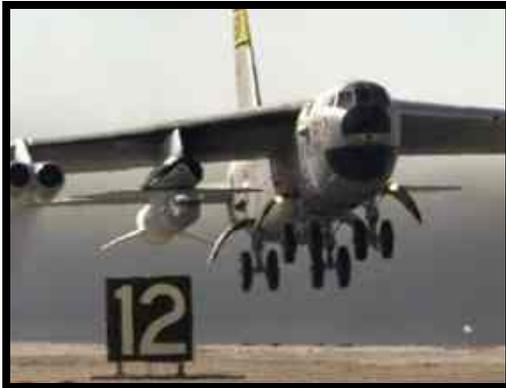
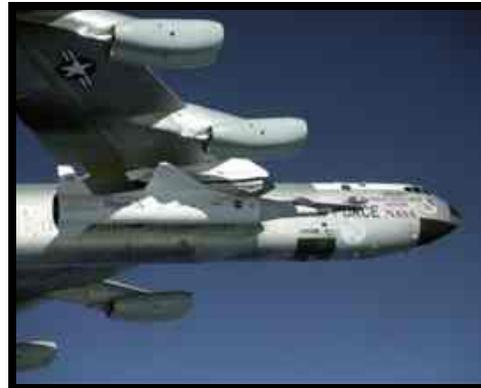
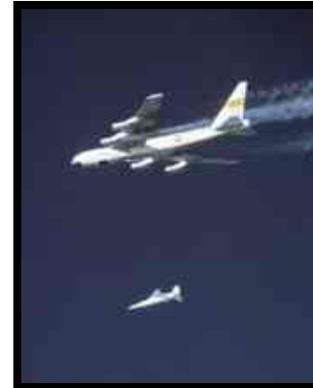
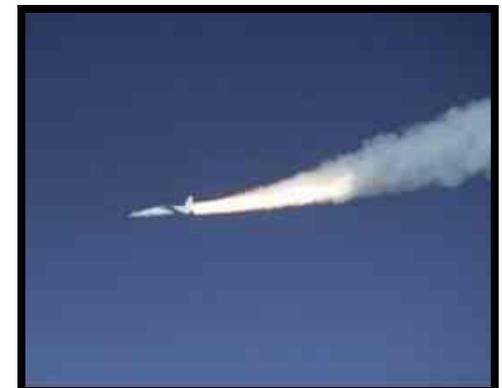
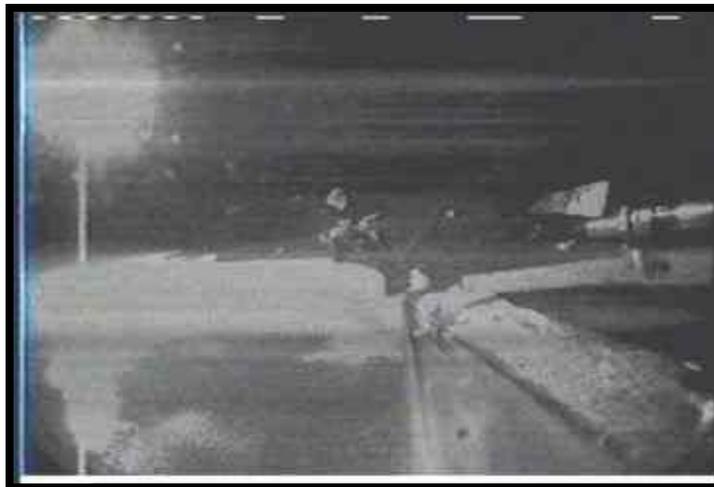
Flight 3 – November 16, 2004

- The scramjet experiment/fuel on began approximately 5 seconds after separation
- The maximum powered Mach number was 9.68
- During powered flight, the X-43A flight controls maintained the desired vehicle angle-of-attack of 1 degree within an acceptable tolerance.
- The scramjet was fueled for approximately 10 seconds, providing predicted thrust.
- During this time the vehicle achieved cruise condition, sustained thrust equal to drag, as predicted.
- The data collected during the engine test is by far the largest amount of data acquired for a Mach 10 scramjet. The quantity, quality, and type of the data acquired is well beyond what has been acquired in wind tunnels.

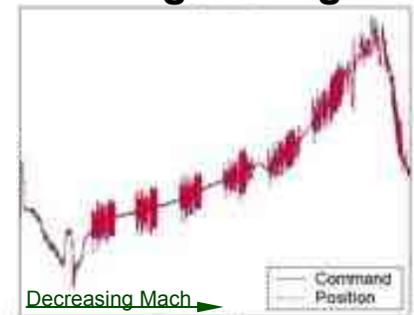
X-43A Control Surfaces Separation to Splash

Left Rudder

Right Rudder

Left Wing

Right Wing

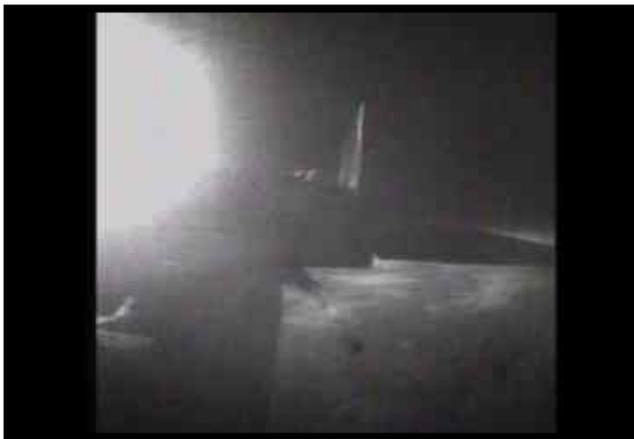
Flight 3 Right Adapter Camera Image

- Time between images is 33.3 milliseconds - 1/30th of real-time.
- Right Adapter Camera Position

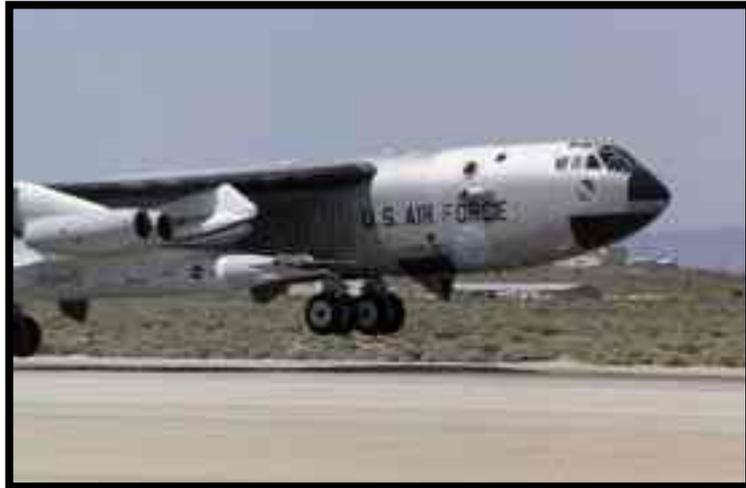
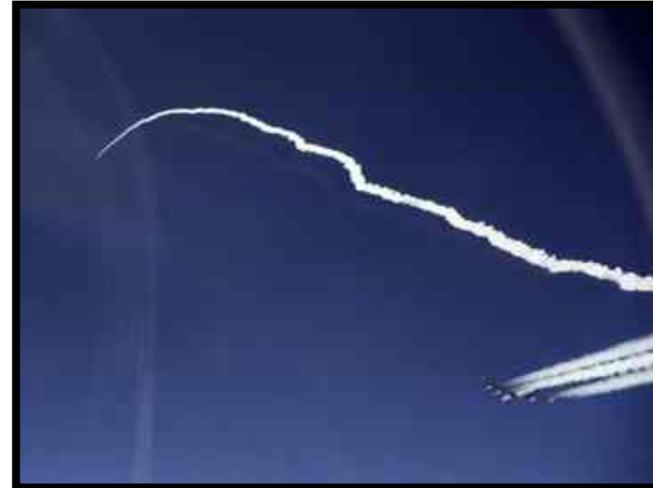
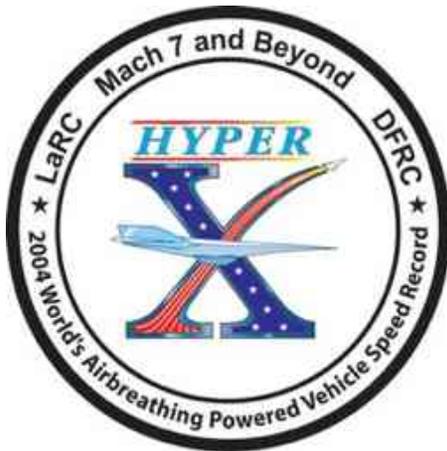
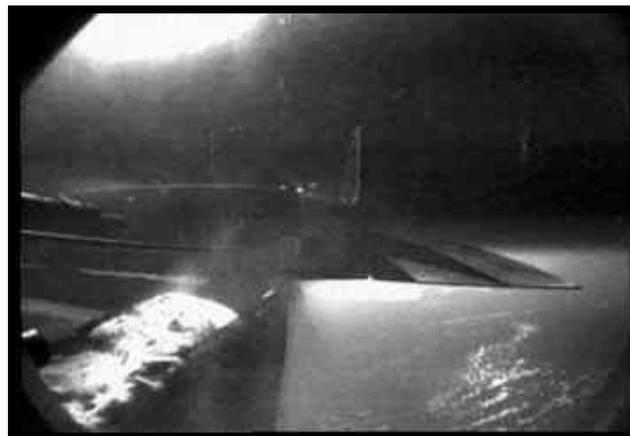
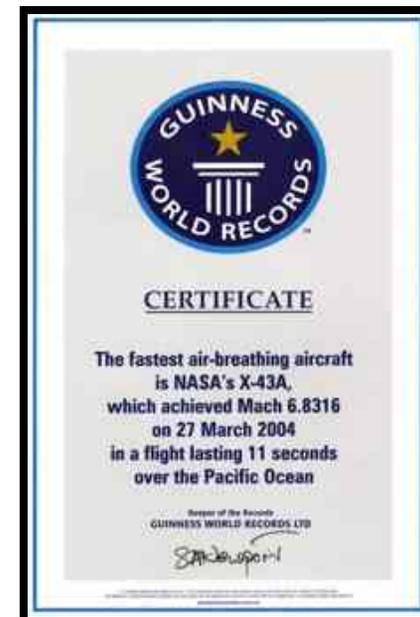
Flight 2 – March 27, 2004

- All launch vehicle separation conditions were essentially nominal and within the specified tolerance.
- The X-43A successfully separated from the launch vehicle and achieved stable free flight throughout the engine test.

- The maximum powered Mach number was 6.8
- Scramjet engine performance was within 3% of preflight predictions – sufficient to overcome additional airframe drag and produce net positive thrust.
- Scramjet engine test conditions were well within preflight uncertainty levels and requirements

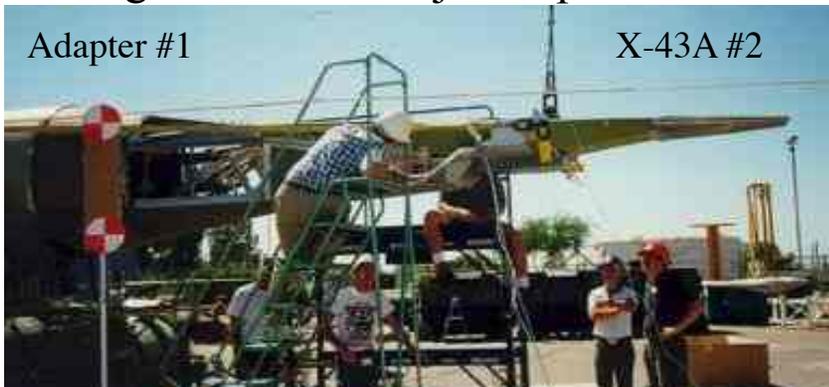
- **Stage Separation Wind Tunnel Test (AEDC)**
 - Full-Interference
 - Varied separation distance between the two models.
 - Allowed detection of interference effects and influences from one on the other.
 - WT data used in conjunction with CFD in Separation Aerodynamic Database.
- **Ejector Piston Test (OSC)**
 - Blocks used to simulate mass of vehicles
 - Purpose: assess performance of pistons and gather data for ejector piston model.

- **Full-Scale Separation Test (OSC)**
 - X-43A ballasted for flight weight and CG location.
 - Purpose: demonstrate that mechanical systems function as expected, test adapter cameras, and validate separation simulation.

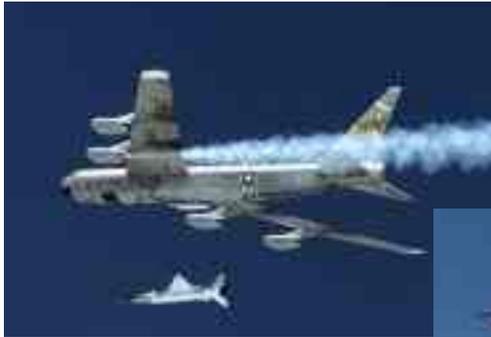
Flight 1 - June 2, 2001

- Approximately 13 seconds after launch, booster departed from controlled flight.
- The right fin broke off, followed within one second by left fin and rudder.
- HXLV FTS was initiated 48 seconds after launch and caused the uncommanded “separation” of the X-43A.
- The X-43A continued to transmit data until 77 seconds after launch, which is consistent with the time splash occurred.

- X-43A Mishap Investigation Board (MIB) was immediately convened following the accident on June 5, 2001 and ended 9 months later.
- *“The X-43A HXLV failed because the vehicle control system design was deficient for the trajectory flown due to inaccurate analytical models which overestimated the system margins” -- Root Cause MIB Report dated 5/8/2003*
 - Modeling deficiencies caused an over-prediction of autopilot stability margins: Aerodynamics, Compliance, and Fin Actuation System
- Return to Flight (RTF) commenced March 2002 (lasted 2 years)
 - Developed a Corrective Action Plan in response to the MIB findings/recommendations
 - ~~Developed an overall approach and roadmap for Return to Flight~~ *Return to Flight*
 - Focused on the root causes and applied lessons learned on the HXLV to the HXRV

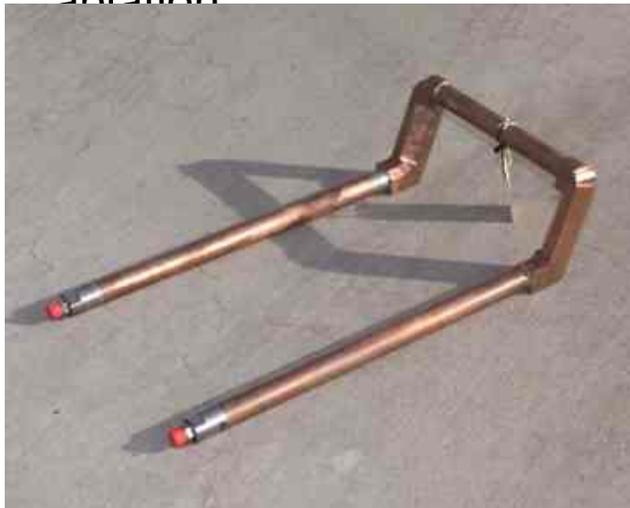
- Heat Exchanger (May '04)
 - Integrated leak and functional testing results showed unacceptable leak rates in Hydrogen System Motorized Control Valve.
 - Inspection indicated contamination as cause.
 - Heat Exchanger was replaced; No leaks.

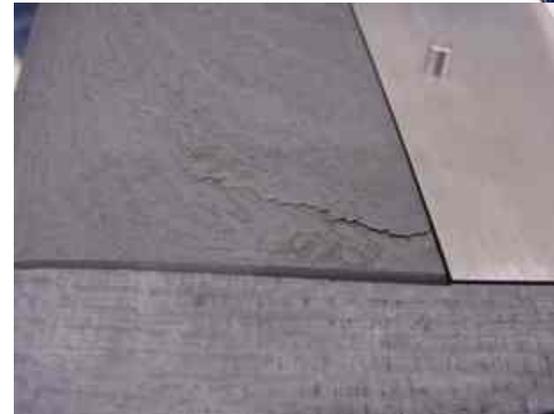
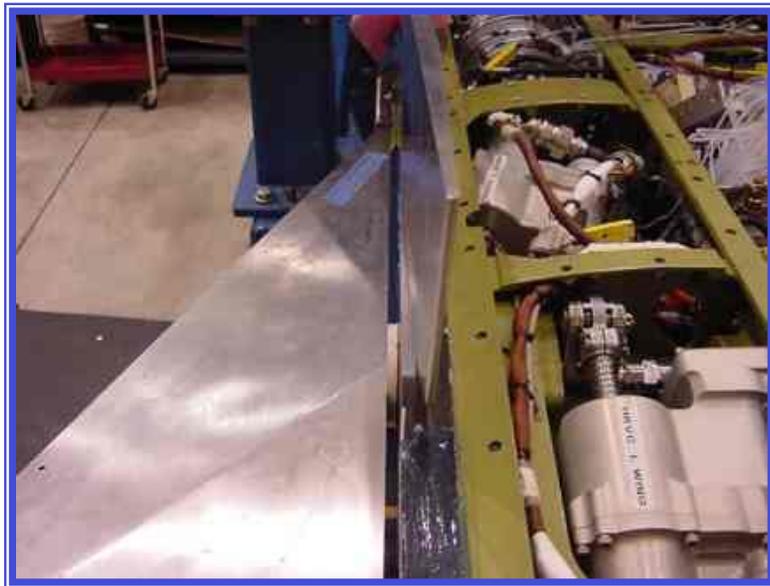
- Carbon-Carbon Delamination (June '04)
 - Observed during fit check.
 - New Chine Fabricated
 - Tap tests & thermographic inspection to ensure all pieces are intact.

- Carbon-Carbon Chine De-lamination
 - C-C chine de-lamination discovered during a final fit check.
 - The C-C pieces went through several heat treatment cycles during the manufacturing process

- Replacement chine was fabricated and special attention was given during the manufacturing process to ensure no repeat occurrence.
 - If not for the spare billet that had already been through some of the heat treatment cycles flight 3 would not have made schedule.
