Utilizing FIB and TEM for Failure Analysis of Char Deposits Obtained From Space Shuttle *Columbia* Window Debris

M. Clara Wright
Materials Engineer
Materials Failure Analysis Section at KSC

Microscopy & Microanalysis 2011
August 10, 2011

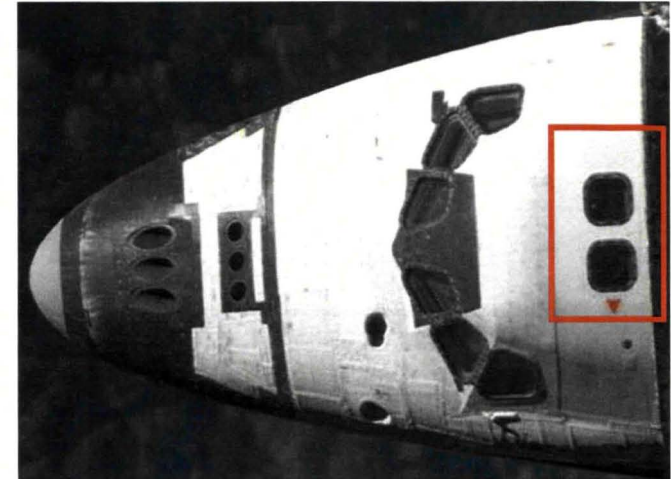
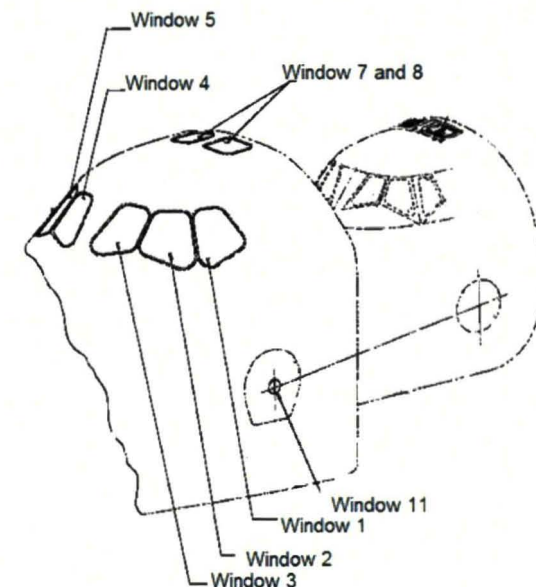
Window Fragments

- The Orbiter windows are comprised of three panes:
 - Inner pressure pane, tempered aluminosilicate glass, 0.625" thick
 - Center pane, low-expansion fused silica for thermal shock, 1.3" thick
 - Outer thermal pane, tempered aluminosilicate glass, 0.625" thick (interior is coated, exterior is not and withstands 430°C)
- Window fragments were removed from 8 thermal panes.
 - Concentrated on deposits on Window 8 overhead thermal panes.
 - Characterization of darkened char that had deposited on overhead windows.

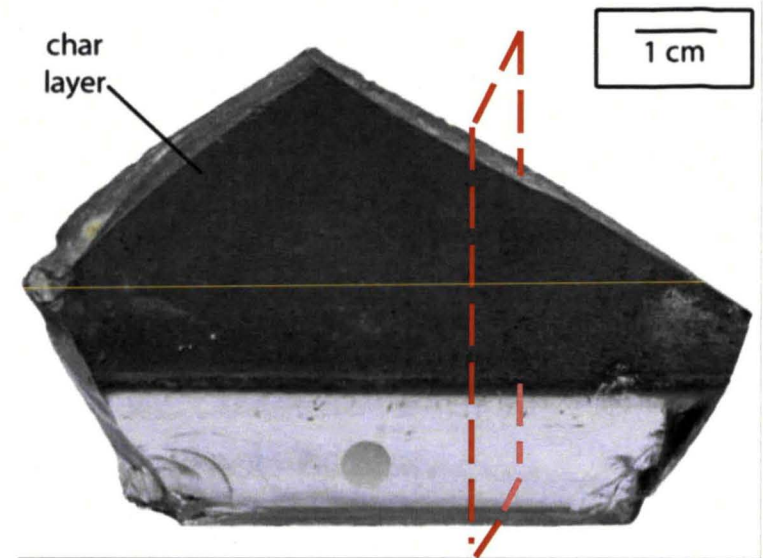
- A fragment of glass containing considerable amount of dark “char” layer on the surface was removed from the frame for characterization.
- Preparation included using cold mounting **two-pour** techniques to preserve the char layer.
 - The sample was first completely covered in epoxy and allowed to cure over night.
 - Then the mounted sample was cross-sectioned and cut to desired shape to reveal the area of interest.
 - The second sample was re-mounted using a two-part epoxy, providing a preserved cross section of the char layer
- Optical microscopy (OM) revealed stratified char layer:
 - Bright and reflective constituent near glass interface
 - Non-uniform, erratically deposited needle-like constituents in middle layer
 - Dark globular constituents throughout

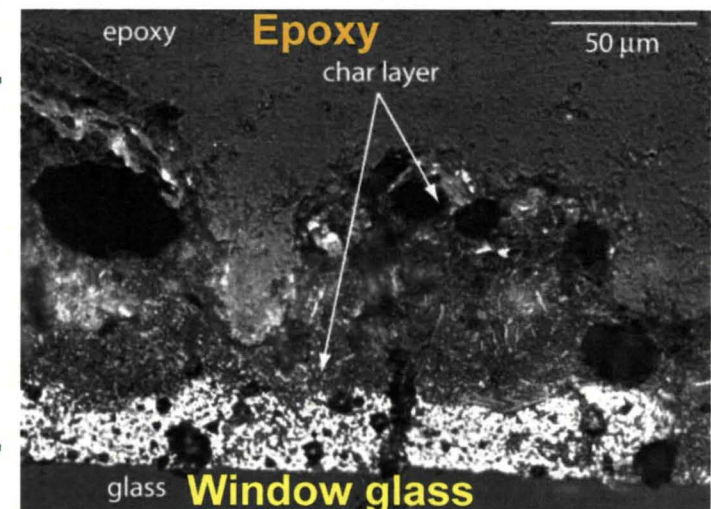
Char layer

Original Magnification: 500X

- Scanning electron microscope (SEM) and Energy Dispersive Spectroscopy (EDS) work characterized layers as:
 - Ti-rich oxide material near the glass substrate, reflective layer
 - Al/Ti-rich oxide material away from glass substrate, needle-like (acicular) layer
 - Si-rich globules throughout
 - Spongy Al layer furthest from glass, likely 2000-series
- Ti deposition being first in sequence of events seemed counter-intuitive:
 - Melting point of Al = 660°C
 - Melting point of Ti = 1668°C
 - Need further understanding of deposition event.

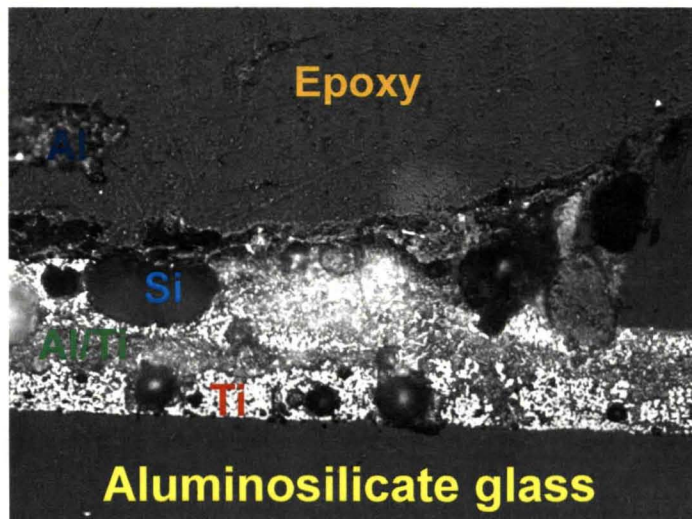
Original Magnification: 500X

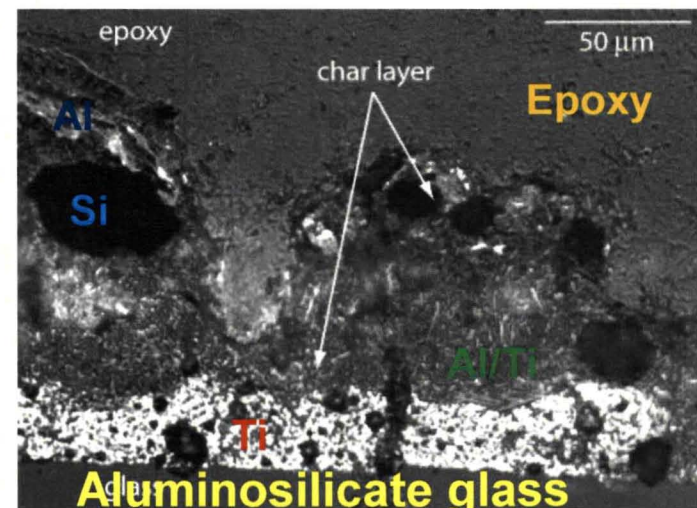
Char layer

Original Magnification: 500X

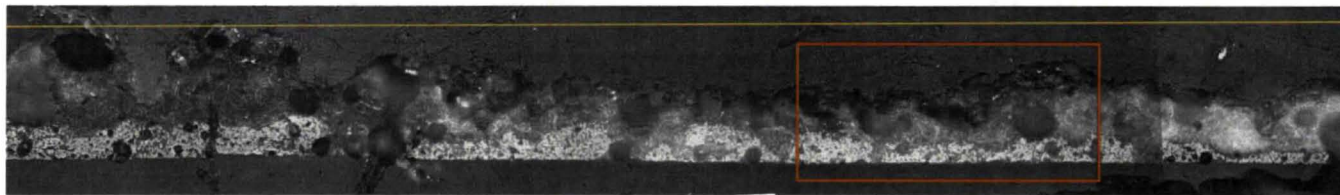
- TEM analysis was needed to further characterize the phases in the char layer.
- Optical micrographs were used to determine areas best suited for the TEM:
 - Layer thickness
 - Constituents at that location (significant amounts of the Ti-rich and Al/Ti acicular layers)

Original Magnification: 500X, montage

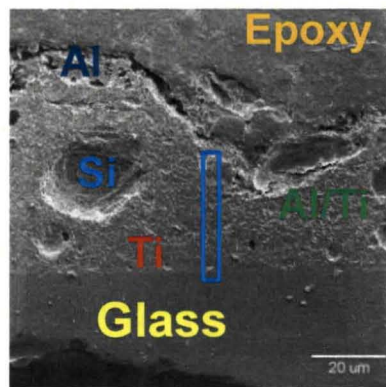
- Platinum was deposited over the Region of Interest (ROI) to protect the layer from ion damage during focused ion beam (FIB) sample preparation.

Original Magnification: 2000X

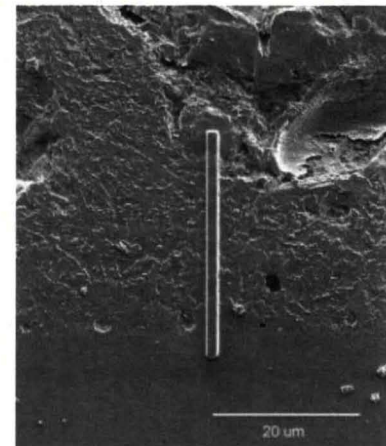
Original Magnification: 5000X

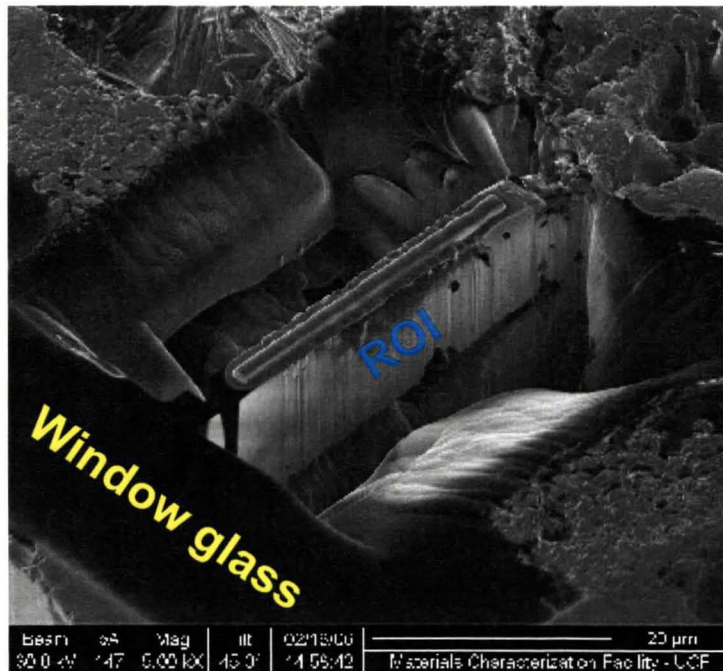
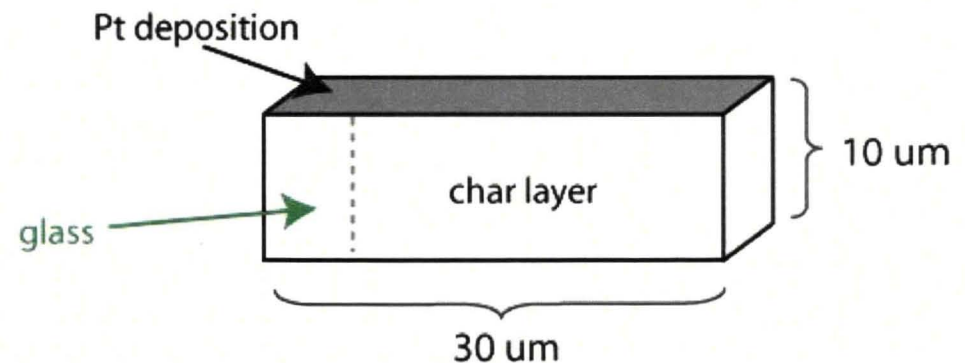
- In-situ sample removal:
 - A rectangular segment was created by milling “trenches” at the front and back of the ROI with the ion beam
 - Rectangular specimen was separated by tilting the stage 45° and using ion beam to cut all sides except one small ligament
 - Pt is used to adhere specimen to in-situ needle

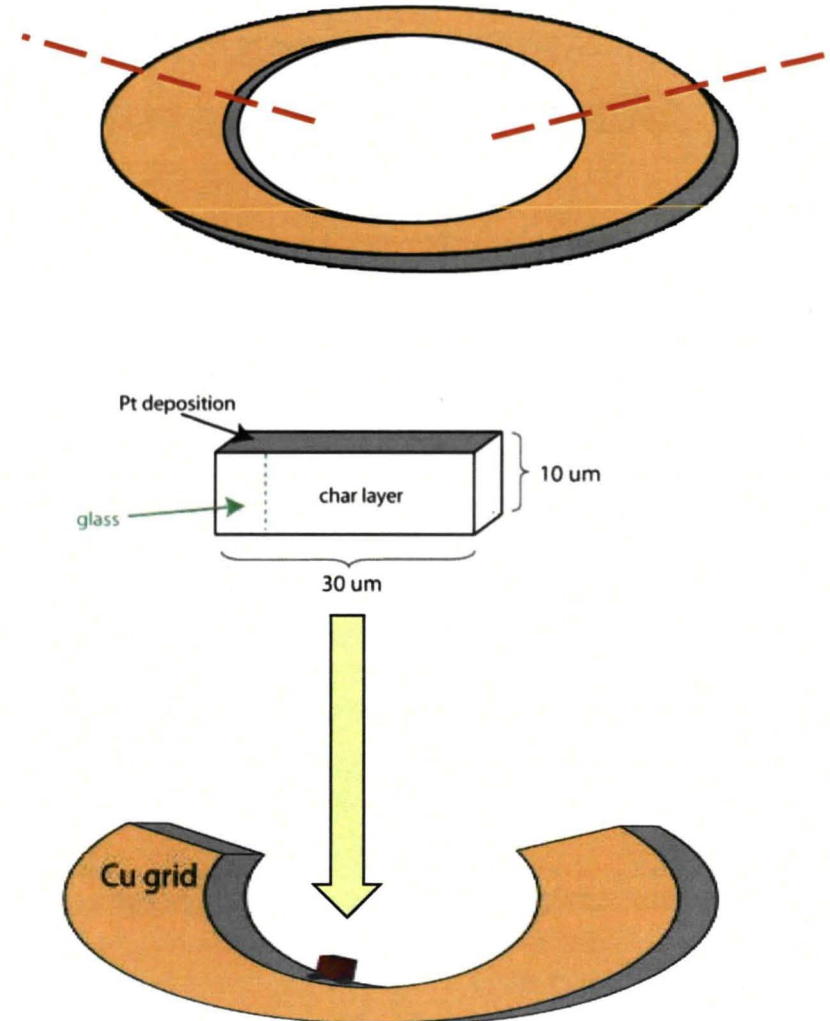
- Adhering sample to Cu grid:
 - A TEM copper grid was snipped to create a horse shoe shape
 - The FIB was used to create a ditch slightly larger than the rectangular sample on the inner radius of the Cu grid
 - Rectangular specimen was positioned inside ditch by lowering the in-situ needle and cut free
 - Pt deposition was used to “spot weld” the rectangular specimen in place

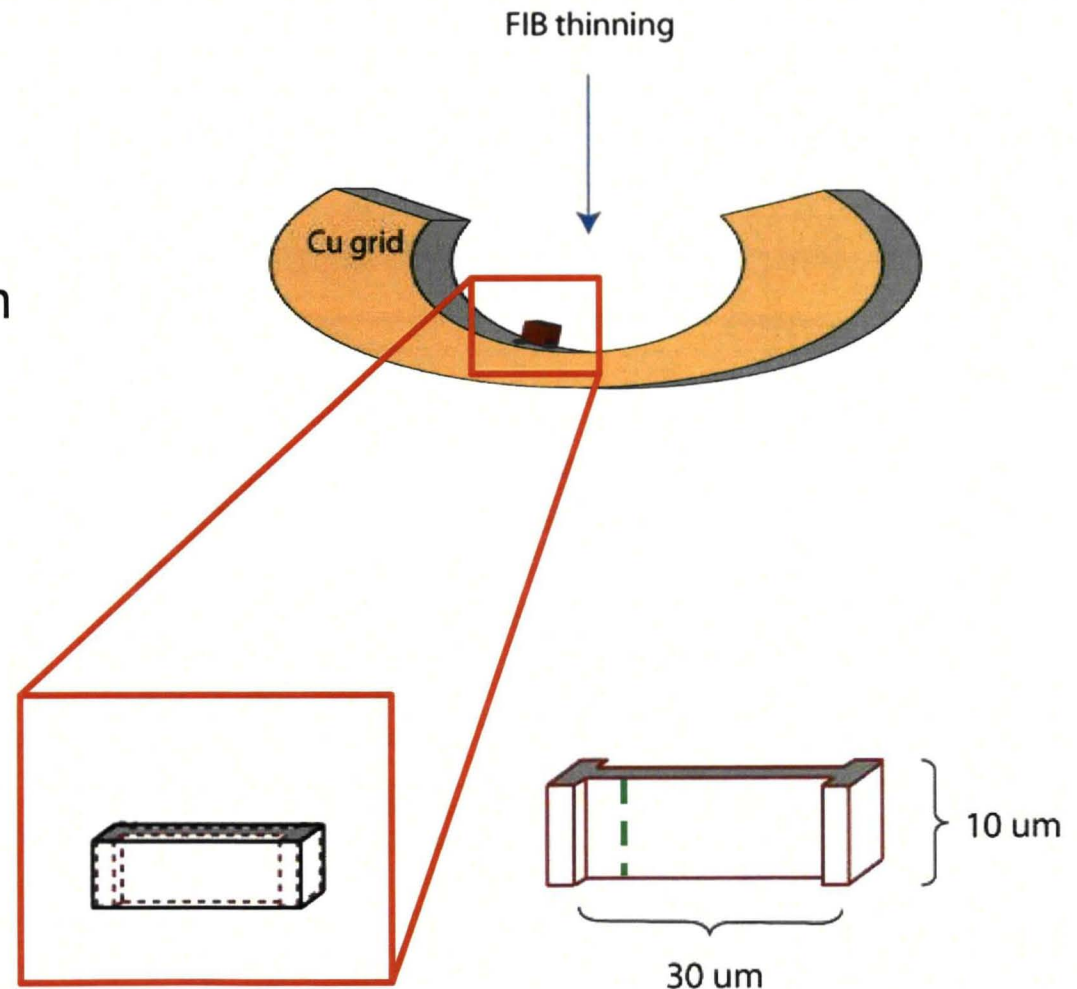
- Specimen thinning:
 - The FIB was used to thin out the rectangular specimen to thickness of $<1000 \text{ \AA}$ to make it electron transparent
 - As a result of material removal, the sample took the shape of an I-beam, with the thicker regions as support “flanges”
 - Specimen was ready for TEM evaluation

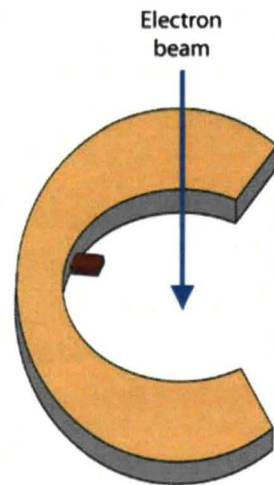
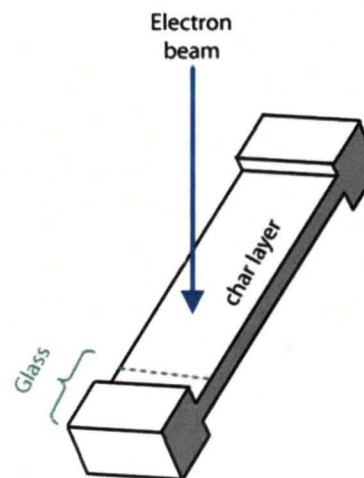
- Specimen inserted in TEM for analysis
- The glass portion of the specimen spanned the “flange” and “web” of the I-beam
 - Between the two regions, there is a transition region (varying thicknesses)
 - A distinction in contrast becomes apparent between the thicker portions and the thinner portions of the glass phase

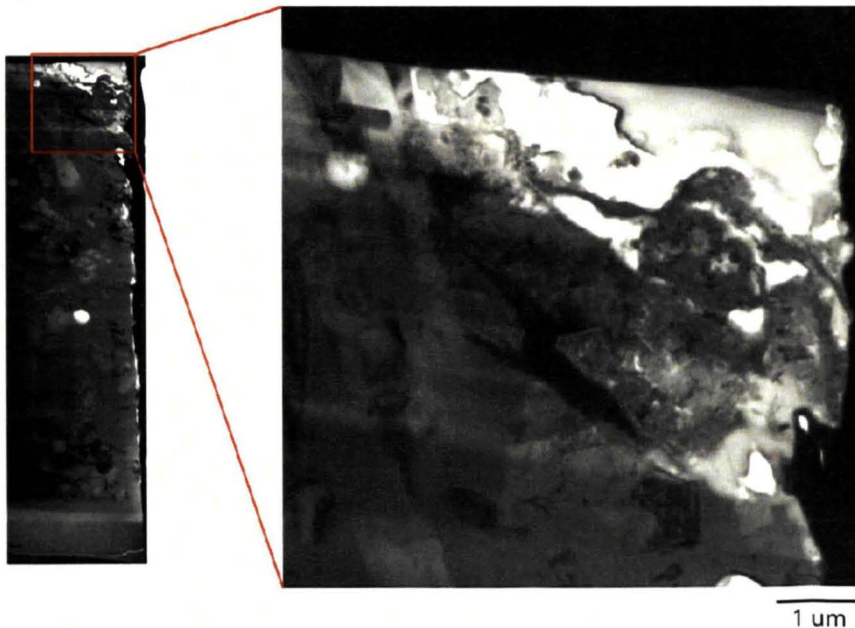
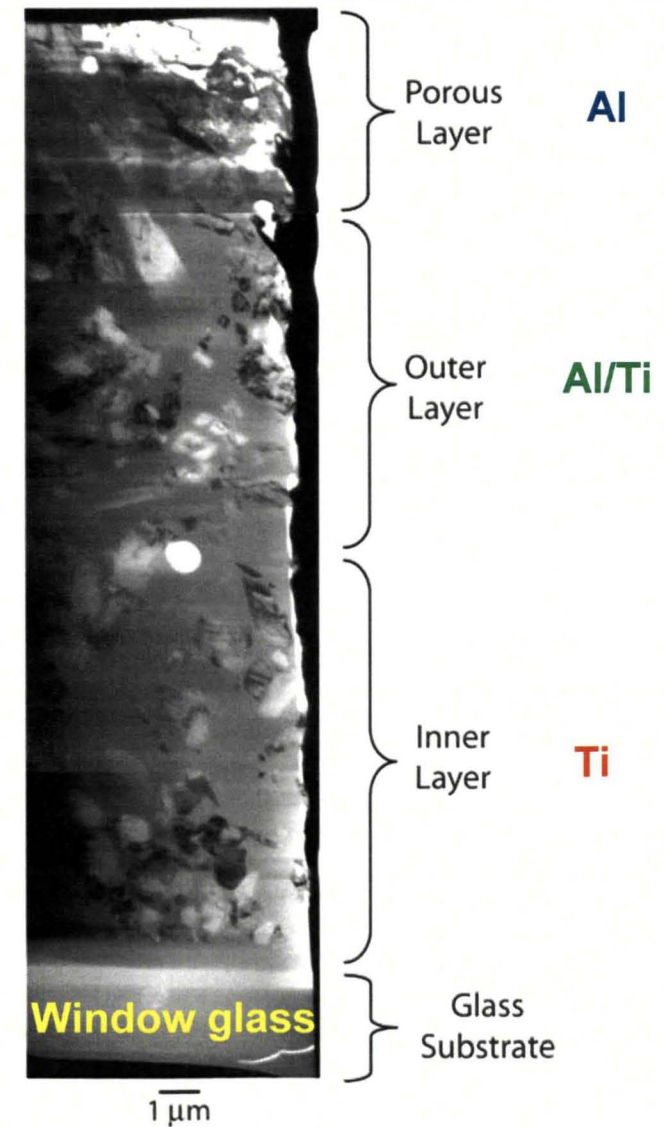
TEM of Char Layer

- TEM analysis gave a wealth of information
- TEM images, Selected Area Electron Diffraction (SAED) and EDS analysis revealed crystallographic oxide phases dispersed throughout a glassy matrix
- Regions were referred to as “porous layer”, “outer layer” and “inner layer”

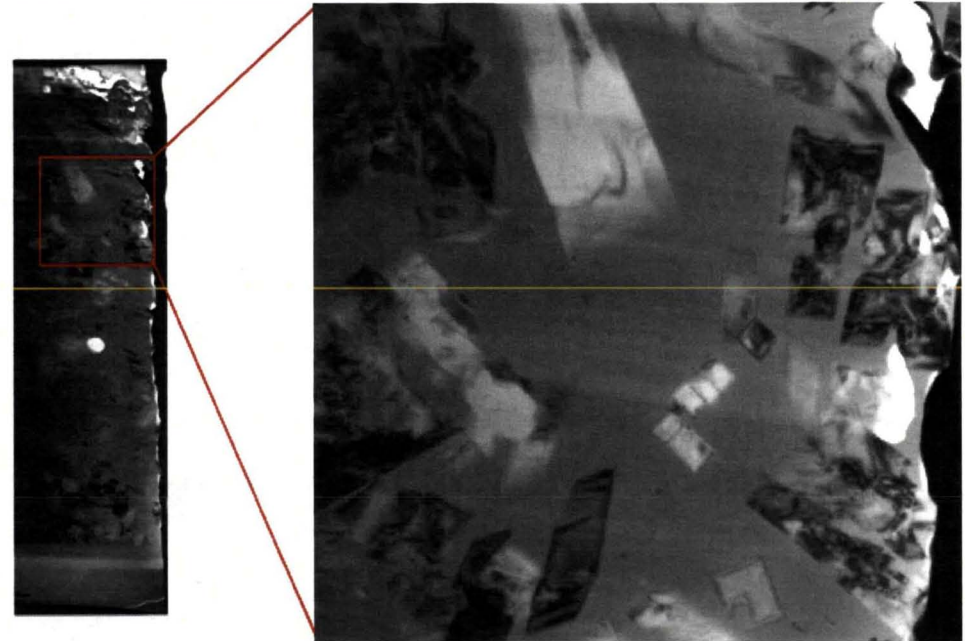
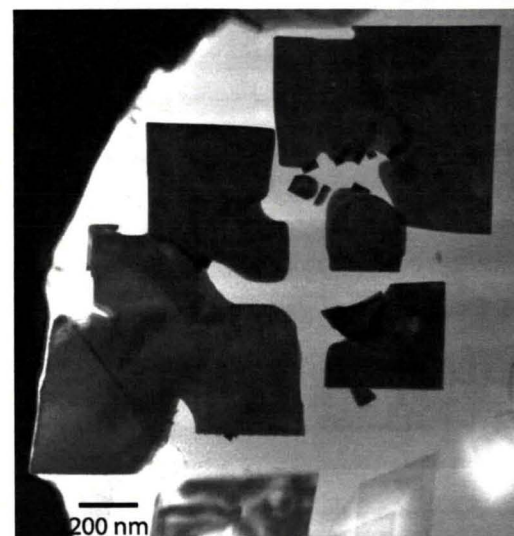
Outer Layer TEM

- Elongated crystals further from the window were a crystalline aluminosilicate phase called mullite ($\text{Al}_{4+2x}\text{Si}_{2-2x}\text{O}_{10-x}$).
 - 11 μm from glass substrate
 - As small as 500 nm x 750 nm to 1 μm x 3.5 μm
- Relatively homogeneous grains
- Some exhibited skeletal morphology due to rapid crystallization from a silicate melt

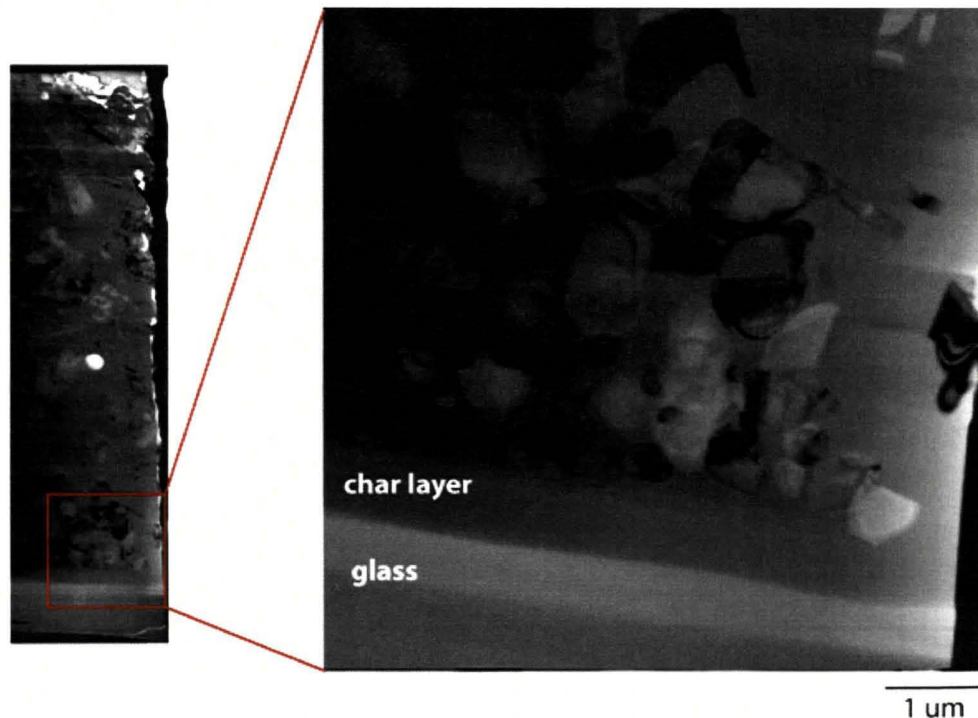
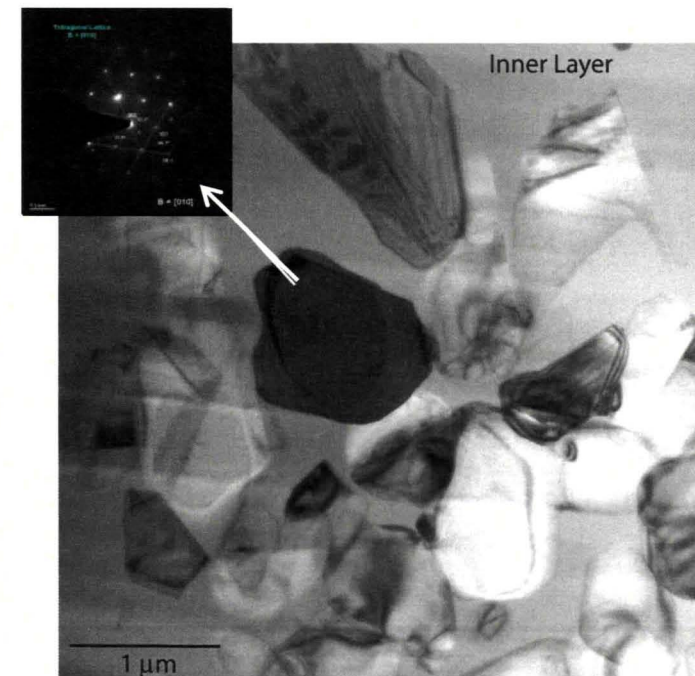
- Crystals closer to the window glass were identified as titanium dioxide (TiO_2 , rutile).
 - Crystals were equidimensional near glass substrate interface and appeared in polycrystalline clusters or isolated islands
 - Morphology became more irregular further from glass interface
 - Crystal size ranged from 300 nm to 1.8 μm

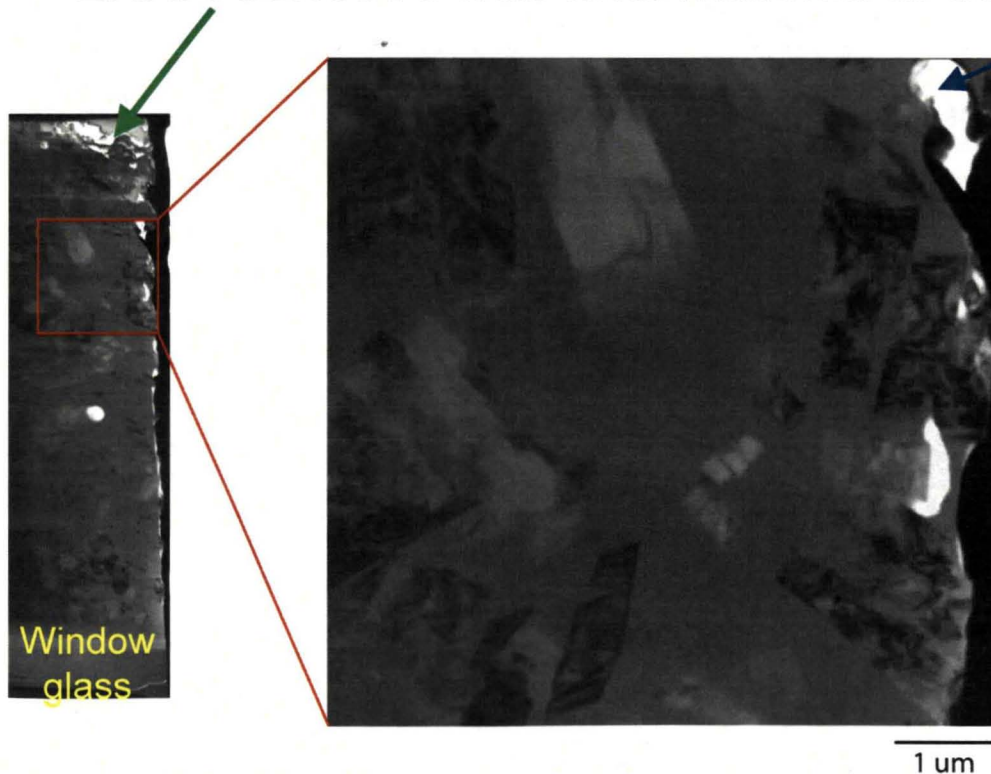
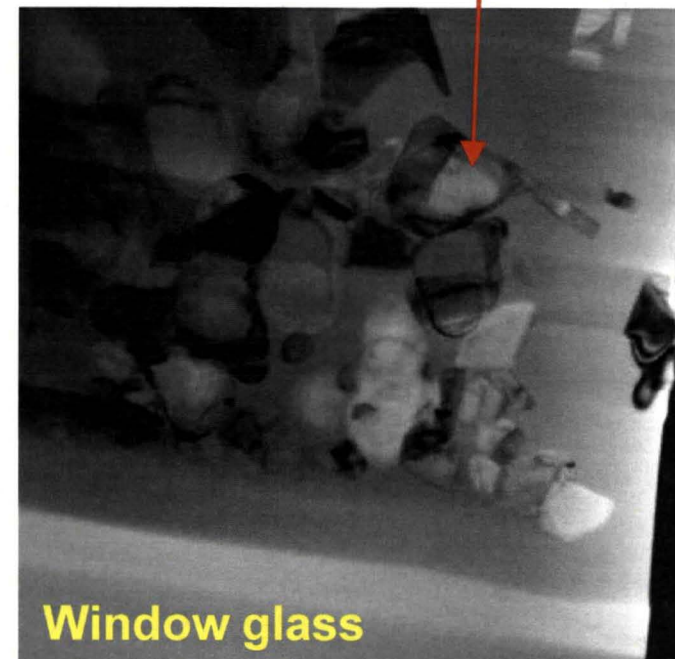
- Found that each region was comprised of crystals dispersed in a glass matrix (aluminosilicate).
- Crystals closer to the window glass were titanium dioxide (TiO_2).
- Elongated crystals further from the window were a crystalline aluminosilicate phase called mullite ($\text{Al}_{4+2x}\text{Si}_{2-2x}\text{O}_{10-x}$).
- 2XXX-series Al was final material to deposit.

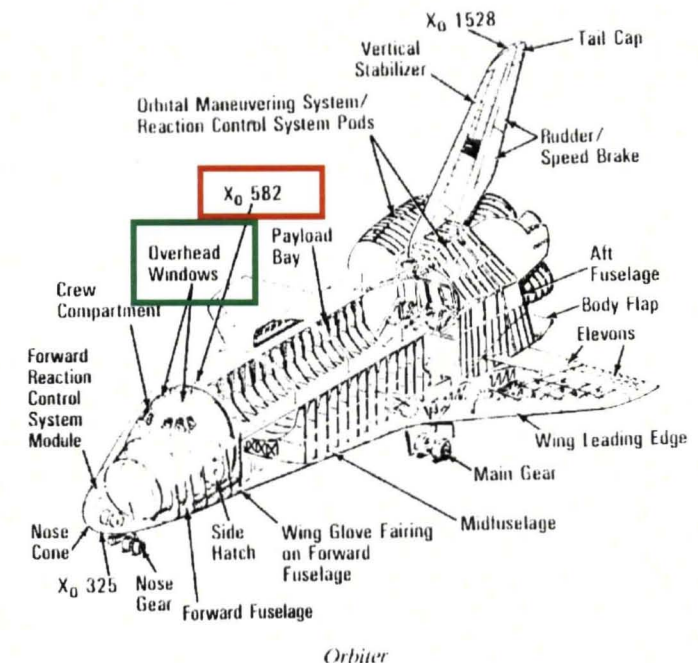
- A gradient in glass composition throughout the char layer was used to determine the temperature at which crystallization occurred.
 - Components underwent temperatures above 1700°C prior to being deposited onto the glass substrate.
- Three-zone char layer was only observed on overhead windows 7 and 8 thermal panes
 - Majority of structural material surrounding the overhead windows is 2000-series aluminum.
 - Payload bay bulkhead latch rollers in close proximity to the overhead windows and are composed of titanium alloy Ti-6Al-4V.
 - Thermal protection system (TPS) nearby is source for silicon.

- Microscopic evaluation of a char layer deposited during re-entry revealed an unexpected sequence of deposition events.
 - Expect Al to deposit first (lower melting point).
- Deposits from a Ti source preceded deposits from other sources.
 - Thermal erosion of suspect Ti-6-4 components was discovered.
- It was hypothesized that materials deposited on windows 7 and 8 were the result of combustion of a Ti-6Al-4V source in addition to interaction with surrounding Al and Si components.
 - Exothermic conversion from metallic Ti to oxidized Ti.
 - Additional heating beyond aerothermal heating was present.
- **Metallic combustion of structural components exposed to entry environments needs to be a design consideration in future spacecraft.**
 - Environmental reactivity of sub-structural material if there is a chance of comprised thermal protection system (TPS).
