# ISS Solar Array Alpha Rotary Joint (SARJ) Bearing Failure and Recovery: Technical and Project Management Lessons Learned

*Christopher DellaCorte and Timothy L. Krantz  
Glenn Research Center, Cleveland, Ohio*

## Summary

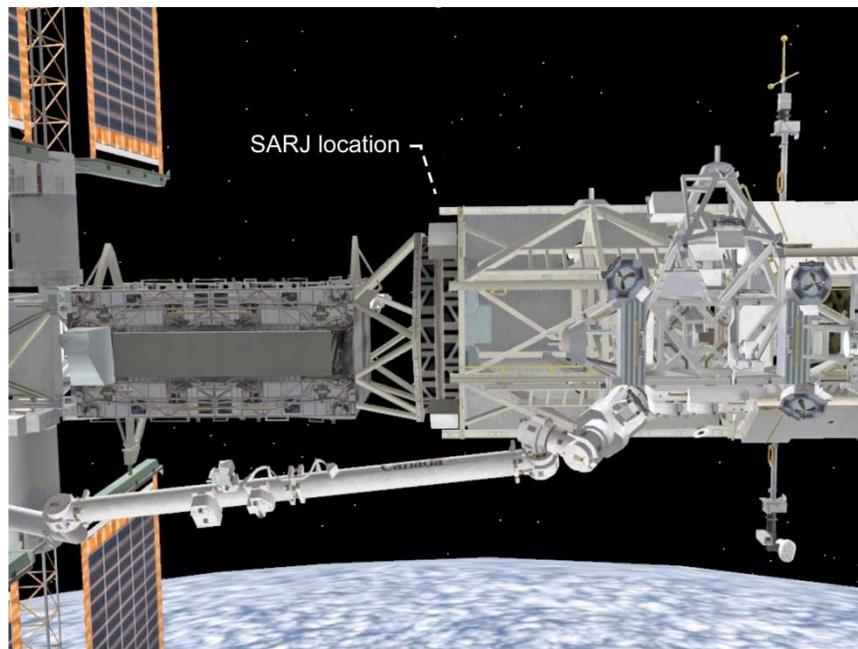
Figure 3.—Side view of ISS backbone truss, showing SARJ location.

The SARJs are shown schematically in Figure 3 and loosely resemble a pair of steel hula hoops, nearly 10 ft in diameter, that are arranged side by side and linked by a dozen arms, called trundle arms, placed at regular 30° intervals around the circumference. Each trundle arm has a clamp (i.e., gorilla mount, or gorilla clamp) on one end to grasp one hula hoop (race ring) and a fixture on the other end containing three opposing rollers that surround the cross section of the other hula hoop, allowing it to roll freely.

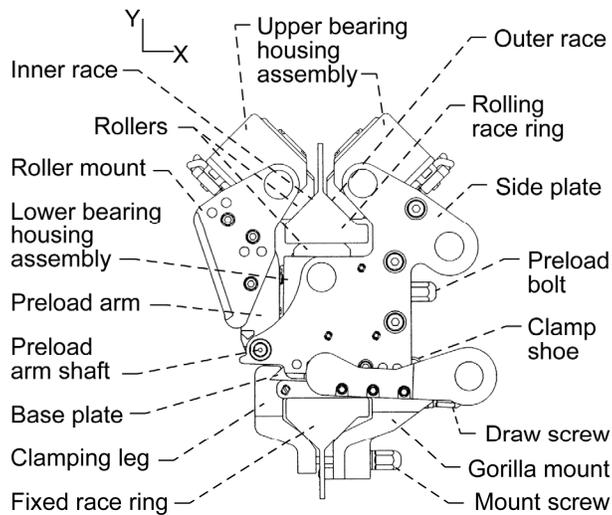
Figure 4.—Annotated drawing of trundle (oriented such that marked Y-axis runs parallel to ISS backbone truss) showing how rollers contain race ring by contacting opposing race ring surfaces.

The other components that received scrutiny during the record review were the trundle rollers, particularly the smaller upper rollers that operate against the canted race surfaces of the race ring. These rollers, pointed out in Figure 4, are specified to be made from hardened 440C stainless bearing steel, precision ground and then plated with a thin layer of gold. The build records indicate that the batch of rollers used for the starboard side were initially defective, in that the contacting surface (roller outside diameter) did not meet straightness requirements. To address this shortcoming, the rollers were hand-polished until the profiles were within specifications.

Unlike hula hoops, which are hollow, made from flimsy plastic, and have a round cross section, the SARJ race rings have a triangular cross section and are made from hard-coated stainless steel. Figures 4, 5, and 6 show more closeup details of the SARJ race arrangement, the trundle arms, and the rollers.

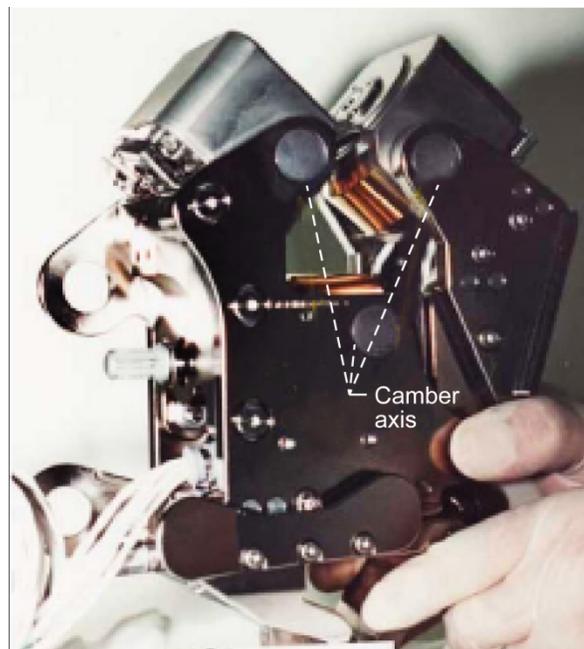
Figure 7.—Completed trundle assembly (port SARJ) in which gold-plated rollers are clearly visible.

The final design included a special nitride treatment for the race rings that deposited a near-diamond-hard iron nitride coating in all locations that would undergo trundle roller contact. With this approach, the anticipated rolling-contact fatigue life was estimated to be literally hundreds of years of ISS operation. Additionally, thin films of gold were deposited onto the trundle roller surfaces for solid lubrication, though it was not clear that this function was widely understood. Figure 7 shows a photograph of a finished trundle assembly (port SARJ) in which the gold-plated rollers are clearly visible.

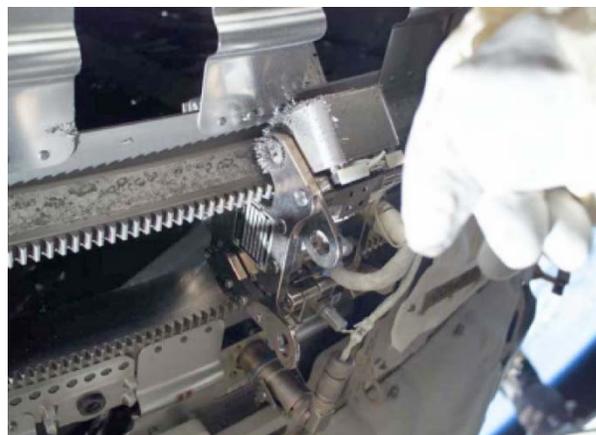
Figure 8.—Starboard SARJ on orbit after approximately 3 months of operation. Contacting race-roller surfaces are highly damaged.

The first EVA, conducted in late November 2007, was initiated to seek obvious causes for SARJ distress. The astronauts were instructed to examine the SARJ multilayer insulation and cover panels for signs of micrometeorite damage and to seek any mechanical interference from nearby hardware such as hold-down brackets and deployment mechanisms. In short, the EVA goal was to look for a “smoking gun” that would explain the anomalous behavior of the starboard SARJ (Ref. 5). The astronauts found nothing off-nominal during the external examination. When they removed one cover to inspect the internal mechanisms they immediately noticed damage to one surface of the rotating race ring and copious amounts of wear debris near and around the damaged race as well as adhered to the trundle bearings (see Fig. 8).

Samples of the debris were collected and returned to Earth for analysis. While the root cause for the race damage was not yet known, it was apparent that the roughened surface was likely the reason for the increased drag torque and the rough nature of the joint operation. A followup inspection of the port SARJ showed no such damage. The port SARJ appeared in pristine condition (see Fig. 9).

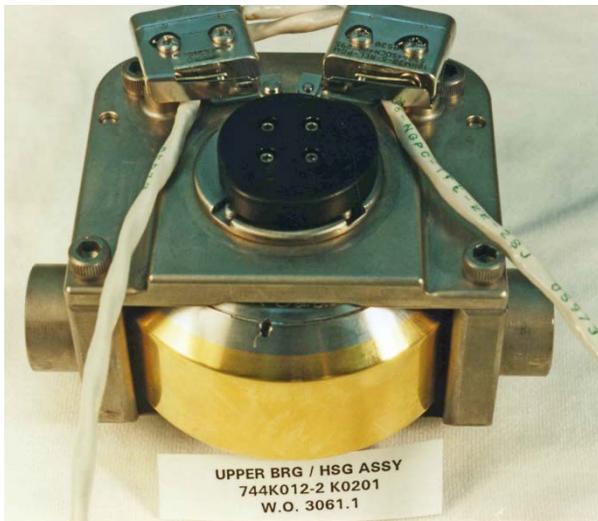
Figure 10.—Port SARJ upper roller showing intact gold plating prior to assembly into trundle.

clues to the SARJ failure. Figure 10 shows a photograph of an assembled roller from the port SARJ buildup in which the gold film is in its intended pristine state.

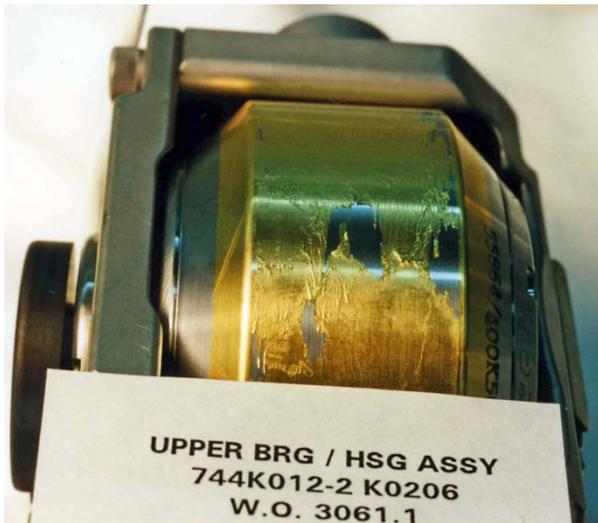
Figure 11.—Upper roller from starboard SARJ, showing peeling of the gold plating prior to assembly into trundle.

In operation, the gold gradually wears out and transfers to the nitrided race ring surface where it helps to lower friction. Figure 11 shows an assembled roller from the failed starboard SARJ in which the gold film is clearly deficient.

This image, similar to those of a majority of the starboard SARJ rollers, shows that the gold layer did not properly adhere to the roller surface. As with the out-of-specification roller profiles condition, the peeling gold was the subject of several fax communications between subcontractors. Because the role of the gold was not understood, the impact of its poor condition was not known. Prevailing thinking was that it

It was later determined that there is a corrosion-driven aging effect for gold films deposited on stainless steel. When exposed to room air, gold films will delaminate because of galvanic corrosion at the interface. Since the port SARJ rollers were assembled immediately after gold deposition, they suffered less delamination than the starboard SARJ rollers that

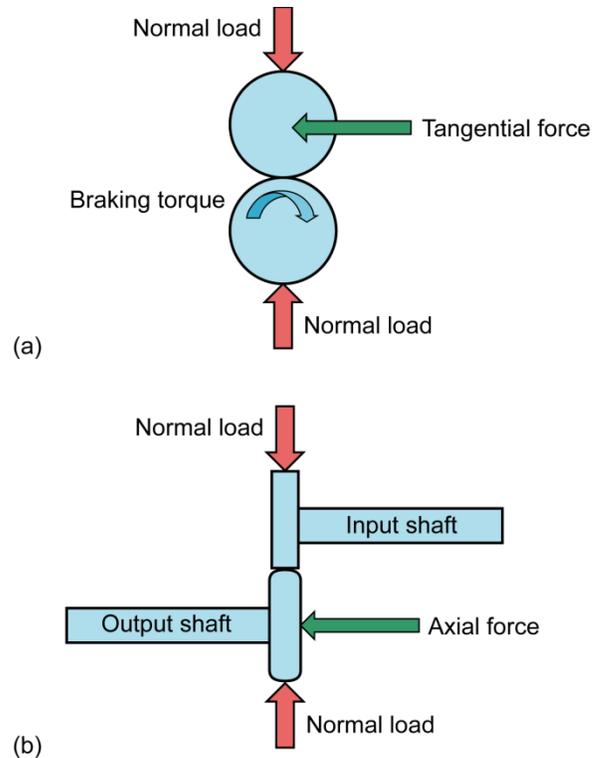
Figure 12.—Vacuum roller rig test specimens, showing applied and measured forces. (a) Front view. (b) Side view.

These effects are best described and quantified by the traction tests conducted at NASA Glenn in the vacuum roller rig (VRR). The VRR test loads two cylindrical rollers (Fig. 12) on one another and simulates the contact between the SARJ rollers and the race ring (Ref. 6). As shown in Figure 13, the motor turns the upper roller. The lower roller is driven by the rotation of the upper roller through the small contact that forms between the rollers under load.

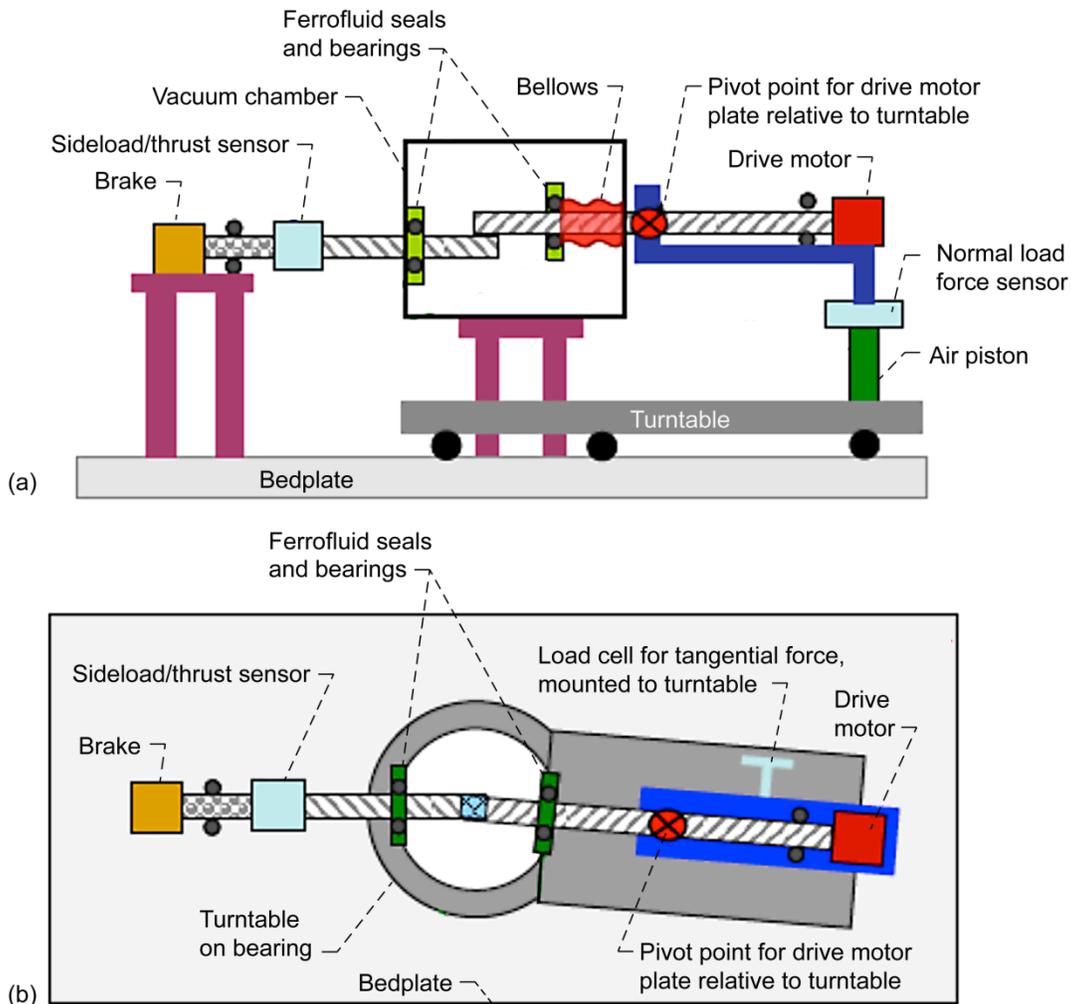
Figure 13.—NASA Glenn's vacuum roller rig (VRR) used to measure forces resulting from contact between rollers in misalignment. (a) Side view. (b) Top view.

With this configuration, one can mimic the SARJ contact, in which small amounts of roller misalignment (less than  $1^\circ$ ) are inevitable because of tolerance stackups and manufacturing errors (Ref. 5). In essence, the contact is mostly pure rolling with a small sliding component. A key feature of this test is that the rotational axes of the rollers can be parallel (pure rolling) or intentionally misaligned resulting in small but controlled amounts of sliding. The roller supports are well instrumented, and all of the forces and torques that arise from the contact (axial thrust forces and radial side forces) are measured.

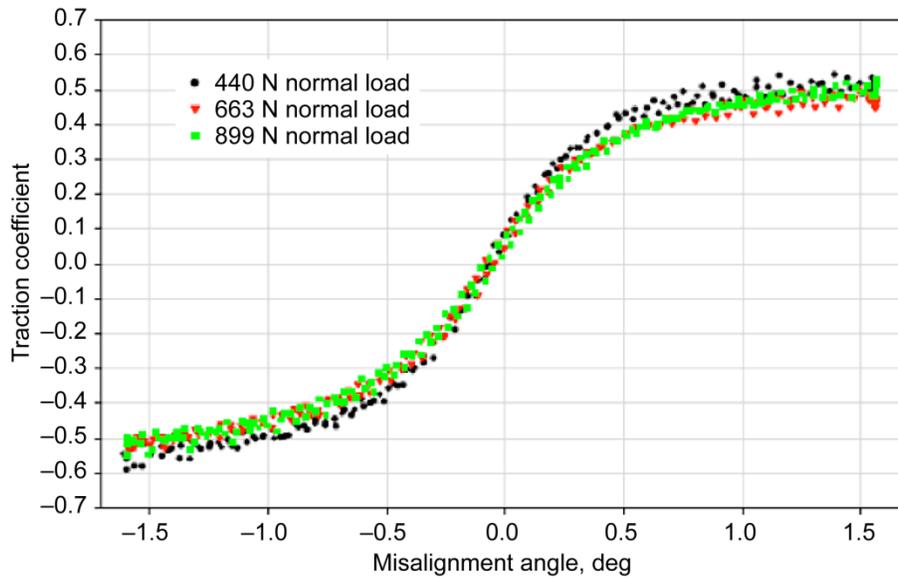
Figure 14.—Traction coefficient (side load/normal load) for stainless steel rollers in contact in VRR at varying loads and misalignment angles. Note that at high misalignment angles, the traction coefficient nears the traditional friction coefficient for pure sliding.

side loads rapidly build, reaching a maximum at an effective friction (traction) coefficient of about 0.6, well above the level that causes roller tipping. Roller tipping alone leads to very high stresses because the load is concentrated. A second but critical aspect of the trundle kinematic design greatly exacerbates the problem, and that is unexpected rigidity of the trundle preload system.

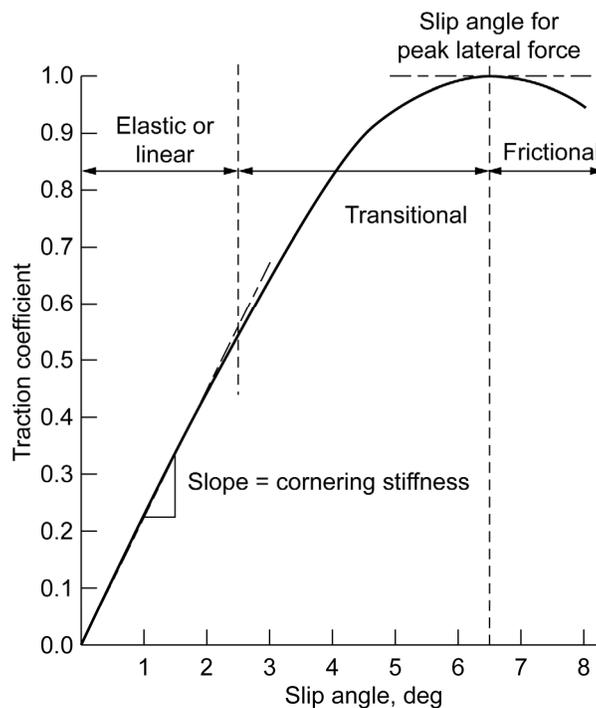
Figure 15.—Traction coefficient for automobile tire as function of varying positive misalignment (slip) angles. Note that for large misalignment the traction coefficient (side load/normal force) is approximately equal to the pure sliding friction coefficient for rubber against concrete (~0.9).

This figure resembles closely the VRR traction curve except that much higher misalignment angles are required to achieve high levels of side load. This is because rubber tires are very elastic and lack rigidity. For the materials used in the SARJ, small misalignment angles result in high side loads.

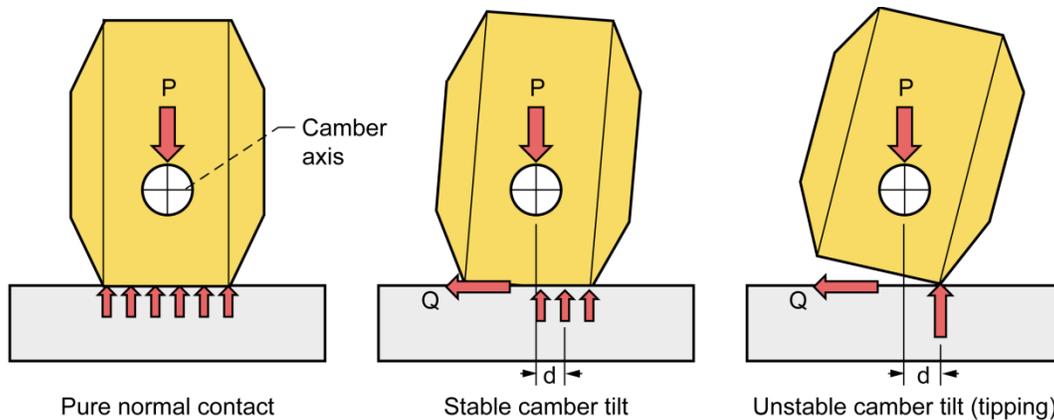
Figure 16.—Trundle roller-race ring contact geometry showing normal load (P), friction and misalignment induced side load (Q), and resulting contact load distribution from pure rolling through roller tipping.

Because of the particular kinematic design of the SARJ trundle assemblies, the side load leads to a potentially damaging condition, depicted in Figure 16 and reported upon previously, namely roller tipping (Ref. 5). The rollers are mounted on camber pivot mechanisms with the intent to ensure flat contact with the race ring surfaces. Under certain conditions the side load is of sufficient magnitude to tip the roller towards its edge.

Such tipping results in high, localized stresses that could damage the contacting surfaces. Based upon detailed modeling, when the sliding friction coefficient between the roller and race ring reaches 0.4, tipping can occur (Ref. 5).

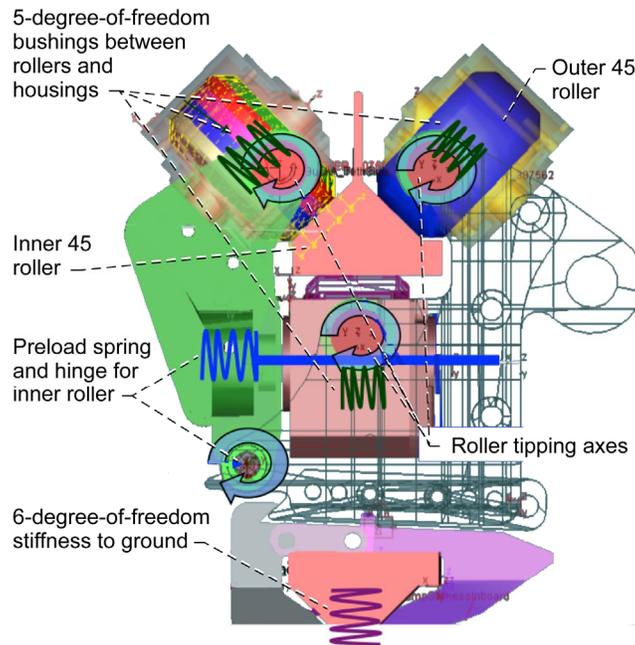
Figure 18.—Cross section representation of trundle showing roller tipping axes and spring preload system, which provides compliance directly to inner 45 roller. For sliding friction coefficients above ~0.4, the other two rollers are more rigidly fixed with respect to one another.

As shown in Figure 18, each trundle roller is held by its own pivot support. The inner 45 roller is additionally backed by a spring preload system that ensures that the load between the rollers and the race ring are maintained within limits. Should mechanical or thermal distortions occur within a trundle, for instance a large particle or other foreign object on

the race ring being rolled over, the spring preload of the lower roller can accommodate race deflection. In effect, all three rollers are designed to be spring preloaded by the single spring pack located behind the inner 45 roller.

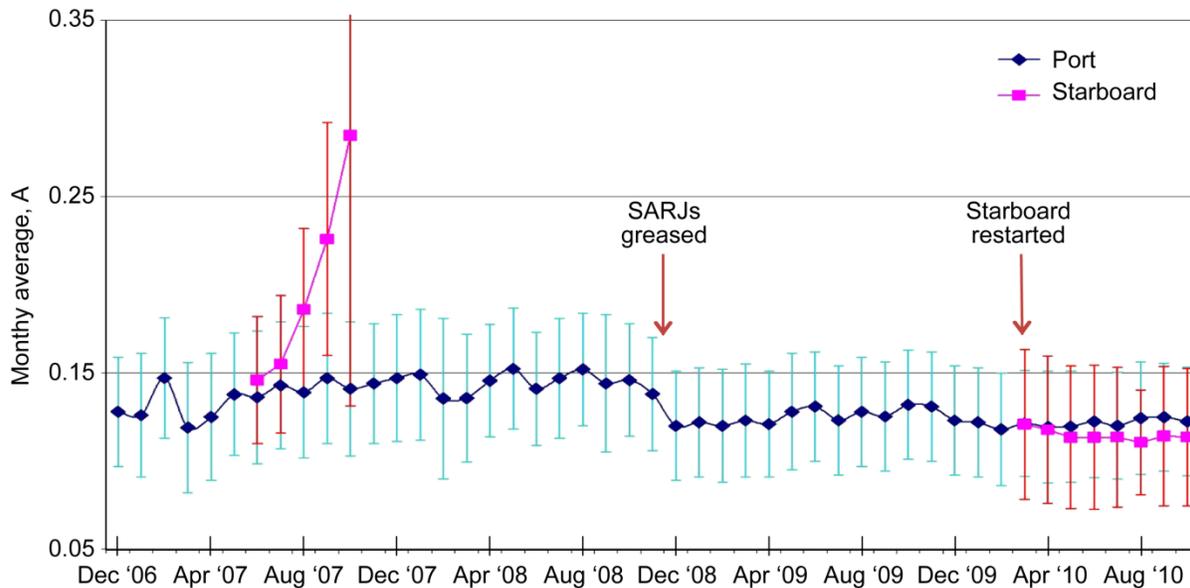
Figure 21.—SARJ drive current (drag torque) history showing behavior before and after on-orbit cleaning and lubrication with grease. Error bars represent current variations during operation.

sat for several months after deposition prior to assembly. Interestingly, when the SARJs were restarted after the application of grease, their overall drag torque levels noticeably dropped (see Fig. 21).

This drop was somewhat unexpected because the addition of an extensive layer of grease was thought to be capable of actually increasing drag. Further, a SARJ drag-torque analysis conducted by the original design team had concluded that roller-race sliding friction had no significant effect on overall joint drag-torque (Ref. 9). To better understand this contradiction, the original torque analysis was examined.

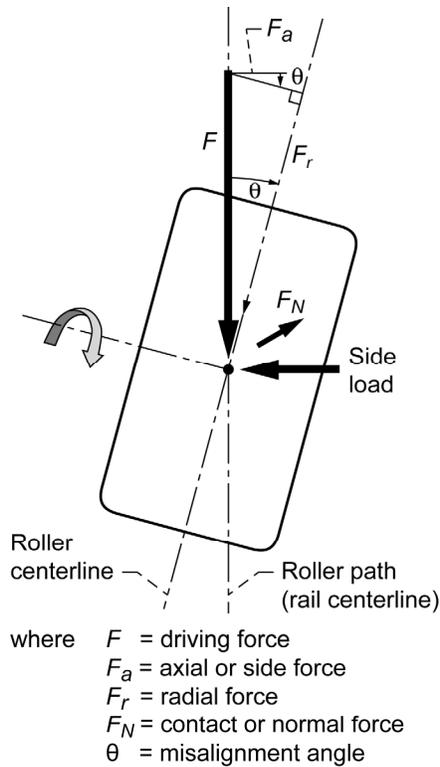
(a)

One key force, the lateral or side force, arises from elastic effects in the contact between the roller and the race surface. For high levels of sliding friction and moderate misalignment angles, the lateral force can reach significant levels, which places an additional load on the internal tapered roller bearings, increasing their drag torque. For the SARJ, this means that a poorly lubricated roller-race ring contact combined with unavoidable misalignment will result in increased overall drag torque. The failure to account for the side load effect on bearing drag led to an incorrect conclusion that roller-race friction (lubrication condition) had no effect on overall SARJ torque, as shown in an excerpt from the original torque study (Ref. 9) reproduced in Figure 22(b).

*Bearing misalignment is a condition where the bearing axis of rotation is not exactly perpendicular to the rail axis. If the bearing is misaligned it will have a tendency to slide as well as roll. This sliding causes an axial load on the bearing as well as a component that resists rotation of the SARJ.*
