EVA – Don't Leave Earth Without It

J. Scott Cupples and Stephen A. Smith

NASA Johnson Space Center EVA Office and NASA Johnson Space Center Engineering Directorate

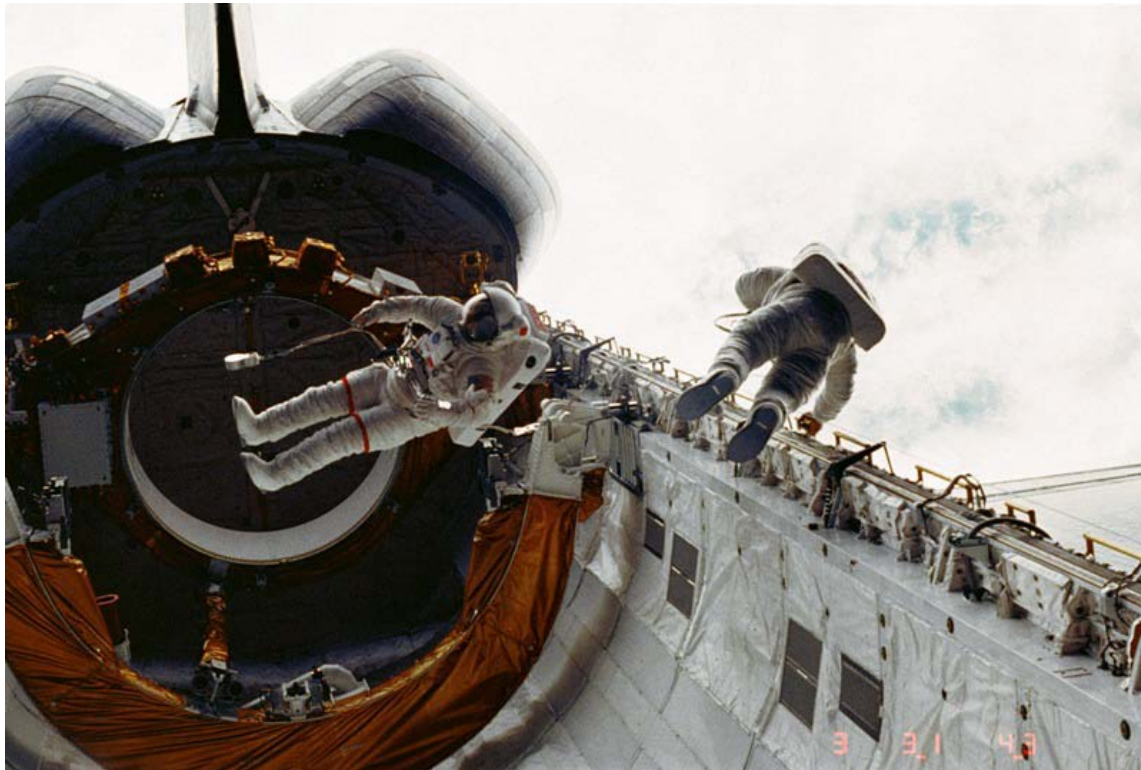
Figure 1 STS-6 First Space Shuttle EVA with newly designed Extra-Vehicular Mobility Units (EMU)

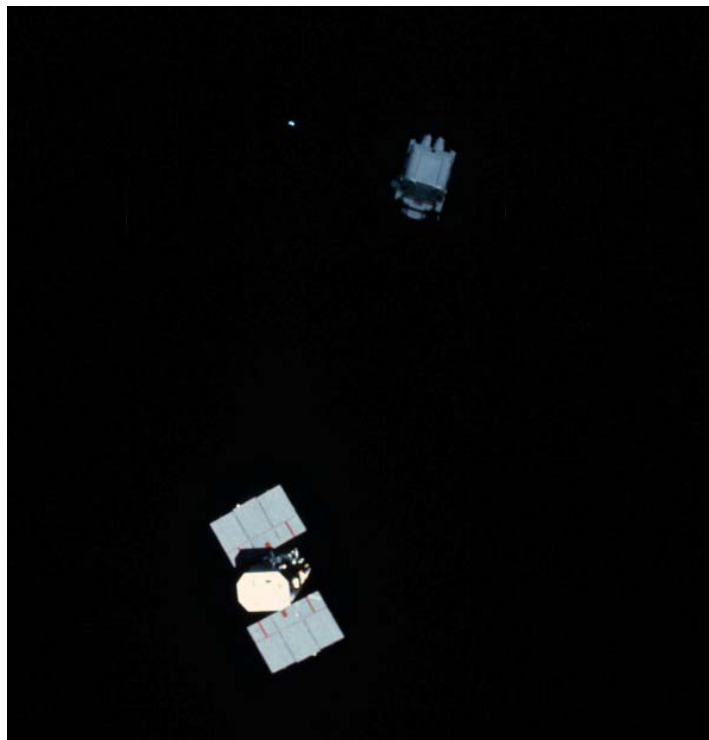
Figure 3 STS-41C MMU rendezvous with Solar Max

The initial EVA satellite rescue missions required flying the Manned Maneuvering Unit (MMU) out to the afflicted satellite, capturing it, and flying it back to the Shuttle. On Shuttle mission STS-41C in April 1984, EVA crewmembers retrieved the Solar Maximum satellite and brought it back to the Orbiter, where it was berthed, repaired and redeployed by Shuttle crewmembers. This was the first satellite repair mission of its kind. It was followed in November by STS-51A, during which the EVA crew flew the MMU to two different satellites, Palapa B-2 and Westar IV, and berthed them in the Shuttle for return to Earth. Once on the ground, the satellites were refurbished and re-launched to orbit.

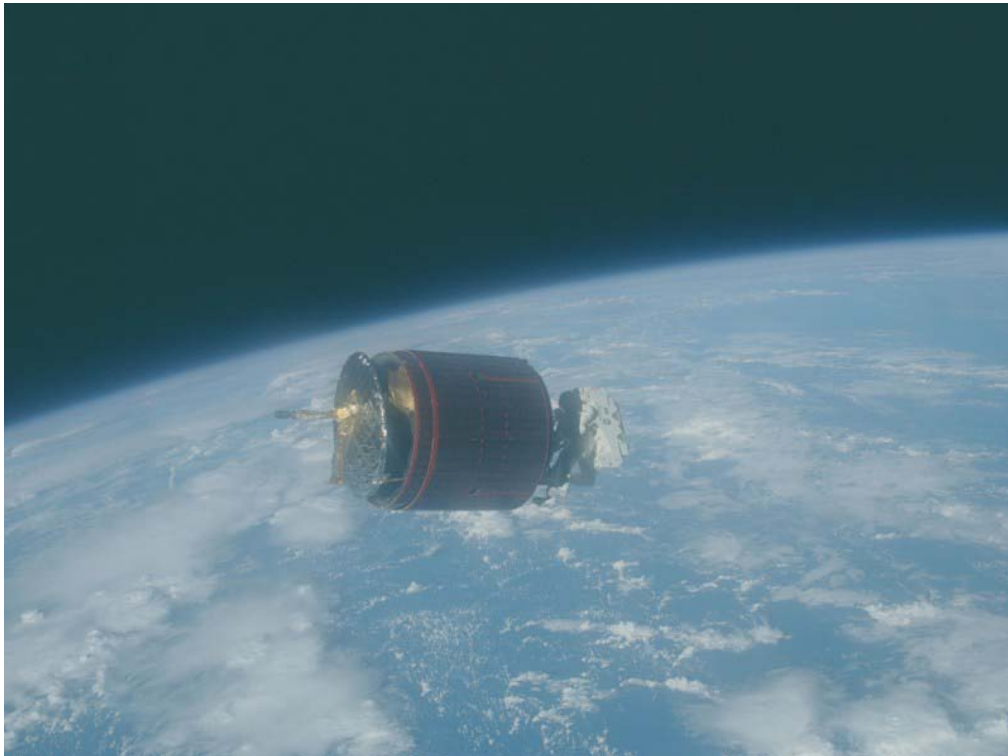
Figure 4 STS-51A MMU Capture of Palapa B-2 Satellite

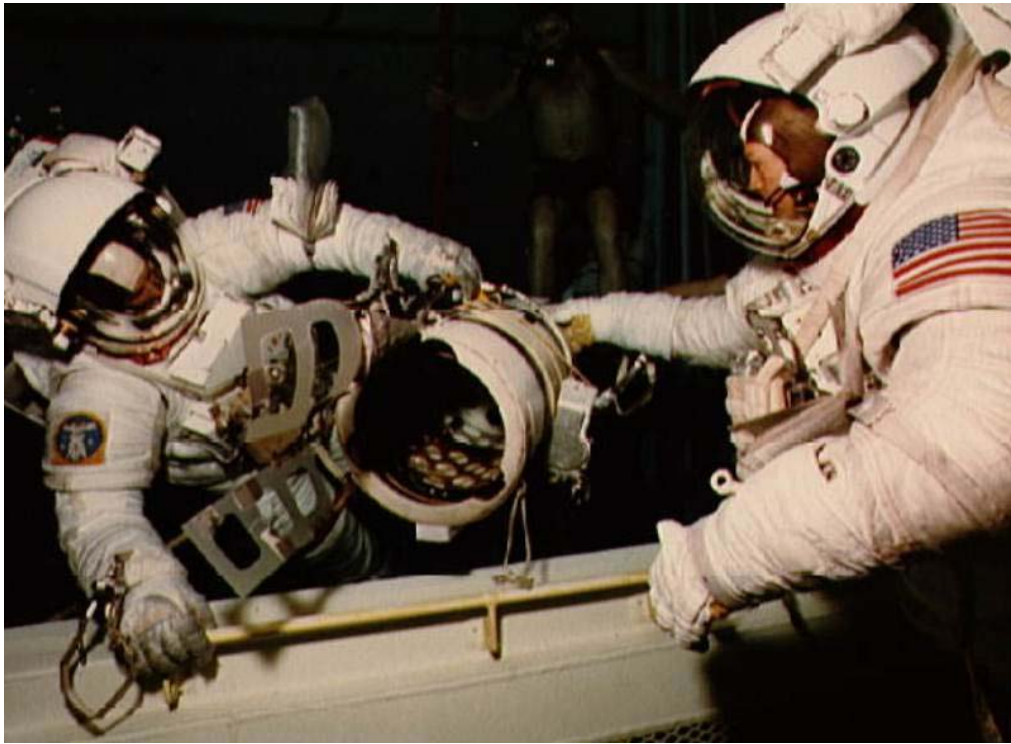
Figure 5 STS-51D WETF Evaluation of Flyswatter installation on Shuttle Robotic Manipulator System (RMS)

In April 1985, Shuttle crewmembers on STS-51D deployed the LEASAT-3 satellite, however its perigee kick motor failed to ignite. The crew performed the first unscheduled EVA in NASA history when crewmembers attached lever extenders the sequencer start lever on the LEASAT satellite, which enabled the crew to activate the motor using the Remote Manipulator System (RMS). Although the crew was successful in actuating the lever, the kick motor still did not initiate. In August, the STS-51I EVA crew revisited LEASAT to berth, complete repairs and redeploy the satellite.

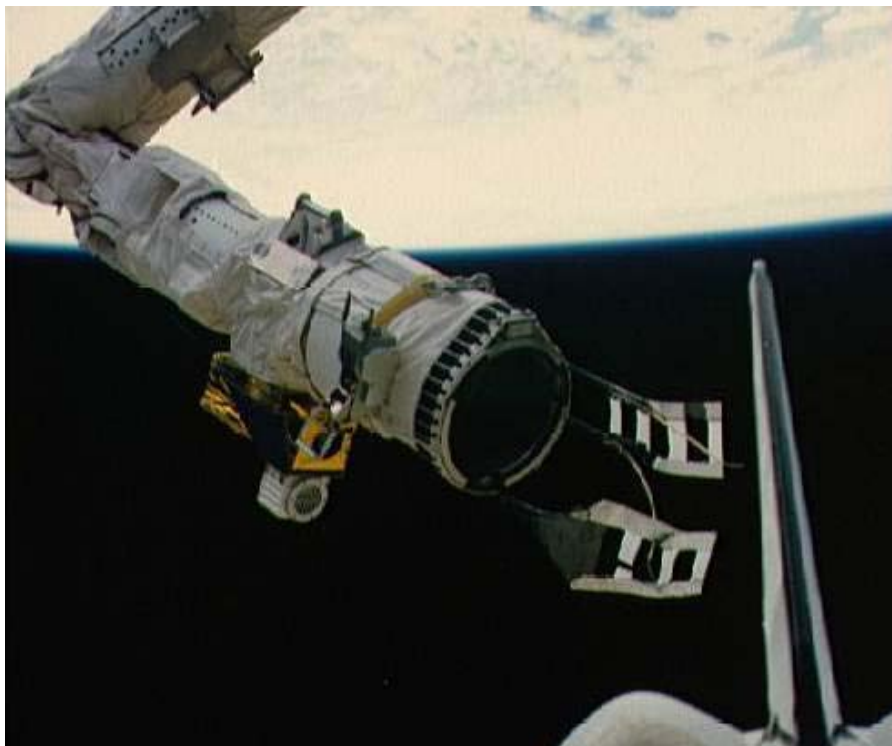
Figure 6 STS-51D Flyswatter affixed during EVA to RMS with help of Payload Retention Device (PRD)

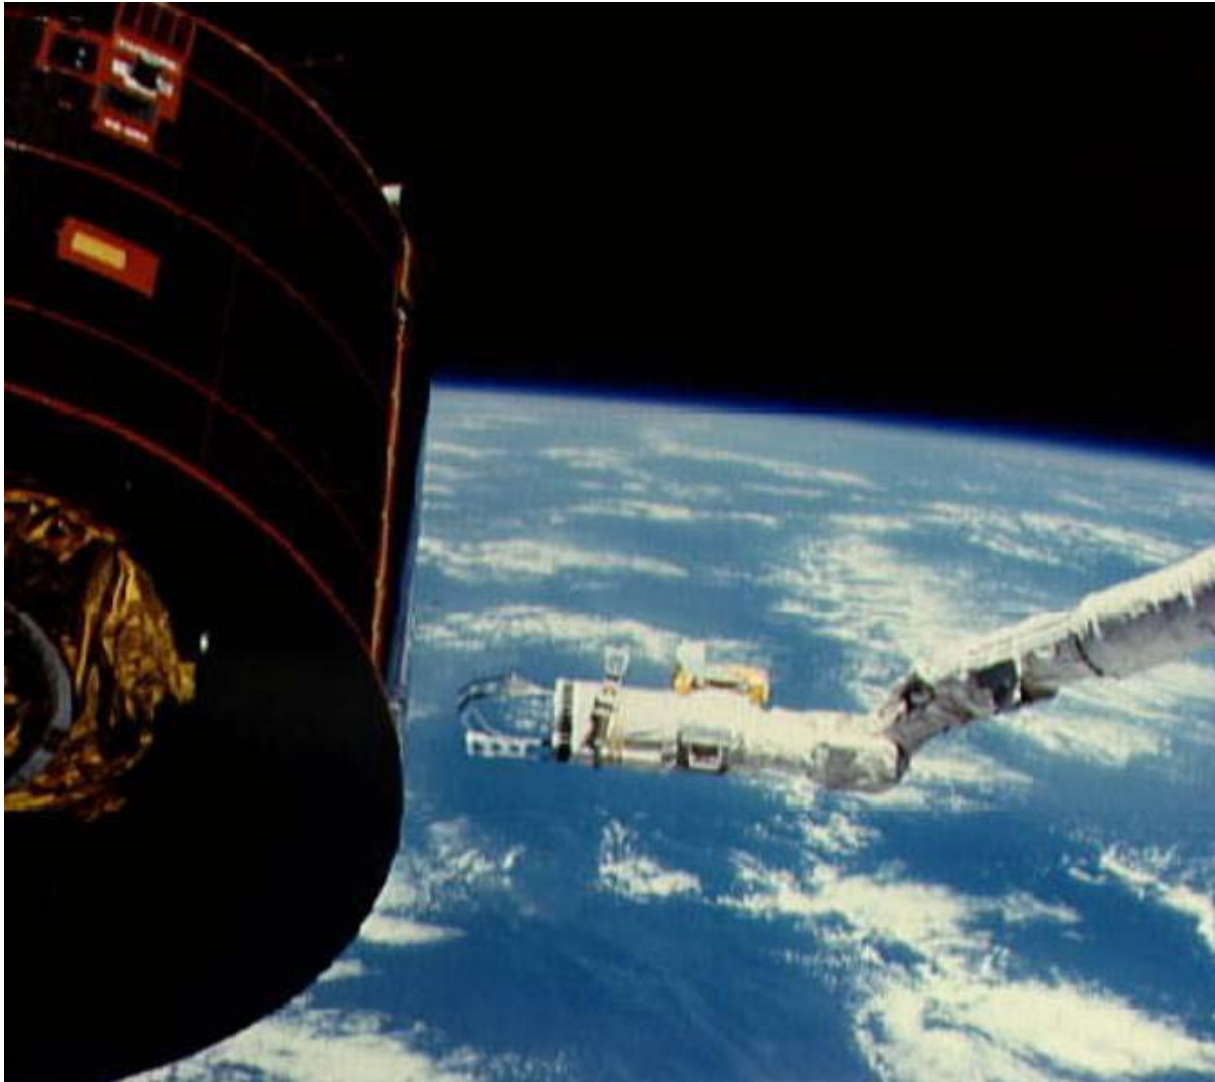
Figure 7 STS-51D Flyswatter in position to engage Sequencer Start Lever on LEASAT-3

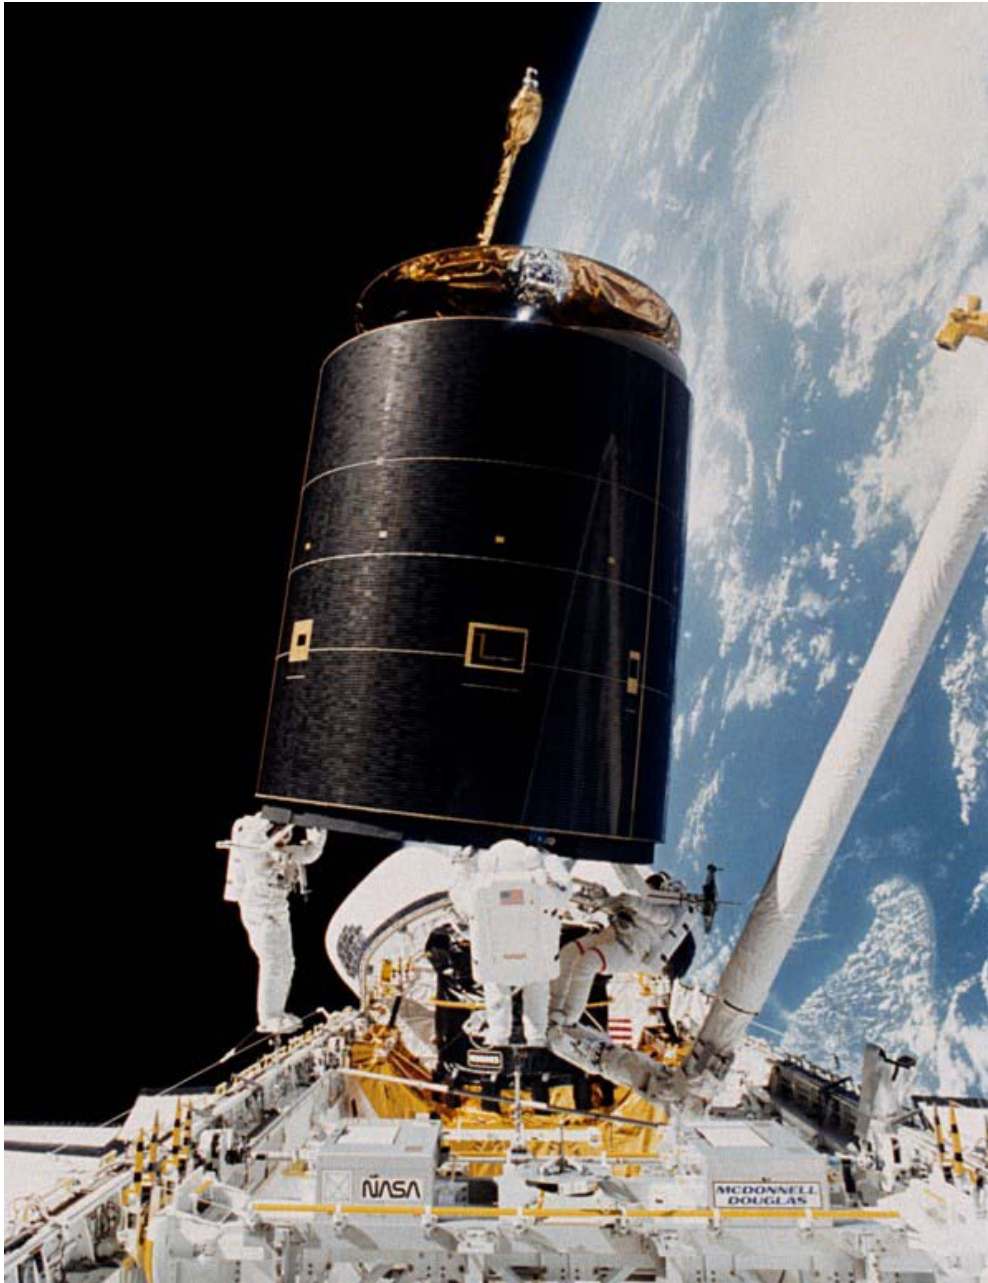
Figure 8 STS-49 Three-crewmember EVA grapple of Intelsat

STS-37 in April 1991 saw another unscheduled EVA, when EVA crewmembers were sent into the payload bay to deploy an antenna that jammed on the Gamma Ray Observatory, just prior to the satellite being launched from the payload bay. STS-49, which flew in May 1992, included the first – and, to date, only – three-person EVA in history. STS-49 was also the first shuttle mission with four EVAs. During that mission, the EVA crew attempted to capture Intelsat VI using a specialized device. When all attempts at grappling the satellite using a specially designed capture bar failed, the Orbiter was flown up to Intelsat so that the three-person EVA crew could capture the satellite by hand and mate it to a perigee kick motor. A kick motor was installed on Intelsat, and the Shuttle crew deployed the satellite. EVA 3 set the record for longest EVA (8 hours 29 minutes), eclipsing the record set by the Apollo 17 EVA crew.

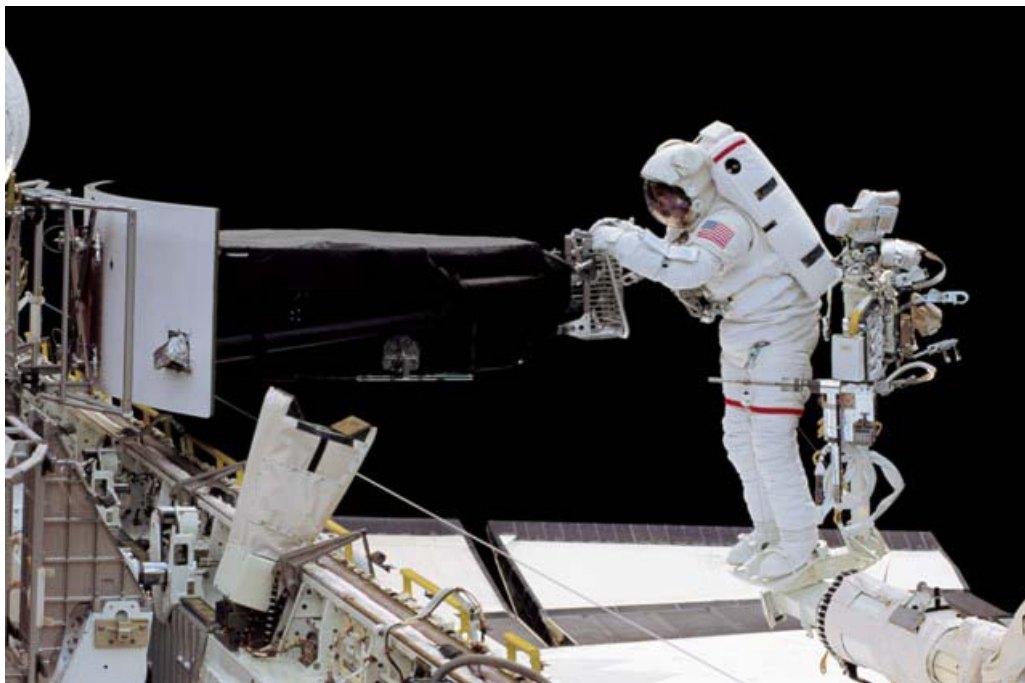
Figure 10 STS-61 On-orbit removal and temporary stowage of WFPC

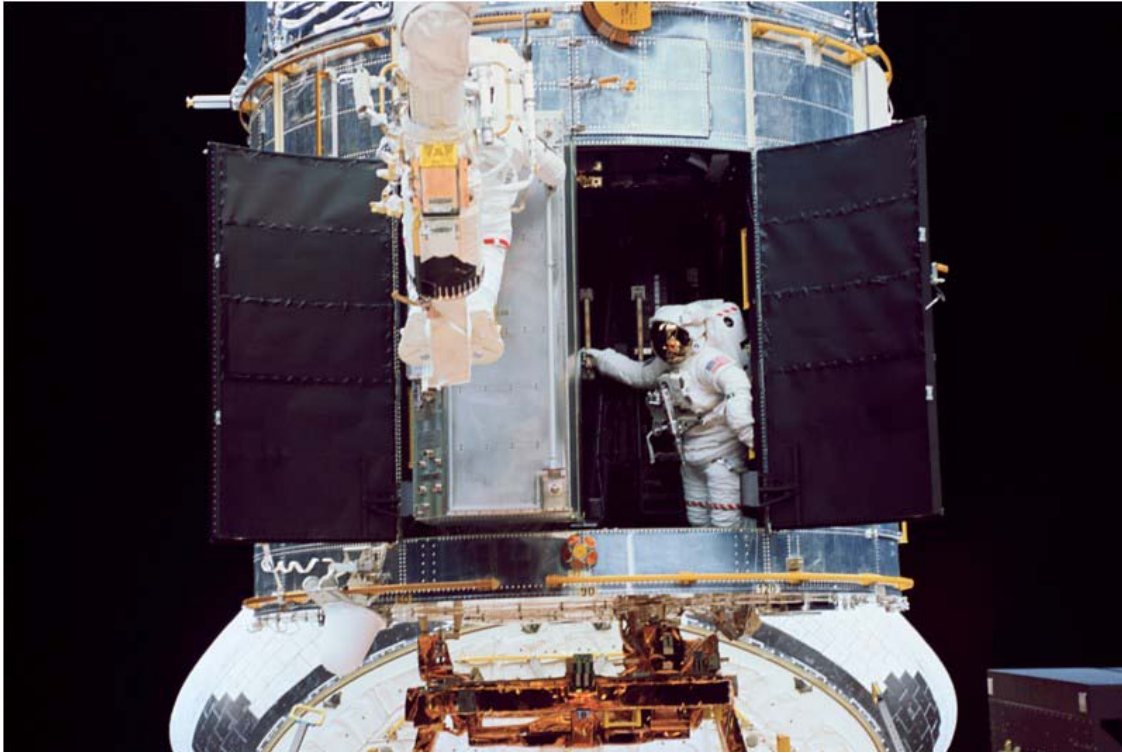
Figure 11 STS-61 COSTAR installation

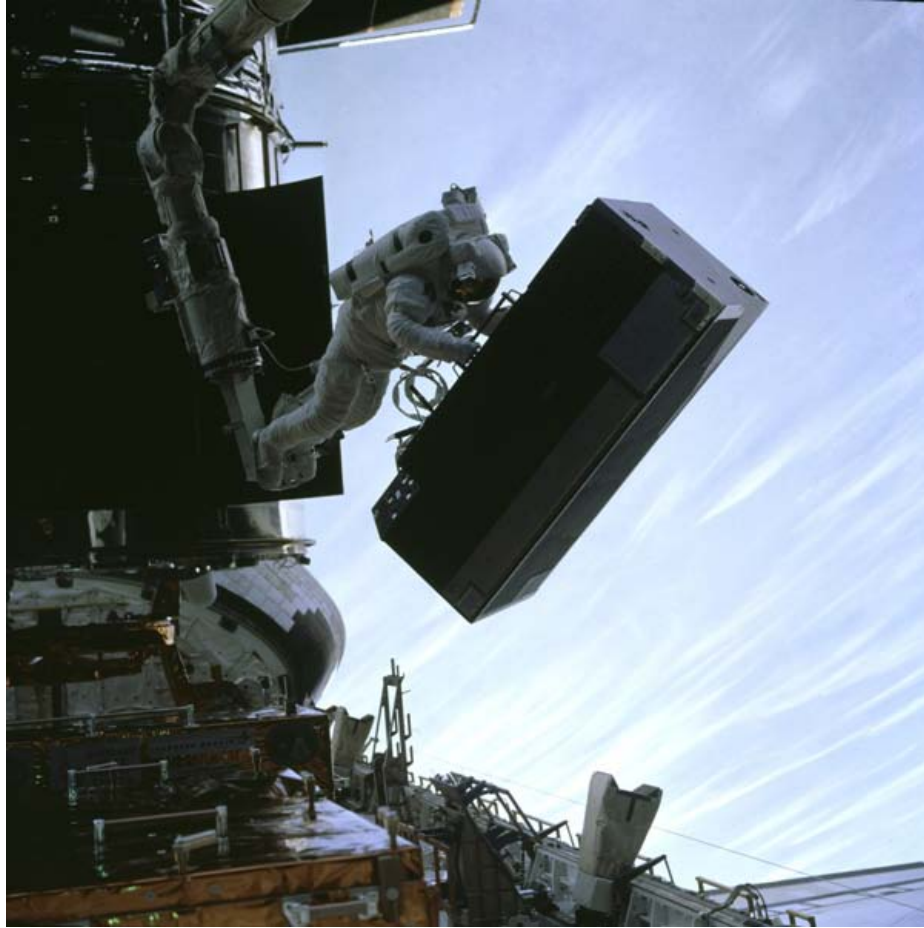
Figure 12 STS-82 NICMOS preparation for installation

Four years later, in February 1997, STS-82 visited HST on SM 2 and swapped two spectrograph instruments for an infrared spectrometer, called the Near Infrared Camera and Multi-Object Spectrometer (NICMOS), and a new spectrograph, called the Space Telescope Imaging Spectrograph (STIS). Both of these instruments included a correction factor for the flawed mirror optics. The EVA crew also replaced thermal insulation on the exterior of the telescope. The spectrometer added an infrared camera to HST, which expanded the telescopes capability to include the infrared light spectrum.

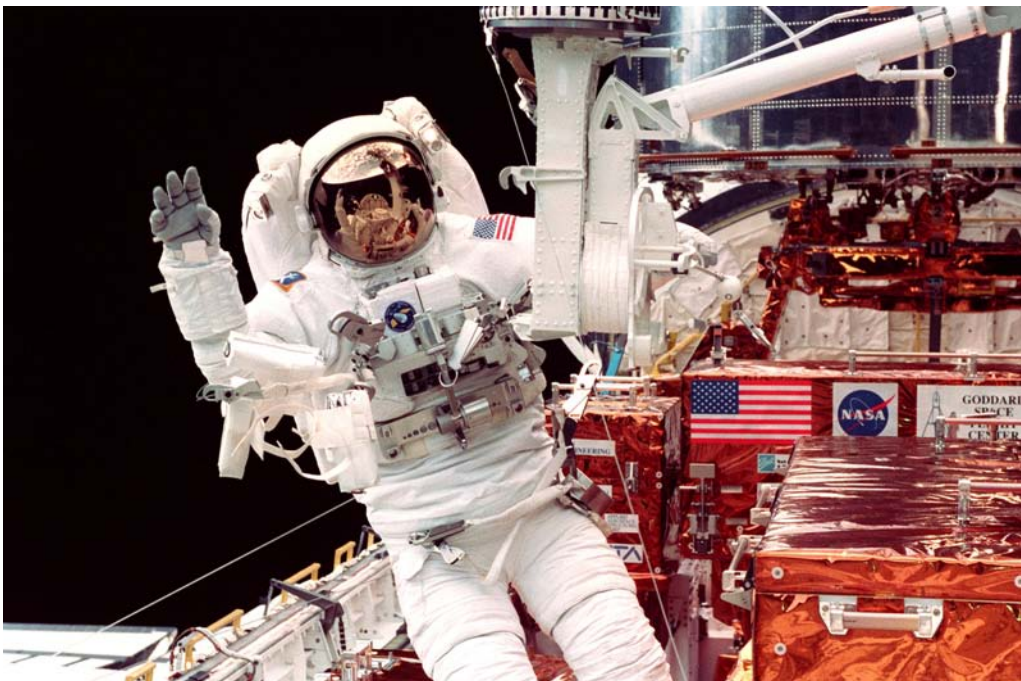
Figure 13 STS-82 Manipulator Foot Restraint (MFR) and tool preparation for EVA

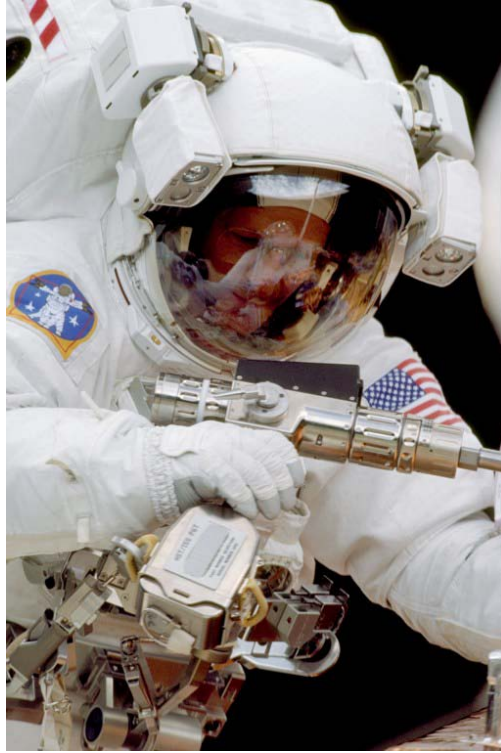
Figure 15 STS-103 Use of Pistol Grip Tool (PGT) to secure bolted fastener on HST Flight Support Equipment

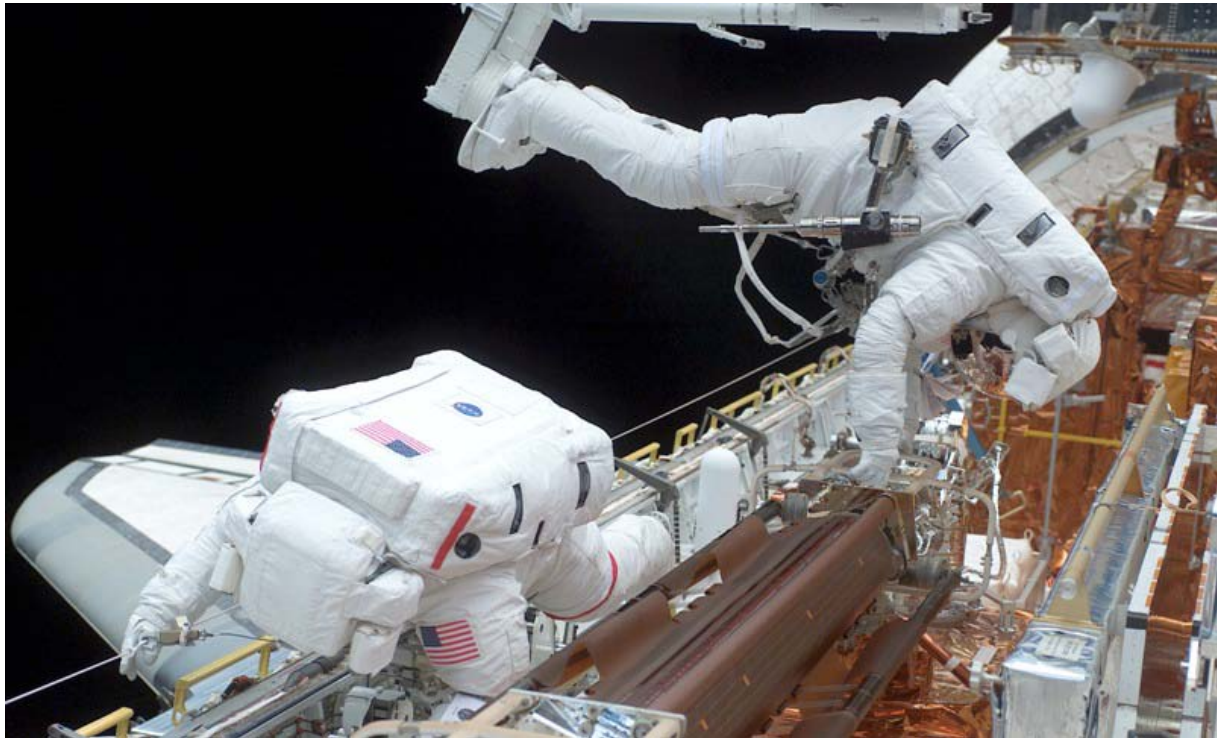
Figure 17 STS-109 Solar Array preparation for FSE removal and HST installation

STS-109 or SM 3B followed in March 2002, and during the course of five EVAs over five consecutive days, the crew installed new, more powerful solar arrays; a new

Power Control Unit that is compatible with the solar arrays; a new instrument, called the Advanced Camera for Surveys (ACS) after removing the Faint Object Camera; and a Cryocooler for NICMOS. With the installation of ACS, COSTAR was no longer needed, as each of the upgraded instruments on board HST corrected for the aberration in the mirror.

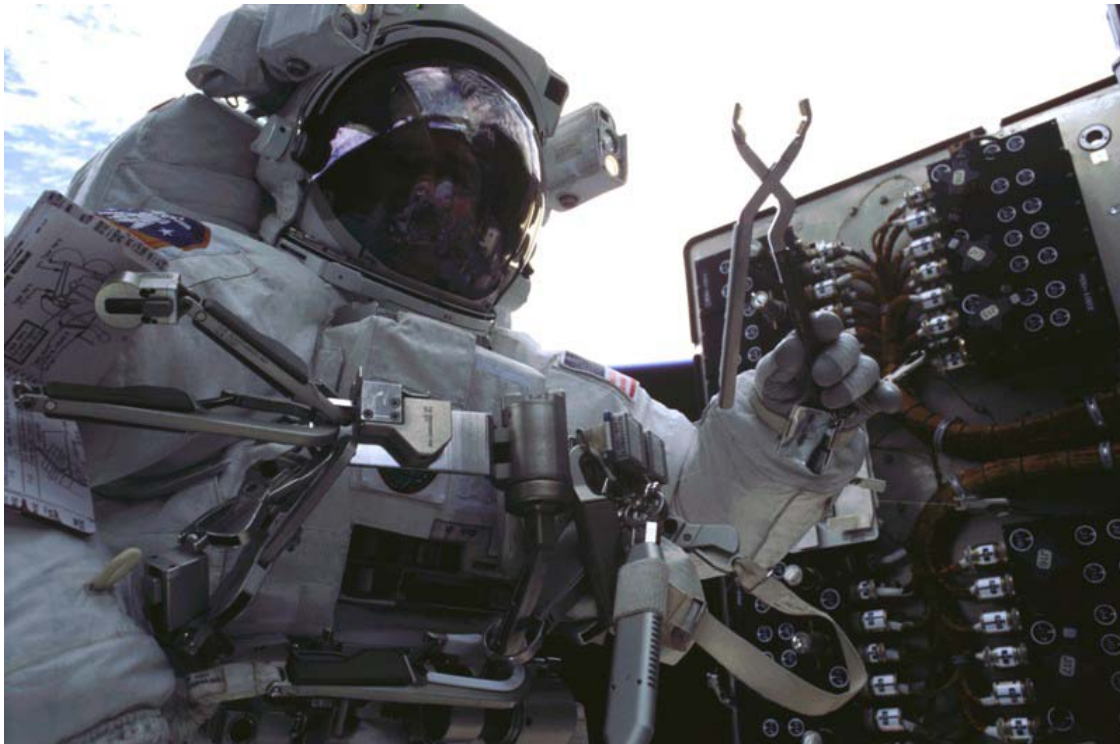
Figure 18 STS-109 HST Connector Tool is ready to assist with connector removal/installation

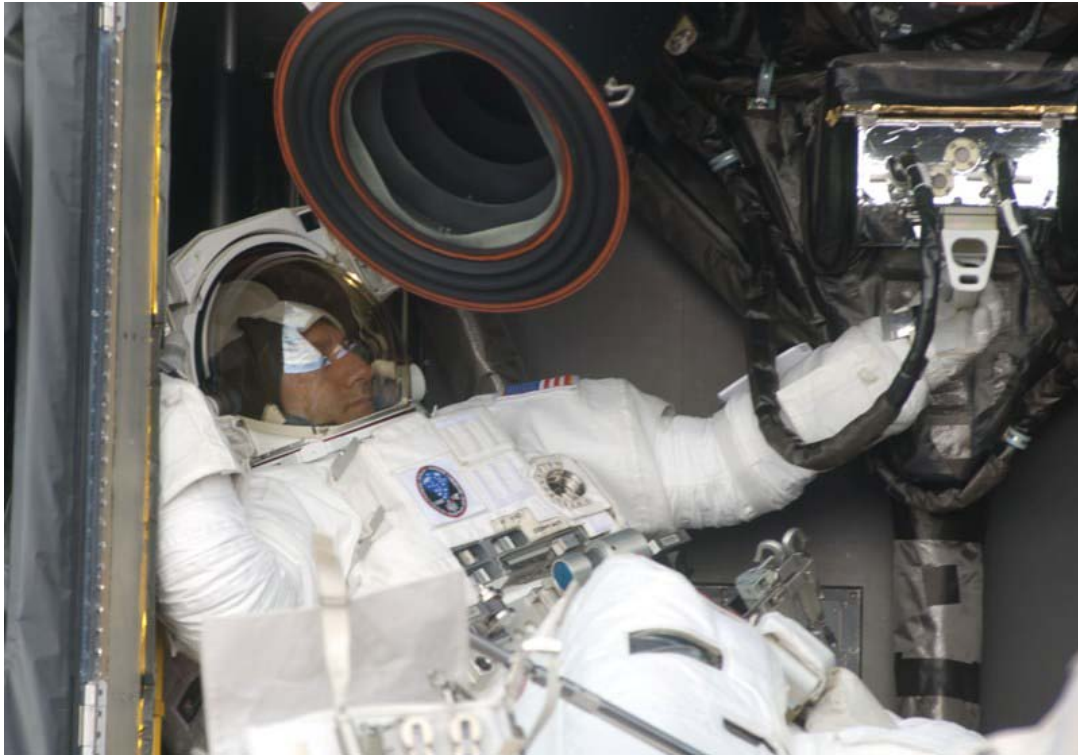
Figure 19 STS-125 Massimino inside HST to remove/replace the Reaction Wheel Assembly (confirm right pic)

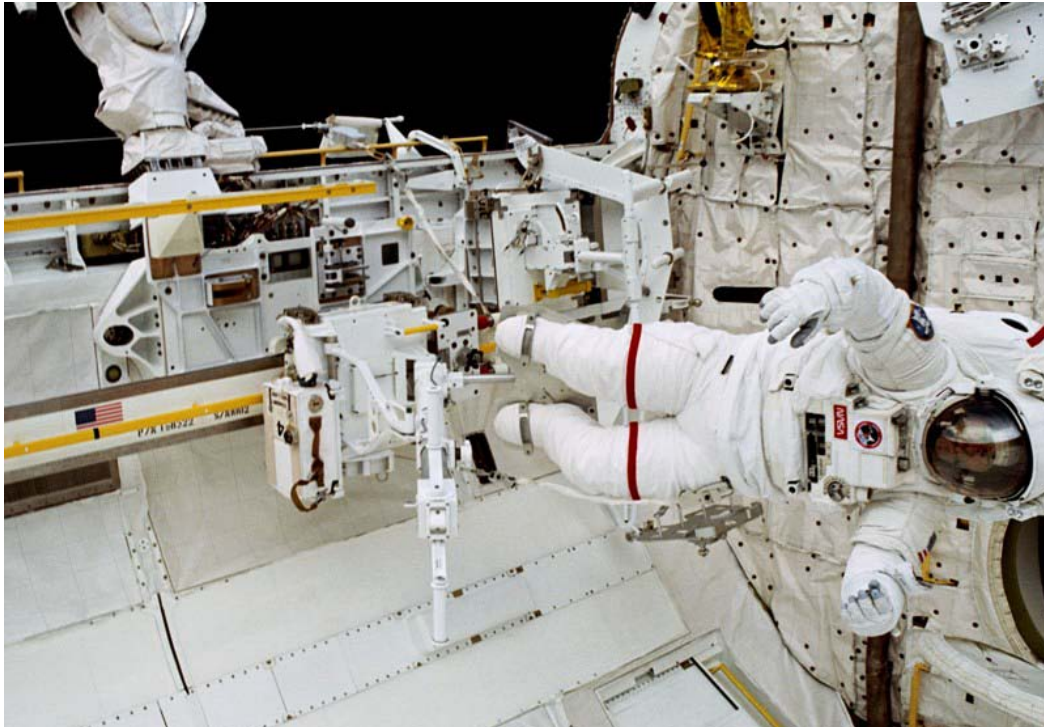
Figure 23 STS-37 Evaluation of Crew and Equipment Translation Aids (CETA)

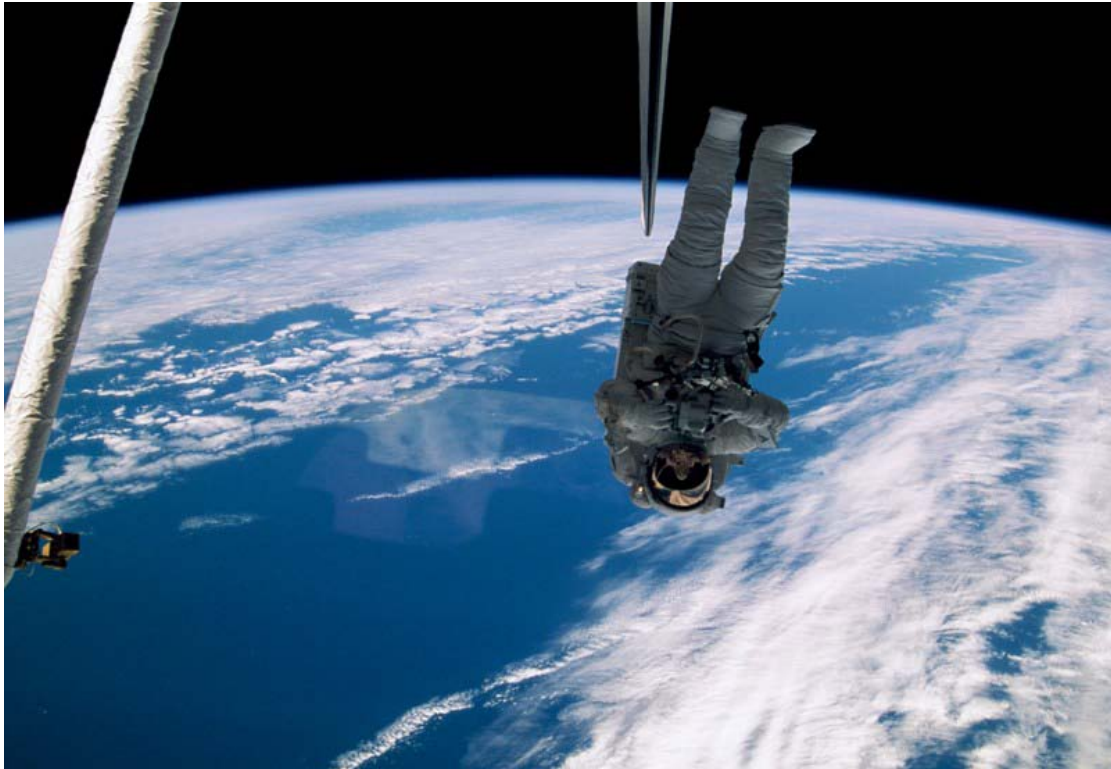
Figure 24STS-64L Detailed Test Objective (DTO) evaluating EVA SAFER

Engineers devised a contingency rescue propulsion system, called the Simplified Aid For EVA Rescue (SAFER), to address this problem. The SAFER integrates to the EMU Life Support System and provides a means for the crewmember to self-rescue should they become untethered from ISS.

The SAFER utilizes technology and capabilities from the MMU, but packaged in a smaller size so that it doesn't interfere with normal EVA hand translations, worksite operations, or airlock egress and ingress. The crewmember 'flies' the SAFER using a hand controller, which provides stabilization feedback. The SAFER uses compressed

nitrogen gas as a propellant and employs gyroscopic sensors to determine crewmember's attitude.

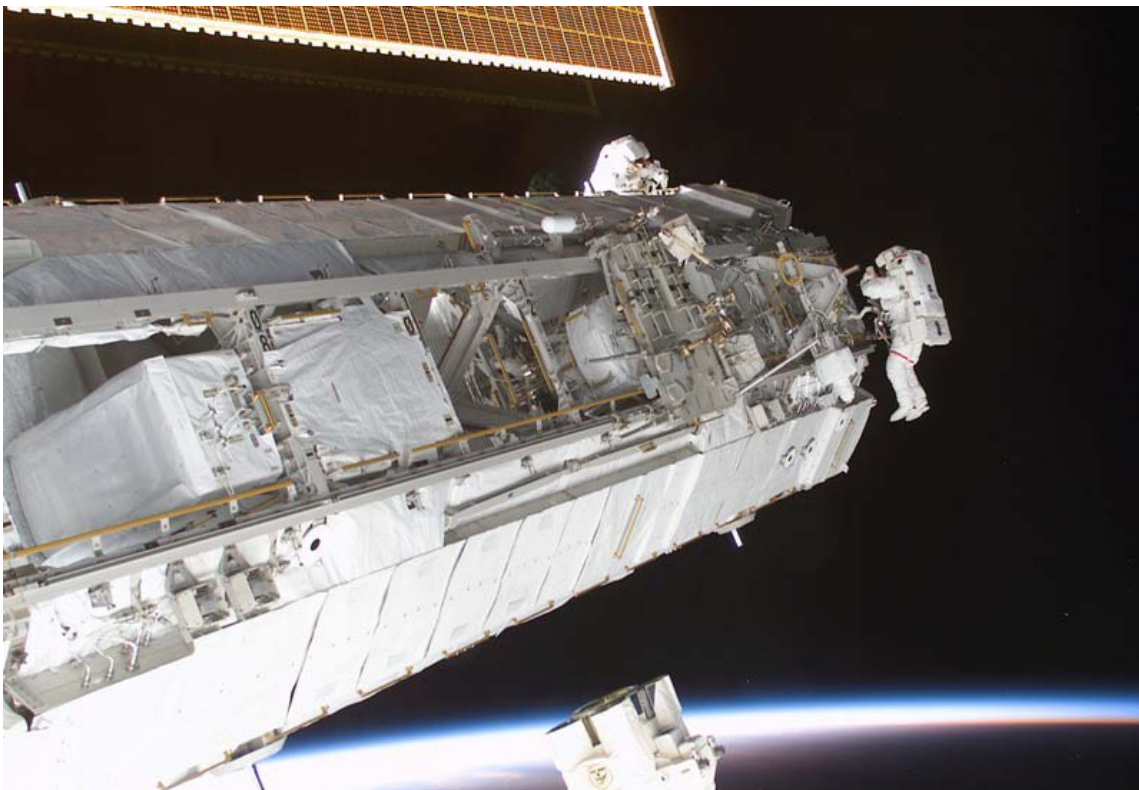
Figure 27 STS-113 EVA Crew completes assembly tasks for ISS Truss Segment P1

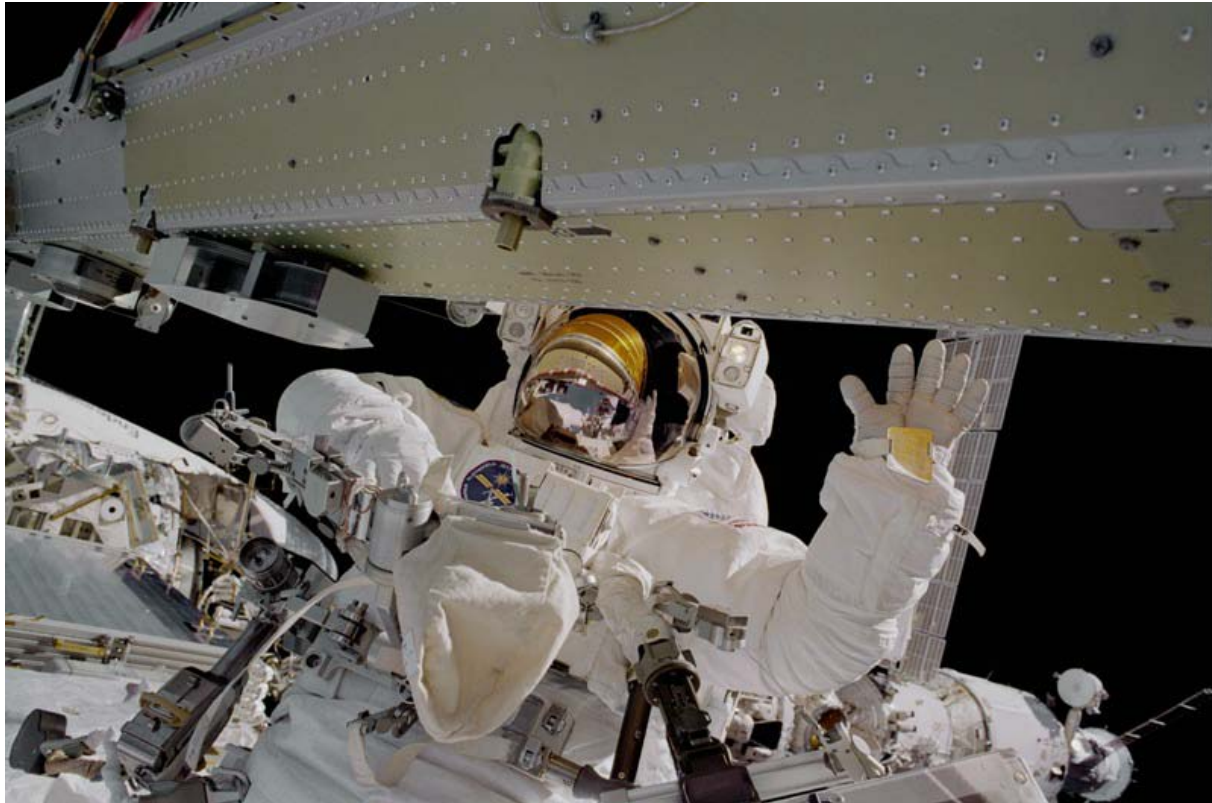
Figure 31 STS-97 Re-positioning of tensioning wire onto pulley of P6 Solar Array Wing (SAW) Blanket Box

Shuttle crews also performed a significant amount of work maintaining and repairing ISS. In December 2000 during STS-97, the EVA crew inspected and repaired an ISS solar array tensioning mechanism that failed during the array's deployment. The crew adapted EVA Contingency Tools from aboard the Shuttle for the EVA, as no suitable equipment was available on ISS for the repair. This repair is one of the many examples of the value of having an adaptable EVA capability on orbit for times when tasks that no one envisioned have to be performed using techniques no one knew to develop.

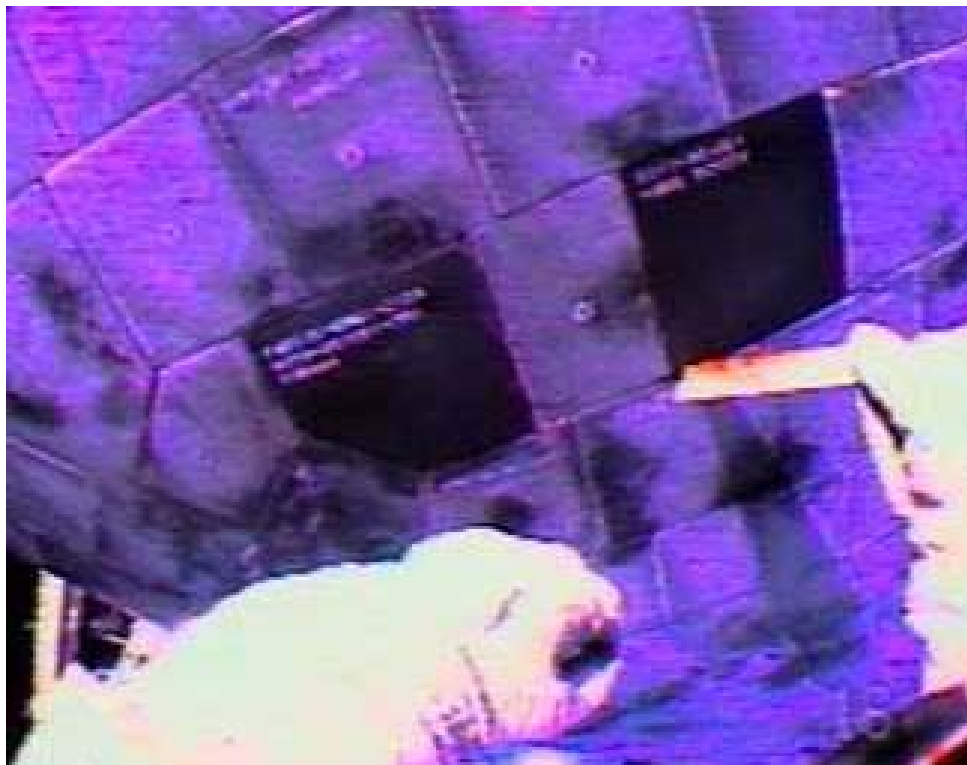
Figure 33 STS-114 EVA Gloved-hand removal of Gap Filler between heat shield tiles (Helmet-cam view)

Following the Columbia Tragedy, NASA aggressively pursued an EVA capability to assess and repair damages to the Orbiter Thermal Protection System (TPS), including the Reinforced Carbon-Carbon (RCC) leading edge sections on the wings, the thermal tile heat shields, and blanket sections. EVA repair capability of the TPS and RCC was critical to NASA's Return To Flight effort. Without the assurance that EVA repair was possible, the Shuttle might not have flown again. The Space Shuttle TPS was inspected and repaired on two separate missions. On STS-114 in August 2005, flight controllers noticed protruding gap fillers on the forward belly of the Orbiter during the TPS inspection. A Shuttle EVA crewmember rode the Space Station Remote Manipulator System (SSRMS) to the worksite on the Orbiter to remove the questionable gap filler. On STS-117 in June 2007, EVA repairs were required for a torn and peeled thermal blanket on the port Orbital Maneuvering System pod.

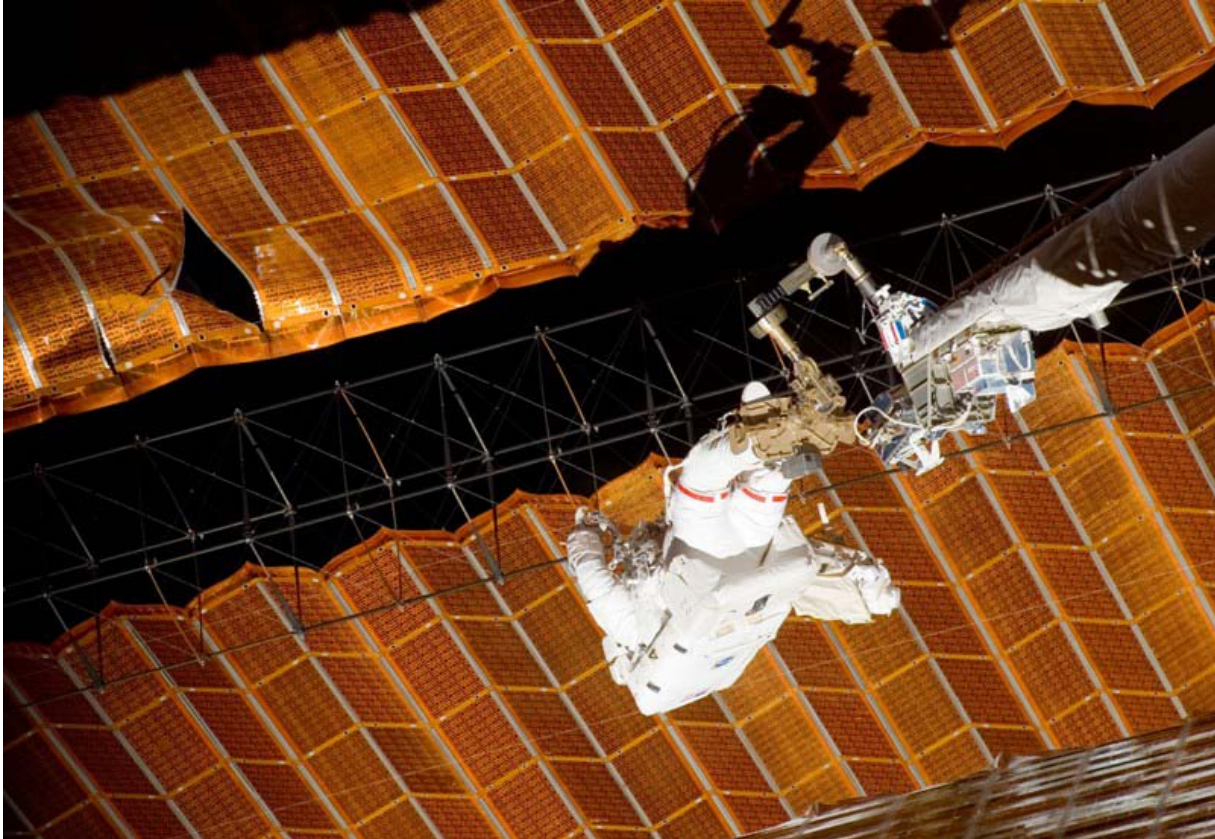
Figure 35 STS-120 Parazynski on OBSS maneuvered to position to repair torn Solar Array Blanket with improvised Cuff-links

During STS-111, the wrist joint on the SSRMS was replaced. During STS-114, both a Control Moment Gyroscope and a Global Positioning System antenna were replaced. In November 2007 during STS-120, EVA crewmembers inspected, repaired and supported the redeployment of the ISS solar array. In November 2008, during STS-126, more maintenance work was performed on the ISS power generation system when the EVA crew spent four EVAs to clean debris, lubricate the solar array race ring and replace the trundle bearing of the ISS Solar Array Rotary Joints.

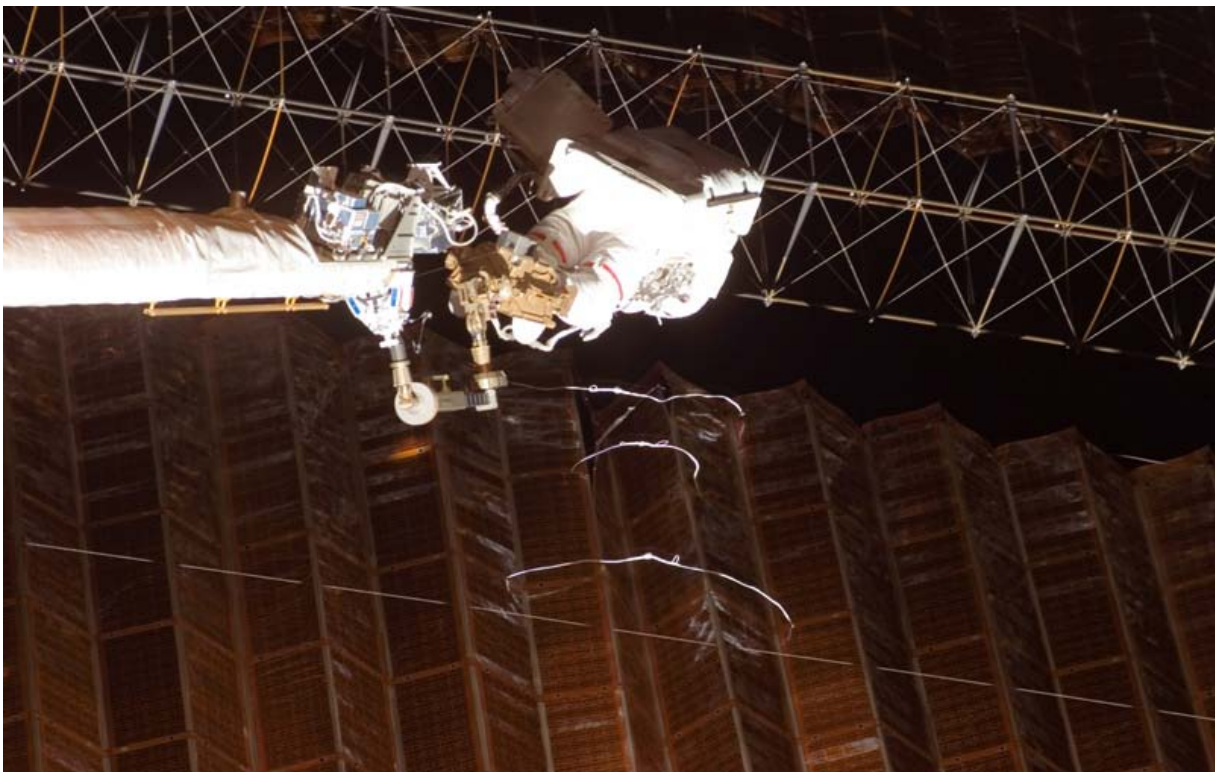
Figure 36 STS-120 Cuff-links installed prior to Solar Array tensioning

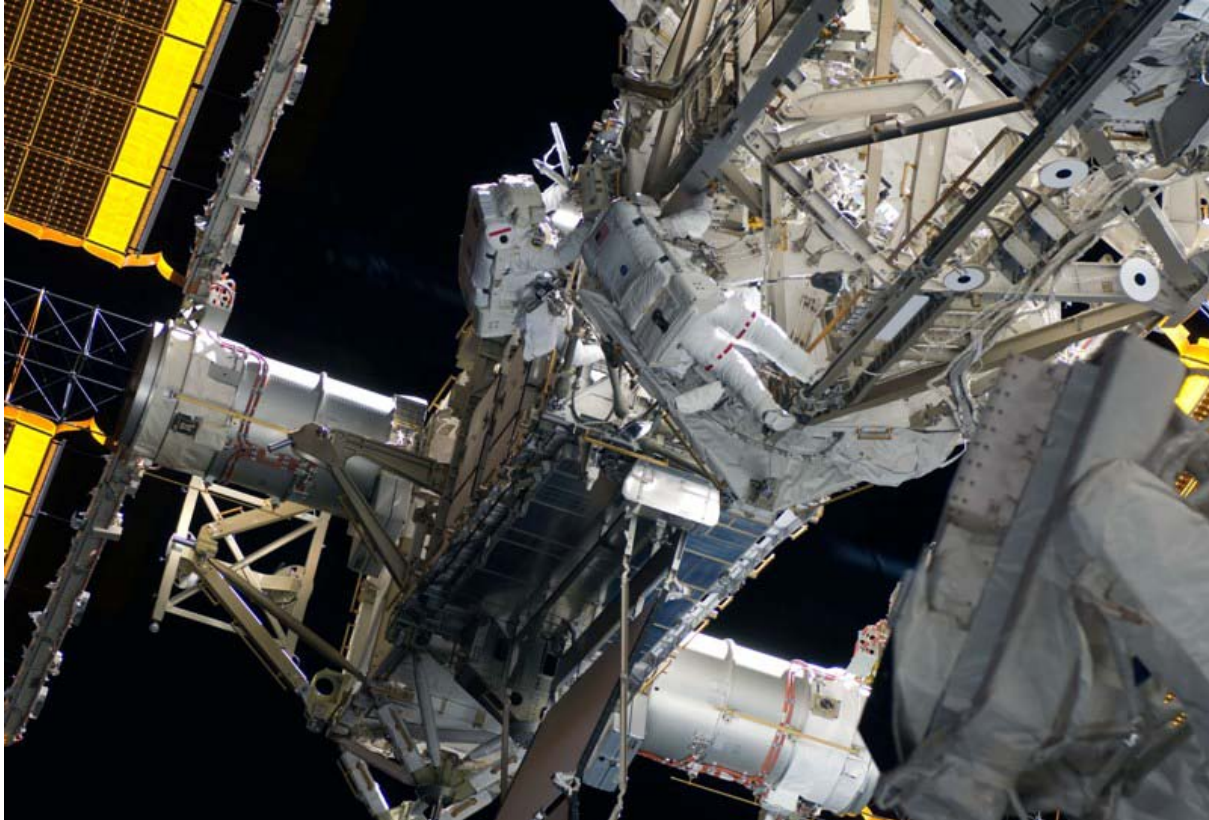
Figure 37 STS-126 EVA Crew prepares Solar Alpha Rotary Joint (SARJ) for application of lubrication on race-ring bearing surfaces
