AIAA Conference, Shuttle Legacy Track
Long Beach, CA
September 2011

Abstract – Structures and Mechanisms

Space Shuttle Orbiter Structures & Mechanisms

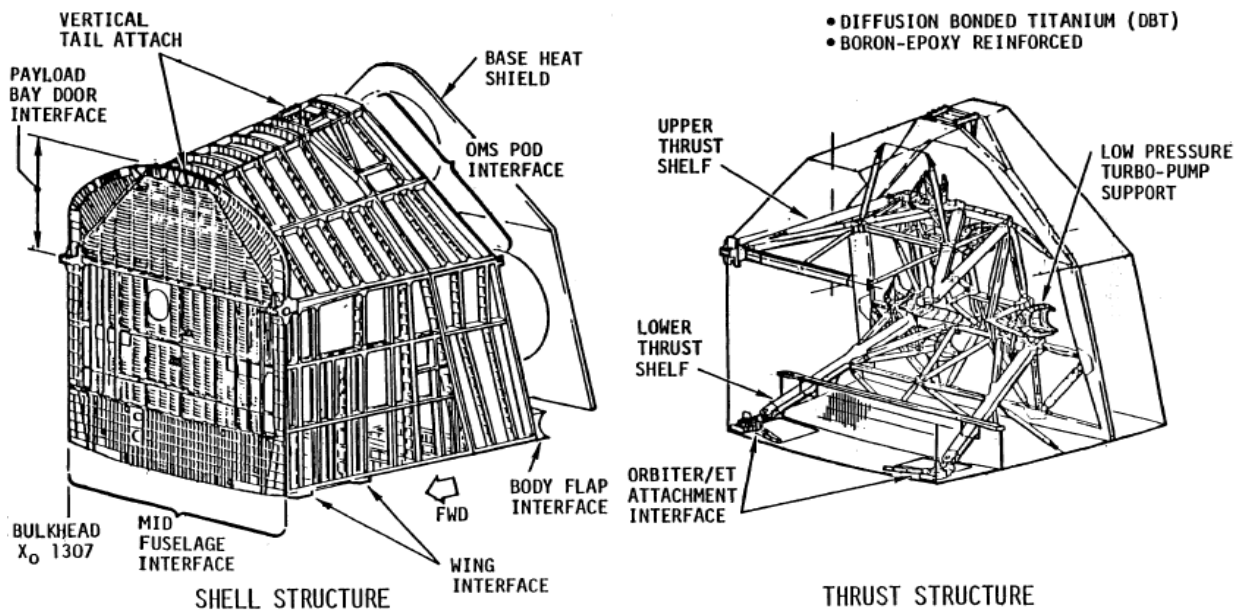
The aft fuselage consists of an outer shell, an internal truss-type thrust structure, and secondary structure for systems attachment. It interfaces with the structure of the mid fuselage, payload bay doors, wings, vertical tail, body flap, and Orbiter maneuvering system pods.

The ET aft attachments are located on the bottom of the aft fuselage. The outer shell is composed of integrally stiffened, machined aluminum skins attached to frames. The forward bulkhead functions as the aft wall of the payload bay, forms part of the wing carry through structure, and provides the forward attach point for the vertical tail. The vertical side walls provide attachment for the aft portion of the wing at the $X_o=1365$ bulkhead, an interface for the T-0 umbilical (connection that releases as the launch countdown clock reaches zero), and include a door on each side for access to the compartment. The upper portions of the aft fuselage are inclined toward the centerline and provide a mounting surface for the OMS Pods. A horizontal upper deck provides for the aft attachment of the vertical tail. The floor of the aft fuselage provides attach points for the external tank structure along with the associated fuel lines and electrical interface on the forward end, and the attachment of the body flap on the aft end. Two machined doors close over the ET attach points after the ET has been jettisoned. The base heat shield forms the rear most wall of the aft fuselage. The base heat shield interfaces

Figure 2-7. Aft Fuselage.

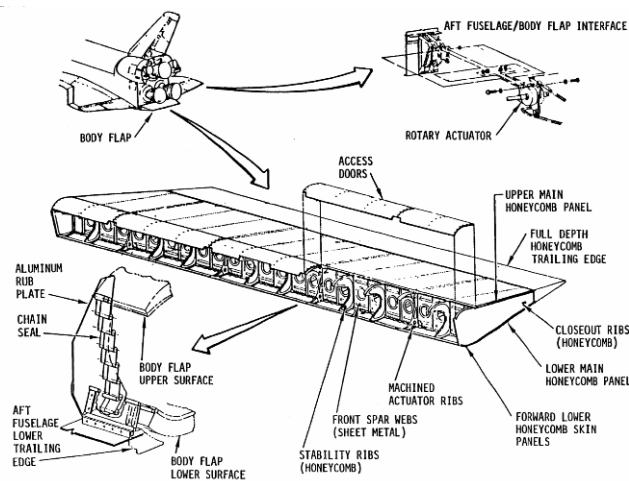
Figure 2-9. Body Flap.

The body flap is attached to the lower aft edge of the aft fuselage. It provides protection for the shuttle main engine bells and helps provides pitch control for the Orbiter during atmospheric flight.

The forward portion of the body flap consists of an aluminum leading edge main spar, four machined aluminum actuator ribs, eight aluminum honeycomb stability ribs, two aluminum honeycomb end closeout ribs, and aluminum honeycomb upper and lower skin panels. The aft portion consists of a full depth aluminum honeycomb trailing edge with the forward closeout skin and piano hinge angle caps forming the rear spar. The forward portion is attached to the aft portion with piano hinges on the upper and lower surface. An articulated pressure and thermal barrier is provided to protect the main spar from excessive heating. Venting and drainage is provided via drain lines which penetrate the trailing edge honeycomb.

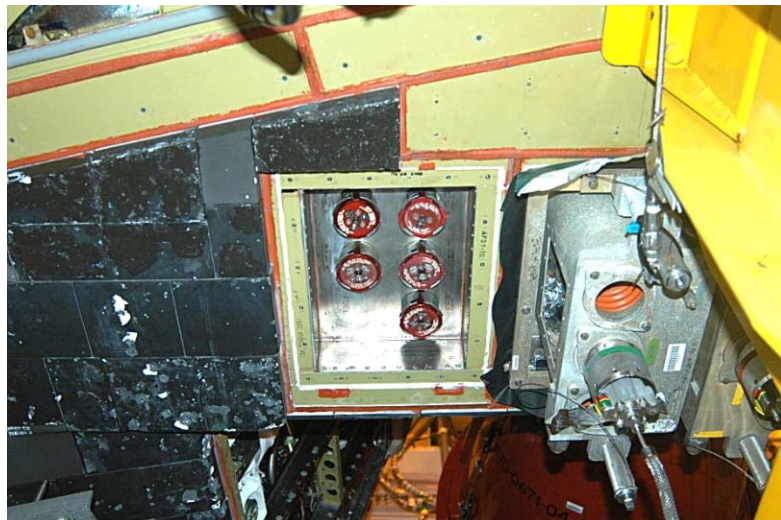
Figure 4-1. Typical Propellant Servicing Opening & GSE Scupper Installation.
Fastener receptacles for Door Installation are Inaccessible for R&R

The main design feature that drove most of these issues revolved around the use of a servicing panel/ servicing well at each of the propellant servicing openings. The servicing well was installed behind the propellant ports and closed out the external opening so that none of the hazardous commodities could propagate into the interior vehicle compartments. The unwanted side effect of this design is that the servicing well also closed out the access to the receptacles used for the servicing door installation. Thus if a receptacle failed, the only available access to remove and replace it was through the interior of the vehicle which required significant internal access and does not lend itself to a launch pad/ vertical operations event timeline. A better solution would have been to keep the receptacles

on the external side of the servicing well/ pan so that they could be replaced externally from the same area. Also many times when a failed fastener receptacle needed to be replaced it required replacing the entire receptacle (drilling out and installing new rivets). A better solution is to use replaceable nut element receptacles, if available for the particular fastening system, wherever high cycle or late installation of access doors occurs.

- 1. Design fastening systems using a screw and nut, so they can be readily replaced externally directly at the access opening.*
- 2. Use replaceable "high re-use" nut elements in receptacles.*
- 3. Use a locking device that is located on the fastener side instead of within the receptacle.*
- 4. Design-in dedicated GSE attach points for ground servicing attachments.*
- 5. Use Guide Pins to maintain alignment during fastener installations.*

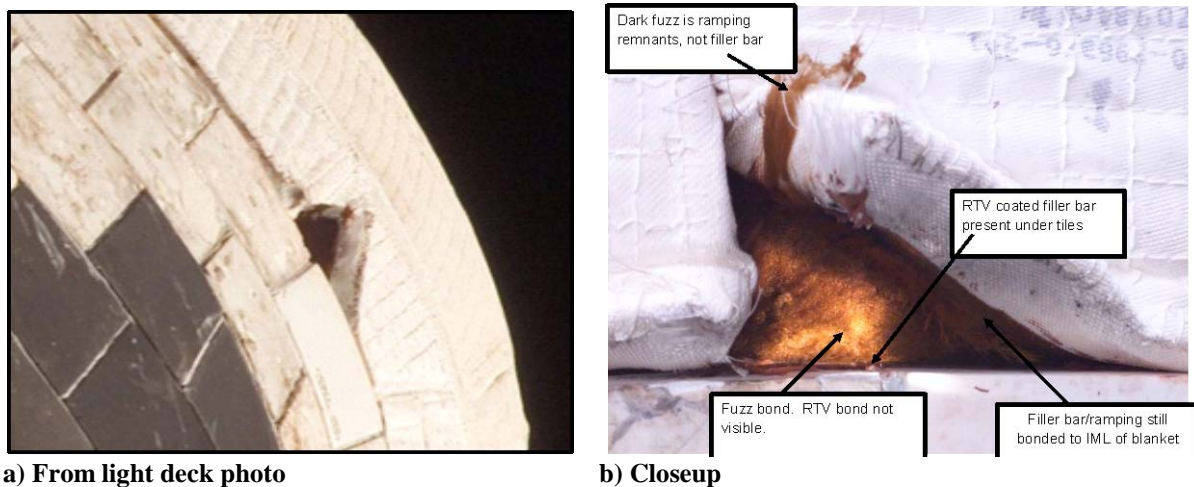
During the first day of the STS-117 mission, astronauts on the flight deck observed that a thermal protection blanket was lifted from its original position on the OMS pod. Thermal blankets are used to protect structure from high ascent and re-entry heating in locations where temperatures will not be as great as the wing leading edge or the Orbiter underbelly. Even though having a blanket for thermal protection in this area might imply that this damage would not be a high concern (blankets are typically used in areas of the vehicle subjected to lower temperatures than those covered with the high temperature tiles or reinforced carbon-carbon), account must be taken of the underlying structure’s sensitivity to thermal loads. In addition, the nearby black tiles transitioning to white tiles transitioning to the blanket indicates a large gradient in aeroheating, and the lifted blanket would change the aeroheating around it. (Figure 4-3a)

Figure 4-3. STS-117 Damaged Blanket on OMS Pod.

The structure underlying the damaged area is graphite epoxy, honeycomb composite. A critical failure mode for material under elevated temperature is honeycomb core burst. High temperatures can cause pressure in the cells to rise, eventually bursting the graphite epoxy facesheets off of the honeycomb. The pressure at which burst can occur for nominal conditions was determined by testing, and is a function of core humidity, mechanical loading and temperature. At the predicted core humidity, development testing allowed for a core pressure of 35.7 psi at temperatures up to 250° F. Using the limited data available for off-nominal conditions, conservative real time analysis set the average core temperature limit at 262° F. During the mission, limited additional testing showed that the graphite epoxy itself begins to degrade at approximately 400° F.

epoxy facesheet, with the 1.5" high blanket protuberance increasing the local aeroheating, temperatures reaching ~900° F were predicted. If .5" of sub-insulation was retained on the facesheet, then temperatures could reach ~400° F. Given that both of these temperatures exceed the limit of 262° F, an astronaut performed a repair of the damaged blanket during an extra vehicular activity (EVA) (Figure 4-4).

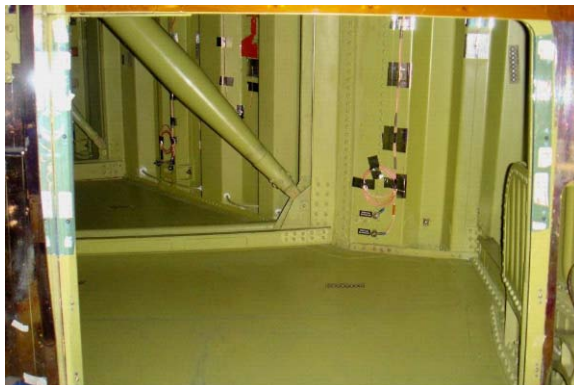
traffic. Both the thin walled aluminum wing struts and the honeycomb panels received significant repair activity over the life of the program. The Space Shuttle also used lightweight thin face sheet aluminum honeycomb panels to house the avionics compartments/ bays. The avionics boxes were frequently removed for testing and evaluation and also saw a high percentage of personnel traffic. Despite the use of GSE to support the weight of the boxes and protective covers, these compartments still received a large number of damages. Even though these structural components were not part of the primary load path, damage to this type of sensitive hardware needs to be repaired so that propagation of an initial defect cannot lead to a more serious damage event. This problem was significantly mitigated on the Space Shuttle program by installing thick aluminum doublers over the thin honeycomb panel face sheets to provide a more robust surface that was less susceptible to damage.

Figure 5-3. Main Ingress/ Egress into the Space Shuttle Wing Compartment.

Lower surface is thin aluminum honeycomb face sheet with thin walled struts in close proximity.

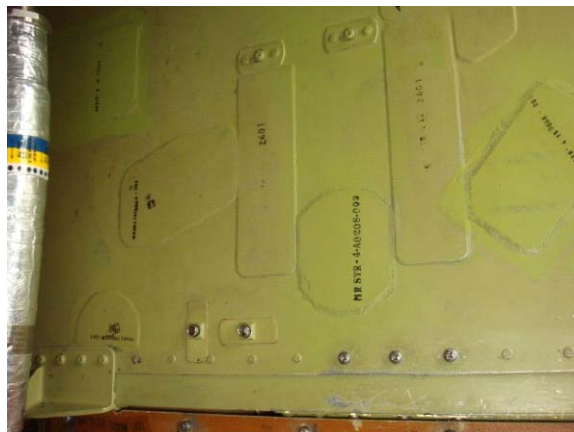
Figure 5-4. Typical Avionics Bay Honeycomb Panel Damages.

Thin face sheet was easily damaged by high traffic and required repairs.
