## ***Long-Term International Space Station (ISS) Risk Reduction Activities***

### **ABSTRACT**

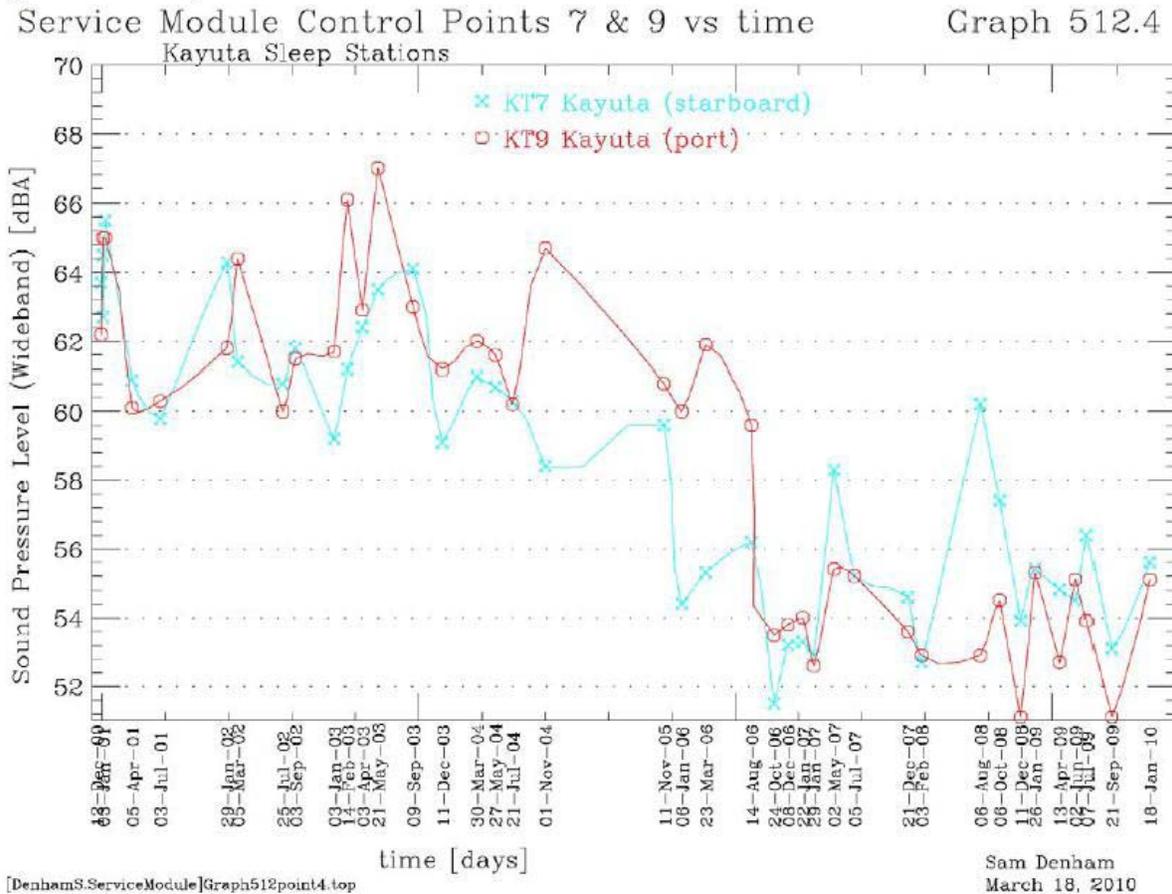
(Contract Goal = 50 dBA)

Acoustic sampling is performed over a wide range of locations in both the US, IP, and Russian Segments of the ISS, and these charts represent only a sample. But note the significant reductions achieved over time, particularly in the Russian Segment. USOS and IP elements have achieved full compliance in many areas, and Russian designers are clearly on track to meet their design goals. The graphs above represent over ten years of efforts to bring the ISS acoustic environment into compliance with initial design requirements, and indicate that we are on a path to success. But more importantly, no reports have been made of any crewmember hearing deficits, either short-term or long term. While 100% compliance with the NC-50 criteria has not yet been achieved, significant progress has been made toward preserving crew health.

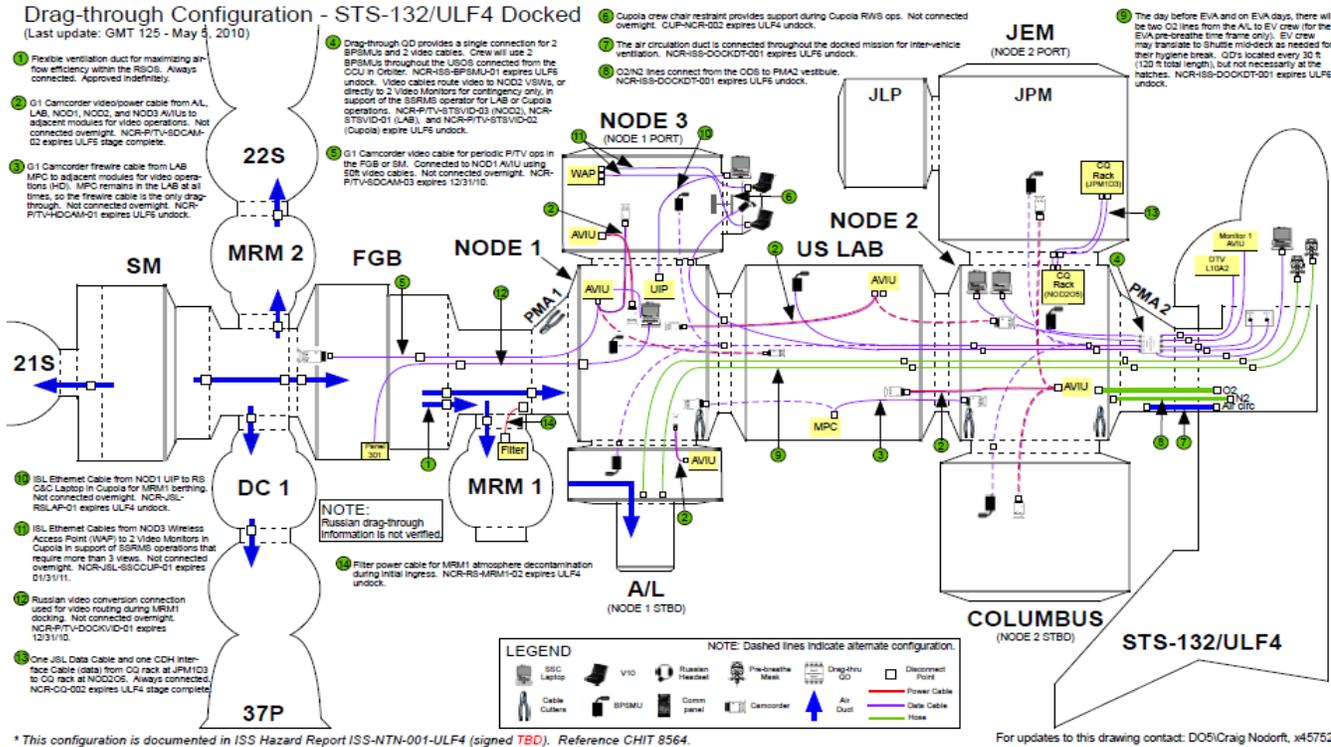
Figure 3

During operations aboard the ISS until 2009, it was common practice to allow the use of drag-throughs, that is to say, equipment which required cables, hoses, or wiring to cross the threshold of an ISS hatch. Cameras, speakers, ducts, hoses, microphones, computers, lights, and many other devices required the use of drag-throughs. Shuttle missions required extensive use of drag-throughs, especially through the Pressurized Mating Adaptor-2 to Orbiter Docking Assembly hatch. At times there were up to seven drag-throughs penetrating a single hatch. (See figure 3). The Program requirement is that a hatch must be able to be closed and latched in three minutes. Many drag through's could be easily dragged back through a hatch. Some provided quick disconnects on both sides of the hatch interface. Some required the use of cutters, which were to be kept near the hatch. And while the Program felt that the three-minute requirement could still be met, the Program manager became uncomfortable with the proliferation of drag-throughs. The major concern was that during an emergency involving a depressurization event, a toxic spill, or a fire, cutting, disconnecting, or otherwise clearing these hatches could prove problematic. In these less than ideal circumstances we might well violate our three-minute rule. So at the Program Risk Assessment Board in February 2009, Mr. Suffredini gave an action to implement a "no drag-through requirement" and to identify ways to eliminate the current drag-throughs on ISS. Since then, the number of drag-throughs has dropped. Every drag-through now requires an NCR, and those are reviewed thoroughly to assure that there is no other possible means of accomplishing the desired function. There are still drag-throughs on the ISS, but the Program manager has effectively halted their proliferation, and biased designers toward looking for solutions that do not require the violation of hatch interfaces.

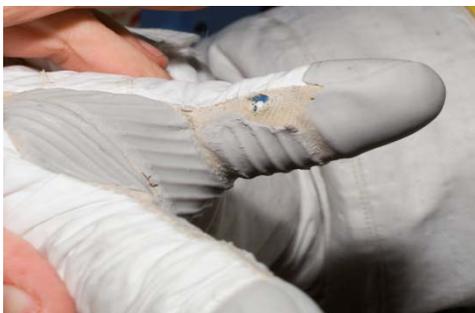
Prior to STS-120/ Flight 10A, there was a rapidly developing concern with respect to out-of-family EVA glove damage observed post-EVA (Figure 1). The concern was of catastrophic significance, as a through-hole in the EVA glove beyond a specific dimensional threshold would result in loss of crew. In some cases, the observed damage had been above or right at the threshold of catastrophic concern, but the damage had always been isolated to the outermost protective layer. The damage never penetrated deep enough to pierce the thin, sensitive pressure bladder layer located just inside the repetitively damaged outermost protective layer, and therefore no leaks to the pressurized suit system had been experienced. At the time, large uncertainties existed as to the possible proximate causes for the glove damage. Open fault tree items ranged from glove workmanship issues to MMOD induced sharp edges on ISS.

Figure 1: STS-120/10A, Right Glove

With heightened priority, a series of glove modification options were rigorously tested and evaluated. The EVA Project Office settled on the addition of a layer of tough “Turtle Skin” material to the affected gripping region of the EVA glove. The recognition of a negative safety risk trend (despite many years of successful performance) and the subsequent effort to provide a more robust EVA glove greatly improved the safety risk posture for all US EVAs. To date, no additional cuts or glove damage have been noted post EVA.

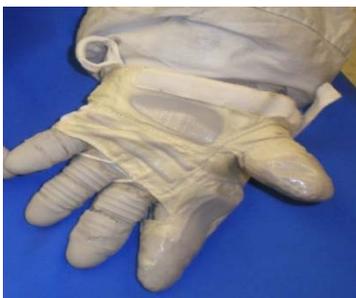
An “overglove” concept (Figure 2), basically a protective mitt worn over the existing EVA gloves, was prototyped on a highly accelerated schedule in an attempt to support the quickest possible manifesting for interim risk reduction. The overgloves intuitively added an additional layer of cut protection, but the crew had not been appropriately trained to use them... and there were several other concerns with respect to the cumbersomeness of their use. However, the overgloves were used successfully over several EVAs while a more extensive and permanent EVA glove modification was completed.

Figure 2: Overglove shown installed on glove
