# Examination of Relationship Between Photonic Signatures and Fracture Strength of Fused Silica Used in Orbiter Windows

NASA/TP-2011-217322

A commercially available grey-field polariscope (GFP) instrument for photoelastic examination is used to assess impact damage inflicted upon the outer-most pane of the orbiter windows. Four categories of damage: hyper-velocity impacts that occur during space-flight (HVI); hypervelocity impacts artificially made at the Hypervelocity Impact Technology Facility (HIT-F); impacts made by larger objects falling onto the pane surface to simulate dropped items on the window during service/storage of vehicle (Bruises); and light scratches from dull objects designed to mimic those that might occur by dragging a dull object across the glass surface (Chatter Checks) are examined. The damage sites are cored from fused silica window carcasses, examined with the GFP and other methodologies, and broken using the ASTM Standard C1499-09 to measure the fracture strength. A correlation is made between the fracture strength and damage-site measurements including geometrical measurements and GFP measurements of photoelastic retardation (stress patterns) surroundin

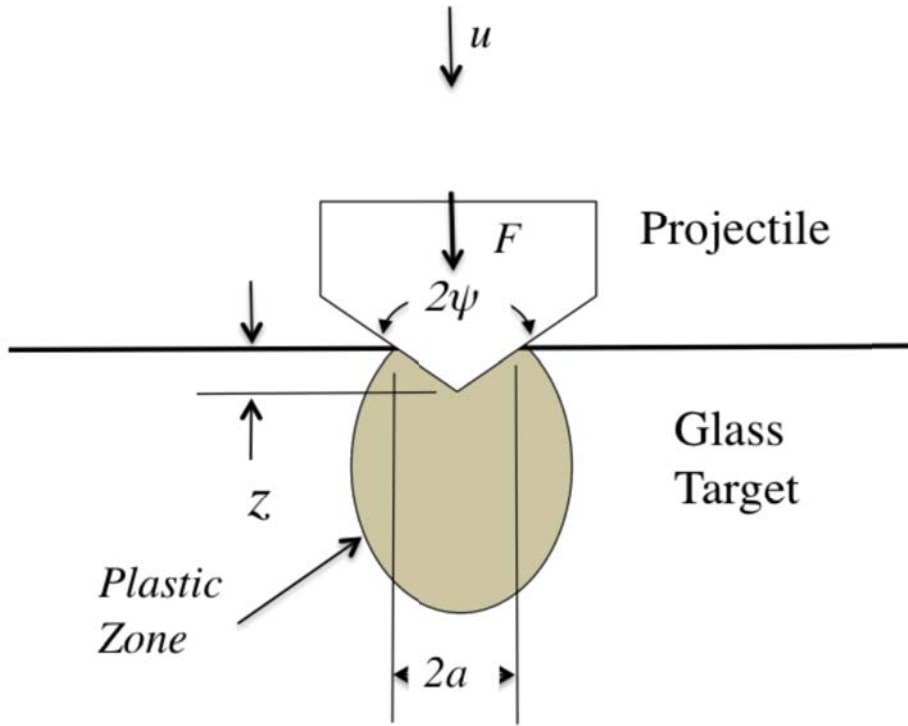
**Figure 1.** Diagram showing the projectile during collision with the glass target.

Following an approach presented in Reference 2, Figure 1 is a schematic diagram of an idealized damage infliction with coordinates shown. The projectile tip formed by an angle of  $2\psi$  penetrates a distance  $z$  into the glass surface. The penetration profile on the glass surface is circular with a radius  $a$ . The penetration causes the formation of the plastic zone in the glass ahead of the projectile, which is treated as an indenter.

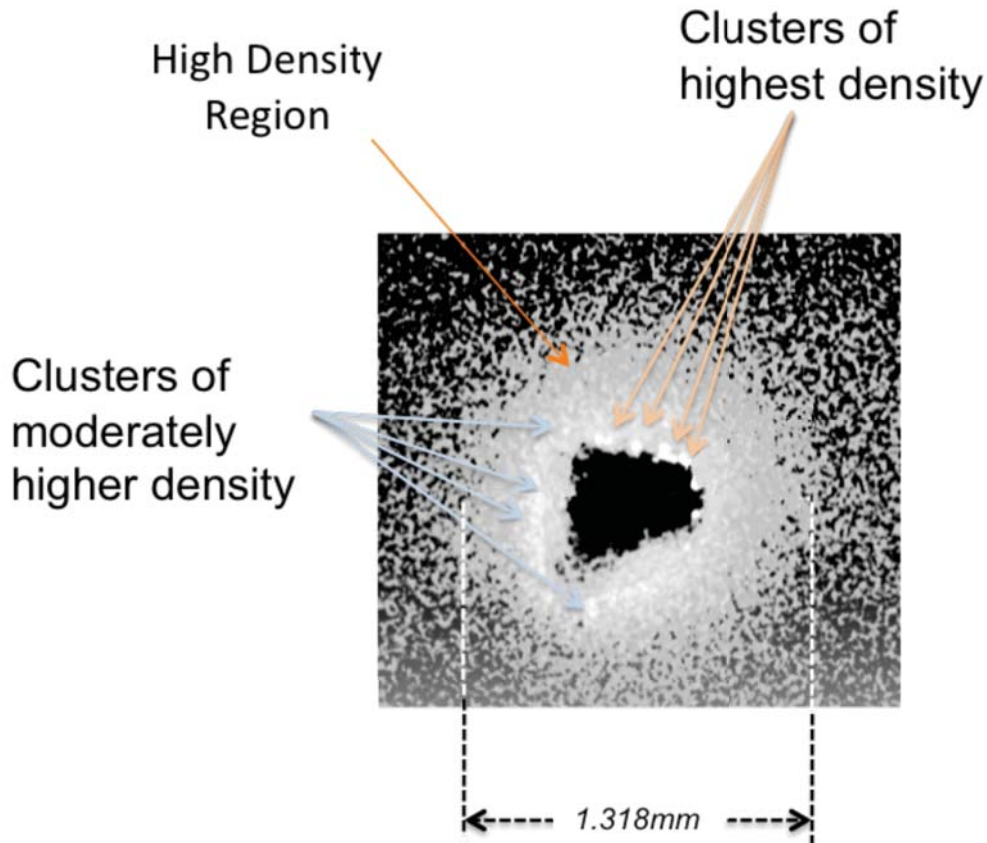
**Figure 2.** An X-Ray tomographic view (slice) of a damage site in shuttle glass specimen 27-165. Within the region of this slice are characteristics showing regions of differing density to x-ray transmission. It is thought that this slice shows a compressive stress field that surrounds the damage site.

Figure 2 is a slice of the x-ray computed tomographic image (negative presentation), which shows the damage in a plane within the fused silica shuttle glass specimen. In this presentation, lighter regions indicate more x-ray absorption, where darker regions indicate relatively less x-ray absorption. The slice shown is relatively close to the surface where some material has been knocked away, and thus leaves a void (black center). The region surrounding the black center extends a distance of 1.3 mm edge-to-edge (a factor of  $\sim 2.7$  larger than the void) and shows a higher density (indicated in the image by lighter shades and shading). Marked on the diagram are regions of various densities. Extending from the perimeter of the damage site outward into the material is a diffused increase in density over the background, thus possibly indicating a region of some strain.

A zone of demarcation is outlined by the slightly brighter regions marked by clusters of moderately higher density. Between the demarcation zone and the black interior are regions with clusters of highest density. This diagram is consistent with compressive stress fields surrounding the damage site.

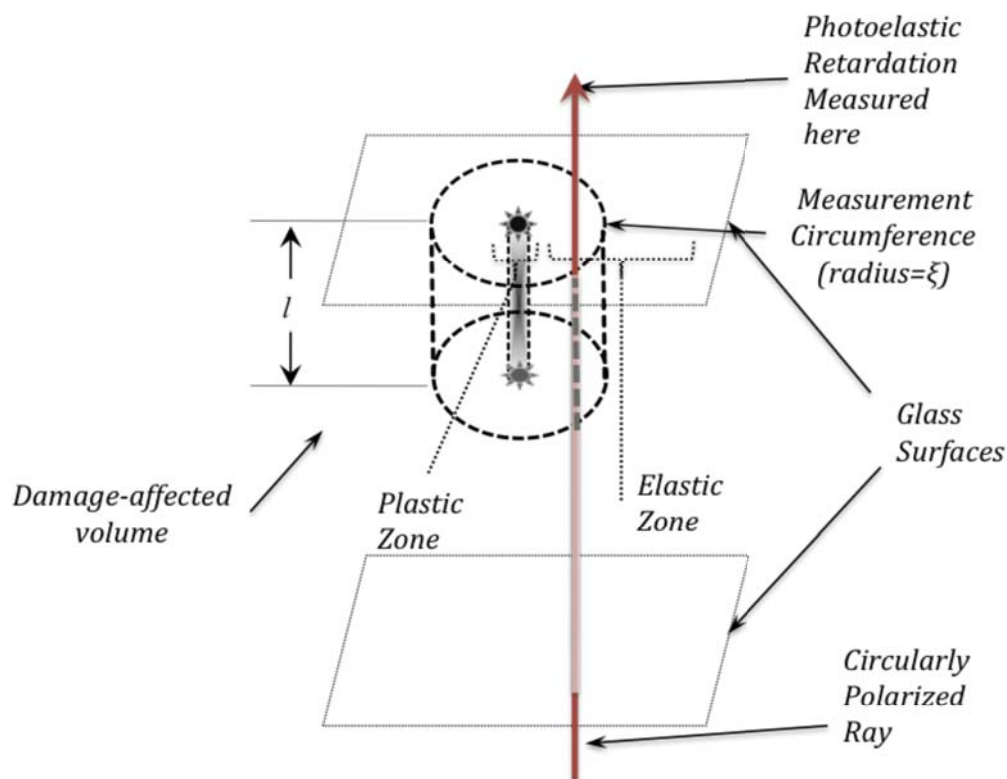
**Figure 4.** A schematic diagram of the elements to illustrate the technique for measuring the photoelastic retardation around a damage site in fused silica. The measurement is made in the elastic zone.

In the experimental design used to collect data for this paper, we kept the measurement radius constant and sufficiently large so that the circumference was always larger than the plastic damage zones<sup>31</sup> for all damage sites except chatter checks<sup>32</sup> Measurements of *PER* were taken and averaged around the measurement circumference, as shown in the diagram. The measurement technique was applied to damage sites of different damage classifications.

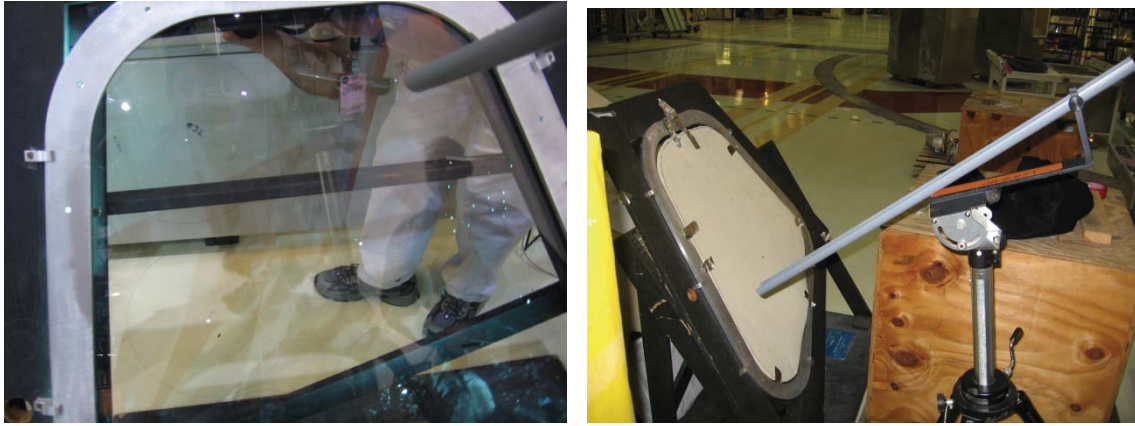
**Figure 5.** Experimental arrangement set-up for inflicting bruise damage on glass panes.

For the *Bruise* category, each specimen was damaged by dropping various sized metal bearings on the glass, causing low-speed (Hertzian) impacts to the pane surface. The bearing drop was controlled by rolling it down a metal channel with one end placed a prescribed distance from the surface of the glass. Various impact velocities (not measured or recorded) were obtained by placing the bearings at various distances up the channel for release. This category of damage is intended to simulate dropped items on the window during servicing of the vehicle.

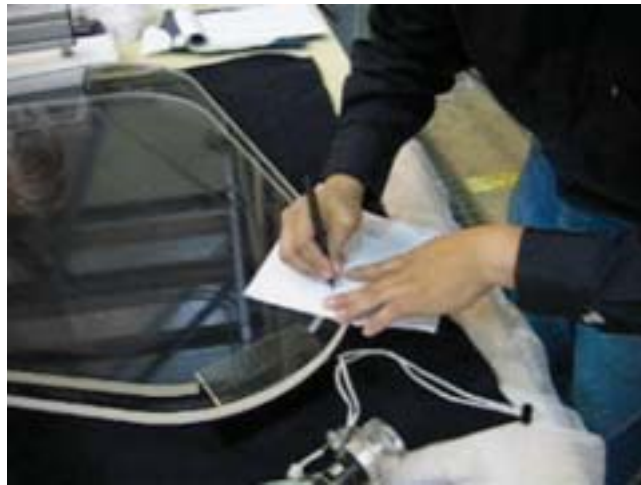
**Figure 6a.** Inflicting chatter check damage on a shuttle windowpane with a ball-point pen acting through a paper sheet on pane surface.

The last damage type, *Chatter Checks*, was formed by placing a sheet of paper on the glass and simply drawing a line on that sheet with a ball-point pen. The metal ball of the pen produced enough friction between the glass and paper to inflict remarkably consistent width chatter checks. The lengths of the chatter checks were varied, as this was (erroneously) thought to be the controlling feature for strength. The chatter check category simulates damage that might be inflicted during storage and preparation for flight. Of all the damage inflicted, the chatter check damage type appeared to cause the least damage.

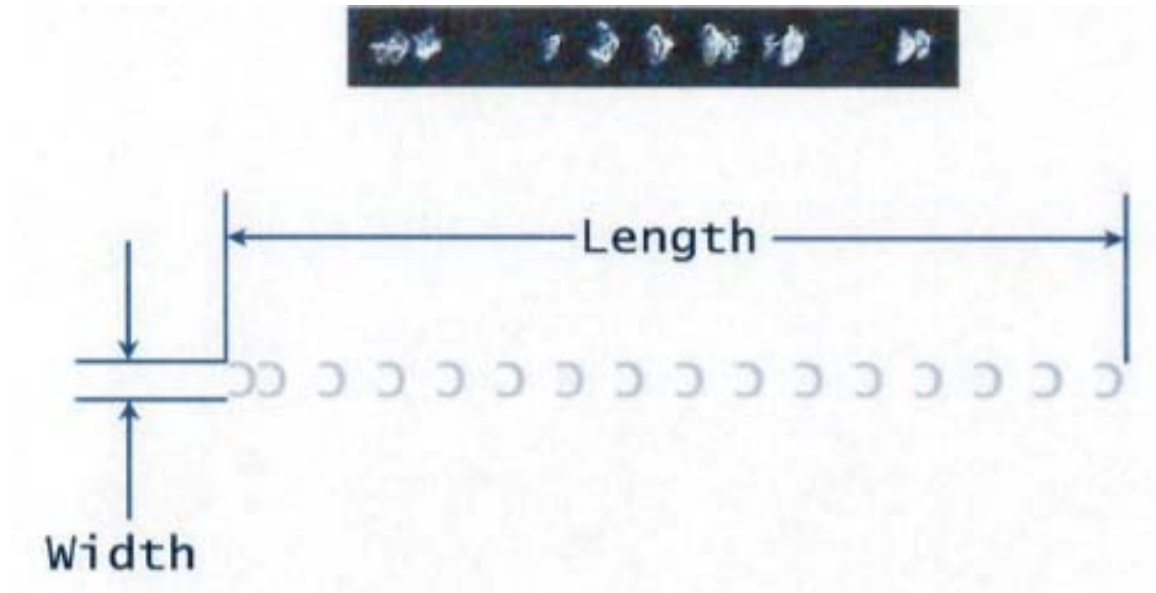
**Figure 6b**<sup>33</sup>. (Top) Photo showing chatter check damage inflicted in windowpane. (Bottom) Chatter Check measurement diagram.

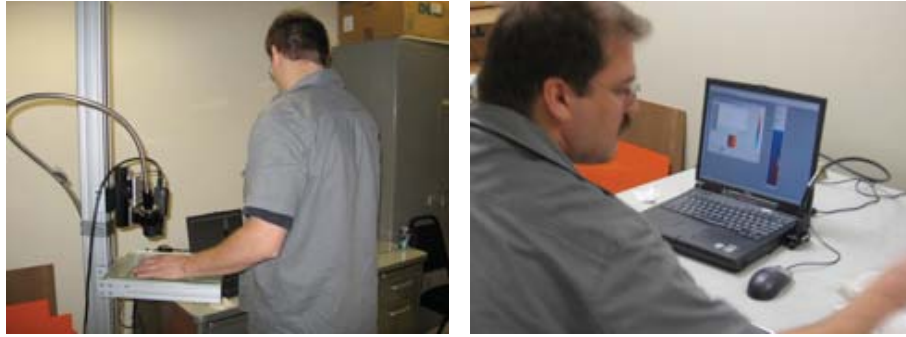
**Figure 7.** Engineer imaging and measuring *PER* at a damage site. A commercially available GFP with special software was used for these measurements.

Each damage site was measured using mold impressions and an optical micrometer, photographed, and imaged using the GFP device (Figure 7). The images were used to measure the *PER* amplitudes used in the stress analysis of regions surrounding the damage sites.

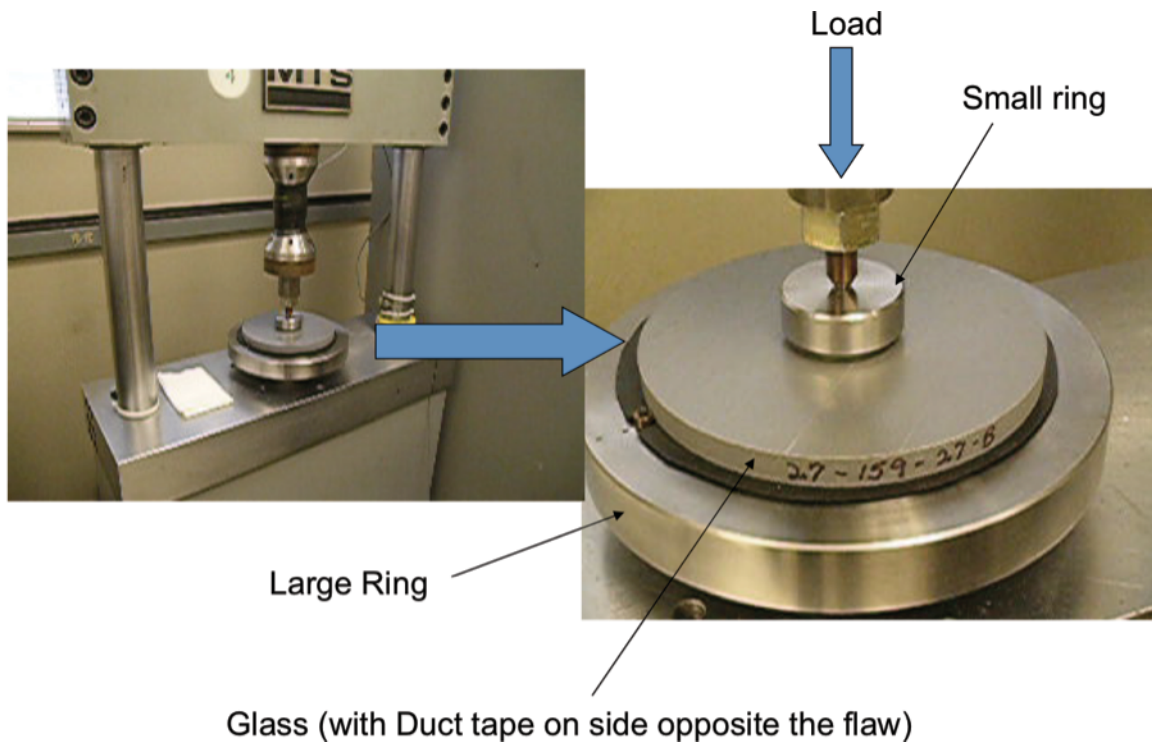
**Figure 8.** Ring-ring biaxial strength measurement of a specimen. In this figure the fracture strength of Specimen 27-159-27 (a Bruise specimen) is under measurement.

Once the bruises and chatter checks were inflicted on the windowpane carcasses, the panes were shipped to Southwest Research Institute for measurements of breakage strength. Similar to the HVI and HIT-F specimens, the damage sites were protected, and the cores were cut from the carcass with a water knife. During the cutting process, the diameters were controlled to meet the parameters outlined in ASTM1499-C.

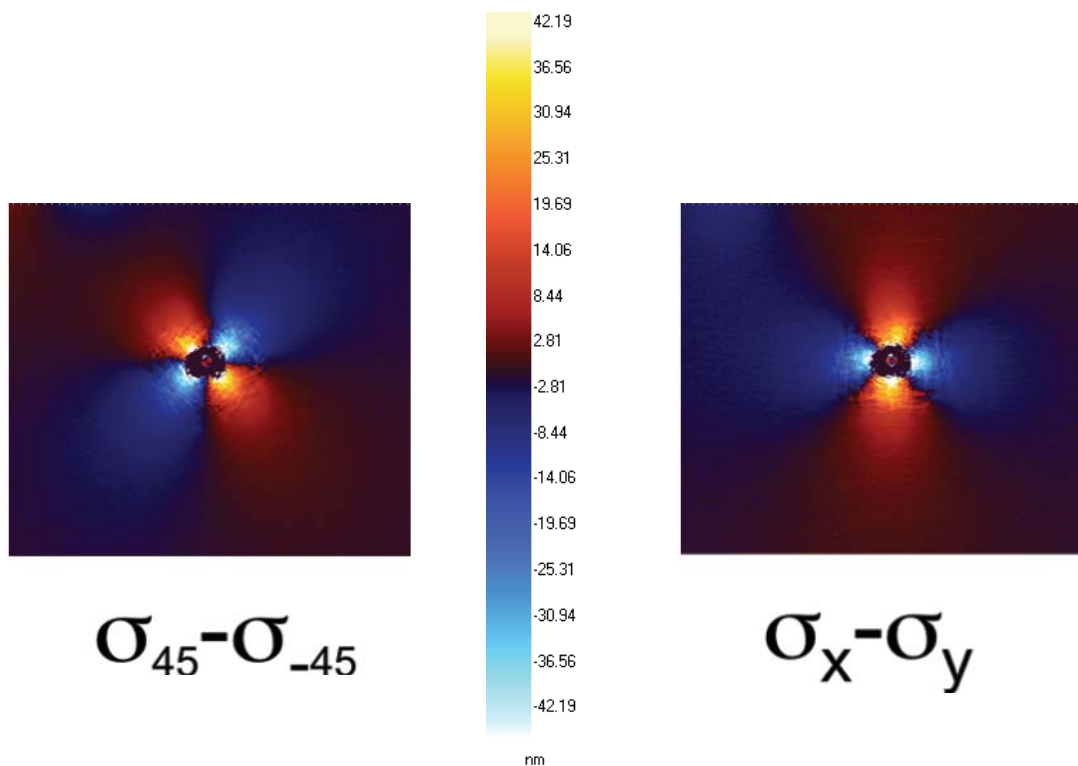
## HVI Specimen 27-135-1

**Figure 9.** Stress-field image of the damage site from high velocity impact damage occurring in space, Specimen HVI 27-135. In the center of the color images is the photoelastic retardation –to-color scale in nanometers.

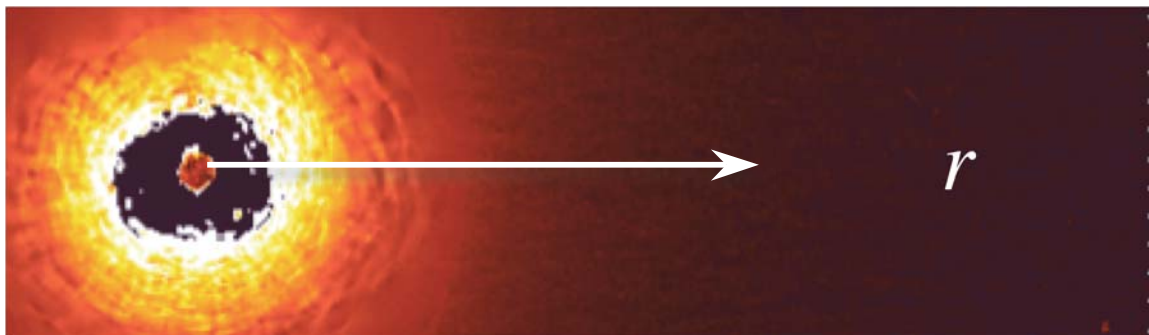
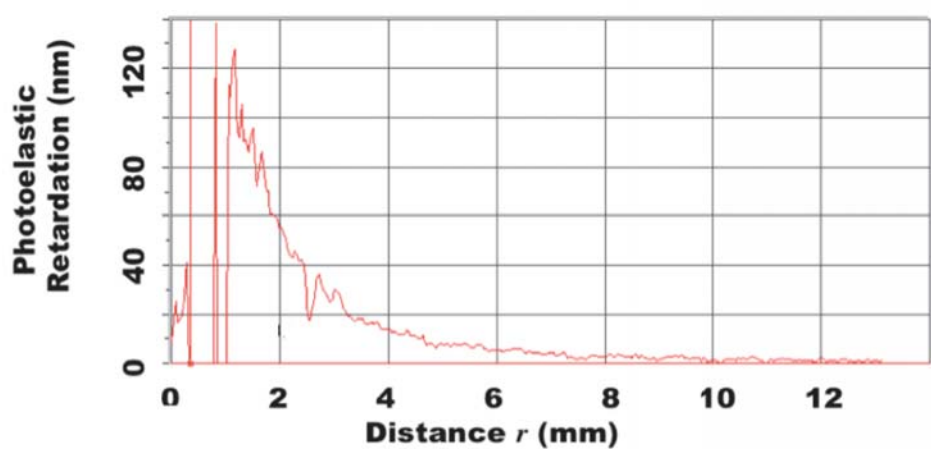
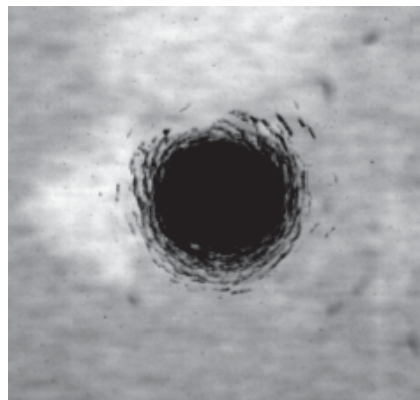
### HVI Specimen 27-135-1 Maximum in-plane shear ( $\sigma_1 - \sigma_2$ )

**Figure 10.** Photoelastic Retardation analysis for HVI Specimen 27-135-1 constructed from the data shown in Figure 9. Below graph is optical image of the damage site taken in circularly polarized light.

in Figure 10 (top), where the *PER* due to the total stress amplitude is shown as a function of  $r$ , the distance from the center of the damage site. One notices that the *PER* is largely radially symmetric with some structure that is azimuthally dependent. Within the image one also notices radially dependent structures of lower *PER* values that are formed. Beneath the image is a plot of the magnitude of the in-plane shear,  $\sigma_1 - \sigma_2$ , versus  $r$ . Based on the character of variations within the top image and the graph, one notices three zones in this diagram. In Zone 1, surrounding the impact site and extending out approximately 1.5 mm, we observe a center region where the *PER* is positive, followed by a region where *PER* is nearly zero. Within the near zero portion we see islands of large stress. Zone 2, [ $1.5 \text{ mm} < r < \sim 2.8 \text{ mm}$ ], is characterized by a mottled appearance, where we note concentric structures that appear to be separated by radial line segments, consistent with the generation of fields of edge dislocations where the extra planes are inserted radially outward from the impact site, and distributed throughout the damage zone. The appearance has a somewhat randomly appearing “clamshell” variation as indicated in the top of Figure 10. Zone 3, [ $r > 3 \text{ mm}$ ] has a relatively smooth appearance and a gradual decrement in magnitude that extends out for a large distance from the center. Even in this region one observes substantial fluctuations. By using GFP technology, we observe that the measurable stress field extends far from the visible damage site.

Beneath the graph is an optical image of a typical damage site taken in circularly polarized light. In this view a dark center appears, surrounded by less pronounced structures noted above. There is no view of the center structure that is so clearly evident in the *PER* image at the top. Close examination in the GFP image reveals a shadowy network with a grain boundary-like appearance near the prominent central feature. This indicates that patterns, within the plastic region, that become prominently visible in birefringence at and near the damage site.

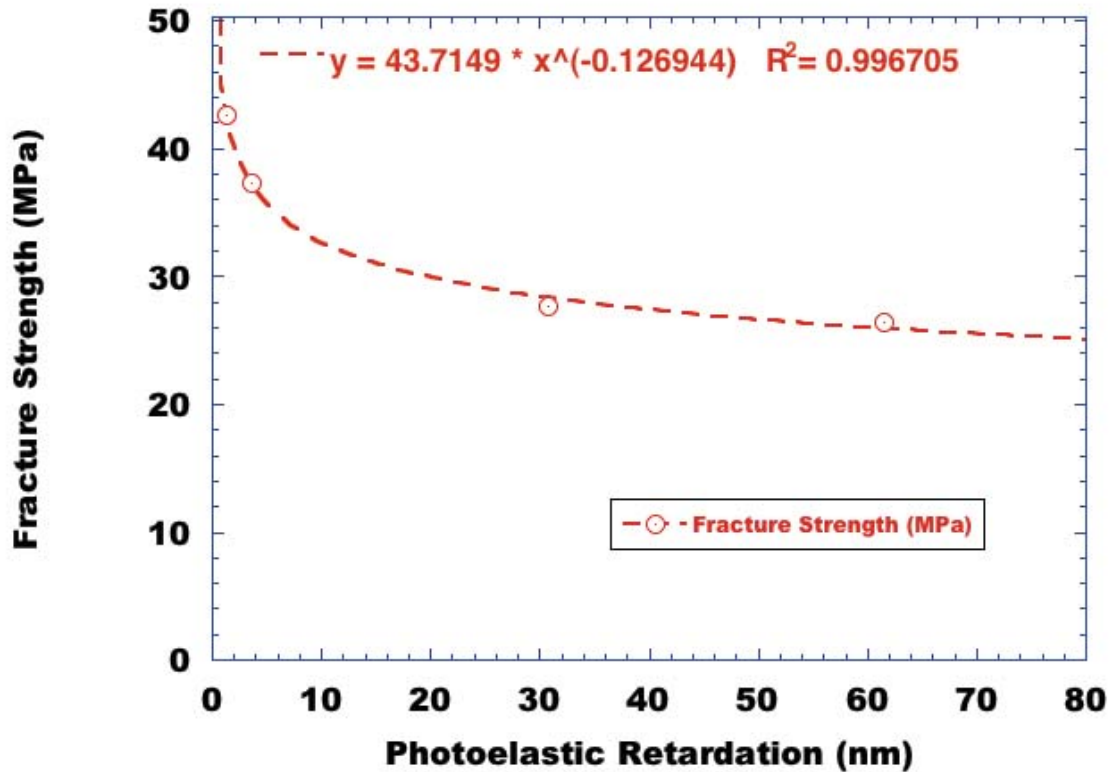
**Figure 11.** A plot of measured fracture strength versus photoelastic retardation for hyper velocity impacts .

We further analyze the power-law fit between the Fracture Strength and *PER*. In Figure 11 we calculate the least squares power-law fit and obtain a square of the correlation coefficient R. As predicted by the theory, this is the best fit with a correlation coefficient of 0.998 ( $R^2=0.9967$ ). Thus the theoretical analysis for the relationship between fracture strength and *PER* is confirmed for HVI damage.

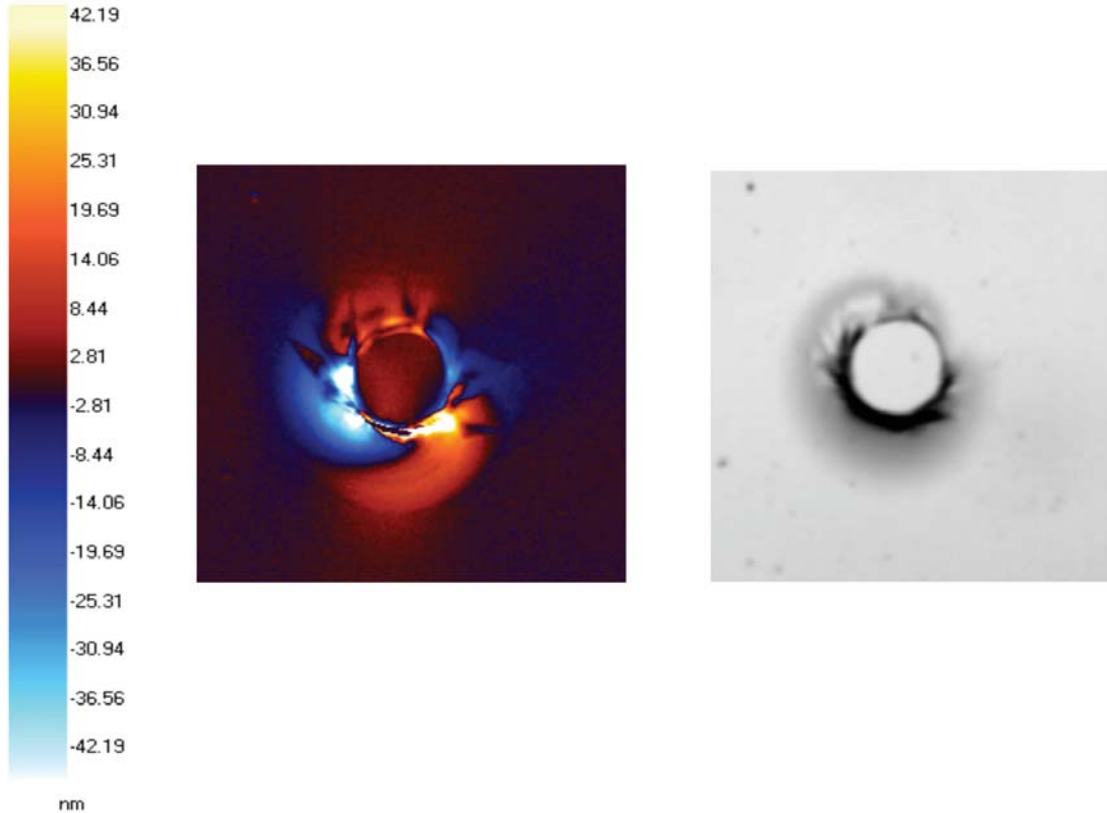
## Bruise 27-139-15

**Figure 12.** Stress Field Image (left) and visual image under circularly polarized light (right) of a typical bruised specimen. At the left of the color image is the photoelastic retardation –to-color scale in nanometers.

dark central region. Directly beyond this is a region where concentric bands appear and extend beyond what appears as impact-related patterns in the glass. This is prominent in both images, as are a series of radial patterns emanating from the impact center. This appears in both the SIB image and the image formed by circularly polarized light. As in the other images, the strain field extends far from the impact site. In this case, however, more structure also appears in the image taken with circularly polarized light. In both images (SIB and circularly polarized light) sharp variations in radial directions appear.

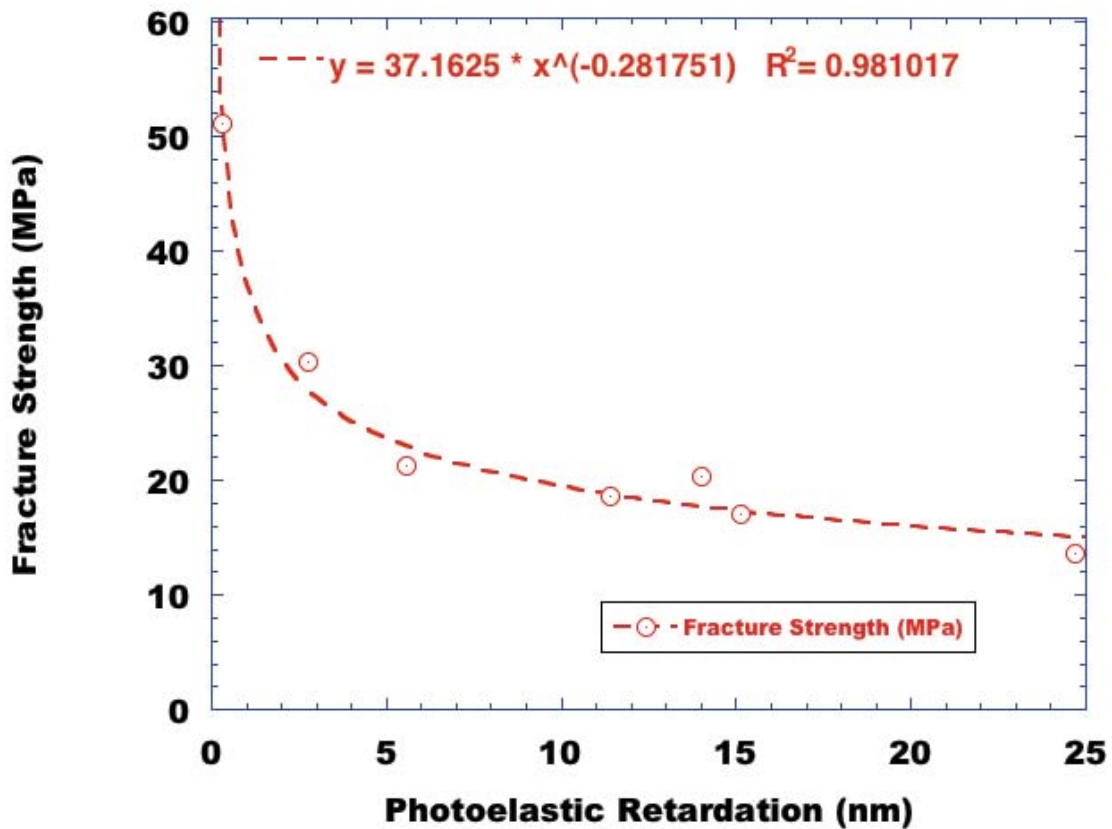
**Figure 13.** A plot of fracture strength versus photoelastic retardation for bruise damage in glass.

Table 3 gives the least-squares fit of the fracture strength (dependent variable) of a set of specimens, each with a bruise damage site, to different measurements taken for the independent variable. Correlation coefficients are relatively high for the Outer Diameter measured with circularly polarized light illumination from the GFP and the Photoelastic Retardation measurement. Additionally for these two independent variable choices the power law is the best fit. The highest correlation coefficient,  $R=0.990$  ( $R^2=0.981$ ) occurs between the Fracture Strength and the *PER* measured with the GFP. A closer examination of the fit is shown in Figure 13, which is a plot of the fracture strength versus the Photoelastic Retardation for the bruise specimens.

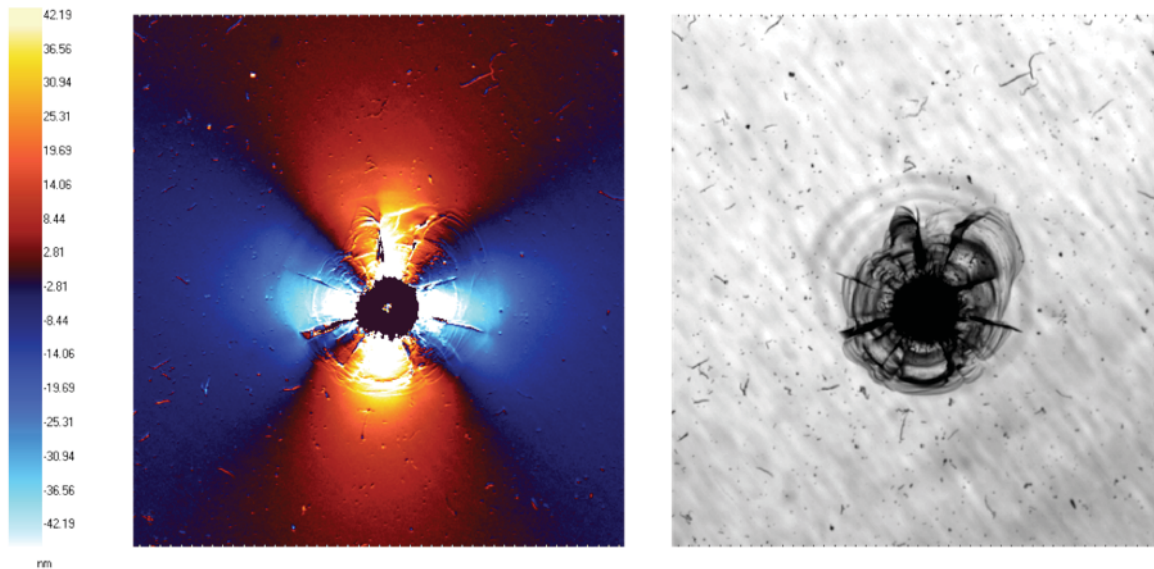
## HITF 05305

**Figure 14.** Stress induced birefringence image (left) and visual (right) of a typical impacted site. At the left of the color image is the photoelastic retardation –to-color scale in nanometers.

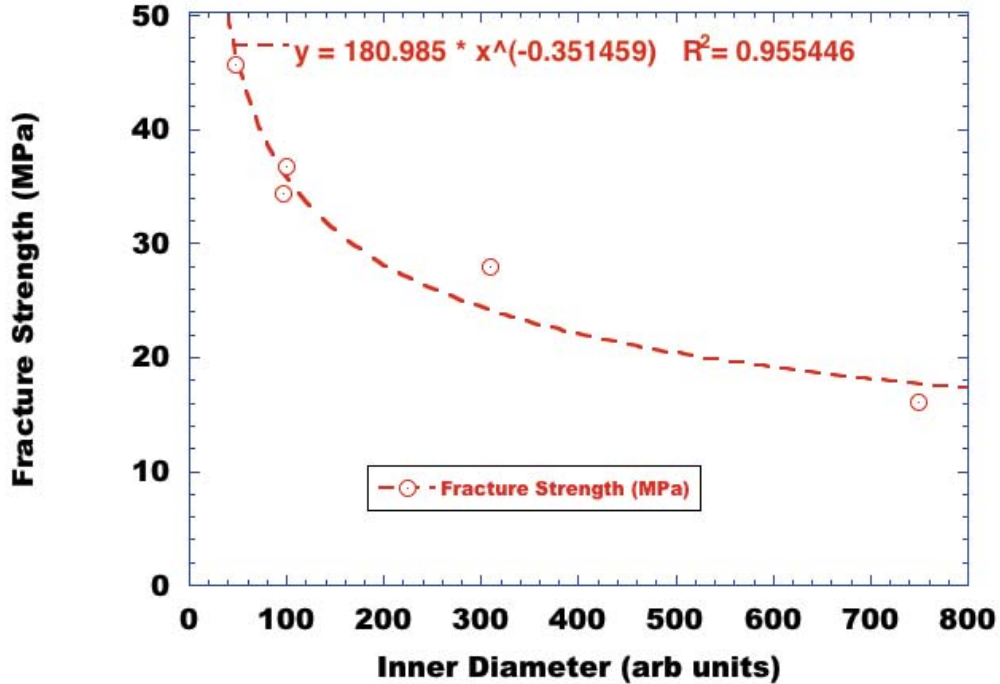
**Figure 15.** A plot of fracture strength as a function of GFP measurement of damage site inner diameter in HIT-F-damaged specimens.

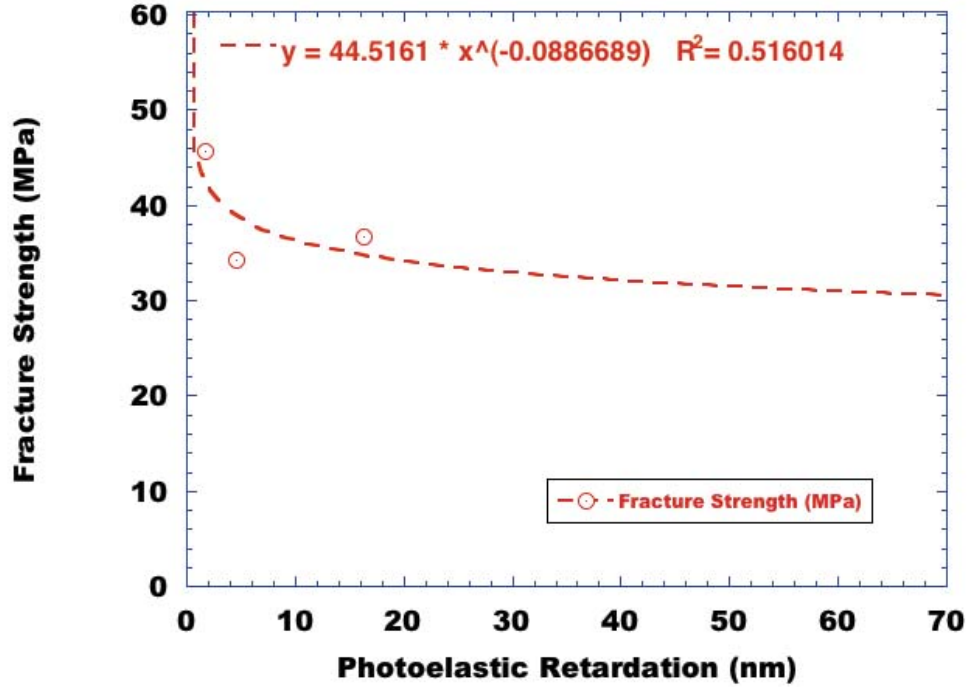
**Figure 16.** A plot of fracture strength of HIT-F-damaged specimens as a function of photoelastic retardation. Only 3 points available make plot inconclusive.

We analyze the five specimens, which were used in this study. Only three specimens had *PER* data. Even though the data is statistically insignificant, we include the HIT-F data for completeness. The HIT-F measurements are evaluated by forming a least-squares fits of the fracture strength (dependent variable) against 6 different independent variables. The results are given in Table 4. As before, the dependent variable, fracture strength, is  $Y$  and the independent variable is  $x$ . The  $x$ -variables are (in order) the outer diameter and inner diameter of the damage site (as measured with the illumination from the circularly polarized light source from the grey-field polarizer), the *PER* measurement, the defect depth taken from the mold casting, and the defect size, taken from a measurement with an optical magnifier and scale. Each set is analyzed for best-fit correlation, with the equation parameters given for each fit. The equations used for the fits are shown in the extreme left column. The top row gives the independent variable used for the fit.

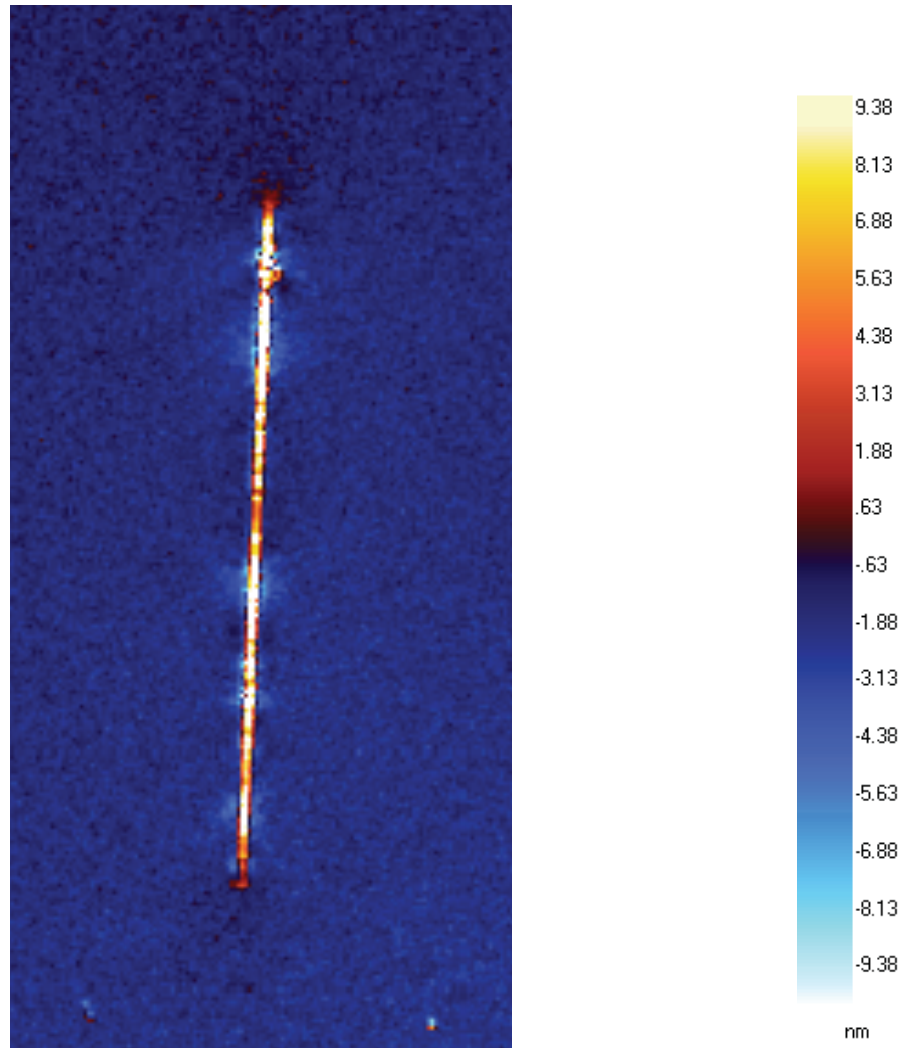
# Chatter Check Specimen 26-210-30

**Figure 17.** Stress-field image of Chatter Check, showing effects of stress fields around the damage (line). To the right of the image is the *PER* color scale in nanometers.

This class of damage is inflicted with dull object pulled across the surface of the glass. Other than the force necessary to hold the object to the surface, no particular normal force is applied to the dull object as it scrapes across the glass surface. The typical resulting damage site is shown in Figure 17, which shows the stress-induced birefringence image. The site appears to have a bright centerline with indications of strain patterns extending, somewhat randomly, normal to the line. In contrast to the other images, the strain fields do not extend far from the scratch (damage site).

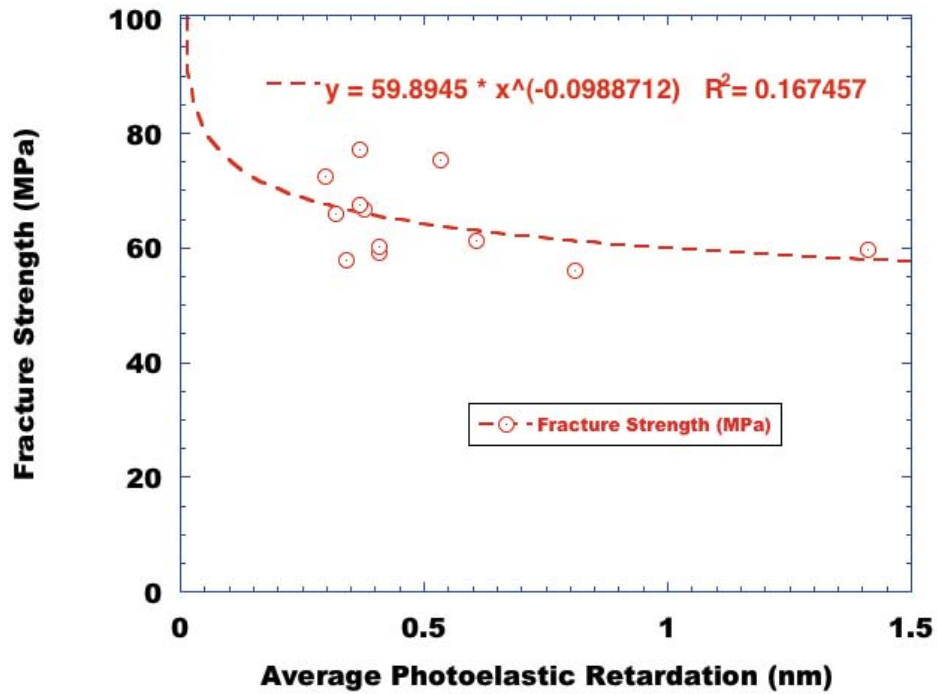
Figure 18. A plot of fracture strength versus average photoelastic retardation for Chatter Checks.

The rankings of the correlation coefficients for each independent variable category (best to worst) are Outer Length from SLOT Measurement, Outer Length (GFP), Area from Slot Measurement, Photoelastic Retardation (GFP), and Outer Breadth (GFP). The power law equation form best predicts the fracture strength (has the higher correlation coefficient), except for outer breadth, where the linear form is the best fit. Whether measured with the GFP or the SLOT measuring instrument, the outer length appears to be the best predictor, with a correlation coefficient of 0.578 ( $R^2=0.335$ ). Generally, the low correlation parameters suggest that none of these variable are predictive of the fracture strength. It is instructive to examine a graph of fracture strength vs. *PER* (Figure 18) even though the least squares fit (and hence its correlation coefficient) is not the best in the list. We find that most of the scatter appears with specimens where the *PER* is less than 1 nm. For comparison fracture strength plotted against outer length is shown in Figure 19. Unfortunately, most of these data lies in the range where *PER* is less than 1 nm.

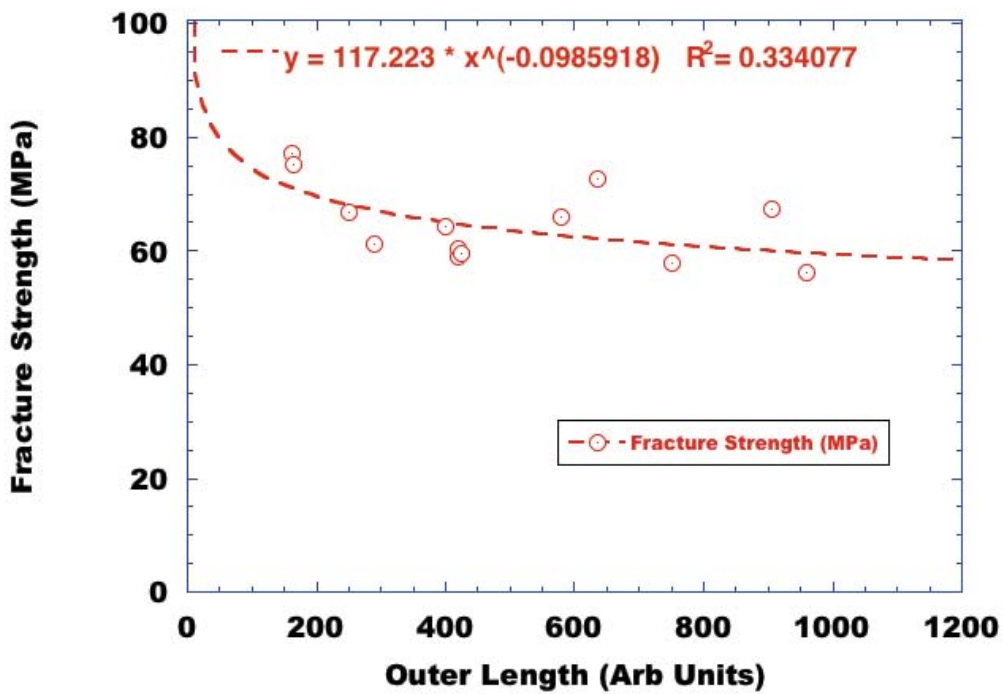
Figure 19. A plot of fracture strength versus outer length for chatter checks.
