# REUSABLE SOLID ROCKET MOTOR—ACCOMPLISHMENTS, LESSONS, AND A CULTURE OF

# SUCCESS

D.R. Moore and W.J. Phelps
NASA Marshall Space Flight Center
Huntsville, Alabama

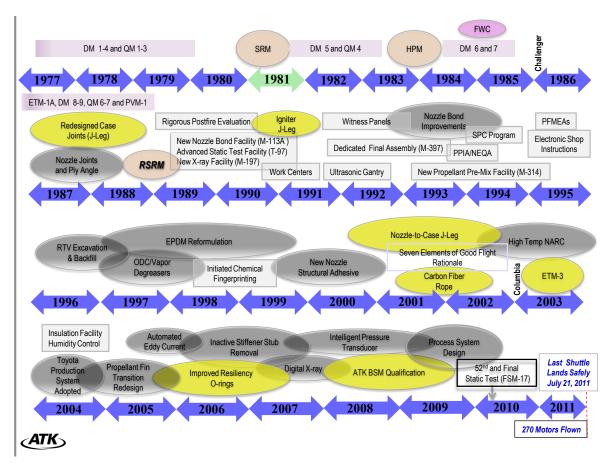
Figure 5. RSRM Evolution.

Figure 5 is a chronological roadmap showing some of the major qualification tests, design changes, process improvements, and operational methodology changes that were incorporated for the SRM as it evolved and matured throughout the life of the Shuttle Program.<sup>2</sup> Between July 1977 with the firing of Demonstration Motor No. 1 (DM-1), and February 2010 with the firing of Flight Support Motor No. 17 (FSM-17), 52 static motor tests were successfully conducted at the ATK facilities in Promontory, Utah to support the Shuttle Program. A total of seven successful tests (four demonstration and three qualification tests) were completed prior to the first Shuttle flight in April 1981. The baseline motor, known as the SRM, was flown on the first seven Space Shuttle missions between 1981 and 1983.<sup>1</sup>

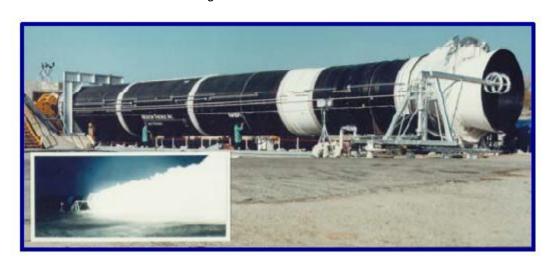
Figure 6. DM-7.

Two full-scale static tests, DM-6 and DM-7, were conducted in October 1984 and May 1985. A full-scale FWC Qualification Motor (QM-5) was assembled and ready to fire when the Challenger accident occurred. At that time, the first FWC flight motors were stacked and ready to support a July 1986 launch at the Vandenburg launch site in California. The FWC development and the plans to launch the Space Shuttle out of Vandenburg were subsequently abandoned.

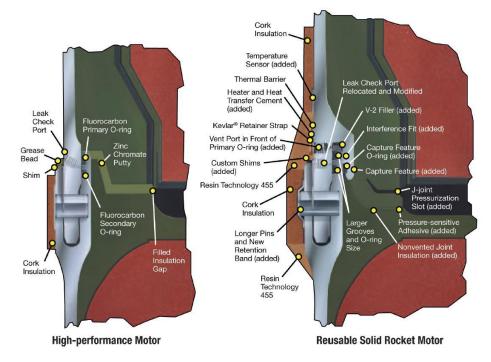
Figure 8. Field Joint Comparison.

extensive subscale and full-scale tests were conducted to verify the cause of the Challenger accident and qualify the necessary design changes. Six static tests were conducted (Engineering Test Motor No. 1A, Demonstration Motors Nos. 8 and 9, Qualification Motors Nos. 6 and 7, and Production Verification Motor No. 1 (PVM-1)) including tests at hot and cold specification bounds with side loads applied to simulate those induced by the external tank attachments. PVM-1, the final static test prior to return to flight, was a full-scale flaw test motor to verify the redundant features of critical seals. The first flight of the redesigned booster occurred on STS-26 in September 1988 (Fig. 7). The key changes between the HPM and RSRM designs (Figs. 8–10) include (1) improved case metal hardware with a capture feature and third o-ring. (2) improved field joint thermal protection with a rubber J-leg replacing the putty, (3) added field joint heaters to ensure orings can track dynamic motions even under cold ambient conditions, (4) improved ply angles in nozzle phenolic rings to preclude anomalous pocketing erosion, (5) more robust metal housings in the nozzle to increase structural margins and accommodate dual and redundant o-ring seals, and (6) an improved nozzle-to-case joint that added 100 radial bolts to reduce the dynamic joint motion plus the addition of a

bonded insulation flap with a wiper o-ring in place of the putty thermal barrier (years later the adhesive was removed and replaced with an insulation j-leg with pressure sensitive adhesive (PSA) and a carbon fiber rope thermal barrier).

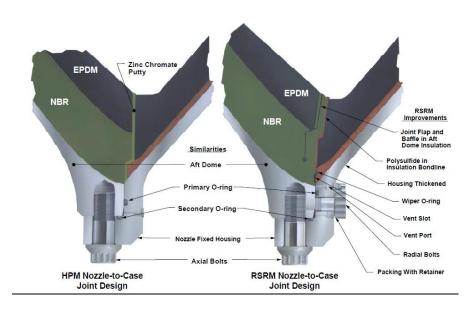
Figure 10. HPM and RSRM Return-to-Flight Joint Design.

Shortly after return-to-flight, an insulation J-leg thermal barrier was developed for the igniter inner and outer joints (Fig. 10).

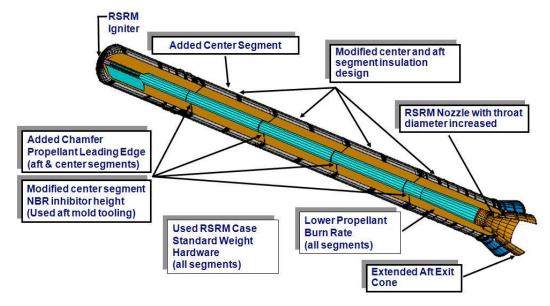
Figure 14. ETM-3 Modifications from RSRM.

ETM-3 (Fig. 14) included the following changes from the RSRM four-segment motor design: 1) added center segment (added 273,000 lb of propellant over the RSRM), 2) bored out nozzle throat, 3) reduced burn rate propellant, 4) extended aft exit cone, 5) added chamfer to propellant leading edges, 6) modified center segment rubber inhibitor heights, and 7) modified center and aft segment insulation design. ETM-3 was instrumented with 620 gauges and a total of 635 channels.

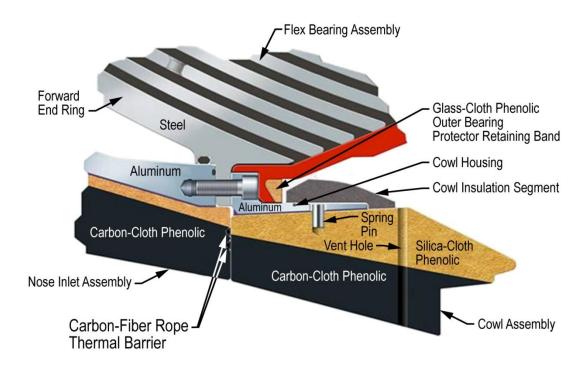
Figure 17. Nozzle Joint 2.

ATK and NASA developed nozzle design solutions for these thermal barrier gas paths that utilized the heat dissipating qualities of the carbon fiber rope (Figs. 17, 18, and 19).

The nozzle joint 2 and 5 designs eliminated the RTV thermal barriers (open volume allowed gas to fully pressurize the joint at ignition) and placed carbon fiber ropes upstream of the o-ring seals, cooling the hot combustion gases that passed through them to temperatures close to ambient. As an example of how well the new designs performed, photos of the typical joint 2 condition before and after incorporation of the carbon fiber rope design is shown in Figure 20. The nozzle-to-case joint design incorporated an insulation j-leg thermal barrier and downstream carbon fiber rope ahead of the o-ring seals that protected them from high temperature exposure in case the J-leg leaked. All incorporated carbon fiber rope designs eliminated thermal barrier gas paths and performed flawlessly after their incorporation on flight hardware.

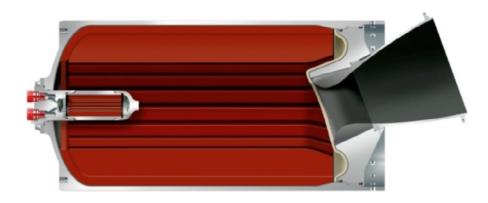
Figure 21. The ATK BSM.

The original shuttle BSM was designed by United Technologies Corporation, Chemical Systems Division (CSD). This design flew on the first 120 Shuttle missions. In October 2003, ATK received an alternate source contract to develop BSMs with selected design and processing upgrades to further enhance motor reliability. The ATK design was heavily based on the CSD design with specific enhancements based on RSRM design practices and modern analytical approaches. The ignition system was completely redesigned to address lessons learned from an investigation of erratic ignition pressures conducted by CSD, ATK, and NASA. Other components of the motor remained essentially unchanged from the CSD design with minor adjustments made to address obsolescence concerns and lessons learned during the baseline flight program. Improvements introduced with the ATK BSM (Fig. 22) included: (1) ATK manufactured only one motor configuration (at KSC, United Space Alliance performed the necessary BSM closeout depending on whether the BSM was mounted in the forward or aft position), (2) sling lined chamber (CSD was hand applied), (3) ATK BSMs were cast in batches of four motors rather than the 64 by CSD, (4) the design used a new stronger adhesive (TIGA), (5) redesigned graphite throat with improved margins, (6) interchangeable case and aft closures eliminated matched sets (7) incorporated new better resiliency low temperature o-rings, (8) increased o-ring squeeze, (9) added an igniter-to-case leak check port, and (10) redesigned igniter. During the development program for the ATK designed BSMs, CSD announced closure of the San Jose, CA facility that produced BSMs. This revelation led NASA to a sole source contract with ATK to manufacture the BSMs and eventually to the

first flight of ATK BSMs in the forward position on STS-122 and in all positions on STS-126. All ATK BSMs exhibited excellent performance through the end of the Shuttle Program.

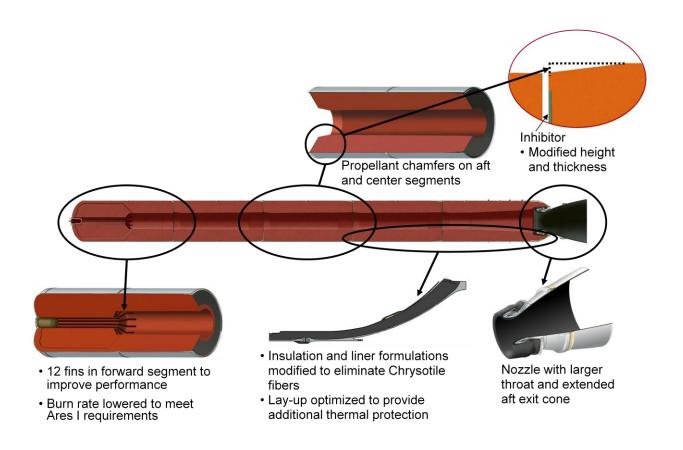
Figure 27. Changes from RSRM to RSRMV.

In the mid-2000's, NASA initiated the Constellation Program which included an objective of developing a spacecraft/launch system that could carry astronauts/payloads to Low Earth Orbit which could support future NASA program needs in this space regime. Known as Ares, the rocket system that was conceived included a five segment first stage solid rocket motor known as the RSRMV. This motor was based off of the Shuttle RSRMs and took advantage of the knowledge gained from the ETM-3 five segment motor test performed in 2003 to assess RSRM margins. Performance drivers for Ares were a

56,200 lb<sub>m</sub> payload to orbit, a maximum dynamic pressure of 800 psf, a maximum acceleration of 3.8 g, and a goal to maximize the use of heritage hardware from the Shuttle. Modifications to the RSRM design were made to improve performance (thrust), eliminate hazardous materials and replace obsolete materials. Changes from the RSRM are shown in Figure 27 and included: (1) increasing the number of center segments from two to three, (2) increasing the number of propellant fins in the forward segment from 11 to 12, (3) the addition of forward chamfers on center and aft segments, (4) lowering the propellant burn rate (5) modification of the propellant inhibitor heights and thicknesses, (6) increasing the nozzle throat diameter, (7) extending the nozzle exit cone, (8) modifying insulation and liner formulations to eliminate Chrysotile fibers, and (9) modifying the insulation lay-up to increase thermal protection. Three development motors were successfully static tested at the ATK test facility in Promontory, Utah before the program was ended in October 2011 (see Figure 28). A comparison of the design characteristics for the RSRM, ETM-3, and RSRMV is shown in Table 1. NASA is now moving forward with the next human space exploration program. The U.S. Space Launch System (SLS) will provide an entirely new capability for human exploration beyond Earth orbit. It also will back up commercial and international partner transportation services to the International Space Station. Designed to be flexible for crew or cargo missions, the SLS will be safe, affordable, and sustainable, to continue America's journey of discovery from the unique vantage point of space. The SLS will take astronauts farther into space than ever before. Marshall Space Flight Center is leading the design and development of the rocket system that can take humans, cargo, equipment, and science experiments to the Moon, asteroids, LaGrange points, and eventually to Mars. The initial lift capability is 70 tonnes (154,323 lb<sub>m</sub>) which is more than double the value of any current lift vehicle today. Future plans will evolve the lift capability to 130 tonnes (286,601 lb<sub>m</sub>), the most of any vehicle ever. RSRMV motors will be used on the first two development flights (one unmanned, one manned). After that, an advanced booster system will be competed for the evolved launch vehicle. Figure 29 shows how the SLS configuration will evolve.
