# **REPLACEMENT FOR A FLEX HOSE COATING AT THE SPACE SHUTTLE LAUNCH PAD**

Aerocoat AR-7 is a coating that has been used to protect stainless steel flex hoses at NASA's Kennedy Space Center launch complex and hydraulic lines of the mobile launch platform (MLP). This coating has great corrosion control performance and low temperature application. AR-7 was developed by NASA and produced exclusively for NASA but its production has been discontinued due to its high content of volatile organic compounds (VOC) and significant environmental impact. The purpose of this project was to select and evaluate candidate coatings to find a replacement coating that is more environmentally friendly, with similar properties to AR-7. No coatings were identified that perform the same as AR-7 in all areas. Candidate coatings failed in comparison to AR-7 in salt fog, beachside atmospheric exposure, pencil hardness, Mandrel bend, chemical compatibility, adhesion, and ease of application tests. However, two coatings were selected for further evaluation.

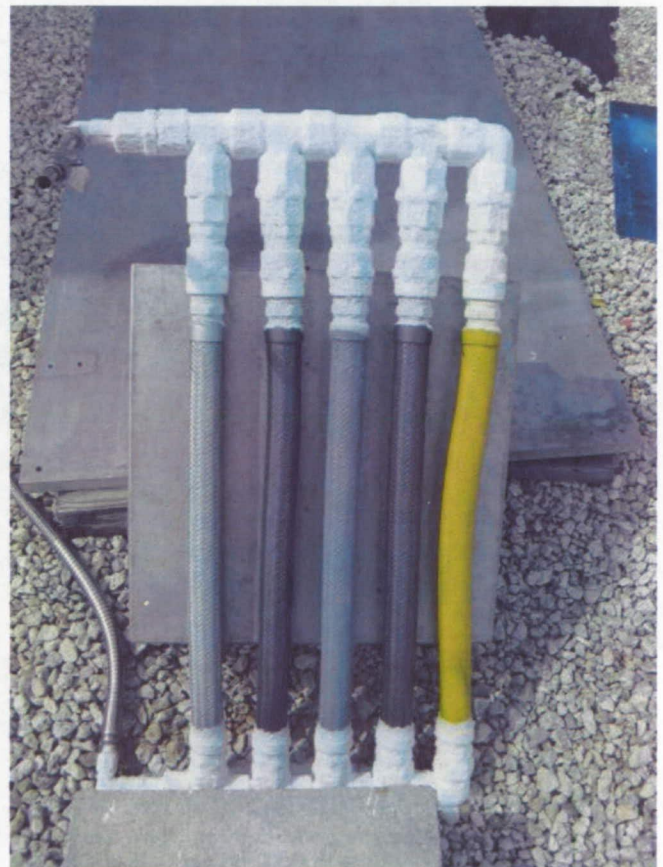
Since the flex hoses are used with cryogenic liquids, flex hoses were coated and arranged as a flex hose manifold. Figure 2 shows the assembly. The flex hose manifold was propped up to provide for positive elevation change during liquid nitrogen flow. A 10-12" stainless steel tube (1/2" o.d.) was attached to the top (outlet) of the manifold to direct the vent stream from the manifold away from the personnel that conducted the testing. The input from the 900 gallon liquid nitrogen tank was attached to the bottom (inlet) of the manifold.

**FIGURE 2 – Flex hose manifold.**

A total of five chilldown, liquid nitrogen flow and warming cycles were completed on the flex hose manifold. During each cycle, the chilldown time was 5 minutes and the liquid nitrogen flow time was 10 minutes. Each warming cycle was approximately 30 minutes in duration. Prior to the start of each cycle, all coated flex lines were inspected for signs of wear.

A liquid nitrogen bath was used to simulate cryogenic spillage or other direct exposure of the flex hose manifold. The manifold was tested in two sections since it could not be totally immersed in the bath at one time. Prior to immersion, the manifold was allowed to warm to ambient temperature, purged with gaseous nitrogen, and capped at both ends. The cap on the ambient end of the manifold was loosened to allow for the escape of any trapped gas inside the manifold. The submerged end of the manifold remained in the bath for 5 minutes after quenching had subsided. After the manifold was allowed to warm-up, this process was repeated by switching submerged and ambient ends of the manifold. All flex lines were inspected after direct exposure in the liquid nitrogen bath.

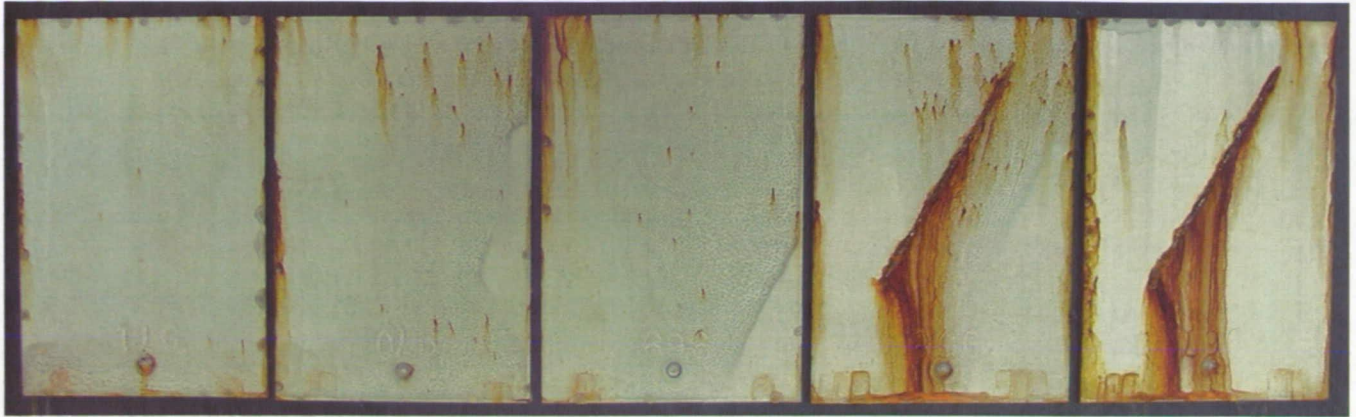
After 2000 hours in the salt fog chamber per ASTM B117, AR-7 and the candidate coatings were evaluated. Three different ASTM methods were used to evaluate the panels. The first was ASTM D 1654-05 *Standard Test Method for Evaluation of Painted or Coated Specimens Subjected to Corrosive Environments*.<sup>5</sup> This method is used as a basis to evaluate corrosion, blistering and adhesion in the area of a scribe on a panel. A rating number of 10 is the best evaluation a panel can receive, with zero being the worst. AR-7 received a rating of 7 after 2000 hours in the salt fog. The second method used was ASTM D 610 -01 *Standard Test Method for Evaluating Degree of Rusting on Painted Steel Surfaces*.<sup>6</sup> A panel with no rusting would receive the highest rating of 10. The percent of rusting of a panel increased with a decreasing rating number. The letter after the number for this method designated the type of corrosion present, spot (S), general (G), or pinpoint (P). After 2000 hours in the salt fog, AR-7 had a rating of 8G. The third ASTM method used for the evaluation of the coatings was ASTM D 714-02, *Standard Test Method for Evaluating Degree of Blistering of Paints*.<sup>7</sup> AR-7 received a rating of Size 6 Medium. Figure 3 shows carbon steel panels coated with AR-7 after 2000 hours in the salt fog chamber. Three panels were not scribed, and two panels were.

**FIGURE 3 – AR-7 after 2000 hours in the salt fog chamber.**

As seen in Table 1, Candidates 6, 8, 9, and 10 performed the same or better than AR-7 after being in the salt fog chamber for 2000 hours. Candidate coatings with an 'N/A' were not placed in the chamber because they never cured properly. Candidate coatings which failed performed worse than AR-7.
