# Turbine Engine Disk Rotor Health Monitoring Assessment Using Spin Tests Data

Ali Abdul-Aziz, Mark Woike, George Baaklini and James R. Bodis  
NASA Glenn Research Center  
Cleveland, Ohio 44135

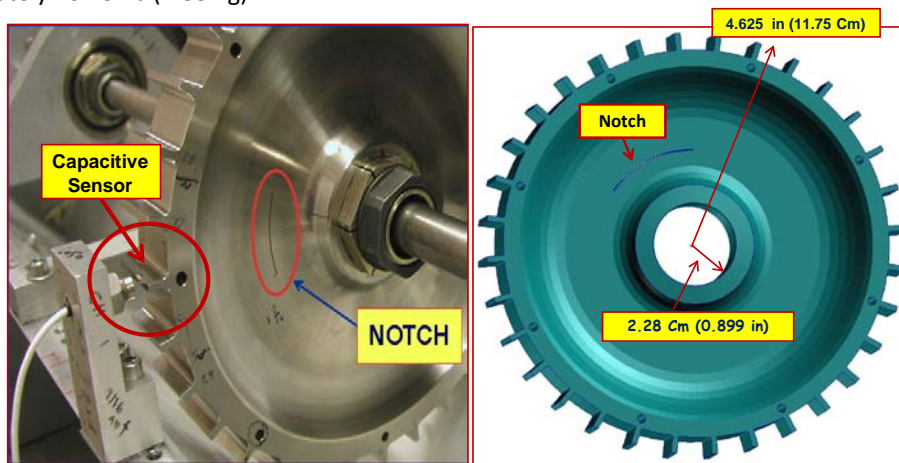
Figure 1 illustrates a description of the disk specimen and the induced crack-notch along with the tip clearance probes. The test specimen disk has an outside diameter of 23.495 cm (9.25 in.); a bore and an outside rim thickness of 2.54 cm (1 in.) and 3.175 cm (1.25 in.); the thickness of the web is 0.254 cm (0.10 in), and the cross section and height of the blades are 3.175 cm x 0.330 cm (1.25 in x 0.13 in) and 0.838 cm (0.33in.), respectively. It has rotor like blades, total of 32, evenly spaced around the circumference. Eight holes, 0.508 cm (0.20 in.) diameter each, were drilled through the disk half-way in the rim. The holes were spaced every 45° and they were designed for future studies as possible mass add-on points or notch initiation sites. The disk specimen is made out of nickel base material alloy Haynes X-750 and it weighs approximately 10.75 Lb (4.88 Kg).

a) Capacitive sensor probe

b) 3-D Model with the Notch

Figure 1. Test disk capacitive sensor assembly.

The experimental work in this study considered a conceptual design of a disk with machined teeth to imitate compressor or turbine blades and provide a cost effective test article to simulate crack initiation and propagation, see Figure 1. The central region of the disk is counter-bored on both sides to create the rim, web, and bore regions of a typical turbine disk. The machined teeth on the rim simulate tip passing but they trim down the blade mass-loading on the web and bore usually experienced in most rotors. The goal is to induce changes in radial tip displacement without disk yielding in order to test the instrumentation, and to then initiate and grow cracks by machining and/or increasing rotational speed. Two sensor types (capacitive and microwave) are employed to capture the blade tip clearance both for health monitoring and comparison purposes. An eddy current sensor is also included in the system to measure the shaft displacements.

For blade tip clearance measurements, a capacitive sensor system was installed; see Figure 1(a). These types of sensors are based on a DC offset, an offsetting of a signal from zero where it refers to a direct current voltage, rather than a modulation technique which is a method used to digitally represent sampled analog signals. The capacitive sensors are designed to monitor the electrical property of “capacitance” to initiate and take measurements. Capacitance is defined as a field that exists between two conductive surfaces within some rational proximity. Variations in the distance between the surfaces lead to changes in the capacitance rate. This capacitance rate change is used by the sensors to indicate difference in position of a target. High-performance displacement sensors use small sensing surfaces and as a result are positioned close to the targets (0.25-2mm). The DC voltage, in conjunction with the motion of the rotor, allowed the current system to record three channels at a rate of 1 MHz each.

Spin tests were performed on the rotor disk and covered base line runs with both undamaged and damaged disks via the artificially induced notch, shown in Figure 1. The tests included spinning the rotor under various simulated engine mission profiles starting at a minimum rotational speed of 3000 up to a maximum of 10000 Rpm. The controlled speed applied during the current testing was made with an acceleration-deceleration rate of 60 rpm/second. This insured passing the critical speed of 2,610 rpm and leading to post critical state<sup>9</sup>. Figure 6 shows samples of two mission profiles that were used to test the rotors. These profiles were derived on the basis of revolutions per minute data obtained on different flights comprising different flight maneuvers<sup>15</sup>.

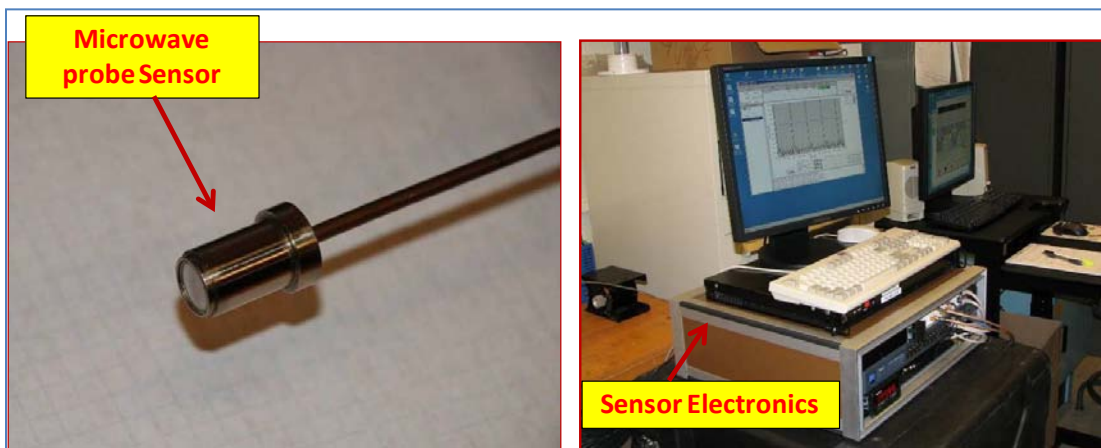
a) Sensor Probe

b) Sensor Electronics

Figure 2. Microwave sensor probe and its elcotronics set-up.

The microwave tip clearance sensor system works on principles that are similar to a short range radar system. The tip clearance probe is both a transmitting and receiving antenna<sup>4-8</sup>. The sensor emits a continuous microwave signal and measures the signal that is reflected off a passing blade. The motion of the blade modulates the reflected signal. The reflected signal is then compared to an internal reference signal and the phase difference directly corresponds to the distance to the blade. The system consists of two major components. The first component is the probe, Fig. 2(a). The second component is the sensor electronics, Fig. 2(b). The probe contains the transmitting and receiving antenna and is designed to be installed in the casing of the engine where it can measure the radial clearance between the face of the sensor and the turbine blade tips. The probes are made of high temperature material and are designed to operate in temperatures of 900 °C uncooled, 1200 °C with cooling air. Two generations of probes are in operation. The first generation probes operate at 5.8 GHz and can measure clearance distances up to ~25 mm (i.e., one-half the radiating wavelength). The second generation probes operate at 24 GHz and in theory can measure clearance distances up to ~6 mm. In regards to physical size, the first generation probes are approximately 14 mm in diameter and 26 mm long. The second generation probes are approximately 9 mm in diameter and 19 mm long. This technology has an ultimate goal of obtaining clearance accuracies approaching 25 μm. Accuracies in this order were observed in the laboratory during testing<sup>4</sup>. A frequency response of up to 5 MHz is typical, with up to 25 MHz being possible with this technology.

The sensor electronics consist of the radio frequency (RF) generator, RF detector, and all of the associated hardware required to generate, measure, and convert the microwave signals into a displacement reading<sup>4</sup>.

The sensor electronics are designed to be located off-board of the engine in an environmentally benign area. The probes are connected to the sensor electronics using a microwave rated co-axial cable. A rack-mounted PC is used to interface to the sensor electronics and run the data acquisition and display software. The data acquisition computer is connected to the sensor electronics through a network switch. The data acquisition computer is intended to be remotely located away from the sensor electronics in an area such as a control room using a CAT5E connection.

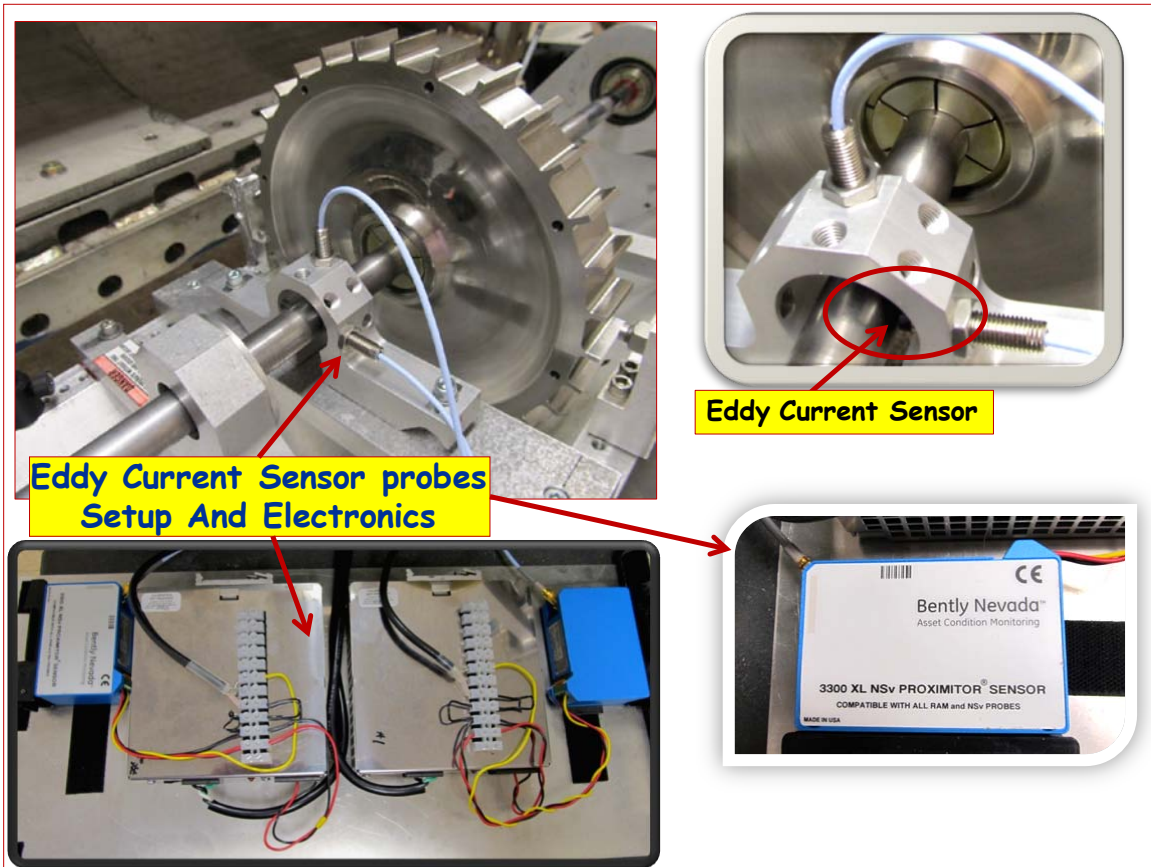
Figure 3 represents a display showing the eddy current sensor system. The eddy current sensor monitors the rotating shaft displacement, while the capacitive-microwave sensors observe the rotor blade tip displacements. Monitoring the shaft displacement has added a much needed attribute to the experimental capacity. This sensor system is tied to reader display within the data acquisition-processing software allowing monitoring of the sensors response and other information related to files directory, storage locations, experimental outputs, etc.

Figure 3. Eddy Current sensor assembly.

The eddy current sensor system employed is the Bently Nevada 3300 XL NSv transducer system. It is typically used in areas where tight installation requirements are present. It is also ideal for small target applications, such as measuring radial vibration on shafts smaller than 51 mm (2 in) or axial position on flat targets smaller than 15 mm (0.6 in). The 3300 XL NSv Proximity Transducer System consists of: 3300 NSv probe, 3300 NSv tension cable, 3300 XL NSv Proximitor Sensor. The 3300 XL NSv Transducer System has an Average Scale Factor of 7.87 V/mm (200 mV/mil). Its enhanced side-view and small target characteristics give it a shorter linear span Within 1.5 mm (60 mils). Figure 4 shows an example of a sample run for the eddy current probe recording illustrating the horizontal and the vertical

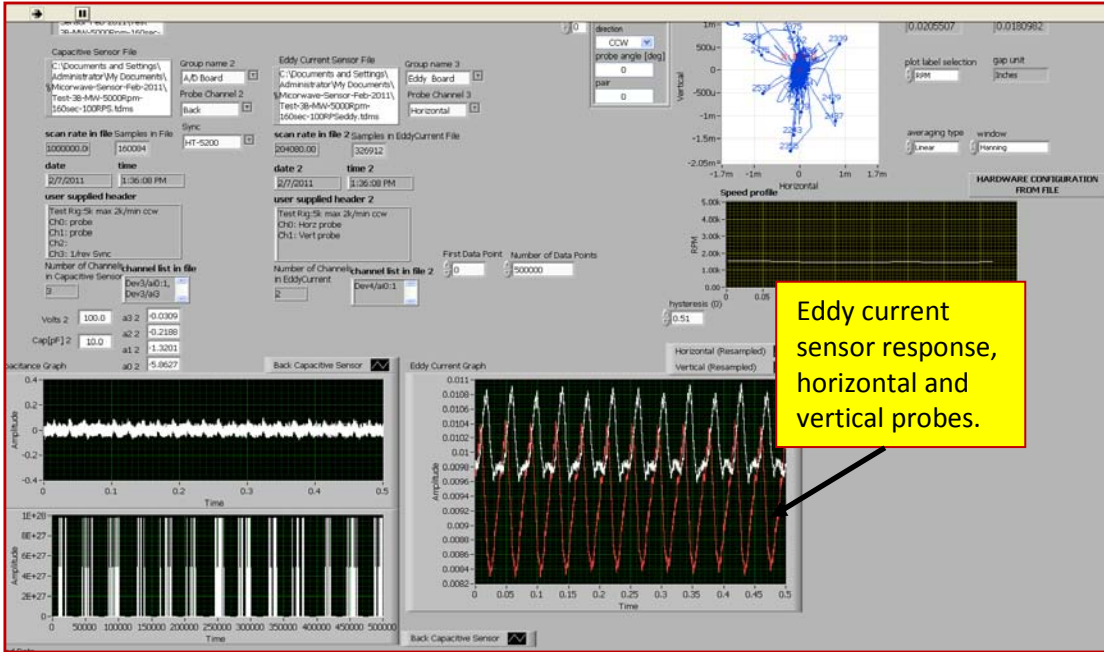
Figure 4. Sample Eddy Current reading at 10,000 Rpm under a segment of a transient Condition mission for the disk with a notch.

readouts of the sensor. Additional details concerning the NSv 3300 functionality and application can be found on Bently Nevada website<sup>14</sup>.

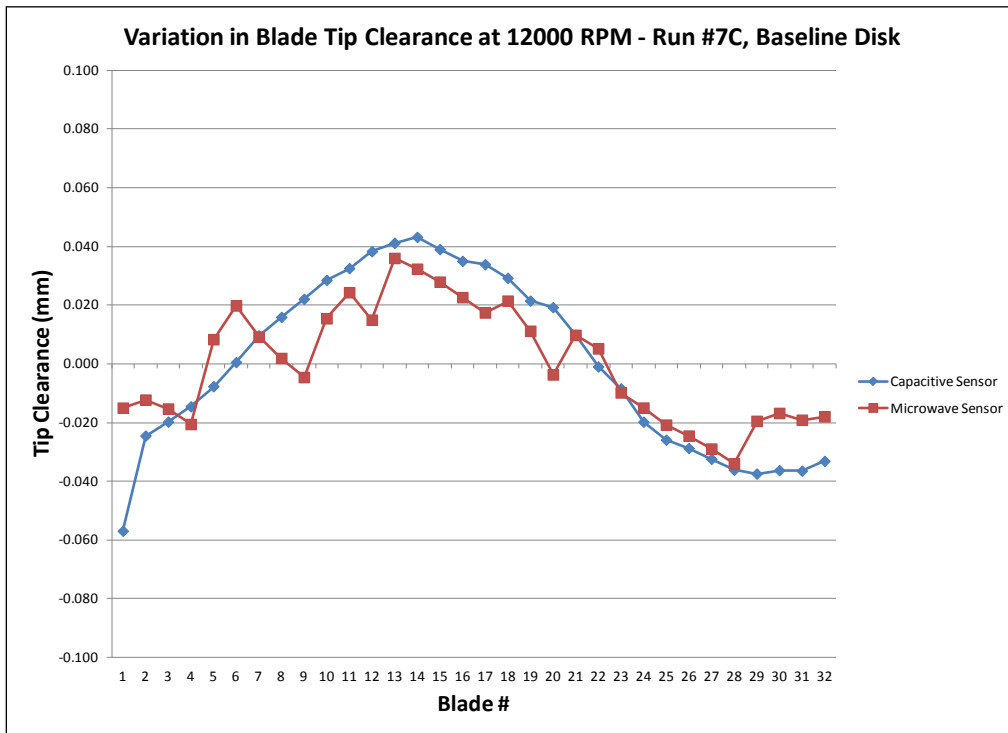
Figure 5. Sample of capacitive and micowave sensor data readings for a baseline disk at 12000 Rpm.

Figure 5 demonstrates a comparison between the two primary blade tip clearance sensors, microwave and capacitive, attached to the data system. The data to some extent compare relatively well which iterates the facts that both sensor systems offer similar information. However, the similarity is not as uniform as anticipated which implies that certain calibration is needed to fine tune the sensor system further and bring the data closer. Nevertheless, each sensor system is operating as expected. Their role in the experiment configuration is to serve the same functionality in a different fashion and to test their performance.

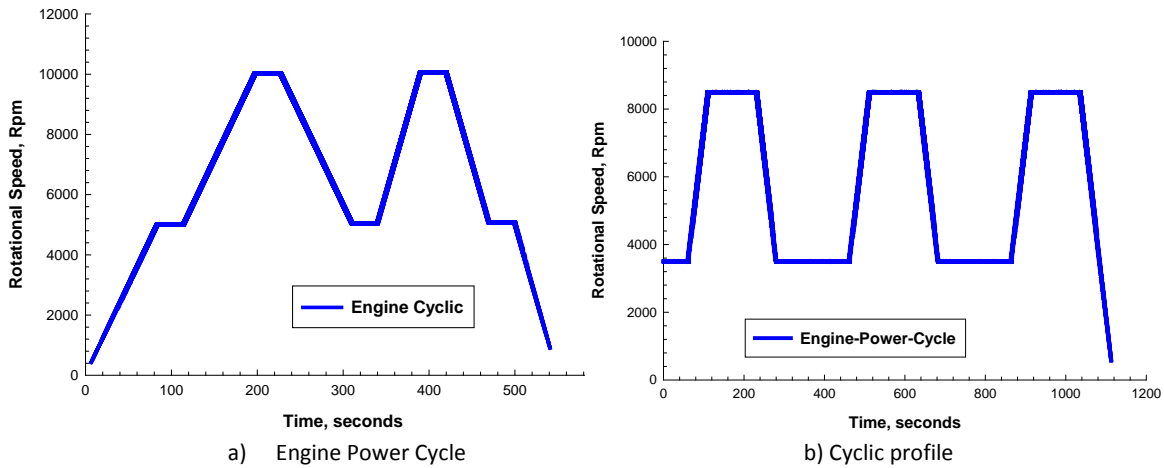
Figure 6. Simulated engine mission history test profiles.

Figure 6(a) is referred to as the constant engine power cycle profile; however the graph shown does not illustrate the constant behavior due to an input offset. The engine speed reaches 10,000 rpm in two steps, a brief hold up at 5000 rpm and 40 seconds hold at 10,000 rpm with a rapid decrease to 5000 and a ramp up to 10,000 rpm and so on. Figure 6(b) shows another mission profile (engine cyclic power cycle) that allows the rotor disk to go through analogous series of events starting at a speed beyond the critical and up to 8500 Rpm. These profiles are being used to imitate non-typical engine conditions and to help in evaluating the rotor performance under harsh and complex loading events in an attempt to fatigue the disk with the expectation that all the existing anomalies would appear in the test data. Additionally, under these conditions, these experiments supplied valuable assessments for both, the crack detection scheme and the structural durability of the disk materials.

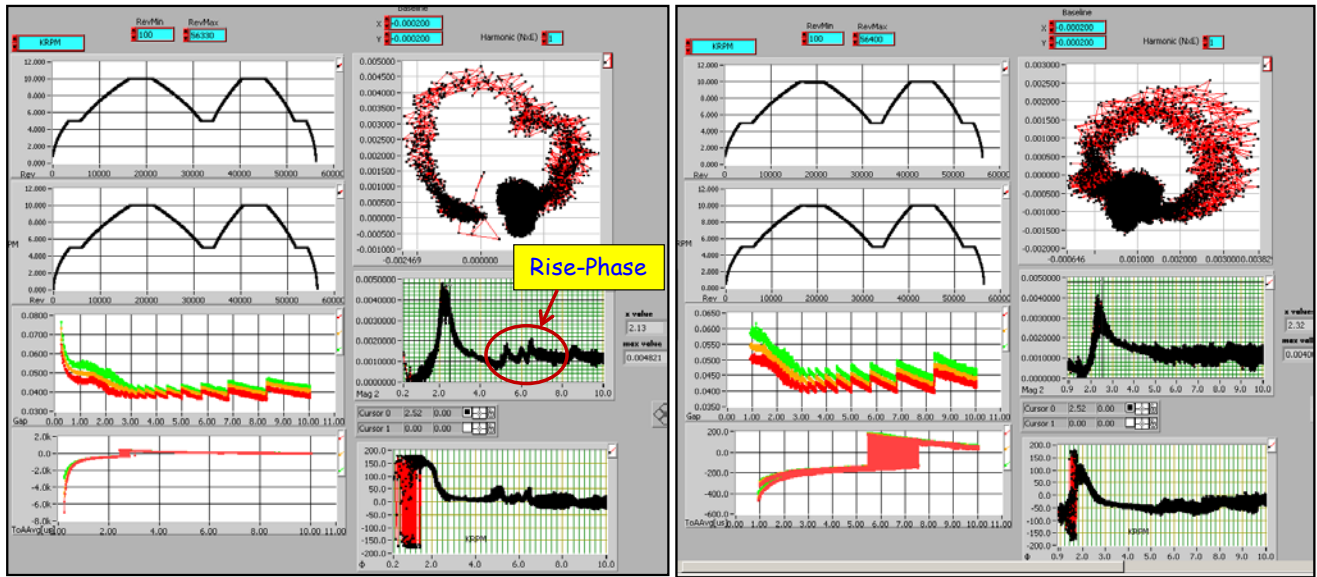
Experimental data under both mission profiles are represented in Figures 7 and 8. The data in Figure 7 are produced under the constant power cycle mission for both the baseline no-notch and the notched disks. The mission history is shown along with the trace vibration vector and Bode plots for the phase and amplitude response. Bode plots are a very useful way to represent the gain and phase of a system as a function of frequency. This is referred to as the frequency domain behavior of a system. The magnitude and phase plots determine the phasor representation of the

transfer function at any frequency. A clear observation is noted for both. For instance; a circular loop representation for the trace of vibration vector is seen for the baseline disk while a gap in the loop is present for the notched disk. This behavior offers a hint that a difference in the vibration response for the two structures is present signifying the existence of some type of irregularity. Such observation has been reported in Reference<sup>9-15</sup>, where a crack in the rotor disk is documented via the presence of distorted trace of the vibration vector distribution and a rise in the phase and amplitude response upon surpassing the 1st critical speed, see Figure 8 for notation and units.

This conduct is surely obvious in Figure 7(a) for the notched disk. A rise in the phase magnitude response is noted. Also, it is noted that the peak is at a critical frequency (5000 – 9000 RPM), and then it begins to settle out at maximum speed close to critical frequency. So the damping ratio keeps the curve from flattening compared to no crack, Figure 7(b). Note how the magnitude phase graphs no longer represents an almost complete circle in the notched disk case, Fig. 7(a).

a) Disk With Notch

b) Disk Without Notch

Figure 7. Bode Plots 9 minutes comparison test of the disk with and without notch, capacitive sensor data, Engine cyclic power profile at 5-10 Krpm rotational speed.

This is a sign of a crack growing and is detected from the plot of a cycle worth of data. At the same time the magnitude graph, (Figure 7(a)), has started a  $\omega^2$  ( $\omega$  is the rotational speed) rise after settling past the critical frequency. This amplitude growth of the magnitude is a significant indication of a crack growing. Therefore, examination of the above data has verified that the detection scheme based on the blade tip clearance response allows identifying the presence of some sort of fault in the rotor disk. However, further confirmation is warranted via conducting more tests for different rotors under similar operating conditions to authenticate that this type of behavior in the vibration response is due to some existing structural defects in the rotor rather than a system related unbalance.

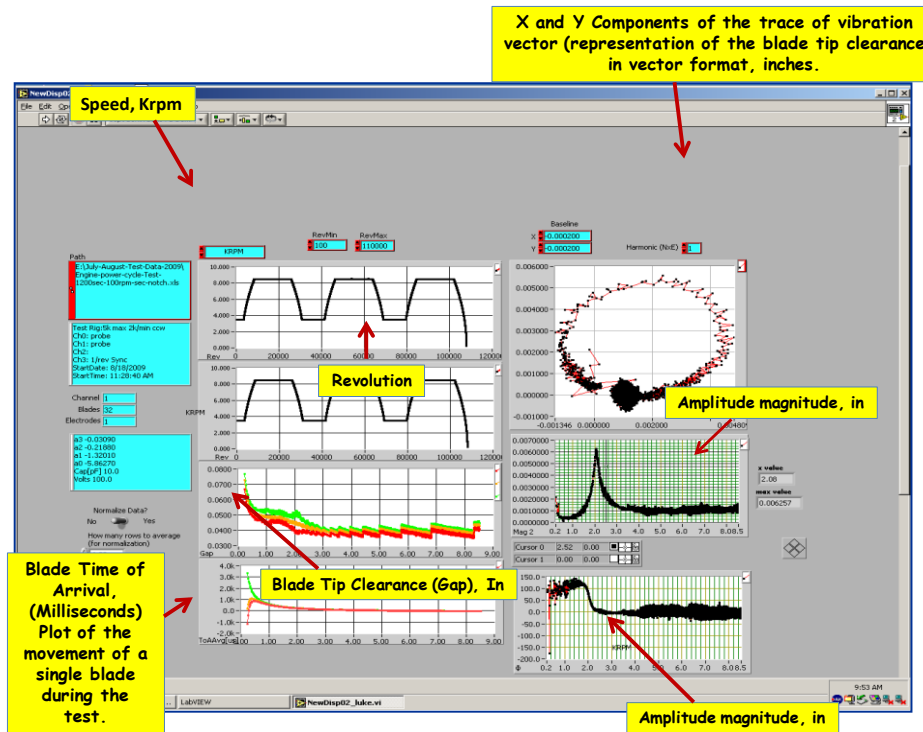
Figure 8 shows the results obtained under the cyclic run time mission profile. The trace of vibrations vector in the Bode plot contains rather distorted data with an incomplete circular shape. Also, the amplitude shows a mild rise at the 5000-6000 RPM range which substantiates the theory of the presence of an unbalance condition or an anomaly state as noted in the data presented in Figure 7. However, the manifestation of such observations remains not as straightforward but it underlines or it confirms the presence of some type of defect. Still, further work to confirm this scrutiny is needed<sup>7</sup>.

Figure 8. Engine constant power cycle test, capacitive sensor data at 8500 Rpm, 1200 Sec long at 100 Rpm acceleration/deceleration rate for the Notched disk.

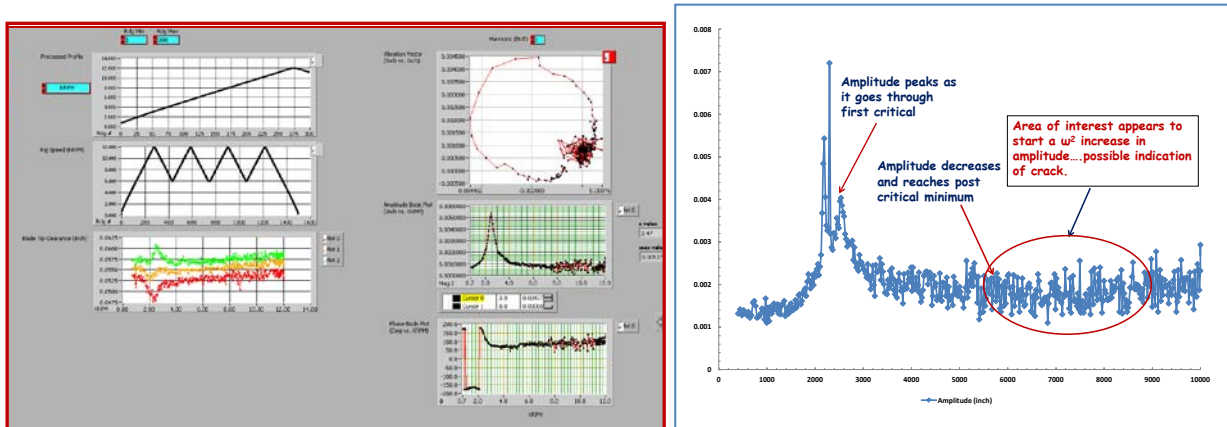
The data reported in Figure 9 shows the test output of the microwave sensor for a constant amplitude engine history profile. Only data for the take off portion of the profile up to the first 300 revolutions is shown, Figure 9(a). This is for a 1500 Seconds long test at 100 Rpm acceleration/deceleration rate for a notched disk. The response of the microwave sensor is very similar to that of the capacitive sensor; it has been introduced into the testing scheme to investigate its applicability and performance for engine health monitoring applications. And as mentioned earlier the microwave tip clearance sensor system works on principles that are similar to a short range radar system and are different than those for the capacitive sensor. The probe is both a transmitting and a receiving antenna; it emits a continuous microwave signal and measures the signal that is reflected off a rotating blade.

a) Bode plot output

b) Vibration amplitude as a function of rotational speed

Figure 9. Simulated engine mission history profile (Constant amplitude) test, Microwave sensor data.

Figure 9(b) shows a magnified phase amplitude output produced by the data obtained from the microwave sensor for a spin test of a notched disk at 10,000 Rpm rotational speed. It is obviously noted that a small rise in the phase exhibiting a second degree order ( $w^2$ ) is recognized at a speed range of 7000 to 10000 Rpm. This supports the observations made earlier for the capacitive sensor data concerning the crack detection phenomena in the rotor and the similarity of the microwave sensor performance.

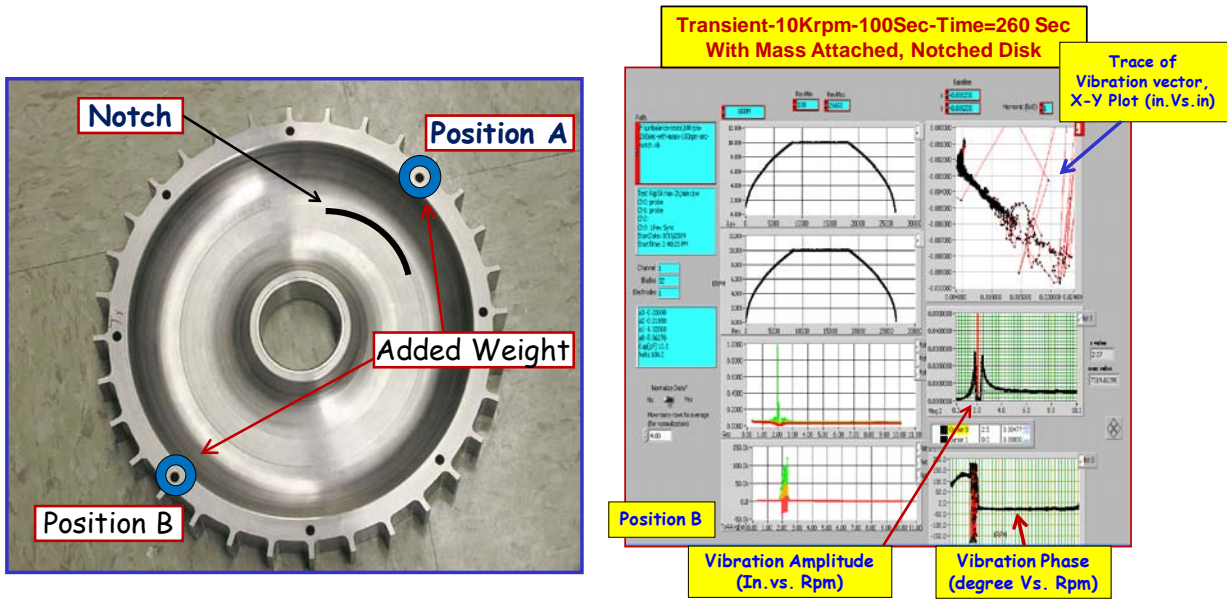
An unbalance test was performed to institute a baseline database for the rotor at various operating conditions and to support investigating and evaluating the vibration response under non-ordinary service environment such as imbalance situations. The test was conducted at 10,000 RPM at 100 seconds acceleration/deceleration rate and lasted 4.33 minutes long. The test covered a standard mission profile under transient ramp up, cruise and ramp down conditions. Test conditions were kept the same as those applied during the non-unbalance state to enable precise assessments of the imbalance factors and their impact on the rotor vibrations response under consistent and refined test margins for the same rotor. Figure 10(a) shows a photo of the disk used for the unbalance tests with labels indicating the sites of the locations of the weight (0.5 gram) during the tests. As noted, two cases were considered. One case with the extra weight being along the notch side (Position A) and another one with weight being across from the notch (position B). Additionally, the purpose of the unbalance test is to check the capability of the sensors technology not in only crack detection but also in predicting other major malfunctions in the rotor system such as unbalance provision. This further supports the theory which relates to rotor design where as the rotational velocity of any rotating object increases, its level of vibration often passes through a maximum at what is called a critical speed<sup>9</sup>. This is commonly excited by unbalance of the rotating structure. If the amplitude of vibration at these critical speeds is excessive, catastrophic failure can occur. For this reason, it is typically recommended that in large rotors design the appropriate approach is to use physical prototypes and tests in order to ensure safe rotating machinery design and balance it well.

a) Unbalance layout with added weight and locations

b) unbalance vibration response

Figure10. Tip clearance variation with blade numbers and simulated rotor unbalance layout.

Figure 10(b) shows a test runs for the notched rotor disk under unbalance test with the mass being at position B as indicated in Figure 9(a). Position B is on the opposite side of the notch. This location was intentionally chosen to investigate imbalance effects not only at positions within the region surrounding the notch but at areas outside the notch section and further out. Test results at “position A” are not shown due to space limitation and since similar results were observed as well.

It also is noted that the trace of vibration vector shown in Figure 9(b) shows a very irregular distribution signifying that the imbalance had eliminated the typical complete circular shape usually encountered when a clean baseline rotor disk without any balance weight or damage is in operation. This further designates that having an imbalance state whether it is due to the existence of a notch or other factors within the system will lead to non-ordinary shape of the trace of the vibration vector curve. Additionally, these data confirm that upon altering the disk weight by adding or removing mass, the state of imbalance is imminent and the tip clearance magnitude will depend on the added mass size and location. Further, the findings of these results substantiated the purpose of these tests to help determine that the blade tip clearance sensors have recognized the significance of these critical parameters and their influence on the disk performance.
