Test-Analysis Correlation of the Single Stringer Bending Tests for the Space Shuttle ET-137 Intertank Stringer Crack Investigation

Dawn R. Phillips¹, Joseph B. Saxon², and Robert J. Wingate³
NASA Marshall Space Flight Center, Huntsville, AL

Extended Abstract of Proposed Paper for the 53rd AIAA/ASME/ASCE/AHS/ASC Structures, Structural Dynamics, and Materials Conference, April 23-26, 2012, Honolulu, Hawaii

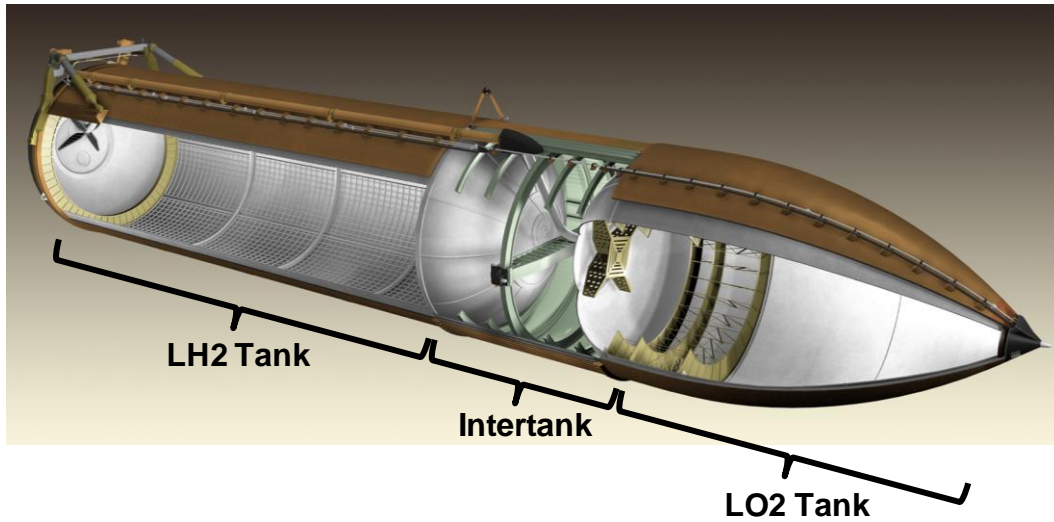
Figure 1. Super Lightweight External Tank.

The Space Transportation System (STS) Super Lightweight ET (SLWT) is shown in Figure 1. The SLWT is comprised of two propellant tanks (an aft liquid hydrogen (LH2) tank and a forward LOX tank) and an Intertank. The Intertank serves as the structural connection between the two propellant tanks and also functions to receive and distribute all thrust loads from the solid rocket boosters (not shown in the figure). The Intertank is a stiffened cylinder structure consisting of eight mechanically joined panels (two integrally-stiffened, machined thrust panels to react the booster loads and six stringer-stiffened skin panels) [1]. There are one main ring frame, four intermediate ring frames, and forward and aft flange chords that mate to the respective propellant tanks. An example of the stringer, skin, and chord assembly on the LOX end of the Intertank is shown in Figure 2. The skin/stringer panels utilize external hat-section stringers that are mechanically attached with rivets along most of their length and with specialty fasteners, such as GP Lockbolts and Hi-Loks, at the forward and aft ends where the stringers attach to the flange chords (as shown in the Figure 2 inset).

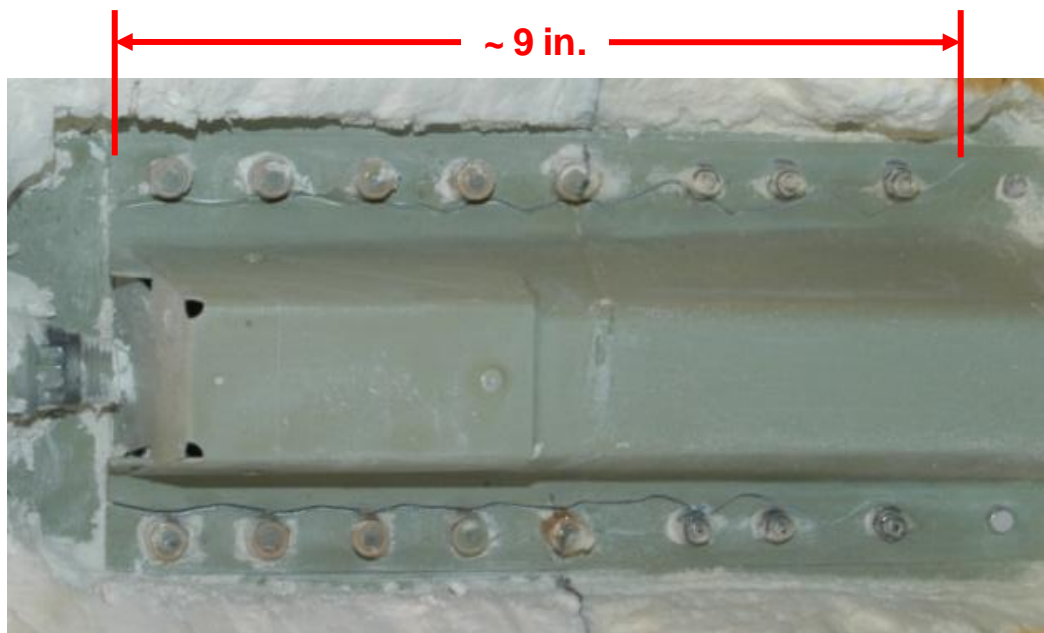
Figure 3. Cracks at LOX end of ET-137 stringer S7-2.

During the STS-133 Intertank stringer crack investigation, cracks were found on a total of five stringers. All of the cracks were at the LOX end, in the feet of the stringers, and near the forward fasteners (GP Lockbolts), as shown in Figure 3. Video of tanking for the November 5 launch attempt was used to determine that the TPS failure, and thus the stringer failure, occurred as the LOX liquid level crossed the LOX tank / Intertank interface ring frame. Hence, cryogenically-induced displacements were suspected as a contributing cause of the stringer cracks. To study the behavior of Intertank stringers subjected to similar displacements, static load tests of individual stringers, colloquially known as “single stringer bending tests” were performed. Approximately thirty stringers were tested, many of which were cut from the partially completed Intertank for what would have been ET-139⁴. In addition to the tests, finite element (FE) analyses of the test configuration were also performed. In this paper, the FE analyses and test-analysis correlation for stringer test S6-8 are presented. Stringer S6-8 is a “short chord” configuration with no doubler panels.

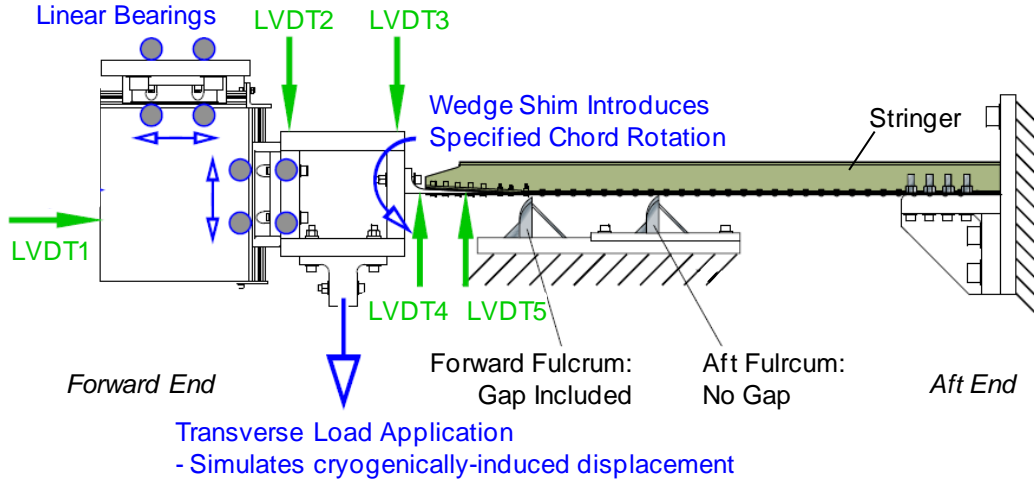
Figure 4. Single stringer bending test configuration.

The single stringer bending test configuration is shown in Figure 4. The test specimen is anchored to the test fixture at the aft end. At the forward end, the specimen is attached to the test fixture through a single bolt in the chord. The fixture at the forward end consists of two blocks mounted on linear bearings that allow for axial (i.e., the tank axial direction) and transverse (i.e., the tank radial direction) displacement but prevent free rotation of the chord. A specified rotation is applied to the chord by introducing a wedge-shaped shim between the chord and the fixture. A transverse load is applied to the fixture using a hydraulic jack to simulate the cryogenically-induced displacements. Two fulcras are mounted to the fixture on the skin side of

the specimen; the aft fulcrum is initially in contact with the specimen, while a small gap is initially present at the forward fulcrum. Linear variable-differential transformers (LVDTs) are mounted to both the fixture and the specimen, strain gages are installed on the stringer, and cameras are set up for photogrammetry measurements. The stringers are tested to failure.

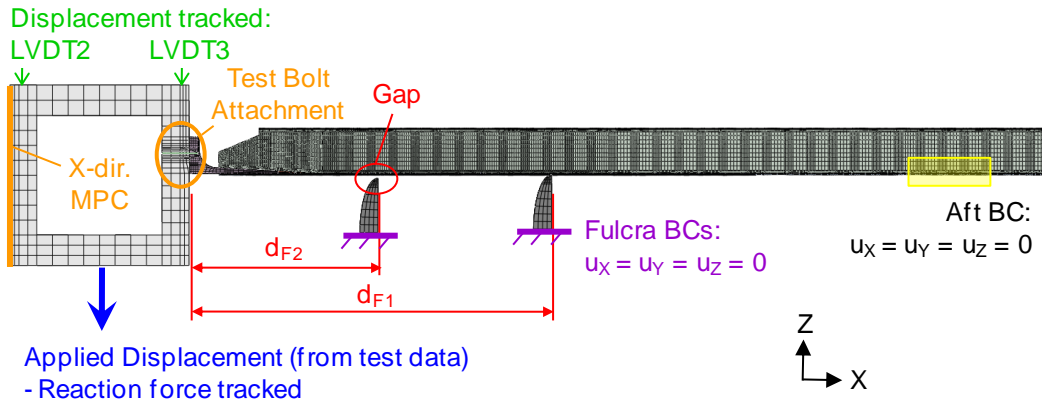
Figure 5. Finite element model of stringer S6-8 bending test configuration.

The finite element model for S6-8 is presented in Figure 5. The model is a three-dimensional (3D) model with solid elements. Only half of the test set-up is modeled to take advantage of symmetry about the X-Z plane. The load-application block of the forward fixture, with the wedge-shaped shim, is explicitly modeled in order to apply the chord rotation through a bolted connection (as in the actual test) and to track displacements and loads at the LVDT2, LVDT3, and applied load locations (as in the actual test). The fulcras are also explicitly modeled. The GP Lockbolts, Hi-Loks, and rivets, collectively referred to in this paper as the “stringer fasteners,” are explicitly modeled using beam elements and spider constraints.

A fixed boundary condition is assumed at the aft end of the model. On the forward face of the fixture, an X-direction multipoint constraint is included to reproduce the assumed displacement and rotation constraints of the actual test fixture. The chord is attached to the fixture through a bolt, called the “test bolt,” which is modeled with beam elements, spider constraints, and an assumed preload. The fulcra are assumed to be rigid in the actual test fixture, and hence fixed boundary conditions are applied to the bottom of the fulcra. The distances, d_{F1} and d_{F2} , from the forward chord face to the aft and forward fulcra, respectively, and the gap at the forward fulcrum were measured for each individual test and are explicitly included in the FE model. The transverse displacement measured at failure during the test is applied to the bottom of the forward fixture.

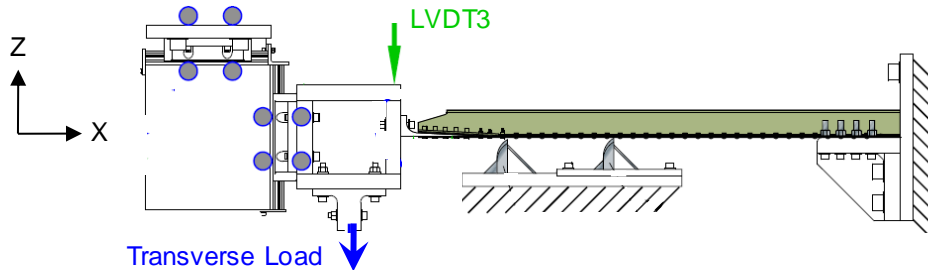
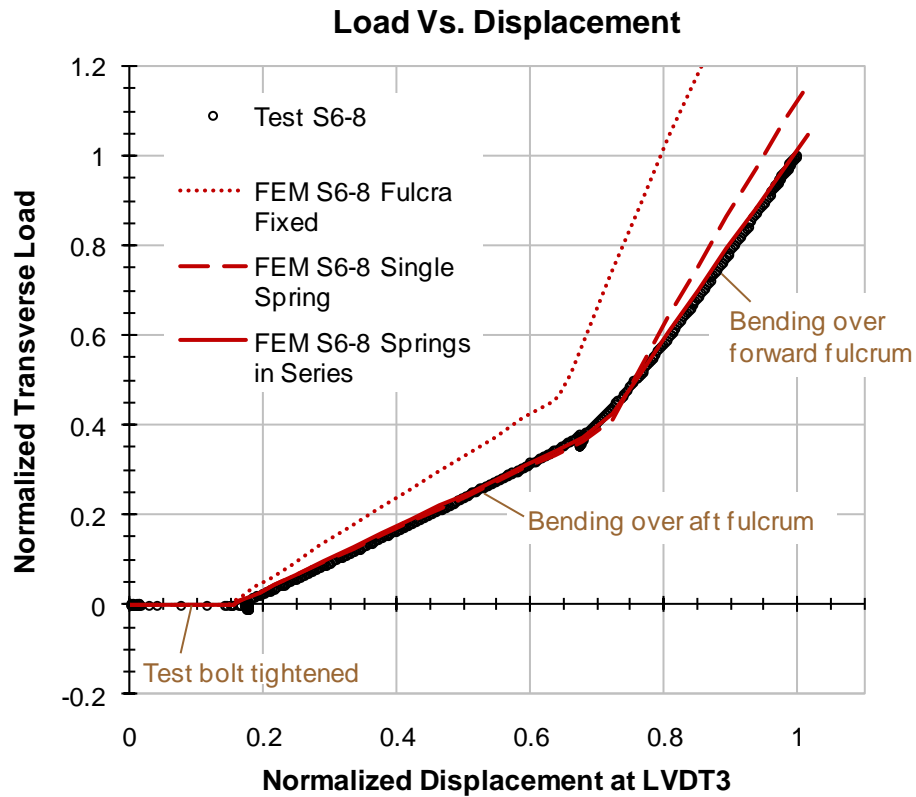
The global load-displacement response of the finite element model is compared to the test data in Figure 6. All of the plots are normalized by the LVDT3 displacement and transverse load

measured at failure during the test. The test data are represented by the open black circles. The initial response with zero slope represents the introduction of the chord rotation through the tightening of the test bolt, which also induces some transverse displacement. The first non-zero sloped region of the curve represents bending over the aft fulcrum, and the second sloped region represents bending over the forward fulcrum.

The dotted red line is the response from the FE model with assumed fixed boundary conditions for the fulcrum. As shown by this line, the FE model is overly stiff in the Z direction. The source of the additional Z-direction stiffness is determined to be due to the rigid fulcrum assumption. To account for compliance in the test fixture in the region where the fulcrum are mounted, the boundary conditions for the fulcrum in the FE model are modified. First, both fulcrum are connected to a single spring with an assumed stiffness, as shown in Figure 7(a). The global load-displacement response for this configuration is shown by the red dashed line in Figure 6. The

results for bending over the aft fulcrum are very closely captured; however, the model is still overly stiff for bending over the forward fulcrum. Therefore, the model is modified again: a second spring in series is used for the forward fulcrum, as shown in Figure 7(b). The global load-displacement response for this configuration is shown by the solid red line in Figure 6. The correlation with the test data is excellent.

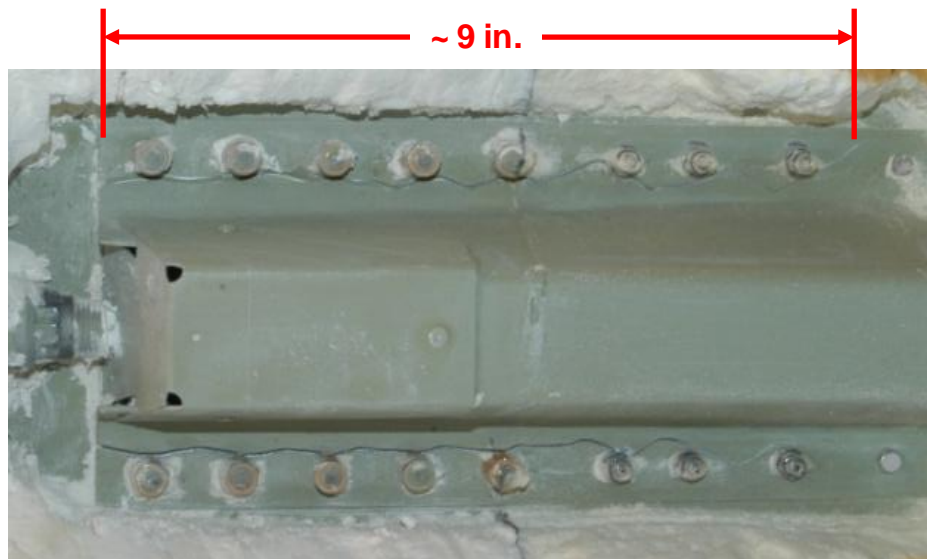
Figure 3. Cracks at LOX end of ET-137 stringer S7-2.

During the STS-133 Intertank stringer crack investigation, cracks were found on a total of five stringers. All of the cracks were similar to those shown in Figure 3, differing primarily in length, occurring at the LOX end, in the feet of the stringers, and near the forward fasteners (GP Lockbolts). Launch pad video of tanking for the November 5 launch attempt was used to determine that the TPS failure, and thus the stringer failure, occurred as the LOX liquid level crossed the LOX tank / Intertank interface ring frame.

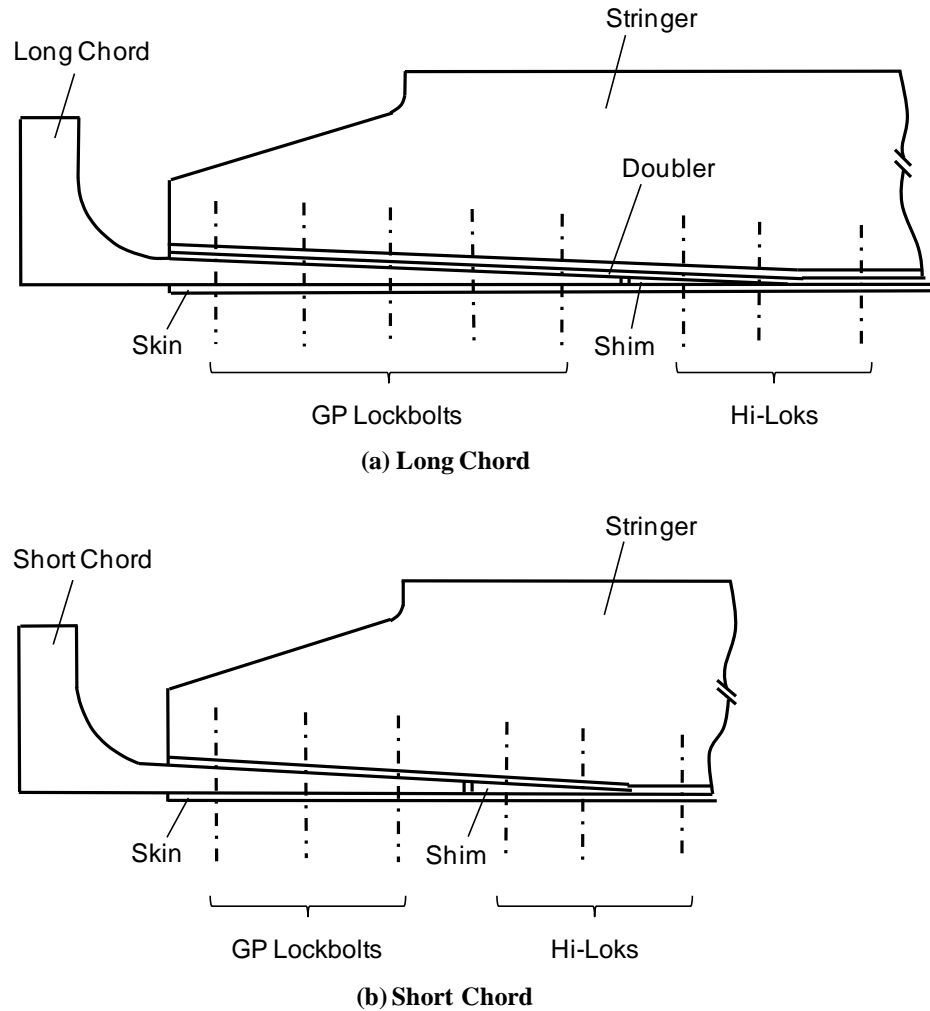
Figure 5. Long- and short-chord configurations.

All of the Intertank flange chords have the same basic L-section shape, as shown in Figure 5, but the length of the axial leg (under the stringers) is longer for some chords than for others. Specifically, the forward chords of the four stringer panels adjacent to the thrust panels have a longer axial leg to accommodate the doubler skins on those panels. These chords are called “long chords” (Figure 5(a)). The forward chords on the remaining two stringer panels and the aft chords for all of the stringer panels have a shorter length axial leg. These chords are called “short chords” (Figure 5(b)). Bending tests were performed for both long-chord and short-chord configurations.

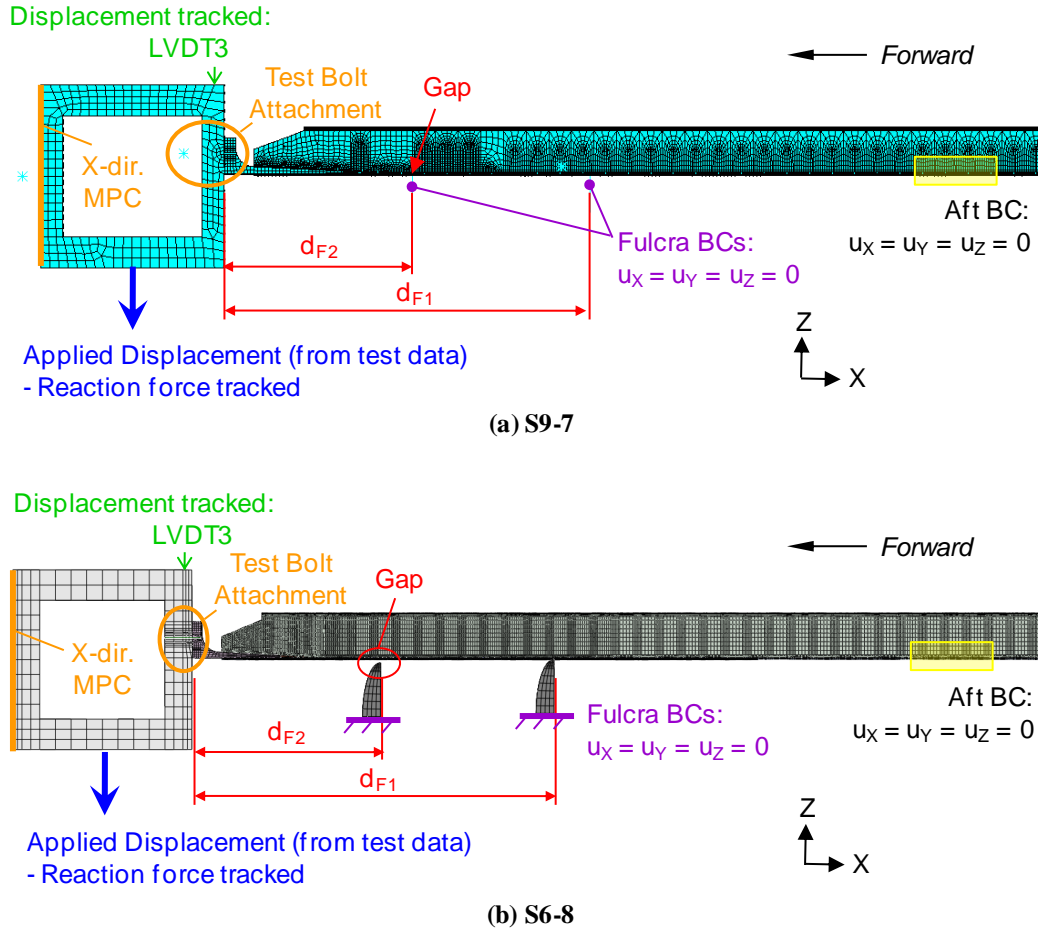
Figure 6. Finite element models of stringer bending test configurations.

The finite element models for stringers S9-7 and S6-8 are presented in Figure 6. Both models were three-dimensional (3D) models with solid elements. For S9-7, the chord, extruded shim, and skin were modeled as a single part, while for S6-8, each part was modeled separately. Only half of the test set-up was modeled to take advantage of symmetry about the X-Z plane. The load-application block of the forward fixture, with the wedge-shaped shim, was explicitly modeled with meshed geometry to realistically model the contact and preload at the bolted block/shim/chord interface and also to track displacements and loads at the LVDT3 and applied load locations (as in the actual test). The GP Lockbolts, Hi-Loks, and rivets, collectively referred to in this paper as the “stringer fasteners,” were explicitly modeled using beam elements, spider constraints, and preloads.

A fixed boundary condition was assumed at the aft end of both models. On the forward face of the load block, an X-direction multipoint constraint was included to reproduce the free translation and fixed rotation constraints provided by the actual test fixture. The chord was attached to the load block through a bolt, called the “test bolt,” which was modeled with beam elements, spider constraints, and a preload estimated from the known torque. The fulcras were initially assumed to be rigid in the actual test fixture, and hence fixed boundary conditions were applied to the bottom of the fulcras. The gap at the forward fulcrum was measured for each individual test and was explicitly included in the FE models. The transverse displacement measured at failure during the test was enforced at the load block to deflect the stringer over the fulcras.

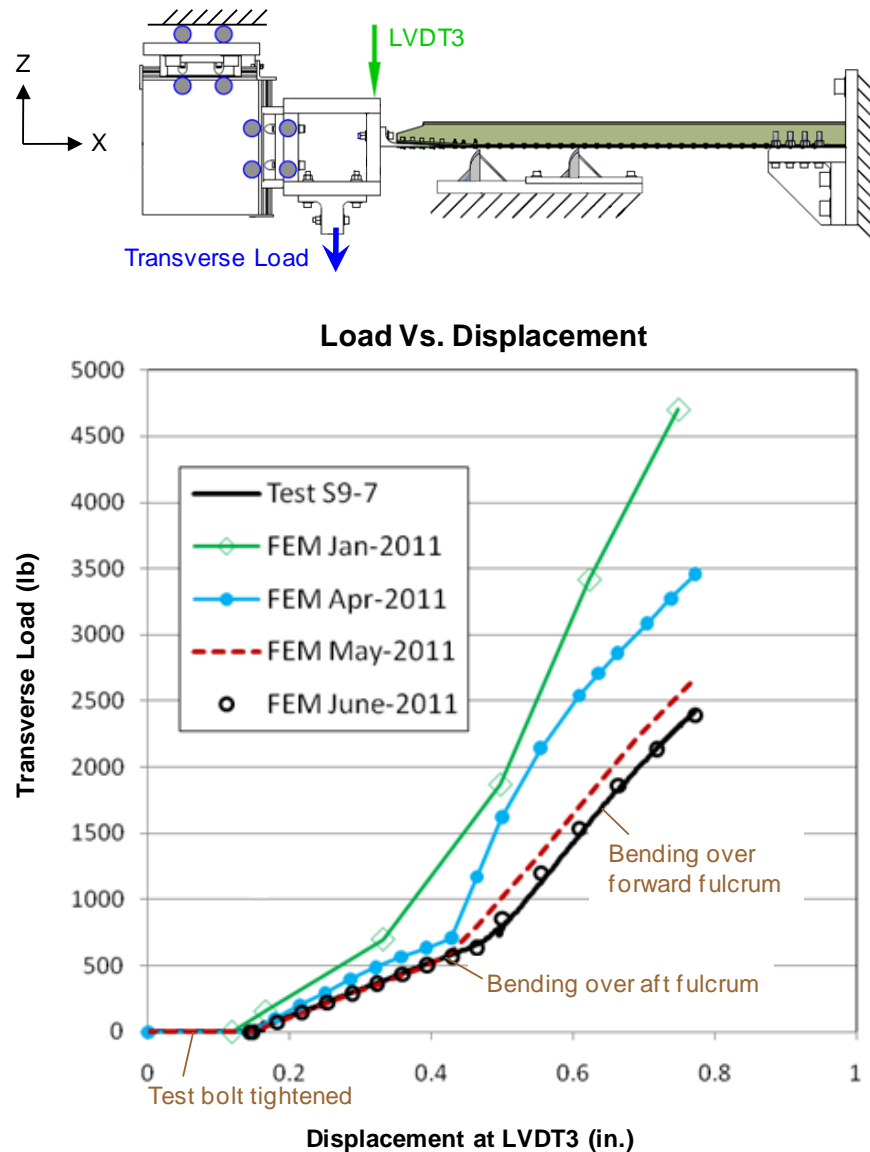
Figure 7. Global load-displacement response for S9-7.

The figure shows how correlation was improved as modeling assumptions were changed. The green curve labeled Jan-2011 shows results from an earlier model without fully developed fastener representations. The blue curve labeled Apr-2011 shows the results for the modeling details described in the previous section with the assumed fixed BCs for the fulcrum. As shown by this line, the FE model was overly stiff in the Z direction. The source of the additional Z-direction stiffness was determined to be due to the rigid fulcrum assumption. This conclusion was supported by limited test data obtained late in the test program. To account for compliance in the test fixture in the region where the fulcrum were mounted, the boundary conditions for the fulcrum in the FE model were modified. First, both fulcrum were connected to a single spring with an assumed stiffness, k , as shown in Figure 8(a). Additionally, the elastic modulus of the stringer-skin aluminum was tweaked to match that from data from a parallel materials testing effort [4]. The value for k was tuned until the best possible correlation to the test data was achieved. The global load-displacement response for this configuration is shown by the red dashed line labeled May-2011 in Figure 7. The results for bending over the aft fulcrum were very closely captured; however, the model was still overly stiff for bending over the forward fulcrum. Therefore, the model was modified again: a second spring in series was used for the forward fulcrum, as shown in Figure 8(b), with k_1 initially equal to k , and the assumed stiffness values for k_1 and k_2 were tuned until the best possible correlation to the test data was achieved. The global load-displacement response for this configuration is shown by the black open circles labeled June-2011

in Figure 7. The values for k_1 and k_2 are 15205 lb/inch and 30000 lb/inch, respectively. The correlation with the test data is excellent.

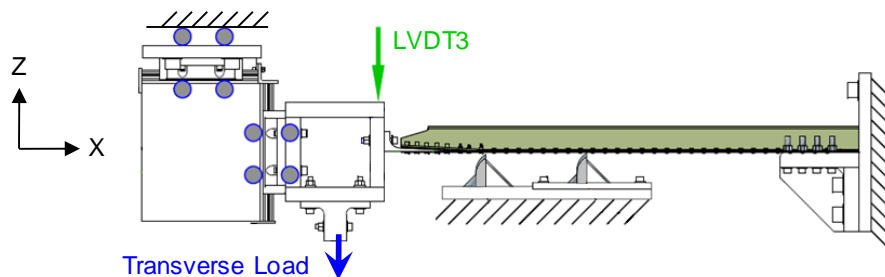
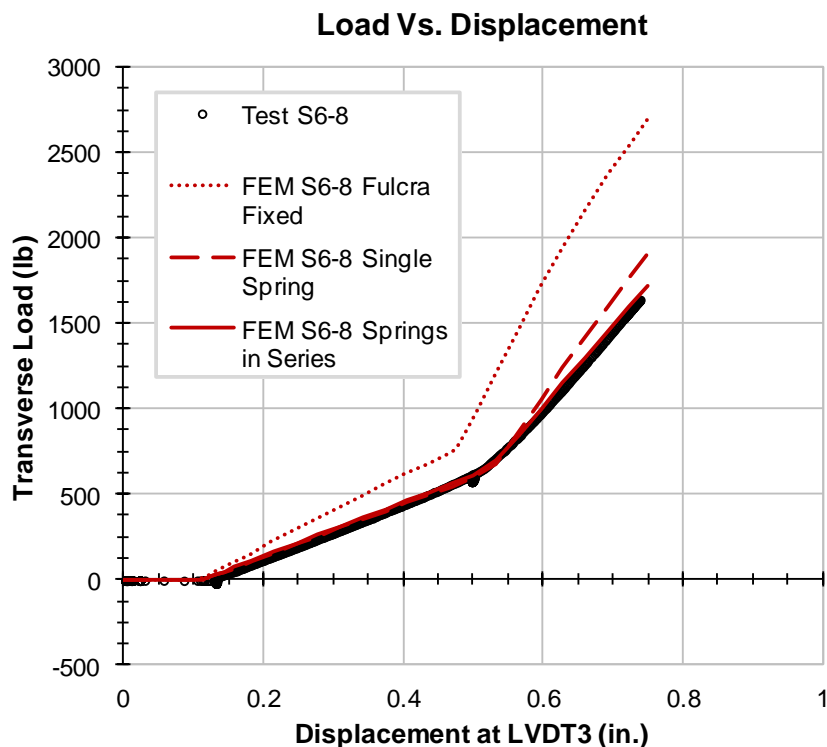
Figure 9. Global load-displacement response for S6-8.

Similarly, the global load-displacement response of the FE model for S6-8 is compared to the corresponding test data in Figure 9. The test data are represented by the open black circles. The dotted red line is the response from the FE model with fixed boundary conditions assumed for the fulcrum; the model was overly stiff in the Z direction. The dashed red line is the response from the FE model with both fulcrum mounted to a single spring; correlation to bending over the aft fulcrum was achieved. The solid red line is the response from the FE model with the fulcrum mounted on springs in series. The values for k_1 and k_2 are 11000 lb/inch and 34000 lb/inch, respectively. Correlation with the test data is excellent.

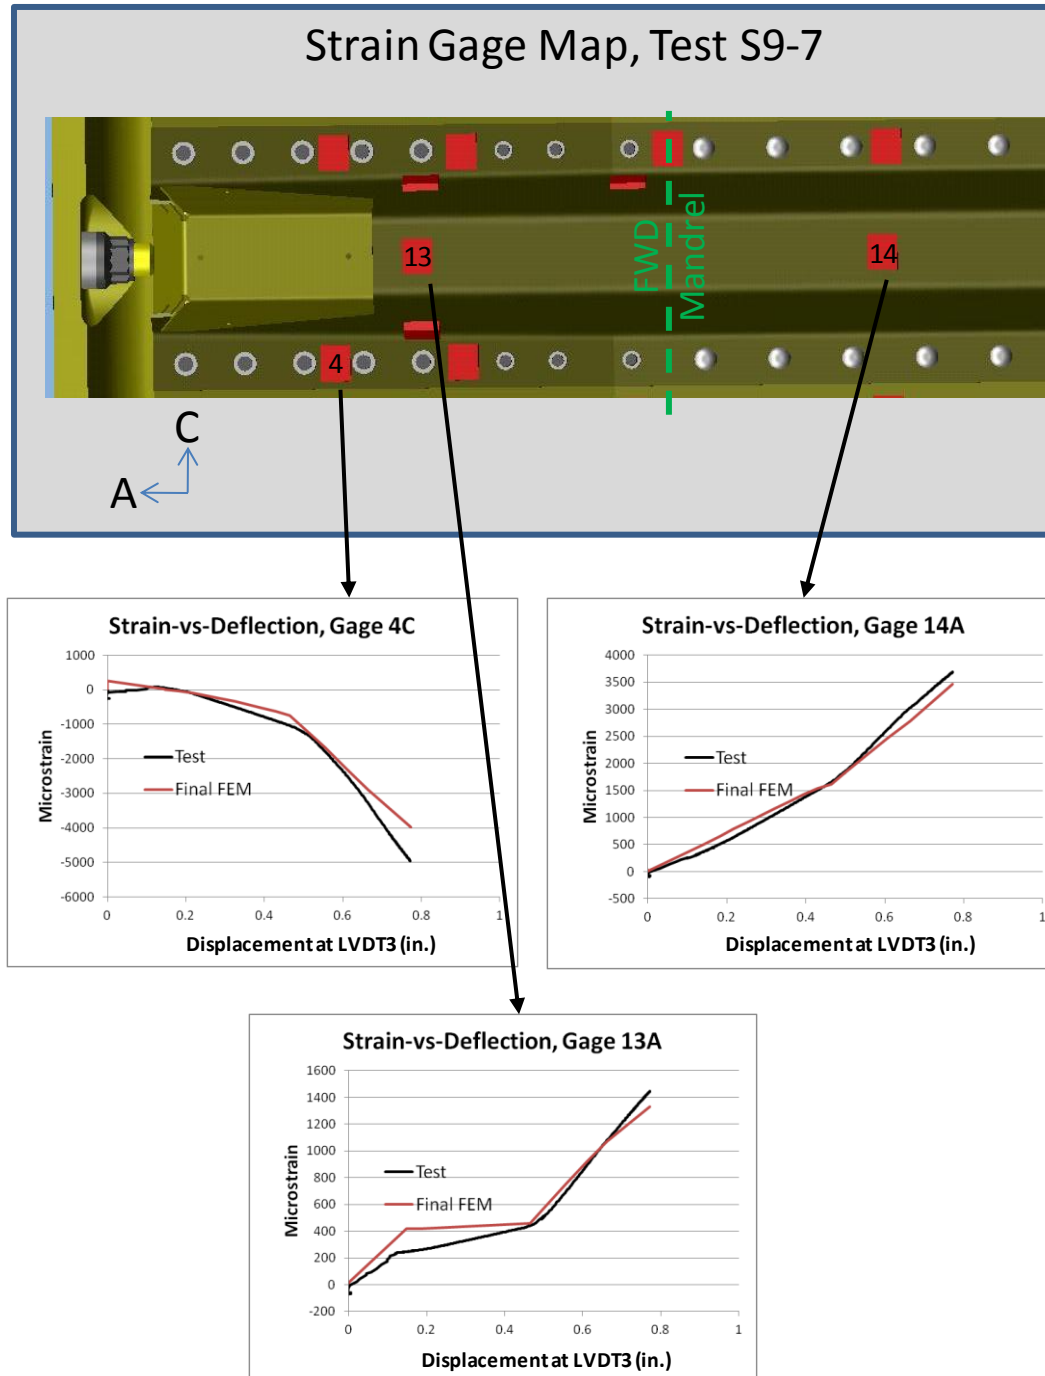
Figure 10. Strain gage comparisons for S9-7.

Figures 10 and 11 present strain gage comparisons from the correlated FE models (i.e., with the fulcrum mounted on springs in series) for S9-7 and S6-8, respectively. The correlation with the test data is excellent.

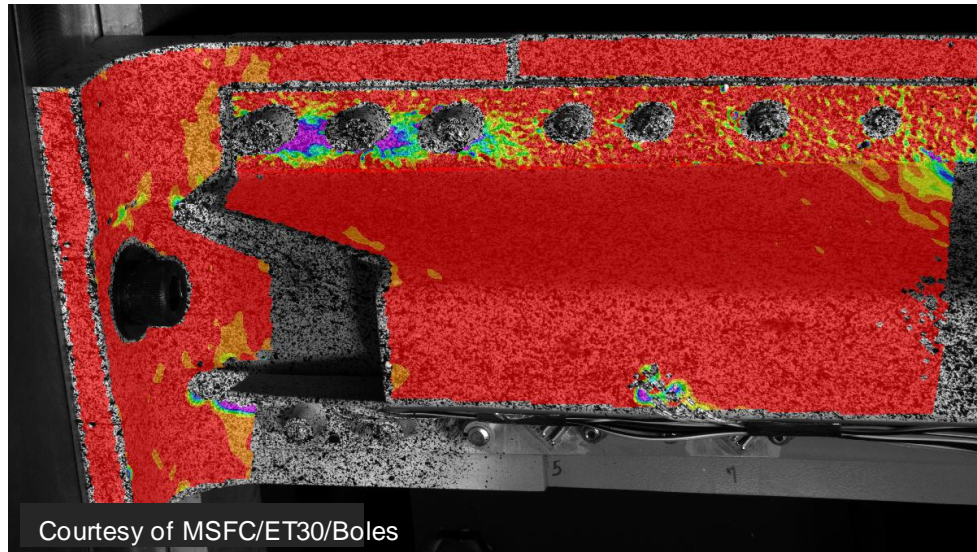
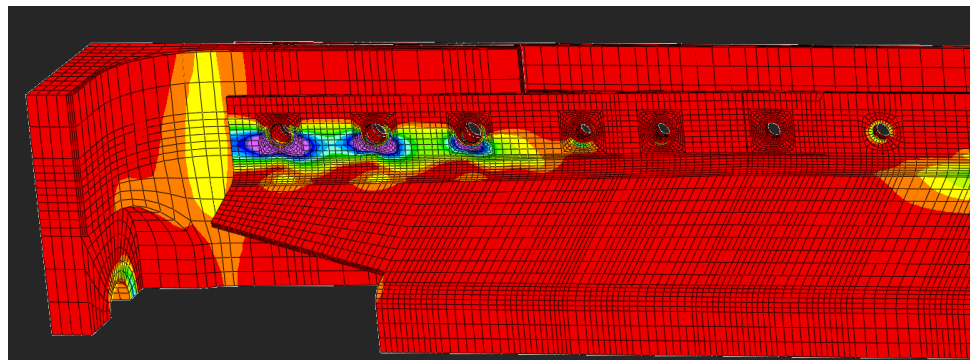
Figure 12. Photogrammetry comparison for S6-8: minimum principal strain at imminent failure.

Figure 12 presents photogrammetry comparisons from the correlated FE model for S6-8. The correlation with the test data is excellent.

The effect of the radius blocks is demonstrated in Figure 21. The strain at imminent failure of S6-8 (see Figure 12) is compared to the strain of S8-8 for the same applied transverse displacement (see Figure 20). Note the decrease in strain around the forward-most fastener. The extent of the area of high microstrain is much smaller for the stringer with the radius block, and the strain level over part of that area decreases from approximately -10000 microstrain to as low as -5000 microstrain. Also note the additional capability demonstrated by comparing the load-displacement results; the stringer with the radius block carried more load before rupture.

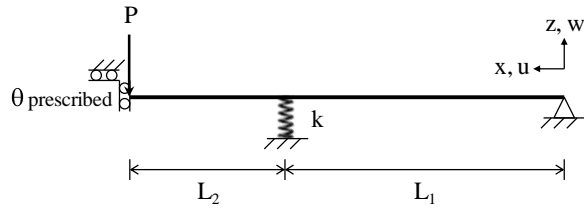
Figure 13. Simple beam resembling test configuration.

As mentioned previously, the key to analysis correlation to the single stringer bending test data turned out to be the correct application of boundary conditions at the two fulcrums. After many iterations with the 3D solid model, it became increasingly evident, as originally thought, that the behavior of the stringer should approximate that of a simple beam with appropriate boundary conditions. For example, for bending over the aft fulcrum up until the point of contact with the forward fulcrum, the test resembled the simple beam depicted in Figure 13. The beam is simply supported at one end, has an applied rotation and load at the other end, and is propped by a spring in the middle.

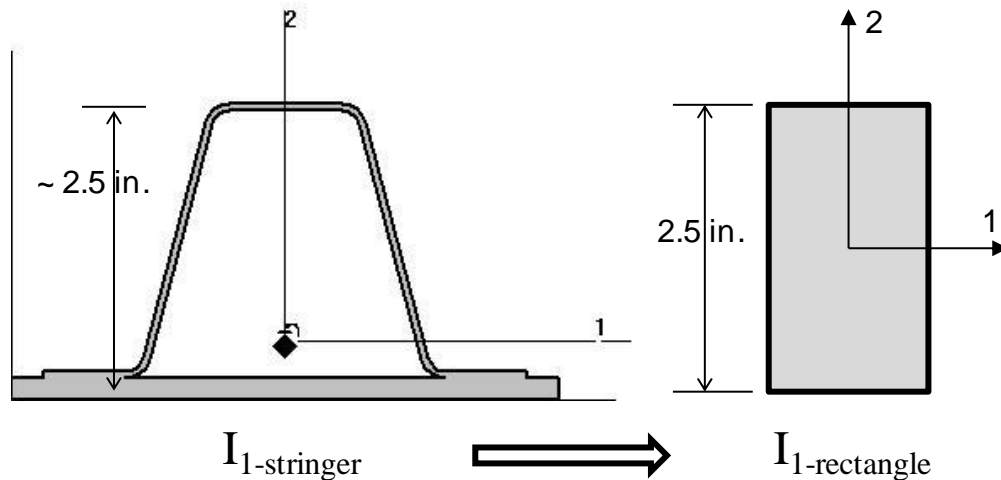
Figure 14. Cross-sections and moments of inertia for simple 1D finite element model of S6-8.

To confirm this idea for stringer S6-8, a simple finite element model, consisting of 1D beam elements, was constructed. The beam element cross-section was rectangular with a moment of inertia equivalent to that of the stringer-skin cross-section, as shown in Figure 14. The fulcrum boundary condition definition included two springs in series, as discussed for the 3D solid model. The gap at the forward fulcrum was represented with a single gap element. Linear, elastic analysis with incremental load steps was performed.

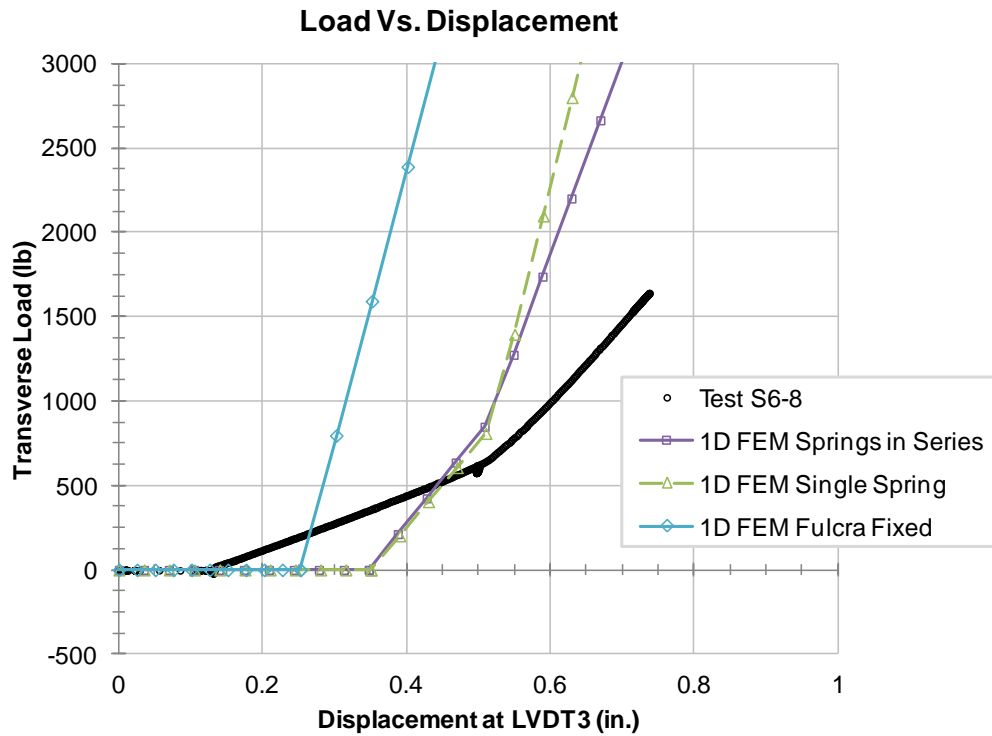
Figure 15. FE comparison of simple model of S6-8 to test data for load vs. displacement.

The FE results for load vs. displacement are compared to the test data for S6-8 in Figure 15. The results for the model with the single spring and rigid fulcrum boundary conditions are also presented in the figure. While the simplified model does not correlate well with the test data, some important observations are made. First, the model captures the two kinks in the load-displacement curve where bending over the fulcrum occurs. Second, the results are on the same order of magnitude as the test data and the various permutations of the 3D solid FE models. Third, the three boundary conditions show the same trend as observed from the 3D solid models; i.e., the correlation improves as the BC is modified from the rigid assumption to include the springs in series. Finally, note that the initial flat regions of the FE curves, which represent the tightening of the test bolt and rotation of the chord against the wedge-shaped shim of the load block, overshoot that of the test data. This result is easily explained. The simplified FE model assumes a constant cross-section, consistent with the stringer-skin cross-section, along the entire length of the test specimen, thus ignoring the contribution of the chord to the moment of inertia at the forward end of the test specimen.

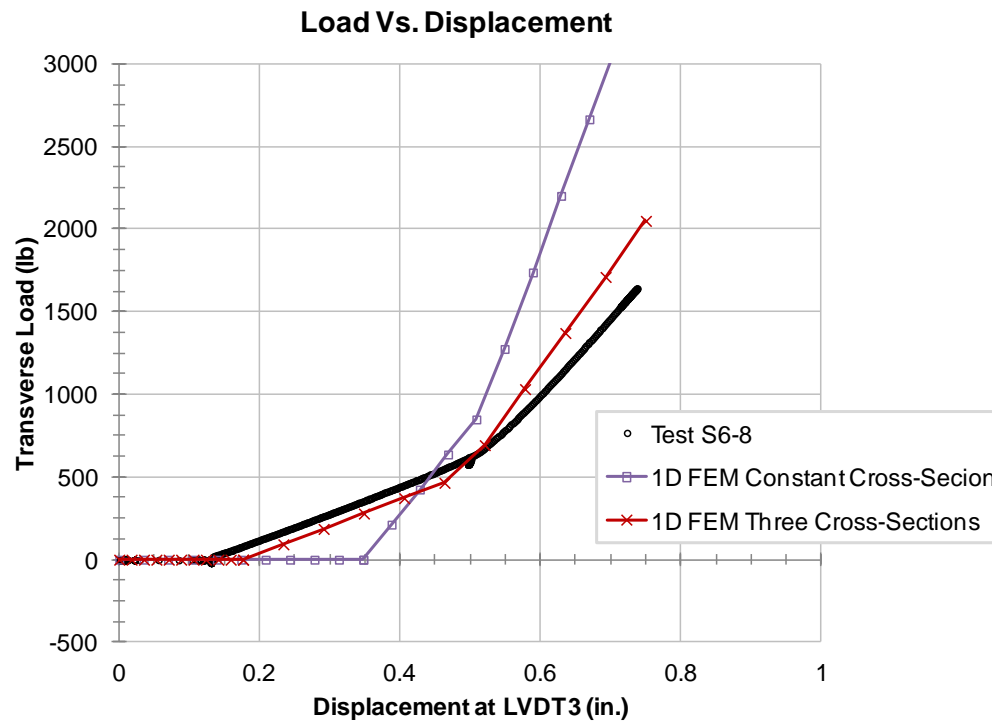
Figure 16. FE comparison of simple model with three cross-sections to test data for load vs. displacement.

To improve the correlation of the simple FE model to the test data, the model was modified to use three separate cross-sections. The beam elements representing a majority of the length of the skin-stringer used a box-shaped cross-section with a moment of inertia consistent with that of the actual cross-section. Similarly, the beam elements over the forward end of the chord and the transition region between the chord and stringer used rectangular cross-sections with moments of inertia consistent with their respective 3D counterparts. The FE results for this model are compared to the test data in Figure 16. The correlation is very good, demonstrating that the simple model with appropriate boundary conditions captured the global behavior well.

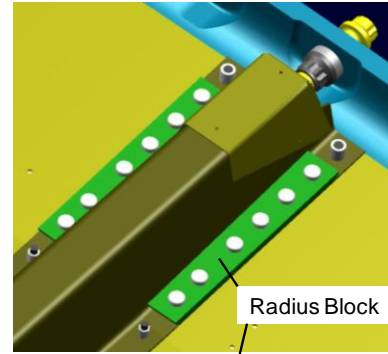
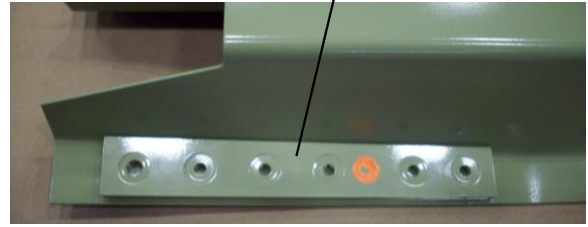
Figure 17. Radius block repair.

ET-137 was repaired by installing radius blocks on all of the stringers on the LOX end of the Intertank. The radius block repair is shown in Figure 17. Radius blocks are pieces of aluminum installed on top of the stringer feet and intended to increase the capability of the stringers to prevent cracking due to the cryogenically-induced displacements.

As part of the single stringer bending tests, stringers with radius blocks installed, including the short-chord stringer S8-8, were also tested. To create an FE model for the S8-8 bending test, the correlated FE model for S6-8 was modified to include radius blocks, and the analysis was repeated. The global load-displacement response, strain gage comparisons, and photogrammetry comparisons are presented in Figures 18, 19, and 20, respectively. The correlation with the test data is excellent. These results further confirm that the compliant fulcrum BC is not a problem-specific fix, but rather the key to achieving correlation with the test data.

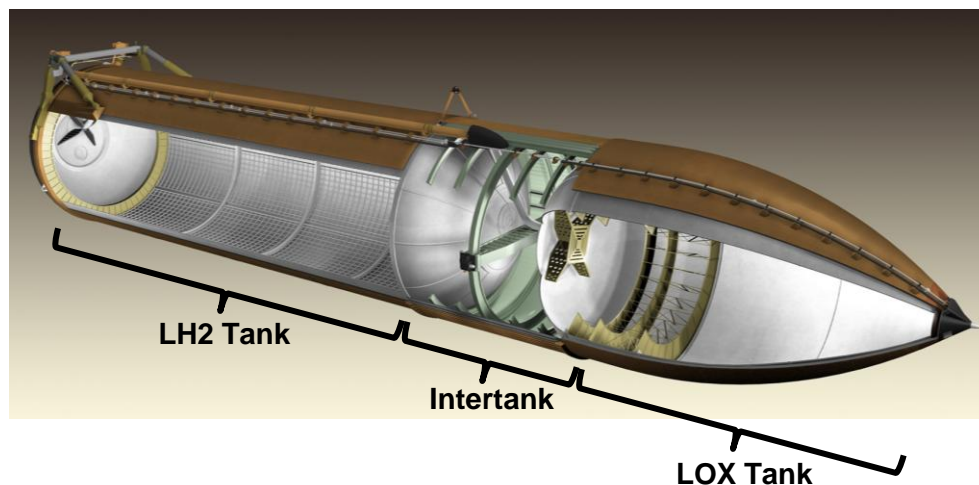
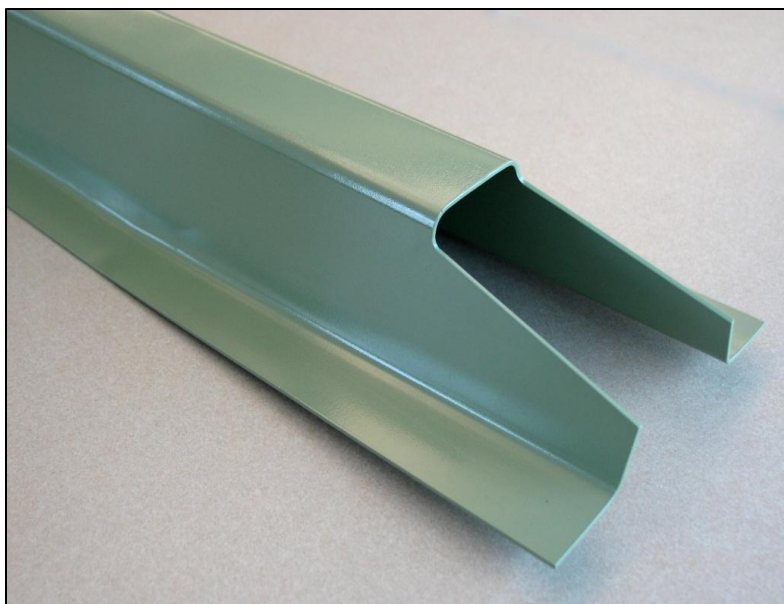
External Tank Intertank Stringers

- Al-Li 2090 Roll Formed Hat Stringers
- 0.063-in. nominal thickness

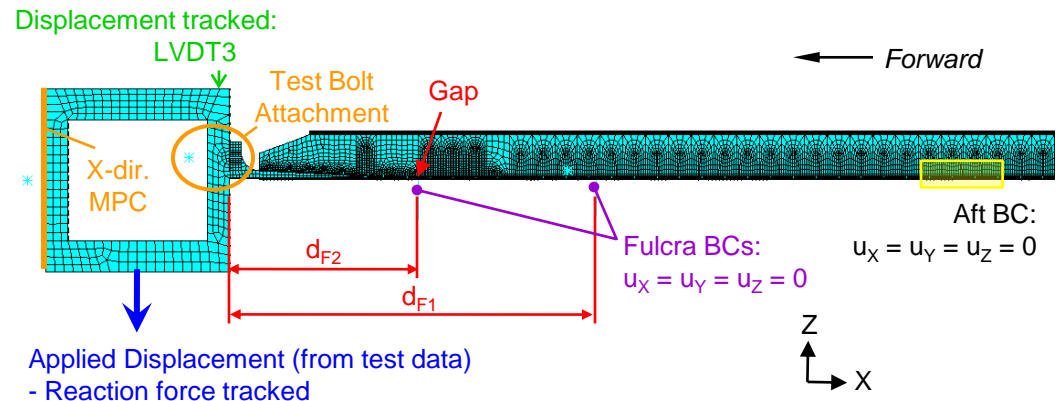
S9-7 (Long Chord)

- Analyst: Joe
- ANSYS v12
- Solid185 elements, 2ttt
- Fulcra as gap elements

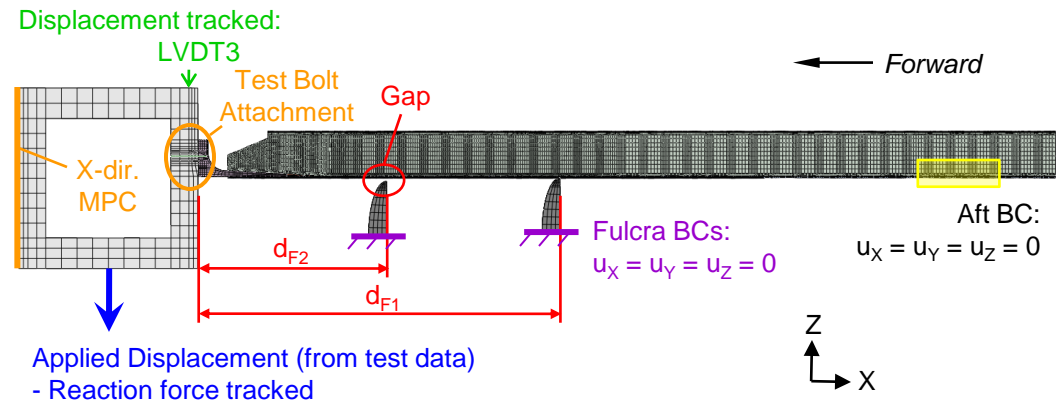
S6-8 (Short Chord)

- Analyst: Dawn
- ABAQUS v6.9-EF
- C3D8I elements, 4ttt
- Fulcra as meshed geometry

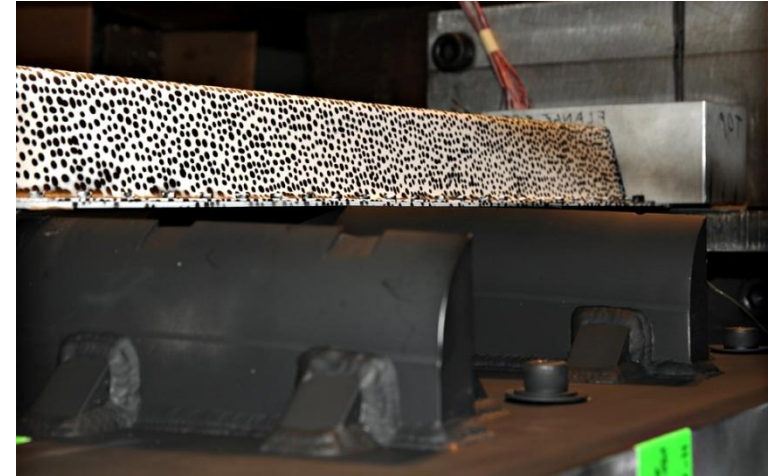
Original assumption – fulcra rigidly mounted
 → FE model overly stiff in Z direction

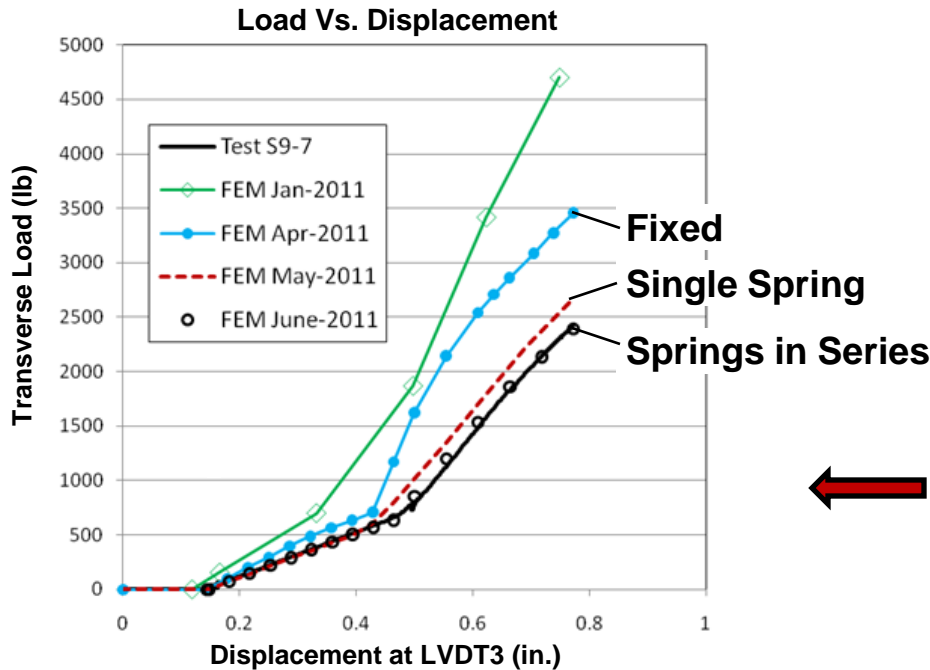
Springs in Series

Fulcra mounted to plate/truss system
 that may not be rigid
 → Modify Fulcra BC

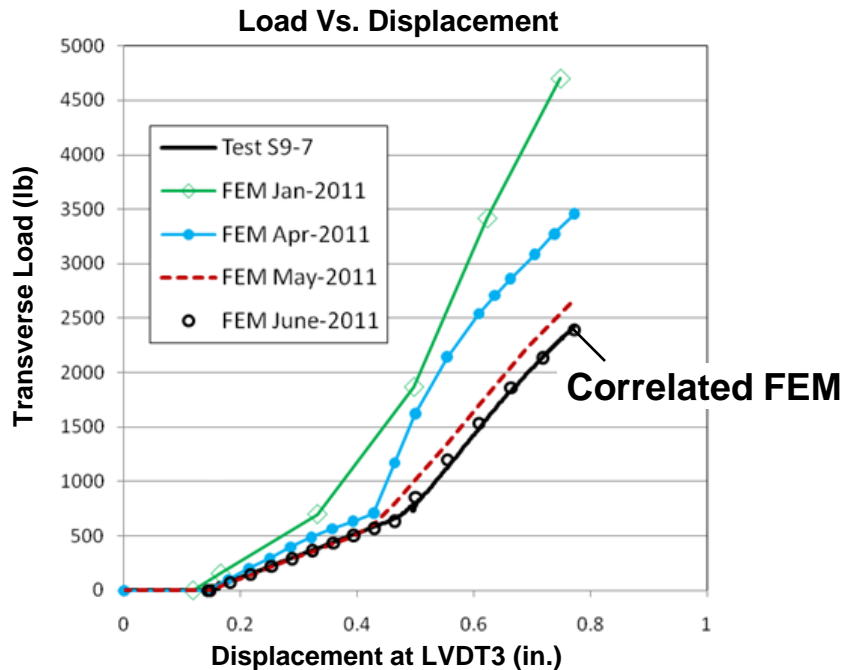
S9-7 (Long Chord)

● Different stringer geometries, different analysts, different FE models, different analysis codes, etc...

→ Final values for fulcrum BC spring stiffness very similar for S9-7 and S6-8

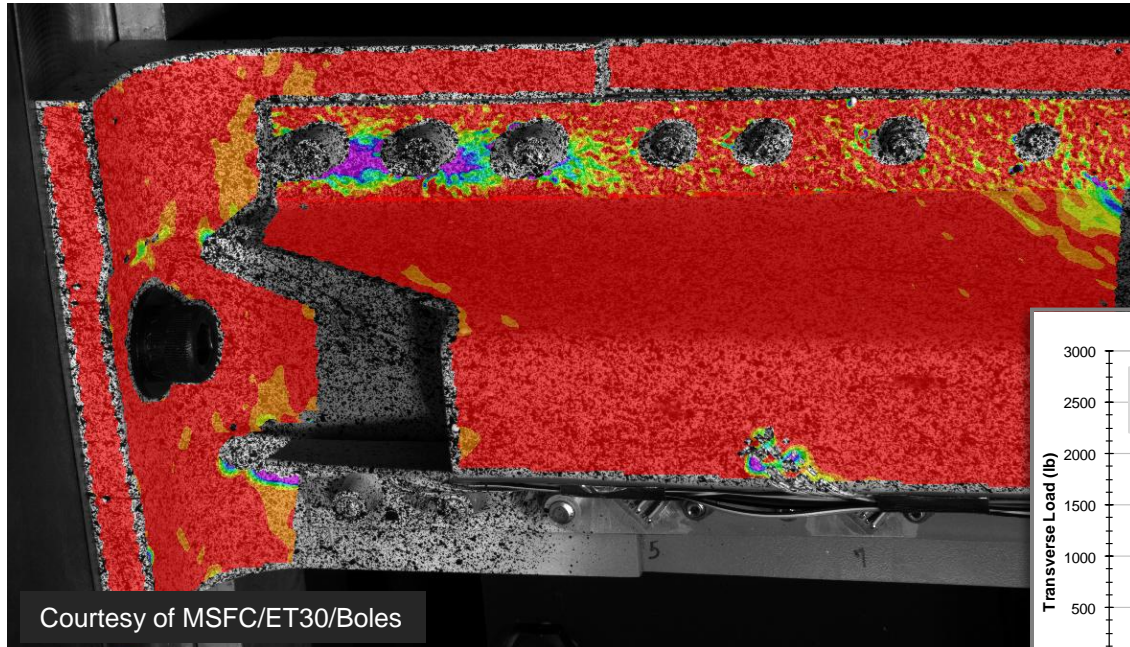
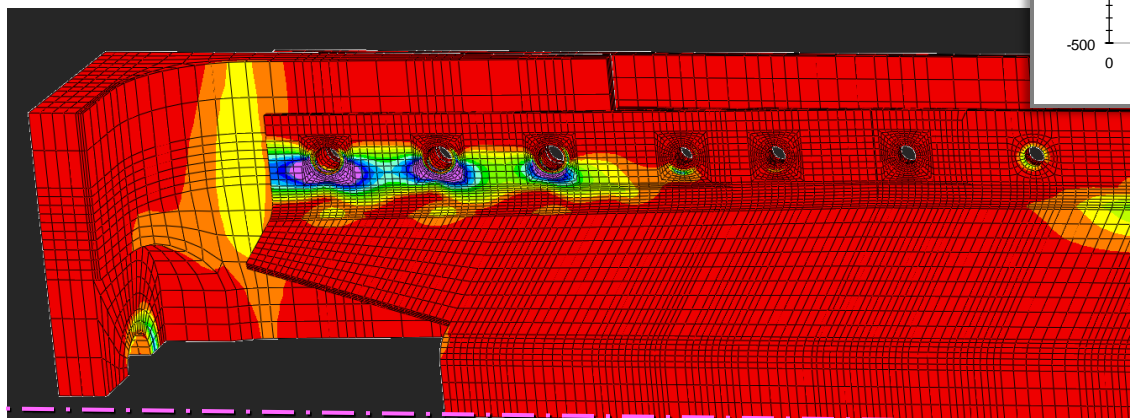
S6-8 (Short Chord) Photogrammetry Comparison

Minimum Principal Strain at Imminent Failure
