Test-Analysis Correlation of the Single Stringer Bending Tests for the Space Shuttle ET-137 Intertank Stringer Crack Investigation

Dawn R. Phillips¹, Joseph B. Saxon², and Robert J. Wingate³
NASA Marshall Space Flight Center, Huntsville, AL

Extended Abstract of Proposed Paper for the 53rd AIAA/ASME/ASCE/AHS/ASC Structures, Structural Dynamics, and Materials Conference, April 23-26, 2012, Honolulu, Hawaii

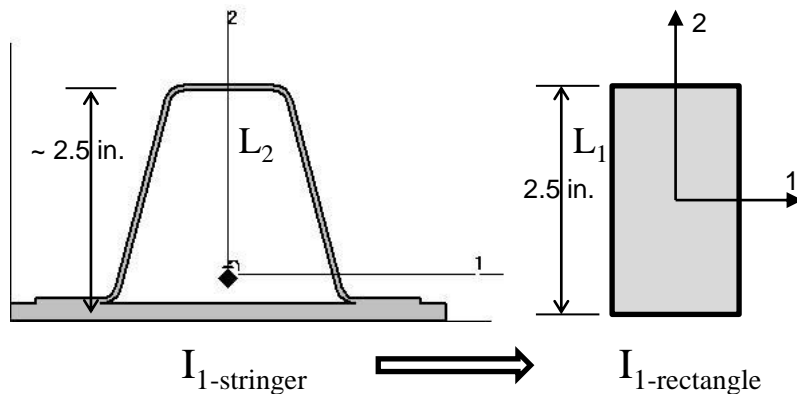
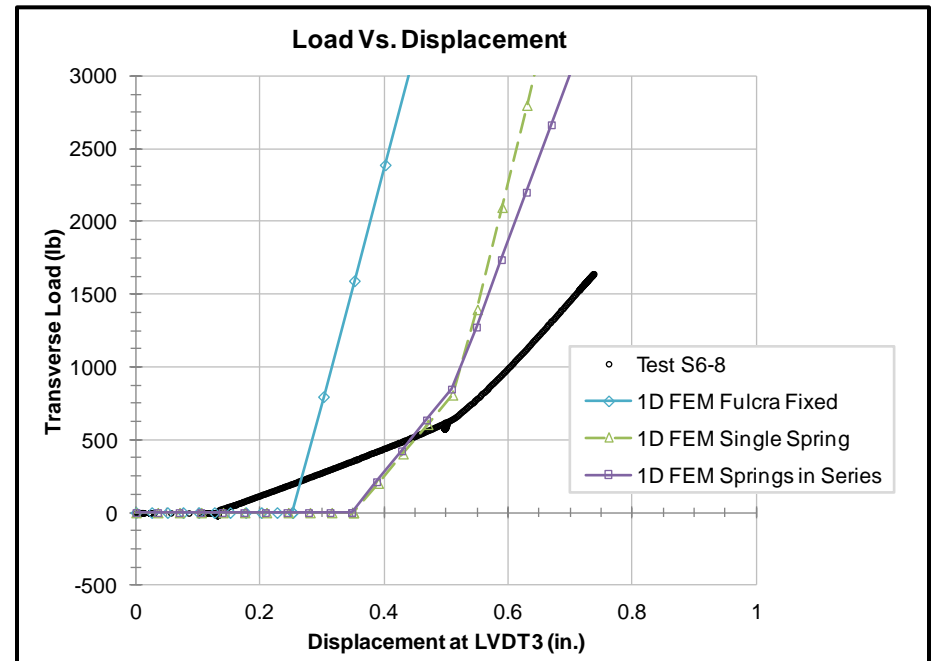
Finite element model for S6-8 (short chord):

- 20 1D beam elements
- Gap element at forward fulcrum
- Linear, elastic
- Applied displacement

● Boundary condition trend is demonstrated

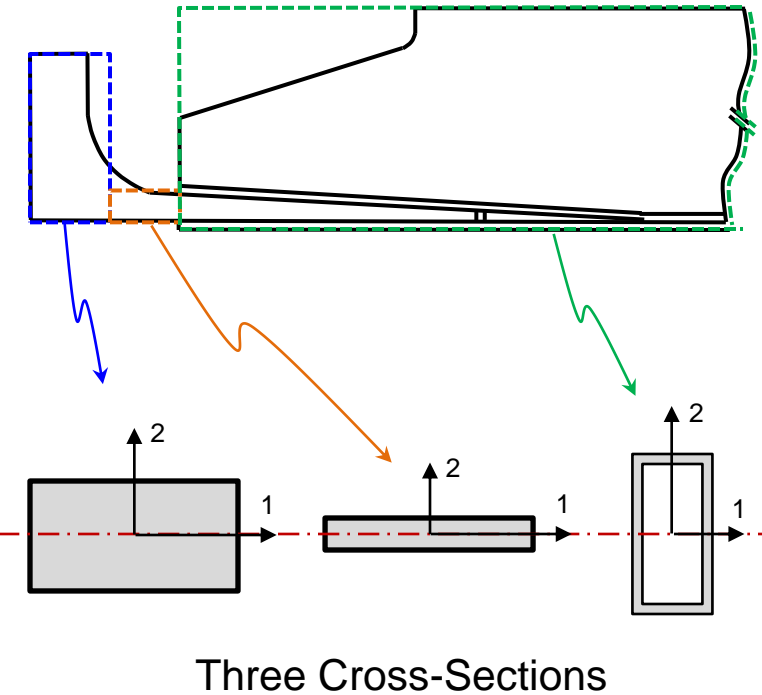
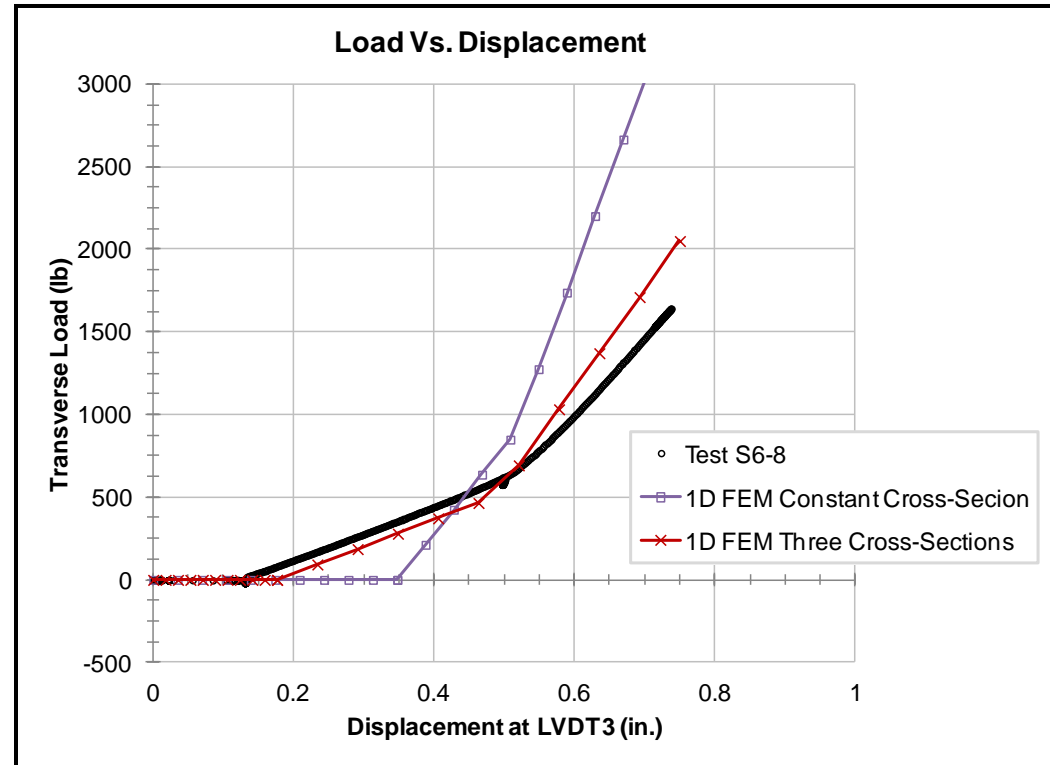
Analysis Using Beam Modeling

● Beam model captures global behavior well

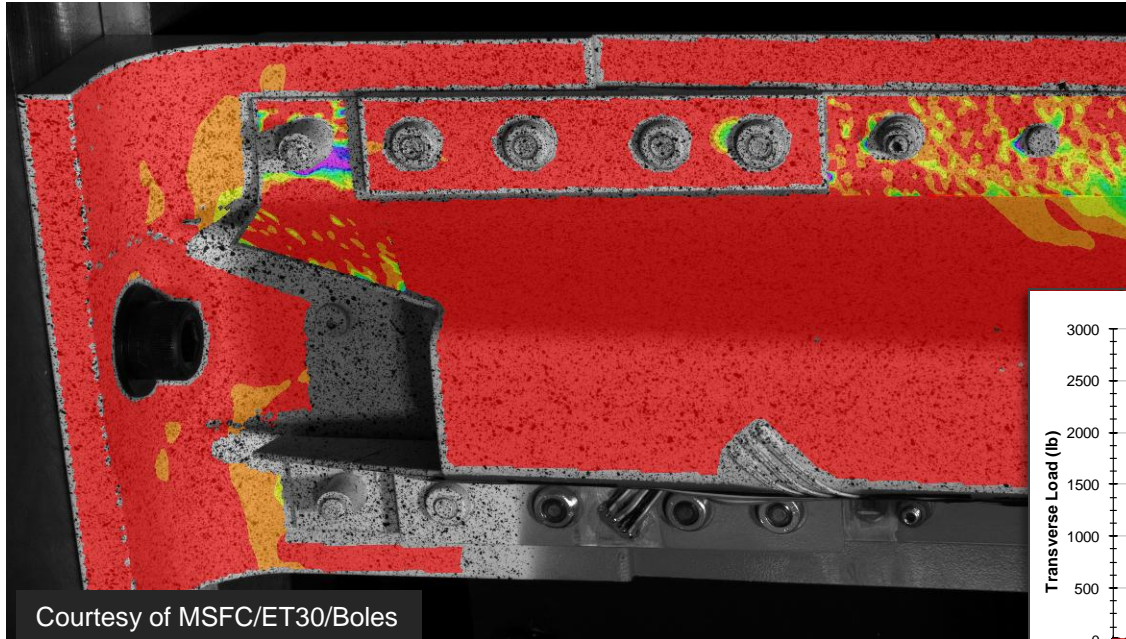
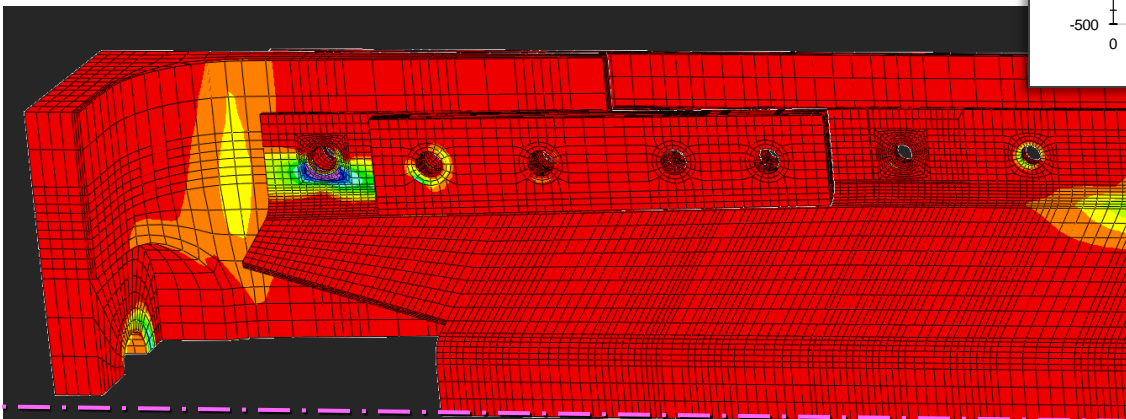
S8-8 Photogrammetry Comparison

Minimum Principal Strain at 0.75 in. LVDT3 Displacement (Imminent Failure of S6-8)

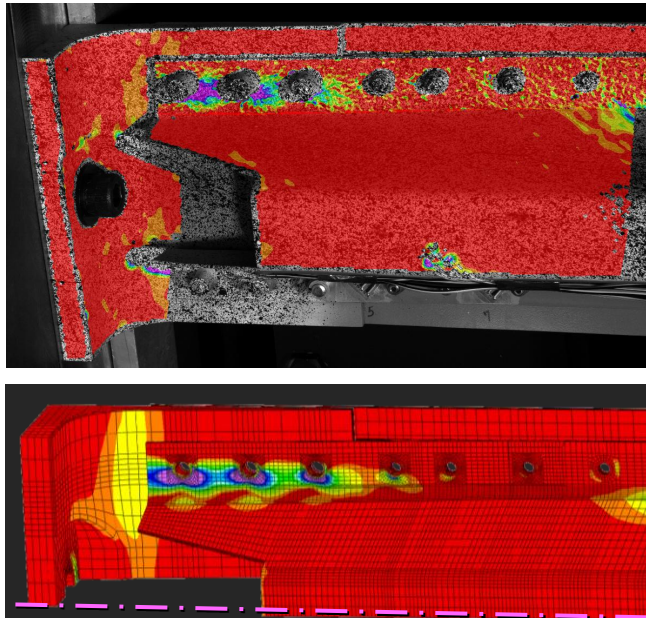
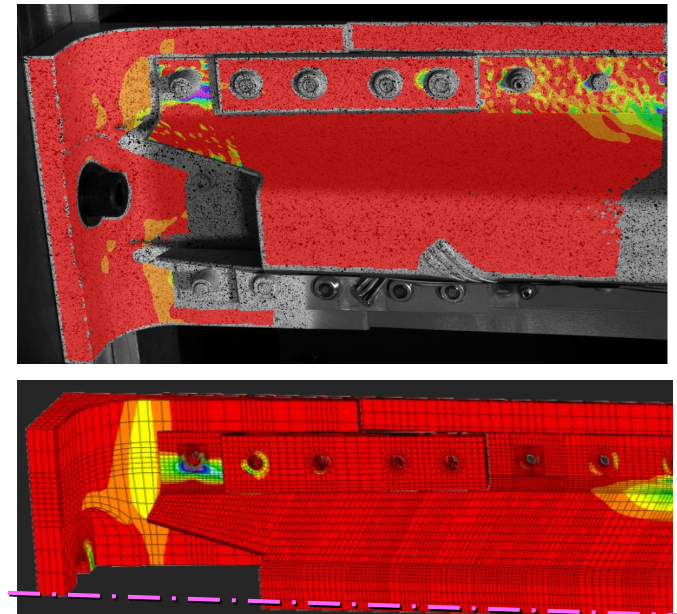
S6-8 (No Radius Blocks)

S8-8 (With Radius Blocks)
